EQC CLAIM DOCUMENTATION CAVITY CRITTER REPORT

Under floor Inspections

Property address: 191 Westminster Street

Date: 26 July 2017

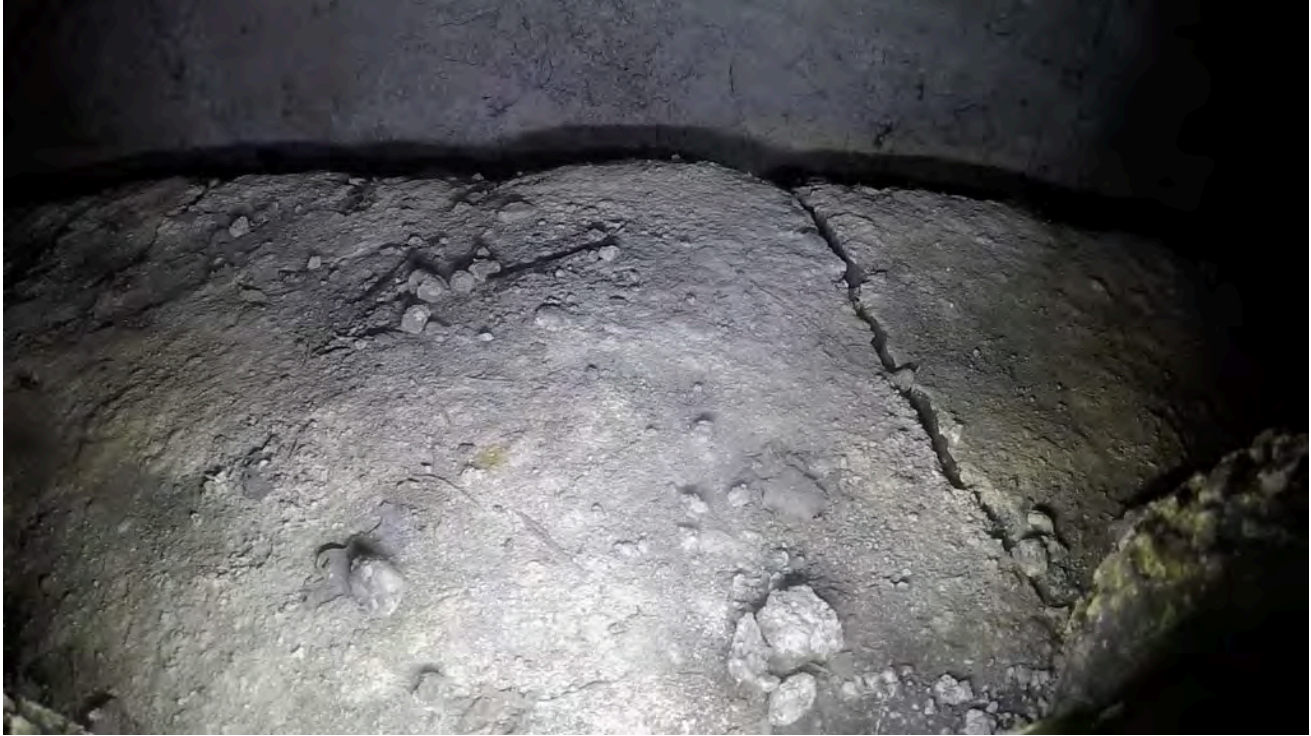
9: Large ground crack heading towards the foundation.

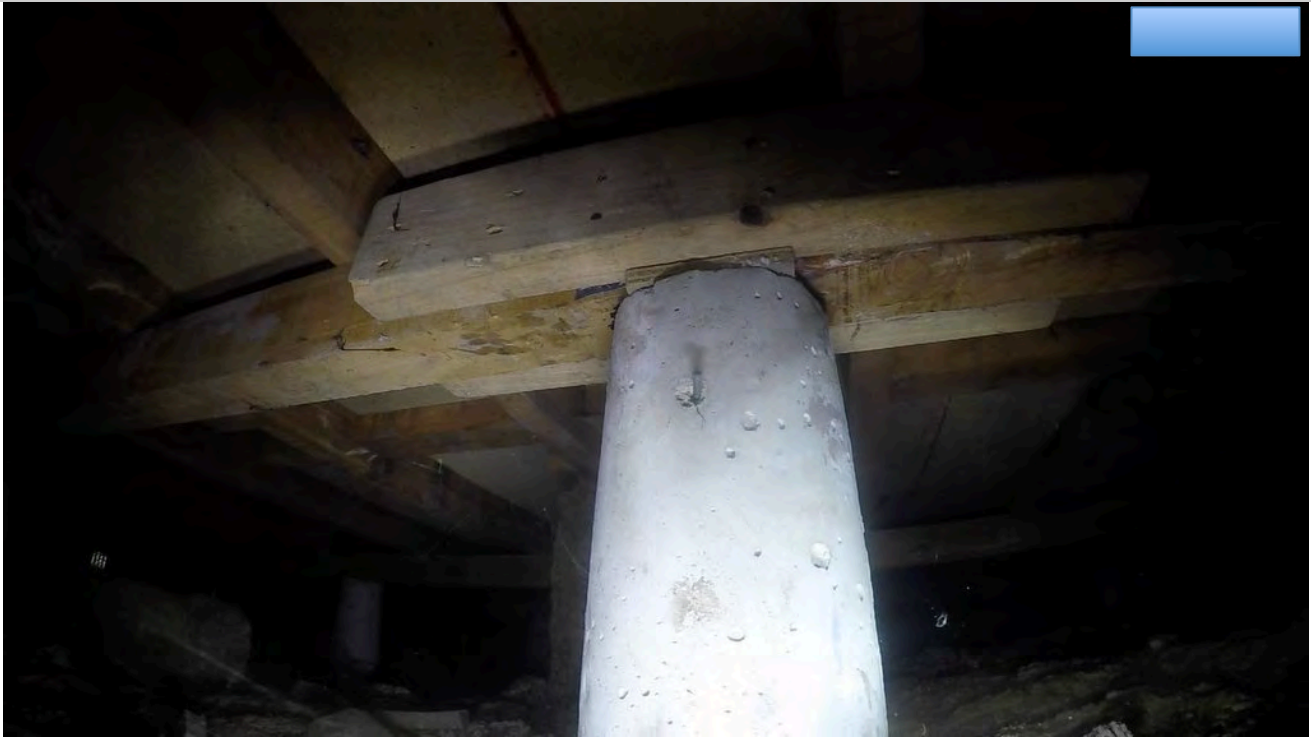
21: The bearer has been clashed on both sides. However the timber used is not of h3.2. The packer used appears to be a piece of plywood.

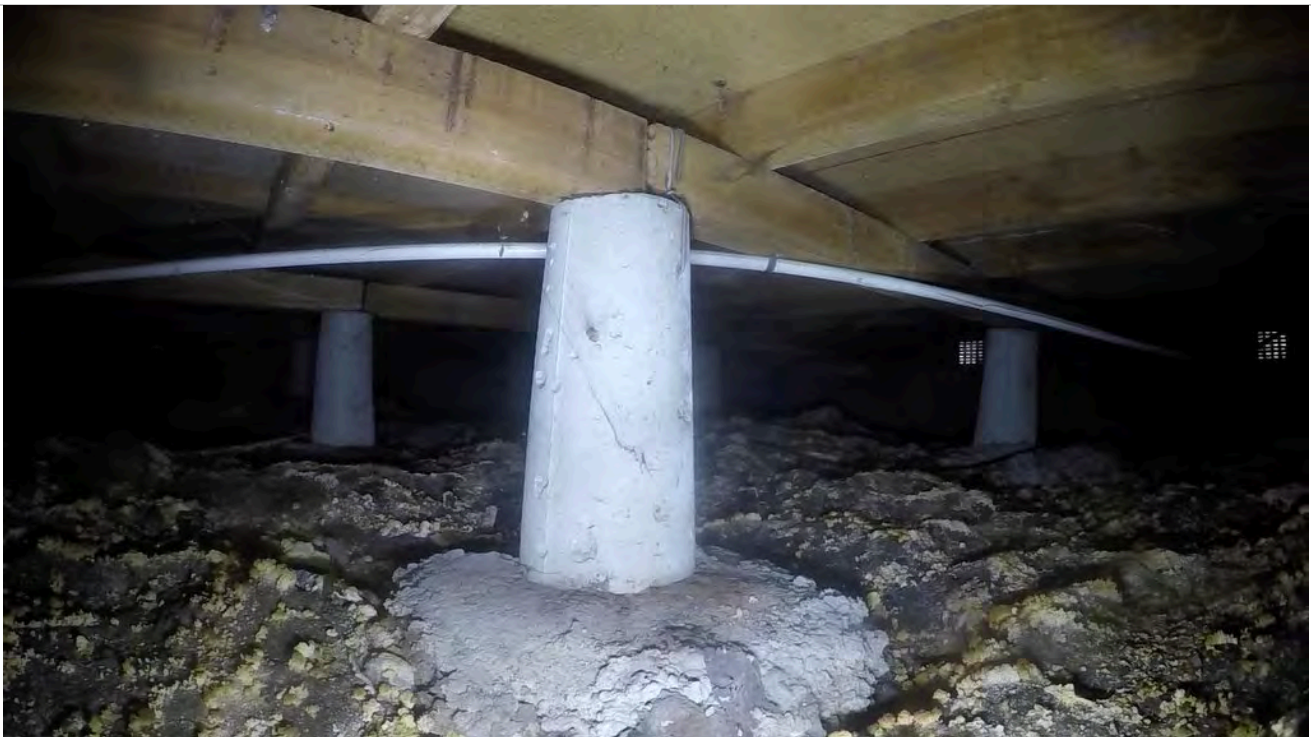
28: Pile with bearer join. There is significant yellow mold growing beneath this home.

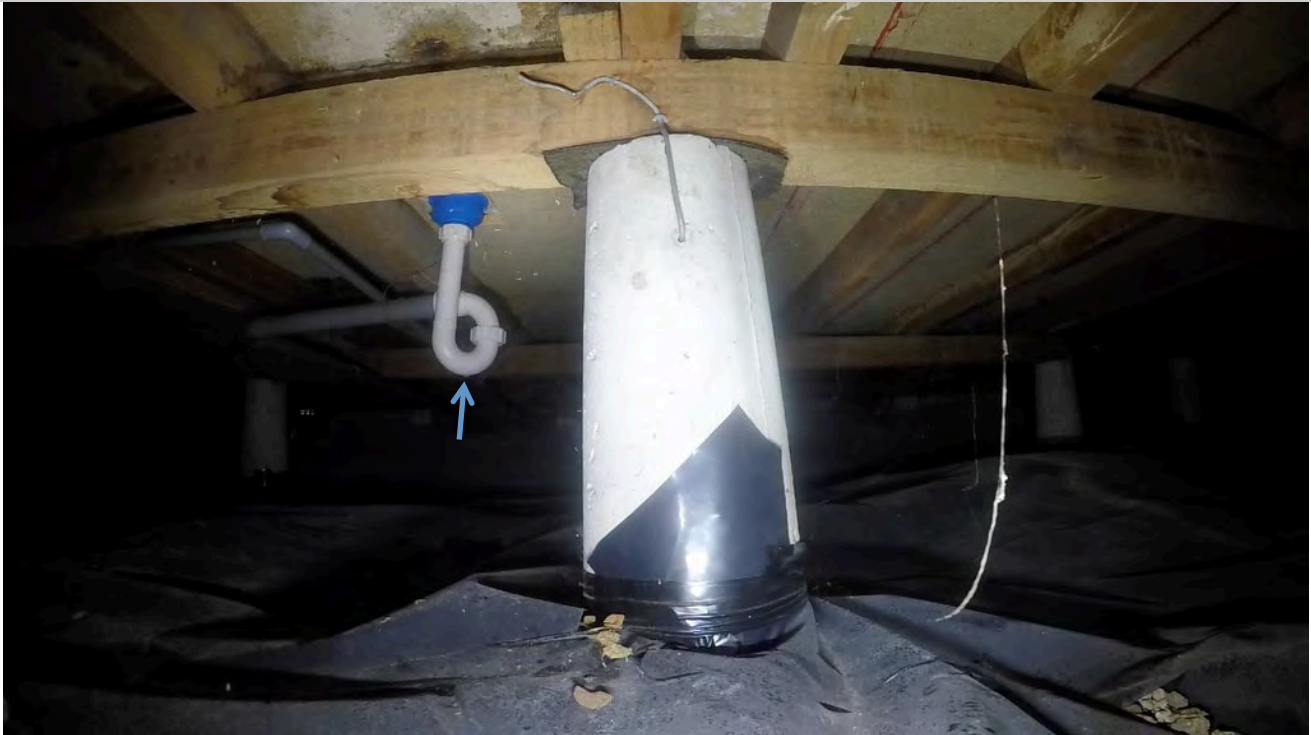
31: Pile with connection. The arrow shows evidence of the waste leaking. The polythene shows signs of dampness.

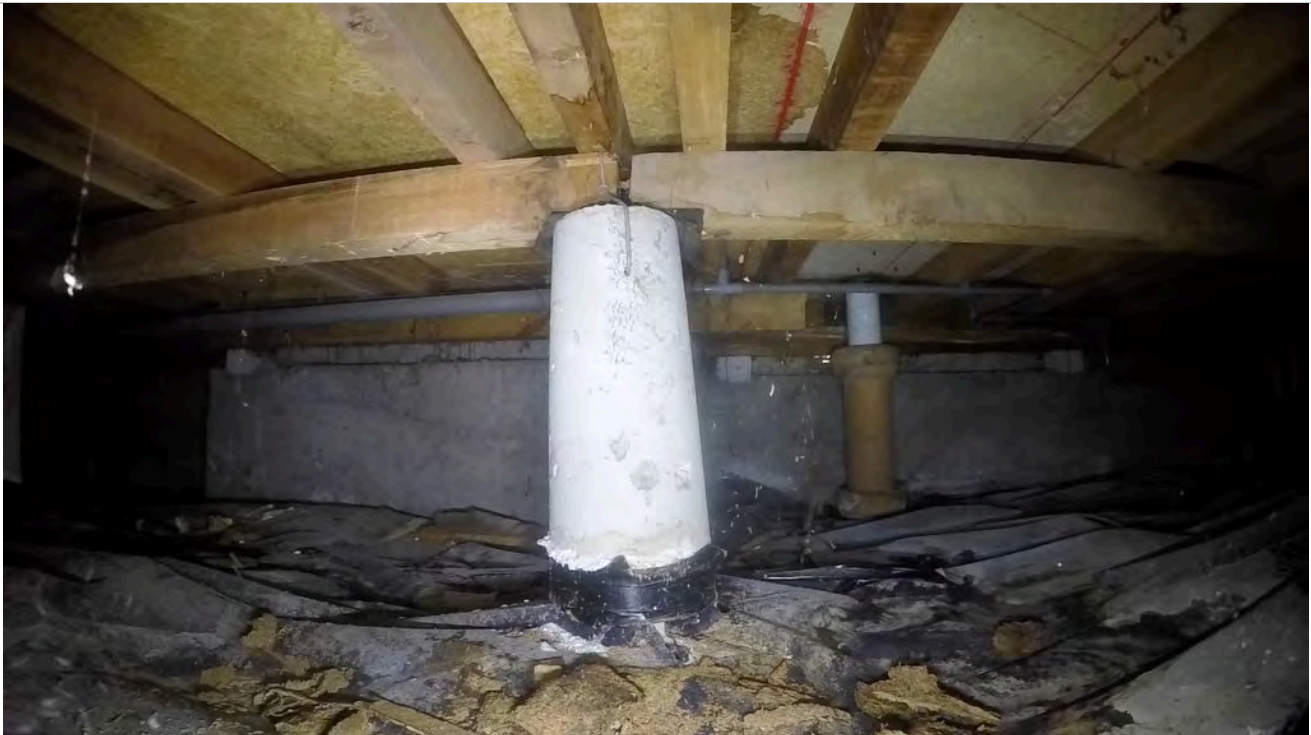
38: There are indications of an above floor water leak here and the timber is showing signs of water damage.
