RED LBP WEATHERTIGHT REPORT

CERTIFICATE OF INSPECTION IN ACCORDANCE WITH NZS 4306:2005

Company: Property Support Ltd Ltd trading as RedLBP Kapiti/Porirua
Client: Carl and Jane Olsson
Date of Inspection: 26th May 2026
Site Address: 10 Edgewater Street Waikanae
Inspector: Trevor Garrett
Qualifications: MSc, LBP, Advanced Trade Cert Carpentry, Nat Diploma Construction Management. Member of NZIOB.

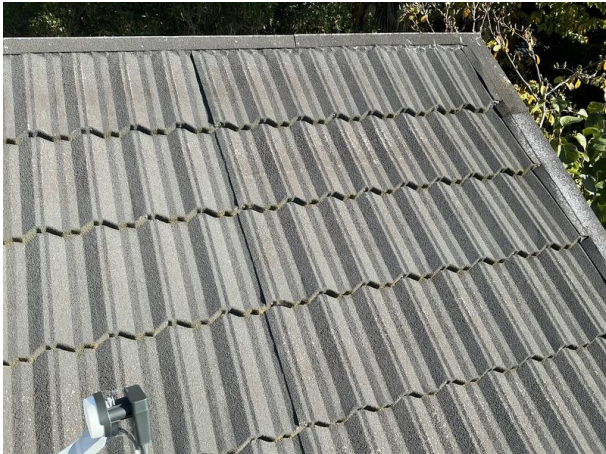
Photo 3
Deterioration to the surface coating
visible in places.

It is recommended to engage a Licensed Building Practitioner (LBP) specialising in roofing to undertake a comprehensive assessment of the roof's condition and provide a detailed report. Without proper evaluation and timely repairs, undetected or unresolved roofing issues could lead to leaks, water intrusion, and subsequent damage to the underlying structures, insulation, and interior spaces. Over time, this could result in costly repairs, reduced energy efficiency, and compromised structural integrity. A thorough inspection ensures potential issues are identified and addressed promptly, safeguarding the long-term durability and performance of the roof system.

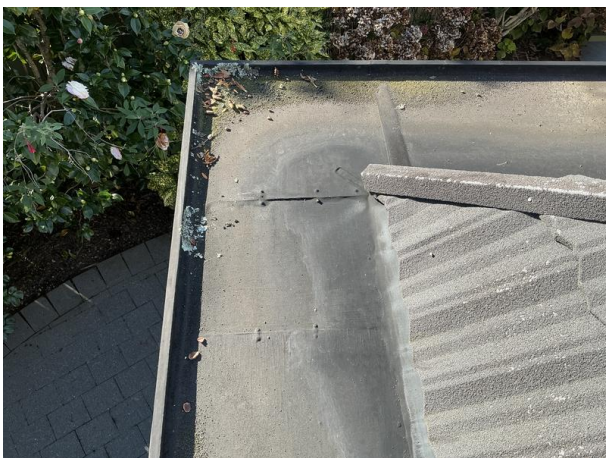
Photo 4
North side split membrane and raised
substrate fixings.

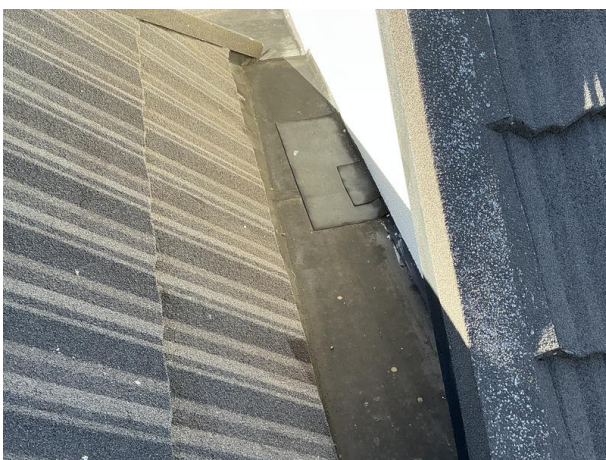
Photo 7
Eastside repairs to the membrane.

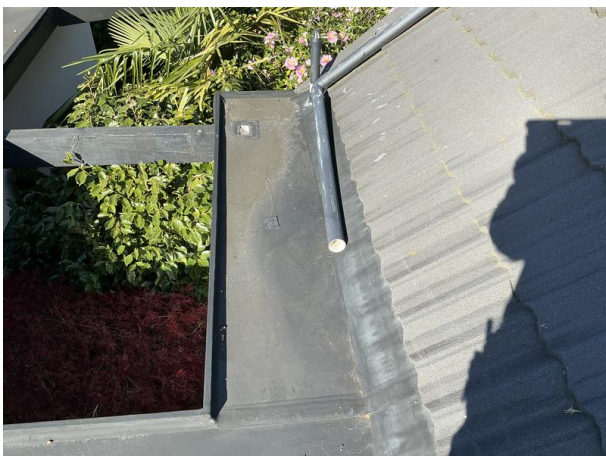
Photo 8
Southside repairs and downpipe
discharging onto membrane roof from
upper level.

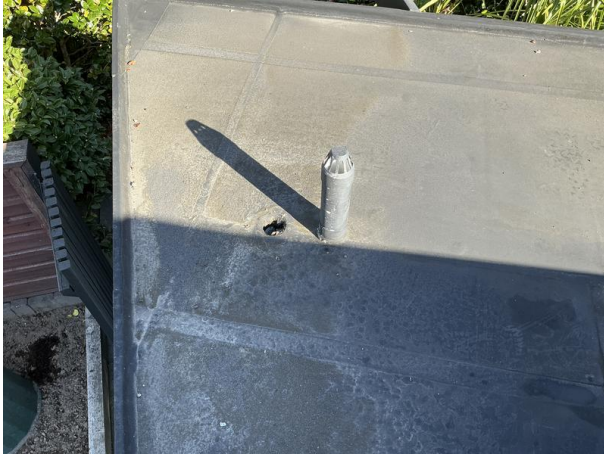
Photo 9
Southside no overflows visible to the membrane roofing.

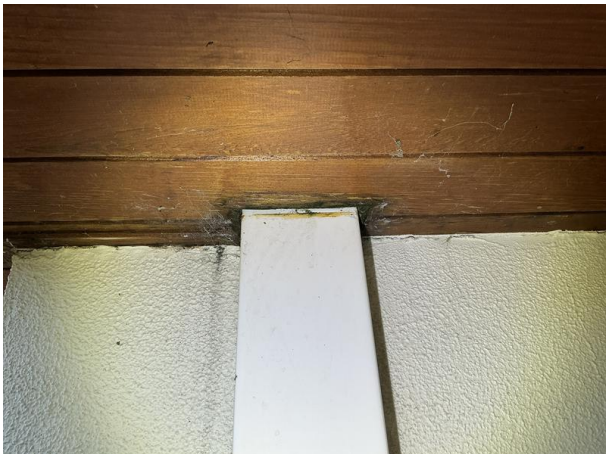
Photo 12
Visible moisture damage around the
southeast downpipe.

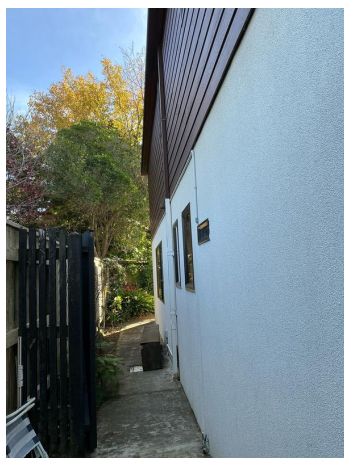
Photo 13

No issues with the downpipes.

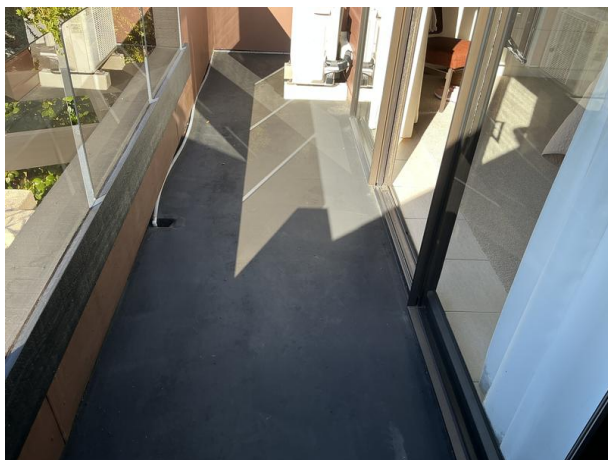
Photo 14
Bedroom 1 balcony.

Refer to the cladding and wall framing sections.

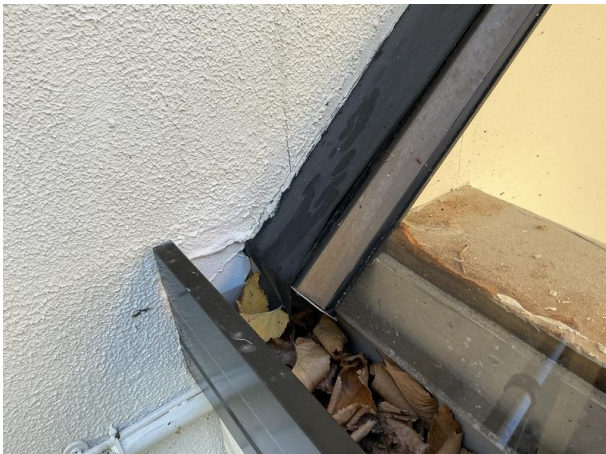
Photo 17
North side roof and wall junction has no kick out diverter flashing. Vertical crack visible.

There are cracks to the exterior cladding, in our view these need to be professionally repaired, as any cracks can allow moisture in behind the cladding and into the timber framing. Some of the cracking may relate to the lack of control joints and this can be determined by a exterior cladding specialist before carrying out the repairs.

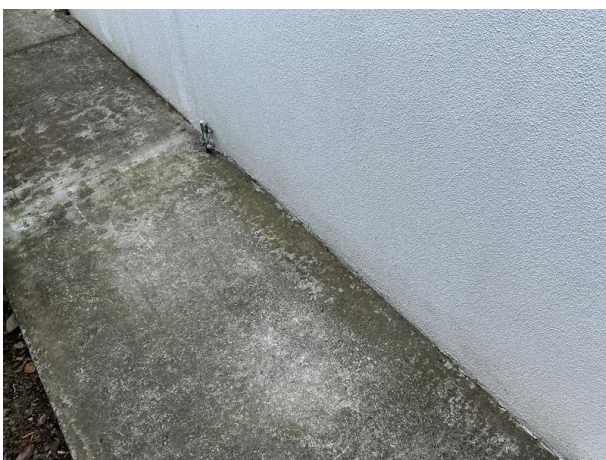
Photo 18
West side has reduced ground clearance.

Some areas around the dwelling, the minimum ground clearance have been compromised due to hard landscaping or gardens. This reduced clearance can lead to accelerated weathering of the cladding and increase the risk of moisture-related damage. To mitigate this, it is recommended to lower the ground levels where feasible or install strip or channel drains. These measures will help protect the cladding by minimising exposure to moisture.

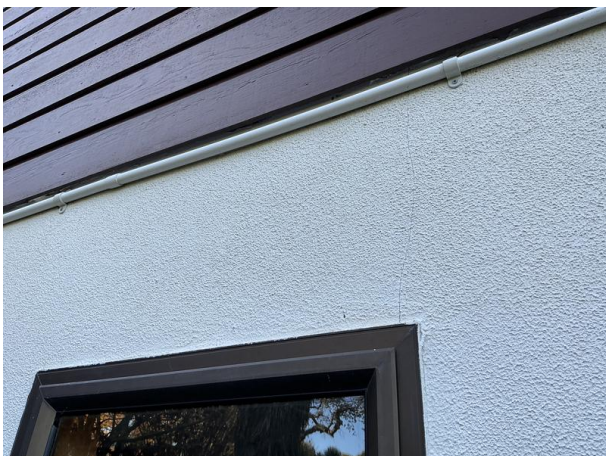
Photo 19
West side windows have no head flashing, crack visible to the corner and side of the window.

Head flashings are absent to sections of the exterior joinery, increasing the risk of moisture ingress at the junction between the joinery and cladding. It is recommended that suitable head flashings be installed by a suitably qualified contractor or Licensed Building Practitioner (LBP) to direct water away from the joinery and improve the weathertightness of the exterior envelope.

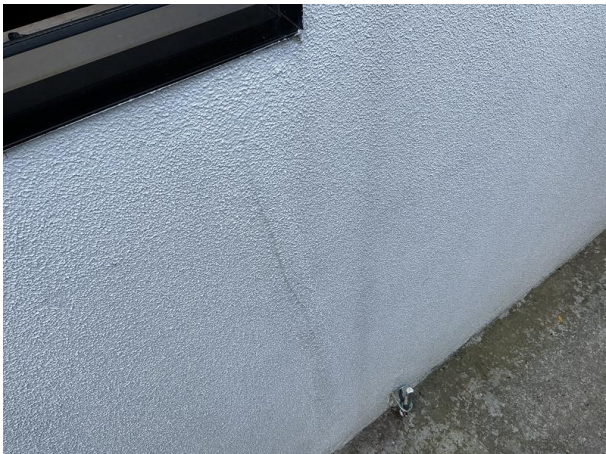
Photo 20
West side crack repair.

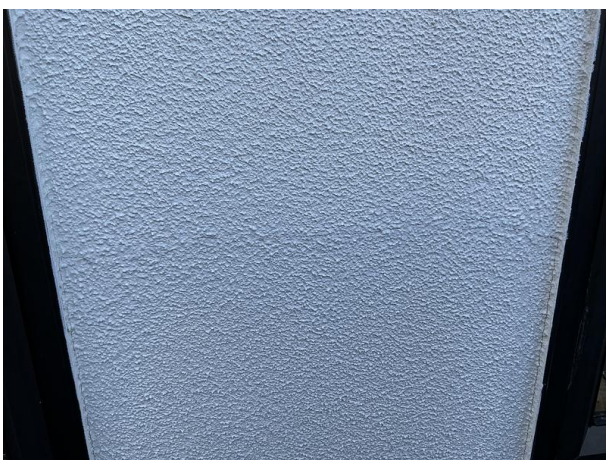
Photo 21
Westside horizontal crack between windows.

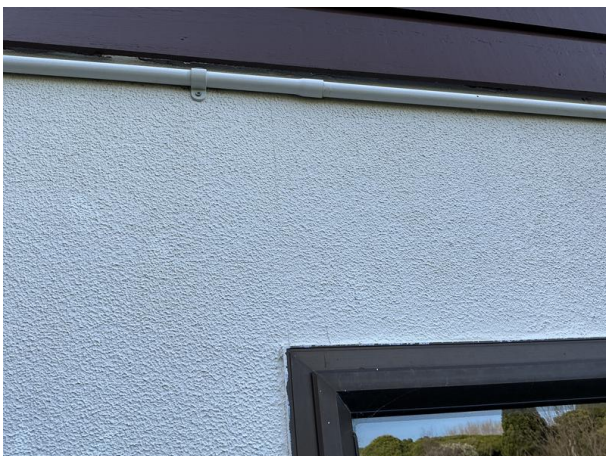
Photo 22
West side vertical crack.

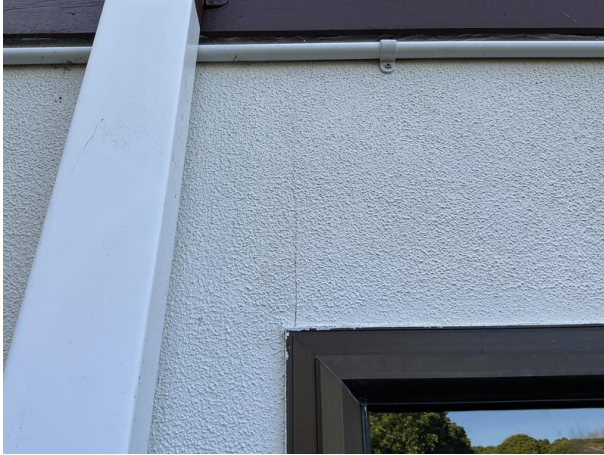
Photo 23
West side crack.

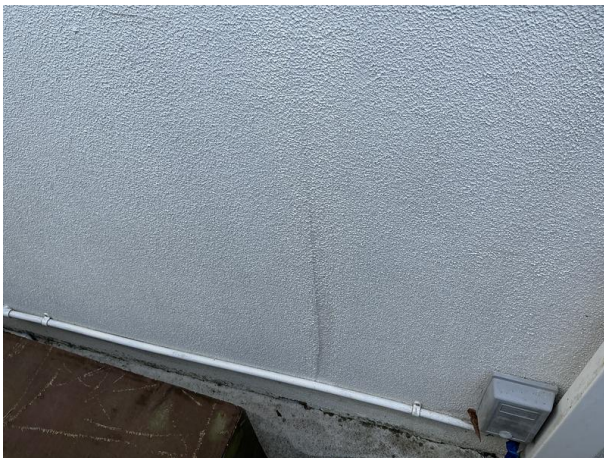
Photo 24
West side crack repair.

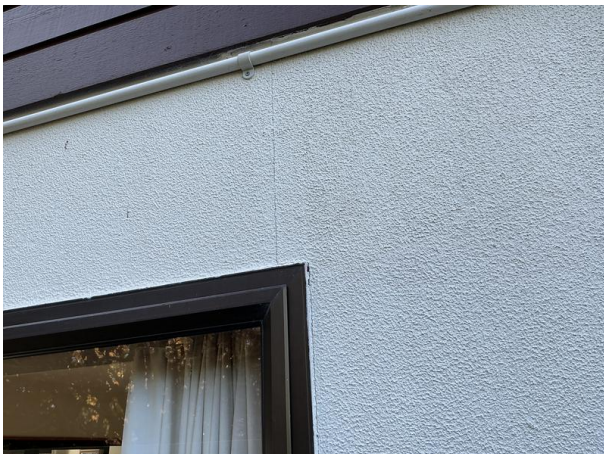
Photo 25
West side crack to corner and side of window.

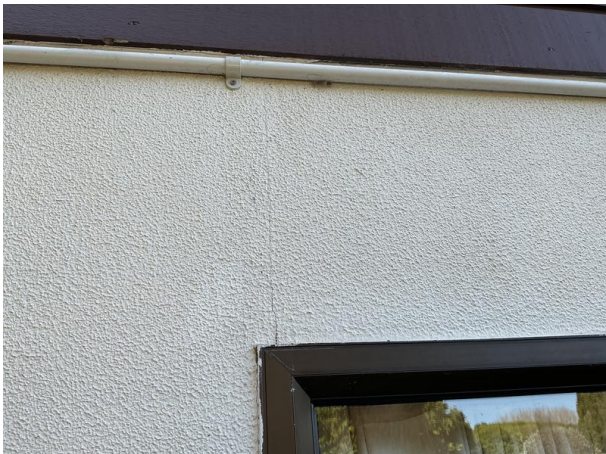
Photo 26
West side crack.

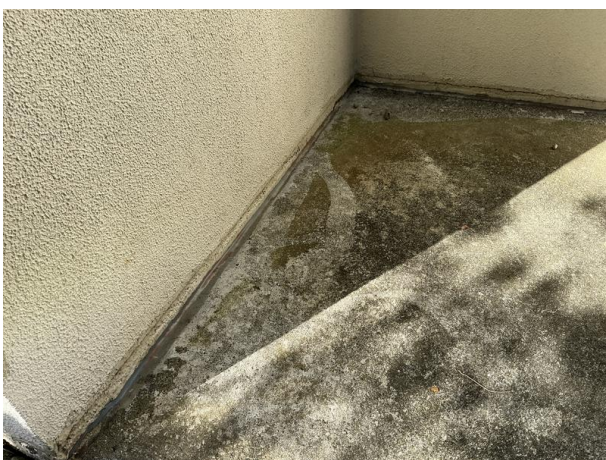
Photo 27
Northwest side sealant repairs. Refer to wall framing section for moisture testing to this area.

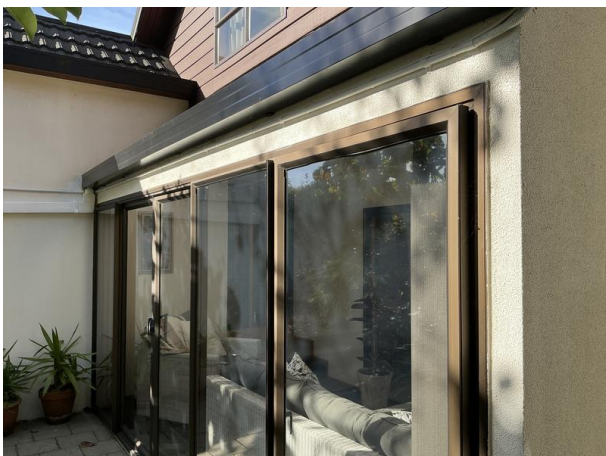
Photo 28
North side window has no head flashing.

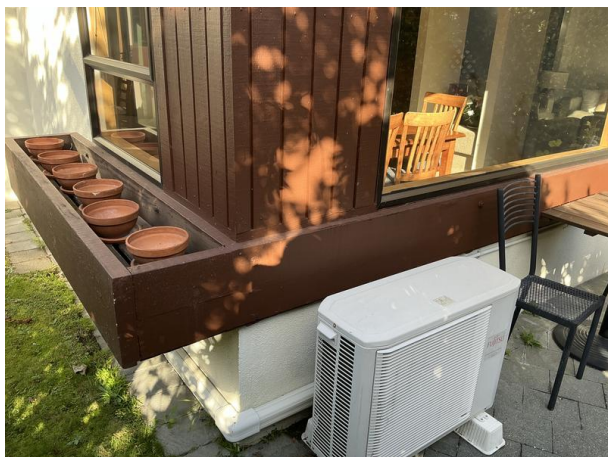
Photo 32
Northside structure fixings penetrate the cladding.

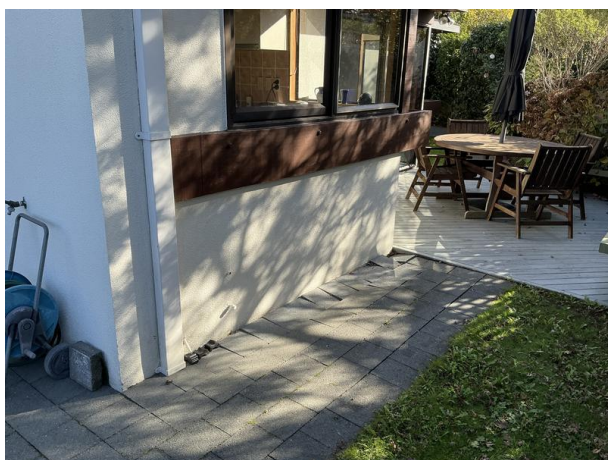
Photo 33
Northside structure fixings penetrate the cladding.

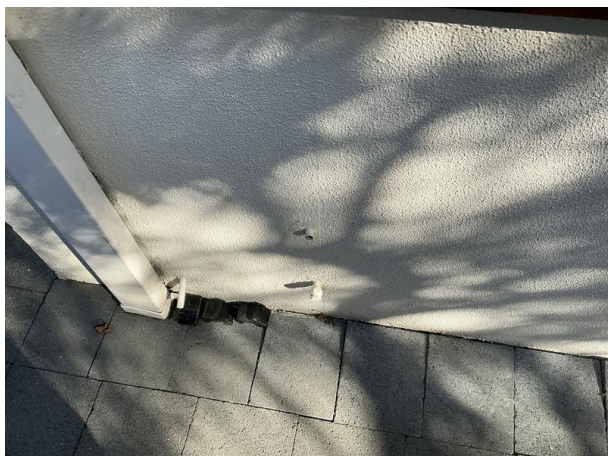
Photo 34
Northside crack.

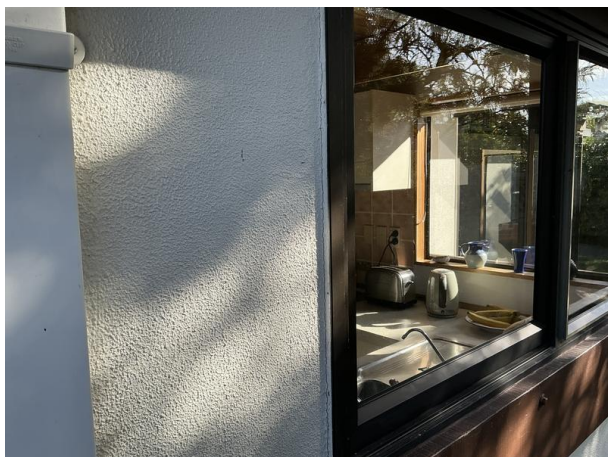
Photo 35
Northside crack to the side of the window.

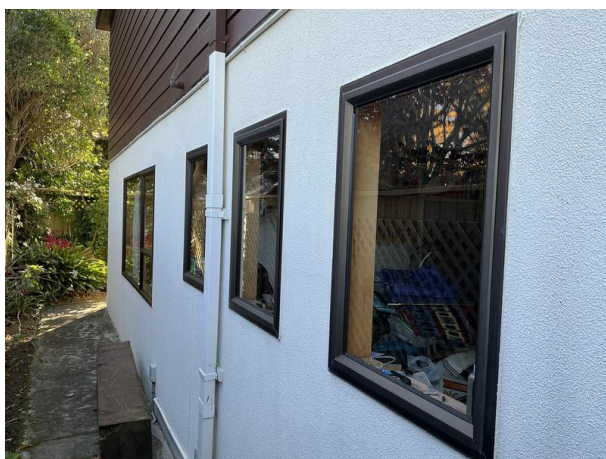
Photo 39

West side windows have no head flashings and are reliant on sealant to maintain weathertightness.

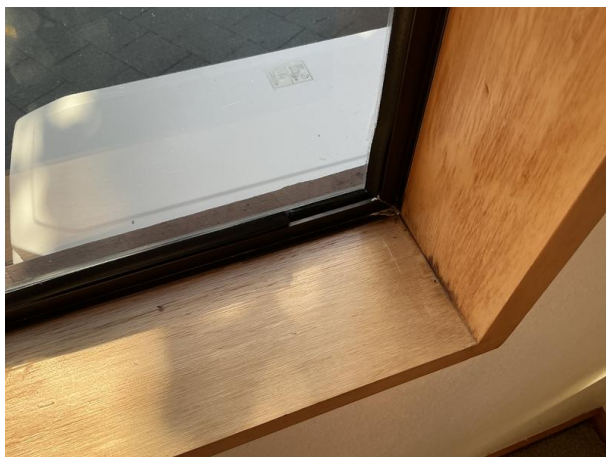
Photo 43
Shrunk glazing.

To prevent water & draughts from entering, it is recommended to replace or properly re-seat the rubber seals on the exterior of the joinery. By doing so, you can ensure a tight seal that effectively safeguards against water & draught ingress.

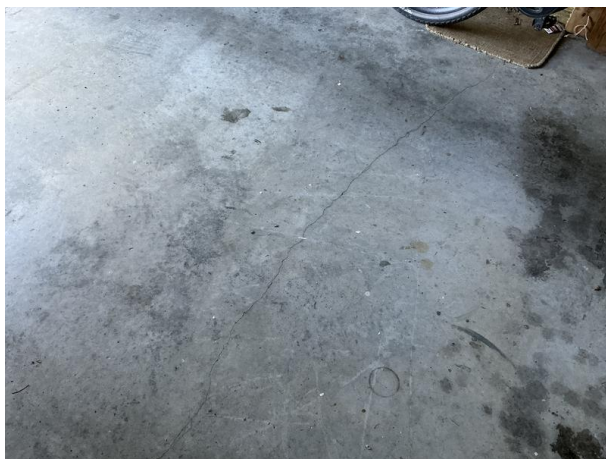
Photo 44
Crack to the slab, no issue.

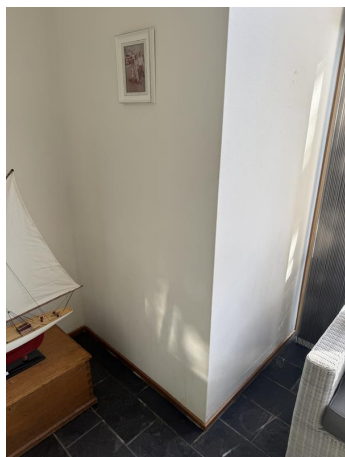
The indications of elevated moisture noted in the wall framing section highlight readings in the northwest corner of the conservatory and the balcony deck barrier wall, which could indicate a failure of weathertightness. Further investigation is recommended to establish the reasons for the indications of elevated moisture. Followed by suitable remediation work as required.

Photo 45
Northwest corner of the conservatory has indications of elevated moisture.

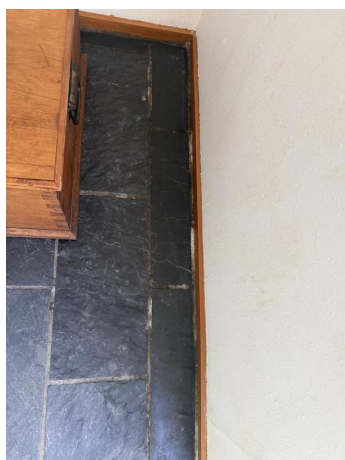
Photo 46
Limescale visible to the tile mortar.

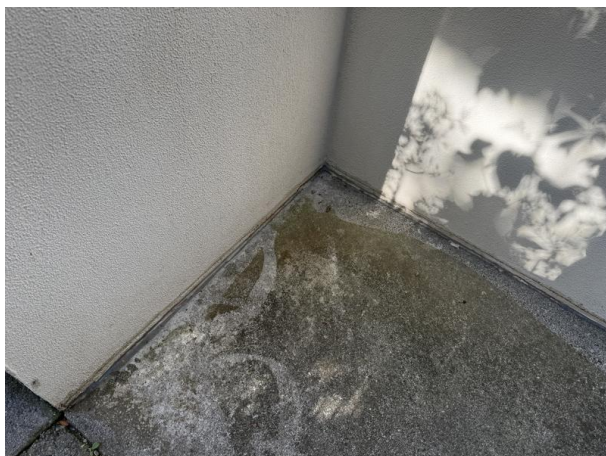
Photo 47
Exterior of the conservatory has visible sealant repairs.

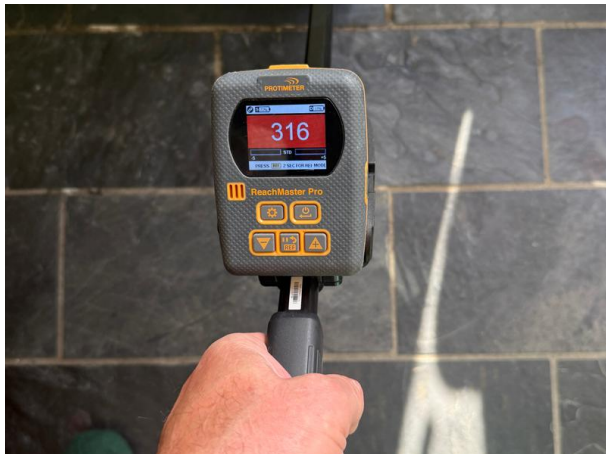
Photo 48
Northwest corner of the conservatory
has indications of elevated moisture.

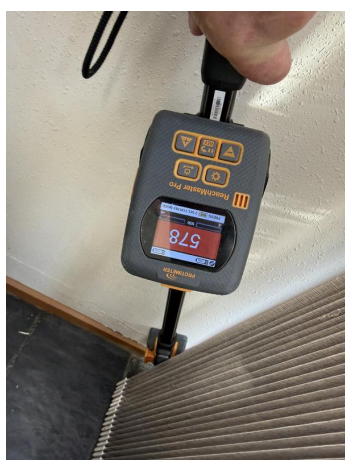
Photo 49
Northwest corner of the conservatory
has indications of elevated moisture.

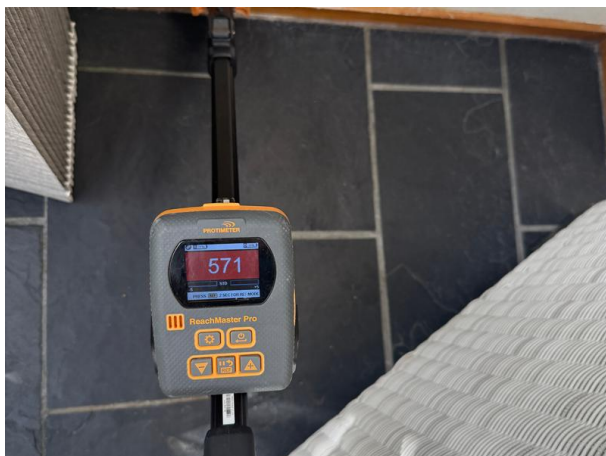
Photo 50
Northwest corner of the conservatory
has indications of elevated moisture.

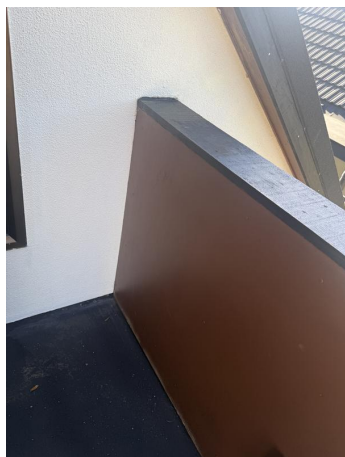
Photo 51
Balcony deck barrier wall has indications of elevated moisture.

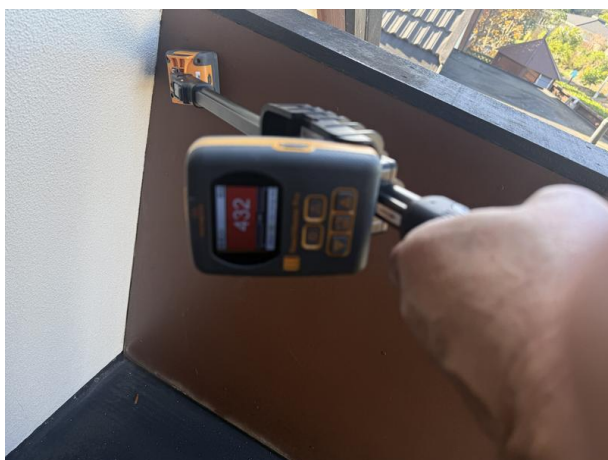
Photo 52
Balcony deck barrier wall has indications of elevated moisture.

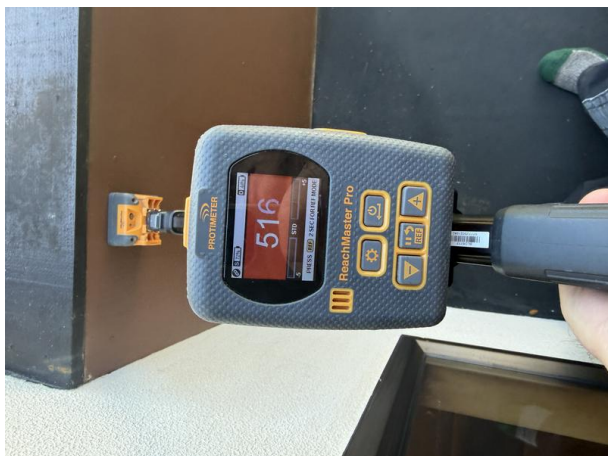
Photo 53
Balcony deck barrier wall has indications of elevated moisture.

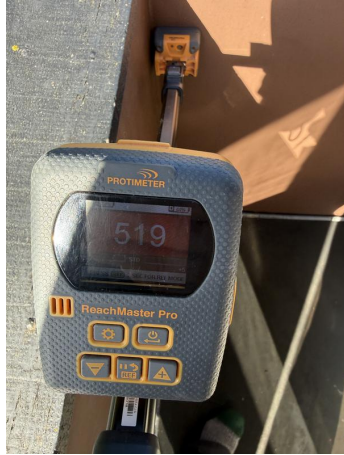
Photo 54
South corner of the balcony barrier wall has indications of elevated moisture.

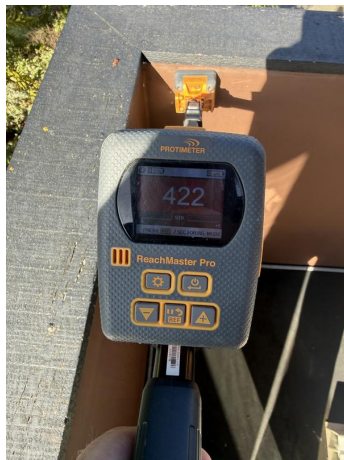
Photo 55
South corner of the balcony barrier wall has indications of elevated moisture.

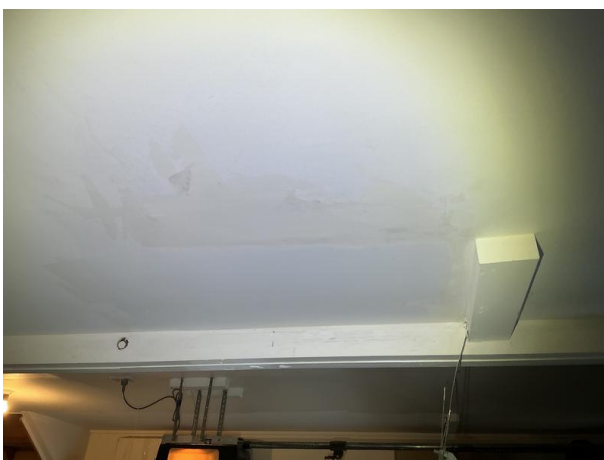
Photo 69
Moisture stain. This was moisture tested and found to be dry at the time of inspection.

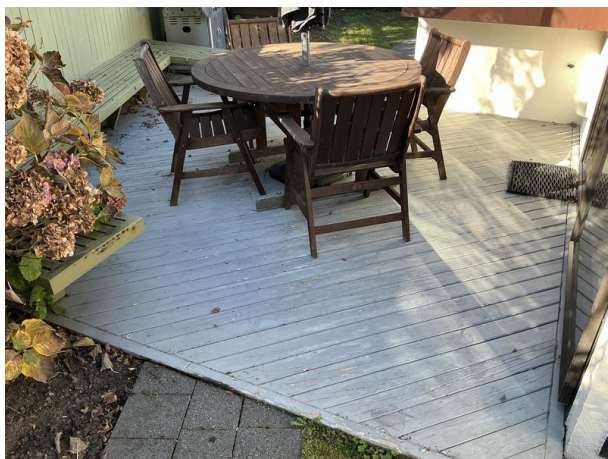
The timber deck is built very low to the ground, making the substructure inaccessible for inspection. If the timbers are in direct contact with the ground or lack a damp-proof membrane, moisture can penetrate the H3-treated timber, leading to prolonged exposure and eventual rot.

Photo 92
East side deck is in contact with the ground.

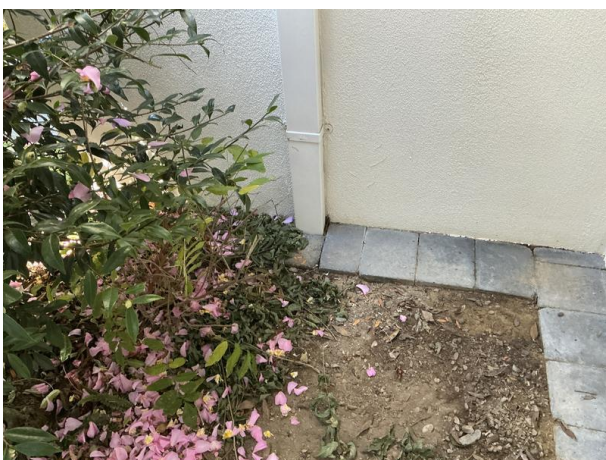
Photo 101
Southside downpipe connection is not visible.
