PRE-PURCHASE BUILDING REPORT

Property Address	179 Tutere Street Waikanae Beach		
Client	Robert Hunsley		
Date of Inspection	18th October 2023	Time	1:00 pm
Inspector	Trevor Garrett MSc, LBP, Advanced Trade Cert Carpentry, Nat Diploma Construction Management. Member of NZIOB.		
LBP Number	131790		
Inspection Type	Pre-Purchase Report		
People Present	Owner		
House Occupied	No

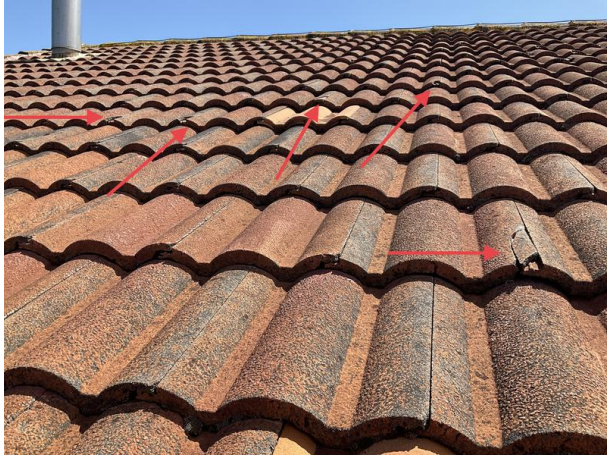
Photo 2

Condition of surface - Deterioration to the surface coating. Some cracked edges of tiles visible.

East side cracked edges are indicated by arrows.

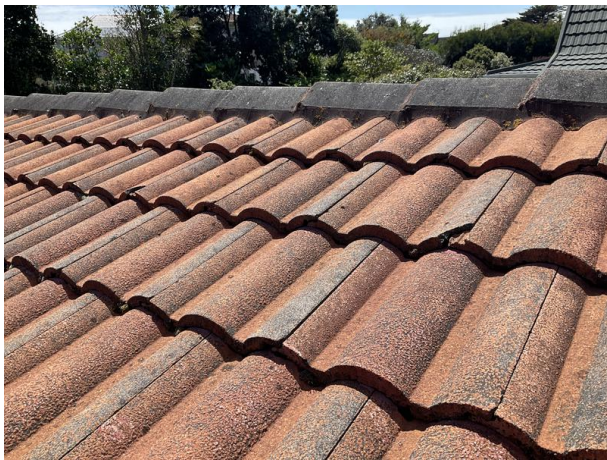
Photo 3

Northside cracked edges of tiles.

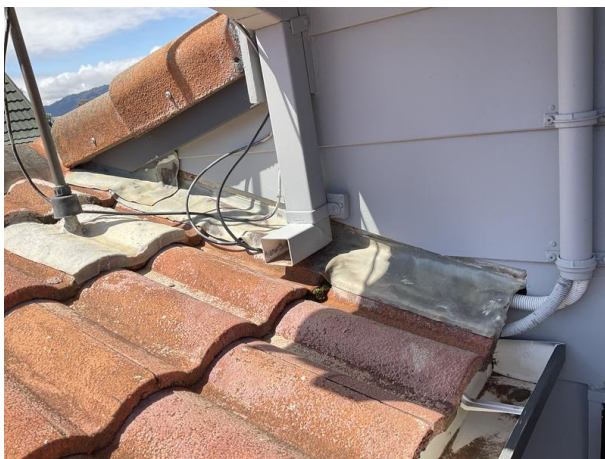
Photo 7

North side penetration, lead apron flashing, downpipe with no spreader. The roof wall junction does not have a kick out flashing.

It is recommended to install spreaders to downpipes that discharge onto lower roofs. This installation helps to distribute the flow of water evenly, preventing excessive water concentration in specific areas and reducing the risk of damage to the lower roofs.

It is recommended to install kick-out flashings to any apron flashing that flows into a gutter, these are a critical flashing in protecting the roof/wall/fascia/gutter junction, that when correctly installed diverts water away from a high weathertight area of risk. Refer to the wall framing section for moisture testing.

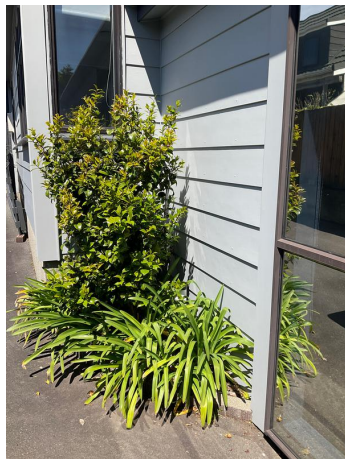
Photo 16

North side raised garden is in contact with the weatherboard.

Recommend reducing pavement and garden beds in contact with the cladding. Refer to the foundation section for detail.

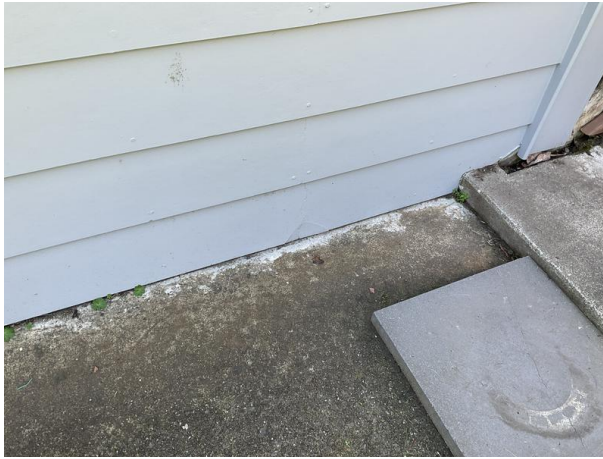
Photo 17

South side impact damage to the weatherboard. The weatherboard is in contact with the pavement.

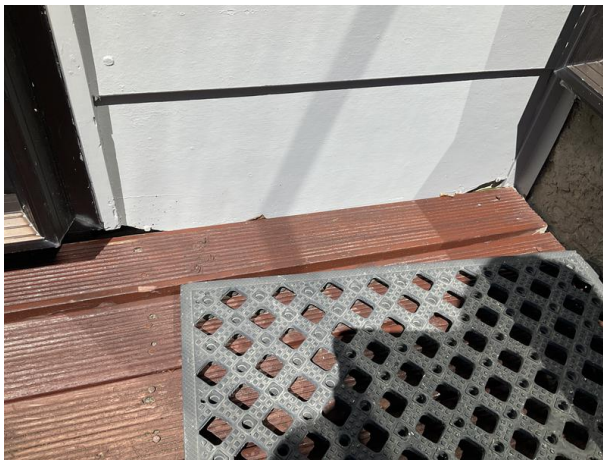
Photo 18

West side weatherboard has cracking.

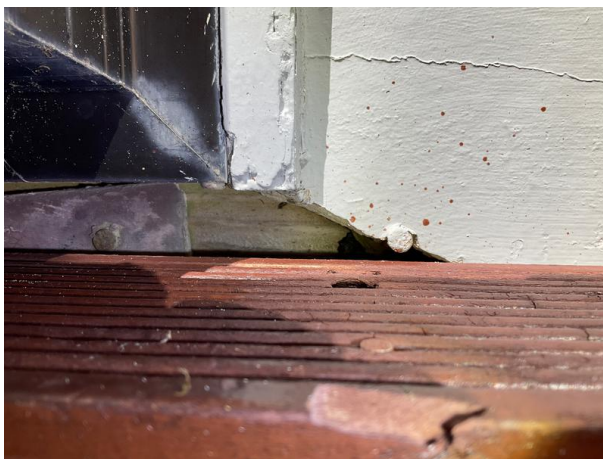
Photo 19

Close up of the previous photo, timber framing is visible.

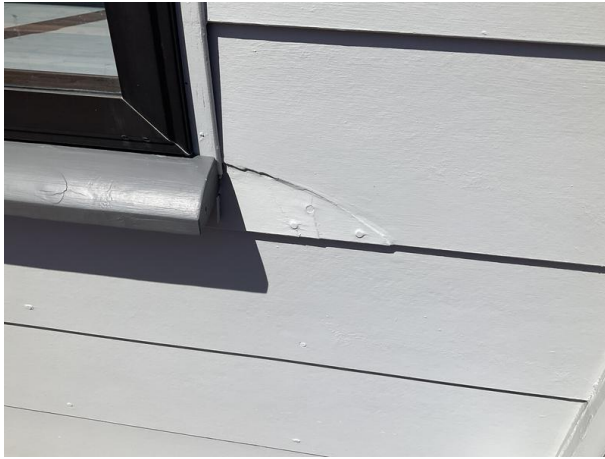
Photo 20

West side historic crack repair.

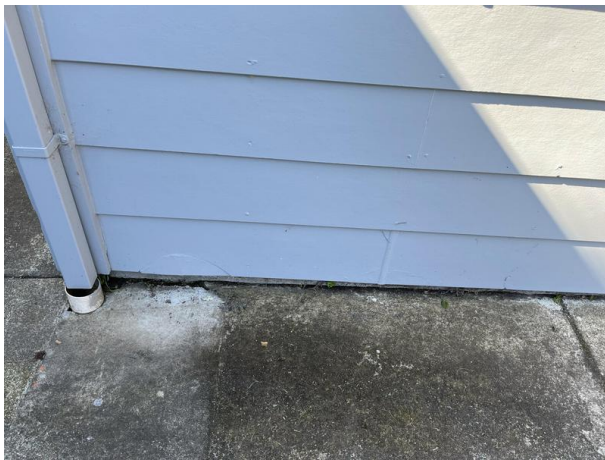
Photo 21

South side historic crack repair.

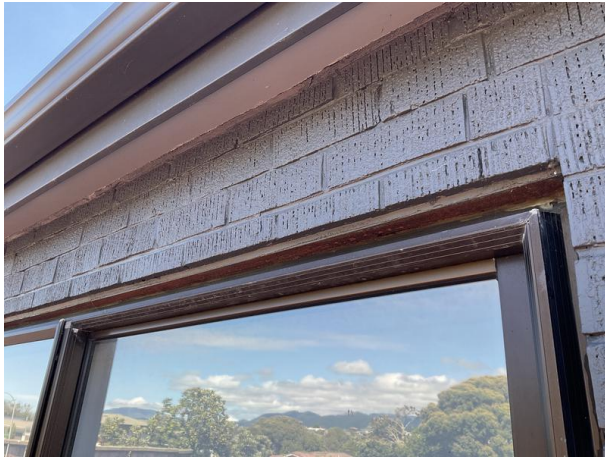
Photo 23

Eastside steel lintel is rusty.

Recommend a brick layer reviews the condition of the rusty lintels and advise repair solutions.

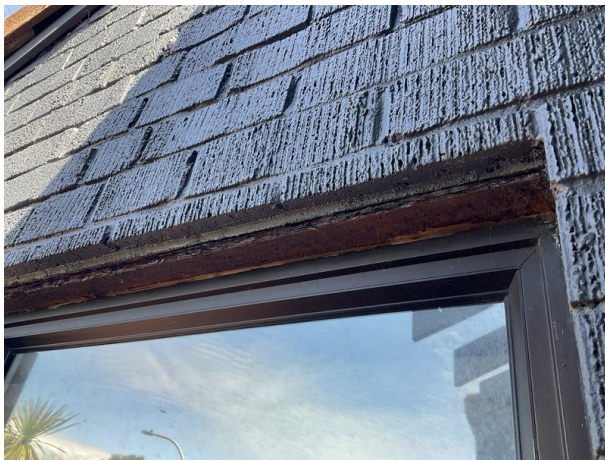
Photo 24

East side steel lintel is very rusty.

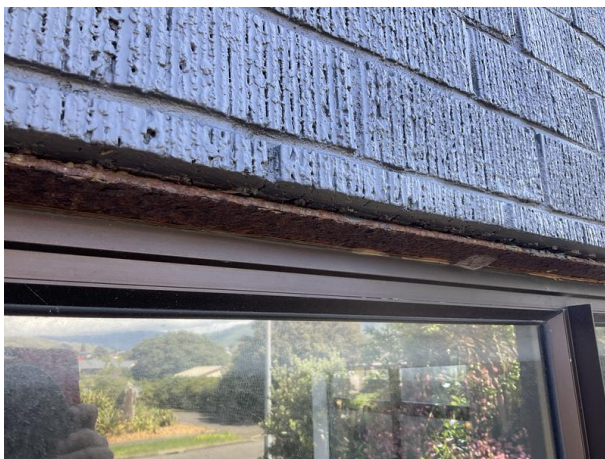
Photo 25

East side rusty lintel.

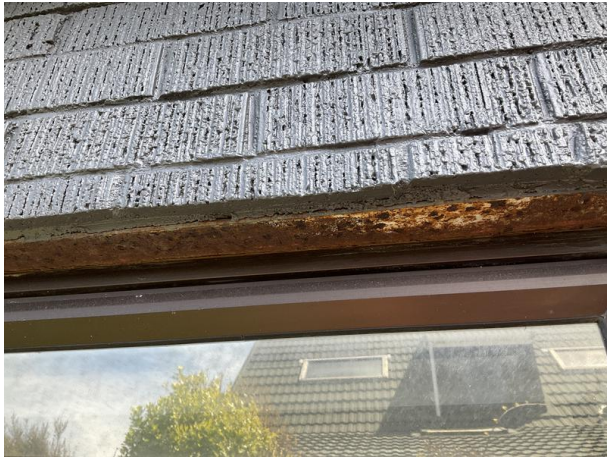
Photo 26

North side rusty lintel.

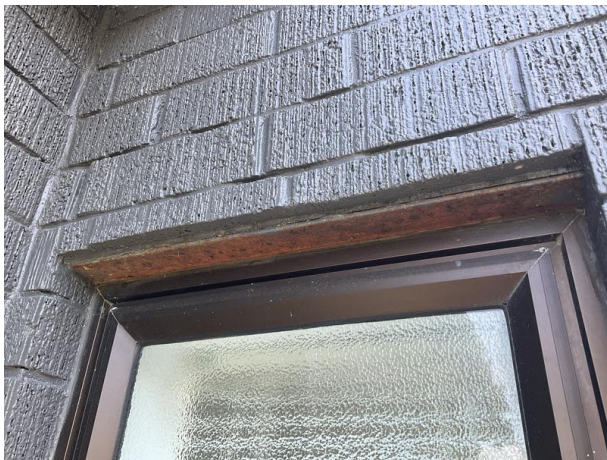
Photo 27

Northside rusty lintel.

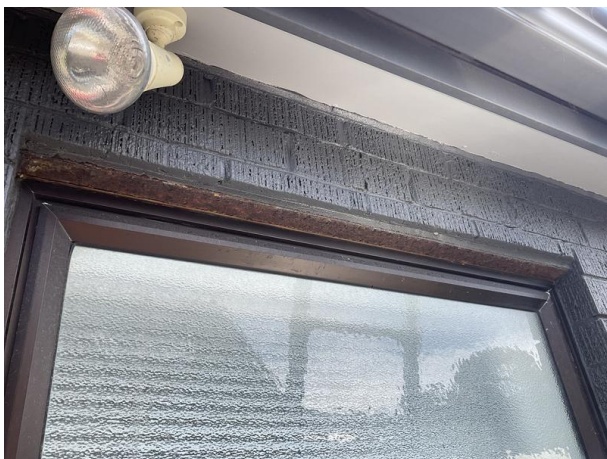
Photo 28

North side rusty lintel.

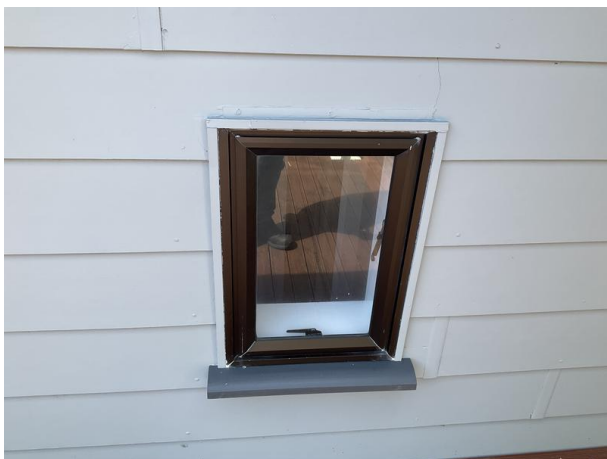
Photo 34

South side crack to weatherboard and historic maintenance to the headflashing.

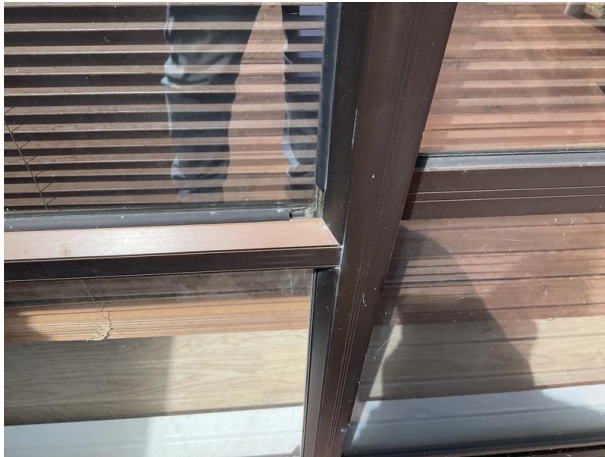
Photo 35

West side shrunken glazing rubber.

To prevent water & drafts from entering, it is recommended to replace or properly reseal the rubber seals on the exterior of the joinery. By doing so, you can ensure a tight seal that effectively safeguards against water & draft ingress.

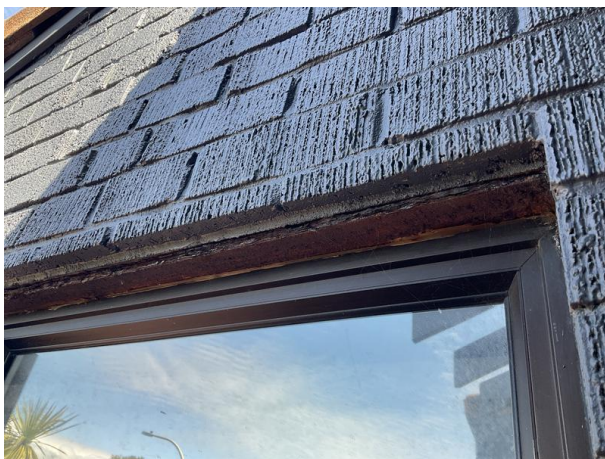
Photo 37

Seals to window heads in contact with steel lintels are degraded.

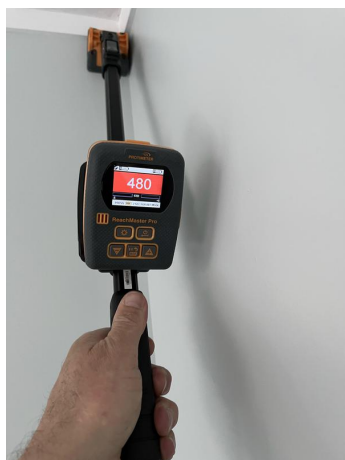
Photo 48

Bedroom 4 north wall adjacent to the roof wall junction has indications of elevated moisture.

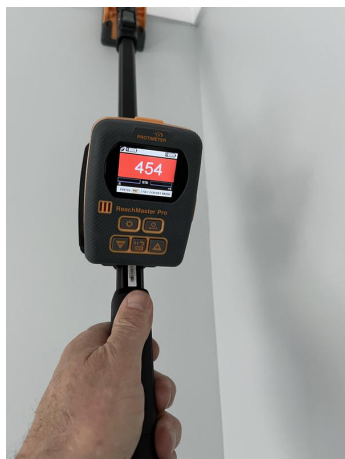
Photo 49

Bedroom 4 north wall adjacent to the roof wall junction has indications of elevated moisture.

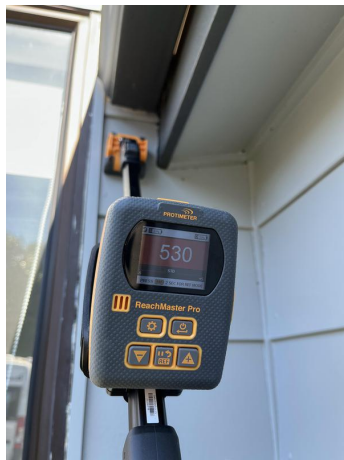
Photo 51

Outside bedroom 4 below the roof wall junction has indications of elevated moisture.

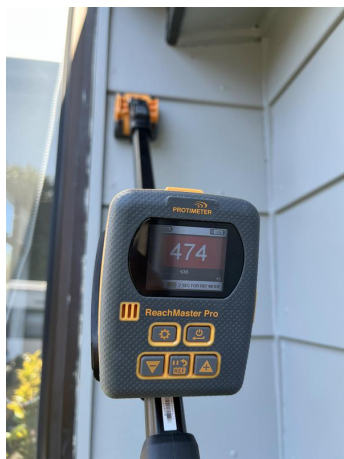
Photo 52

Outside bedroom 4 below the roof wall junction has indications of elevated moisture.

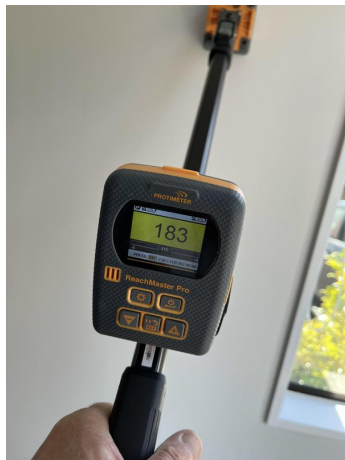
Photo 54

Bedroom 3 below the roof wall junction has indications of elevated moisture.

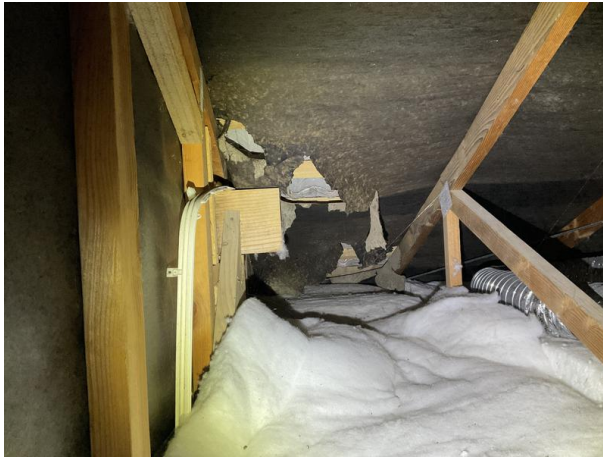
Photo 55

Roofing underlay - Bituminous self-supporting paper. Condition - Torn.

Over the lounge has torn roof underlay.

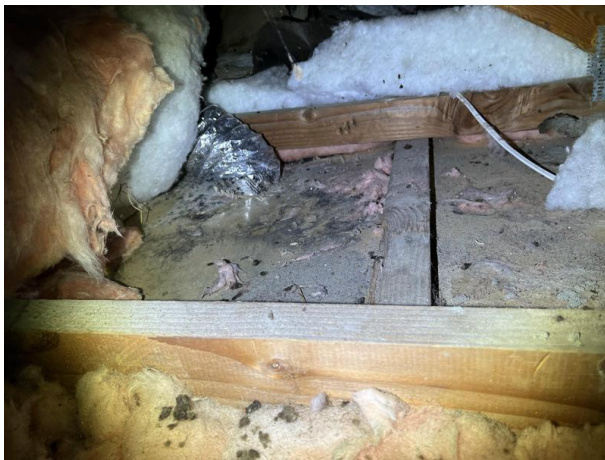
Photo 59

Over bedroom 1 has evidence of a historic leak and disturbed insulation.

Keep an eye on the old previously repaired leak to ensure there are no issues, and rectify immediately if this becomes an issue in the future.

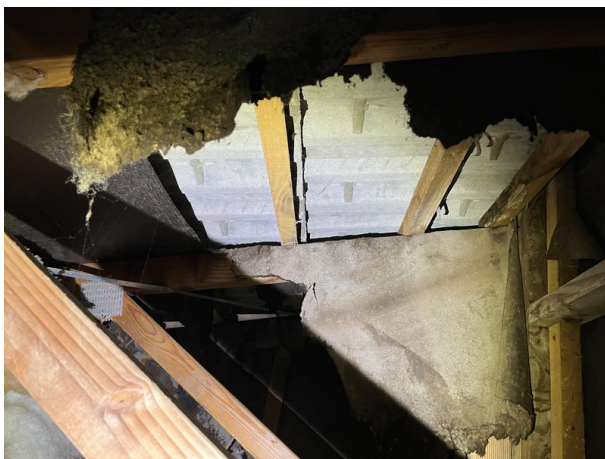
Photo 60

Over bedroom 1 torn roof underlay.

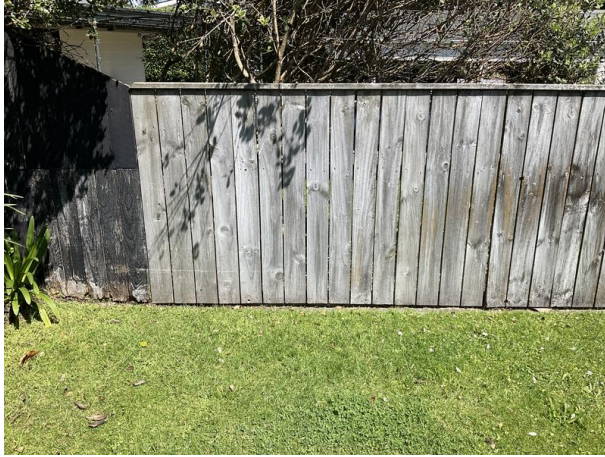
Photo 85

South side has rot to the bottom on the left side.

General upkeep and maintenance, keep vegetation and soils clear of timbers as these timbers are only exterior treated and will rot if vegetation or soils are up against them.

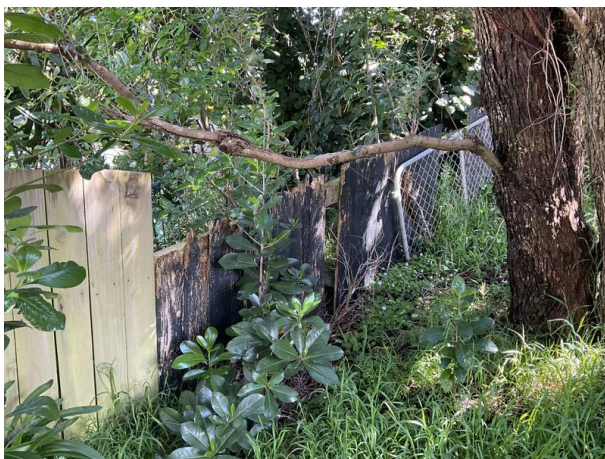
Photo 87

South side is deteriorated.

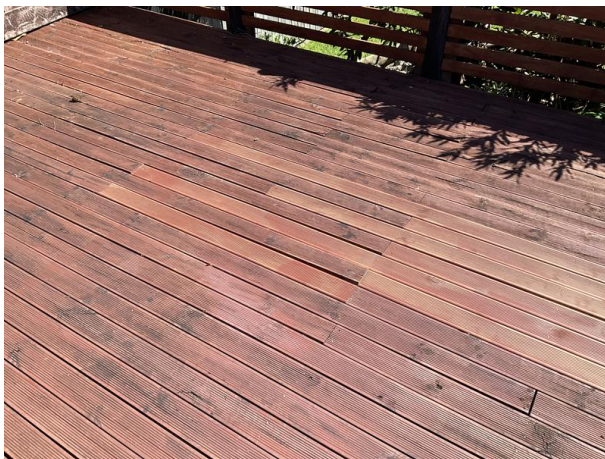
Photo 95

West side has loose boards.

General upkeep and maintenance. Punch nails that are protruding above the decking as required.

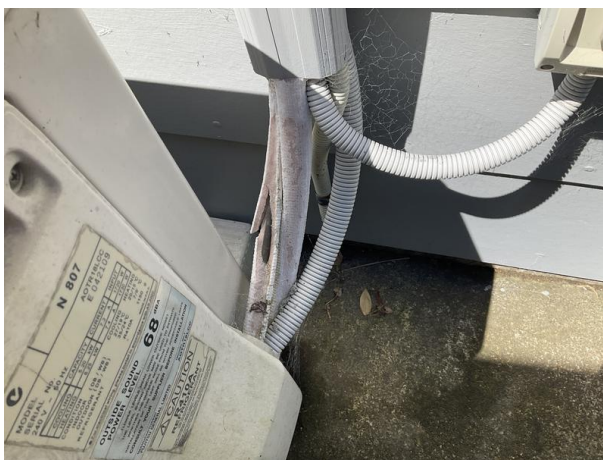
Photo 114

The conduit and insulation protecting the heat pump refrigerant lines has perished exposing the lines where they run into the outdoor unit. It is recommended that these be replaced to protect the lines.

Pipe insulation is deteriorated.

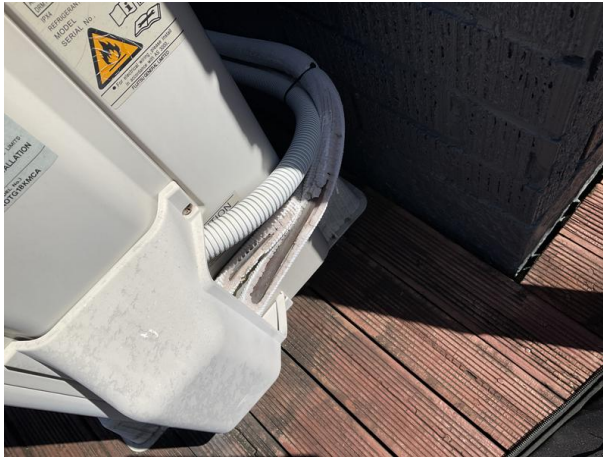
Photo 116

Pipe insulation is deteriorated.
