## Information request - 69 Marshland Road, Shirley, Christchurch 8061

1212251 2011 CHCH EQ - LAND ENGINEERING REPORT LF 10/6/11

22 FEB 2011 - EARTHQUAKE  
SHIRLEY, CHRISTCHURCH  
(C097-092069) - 69 Marshland Road

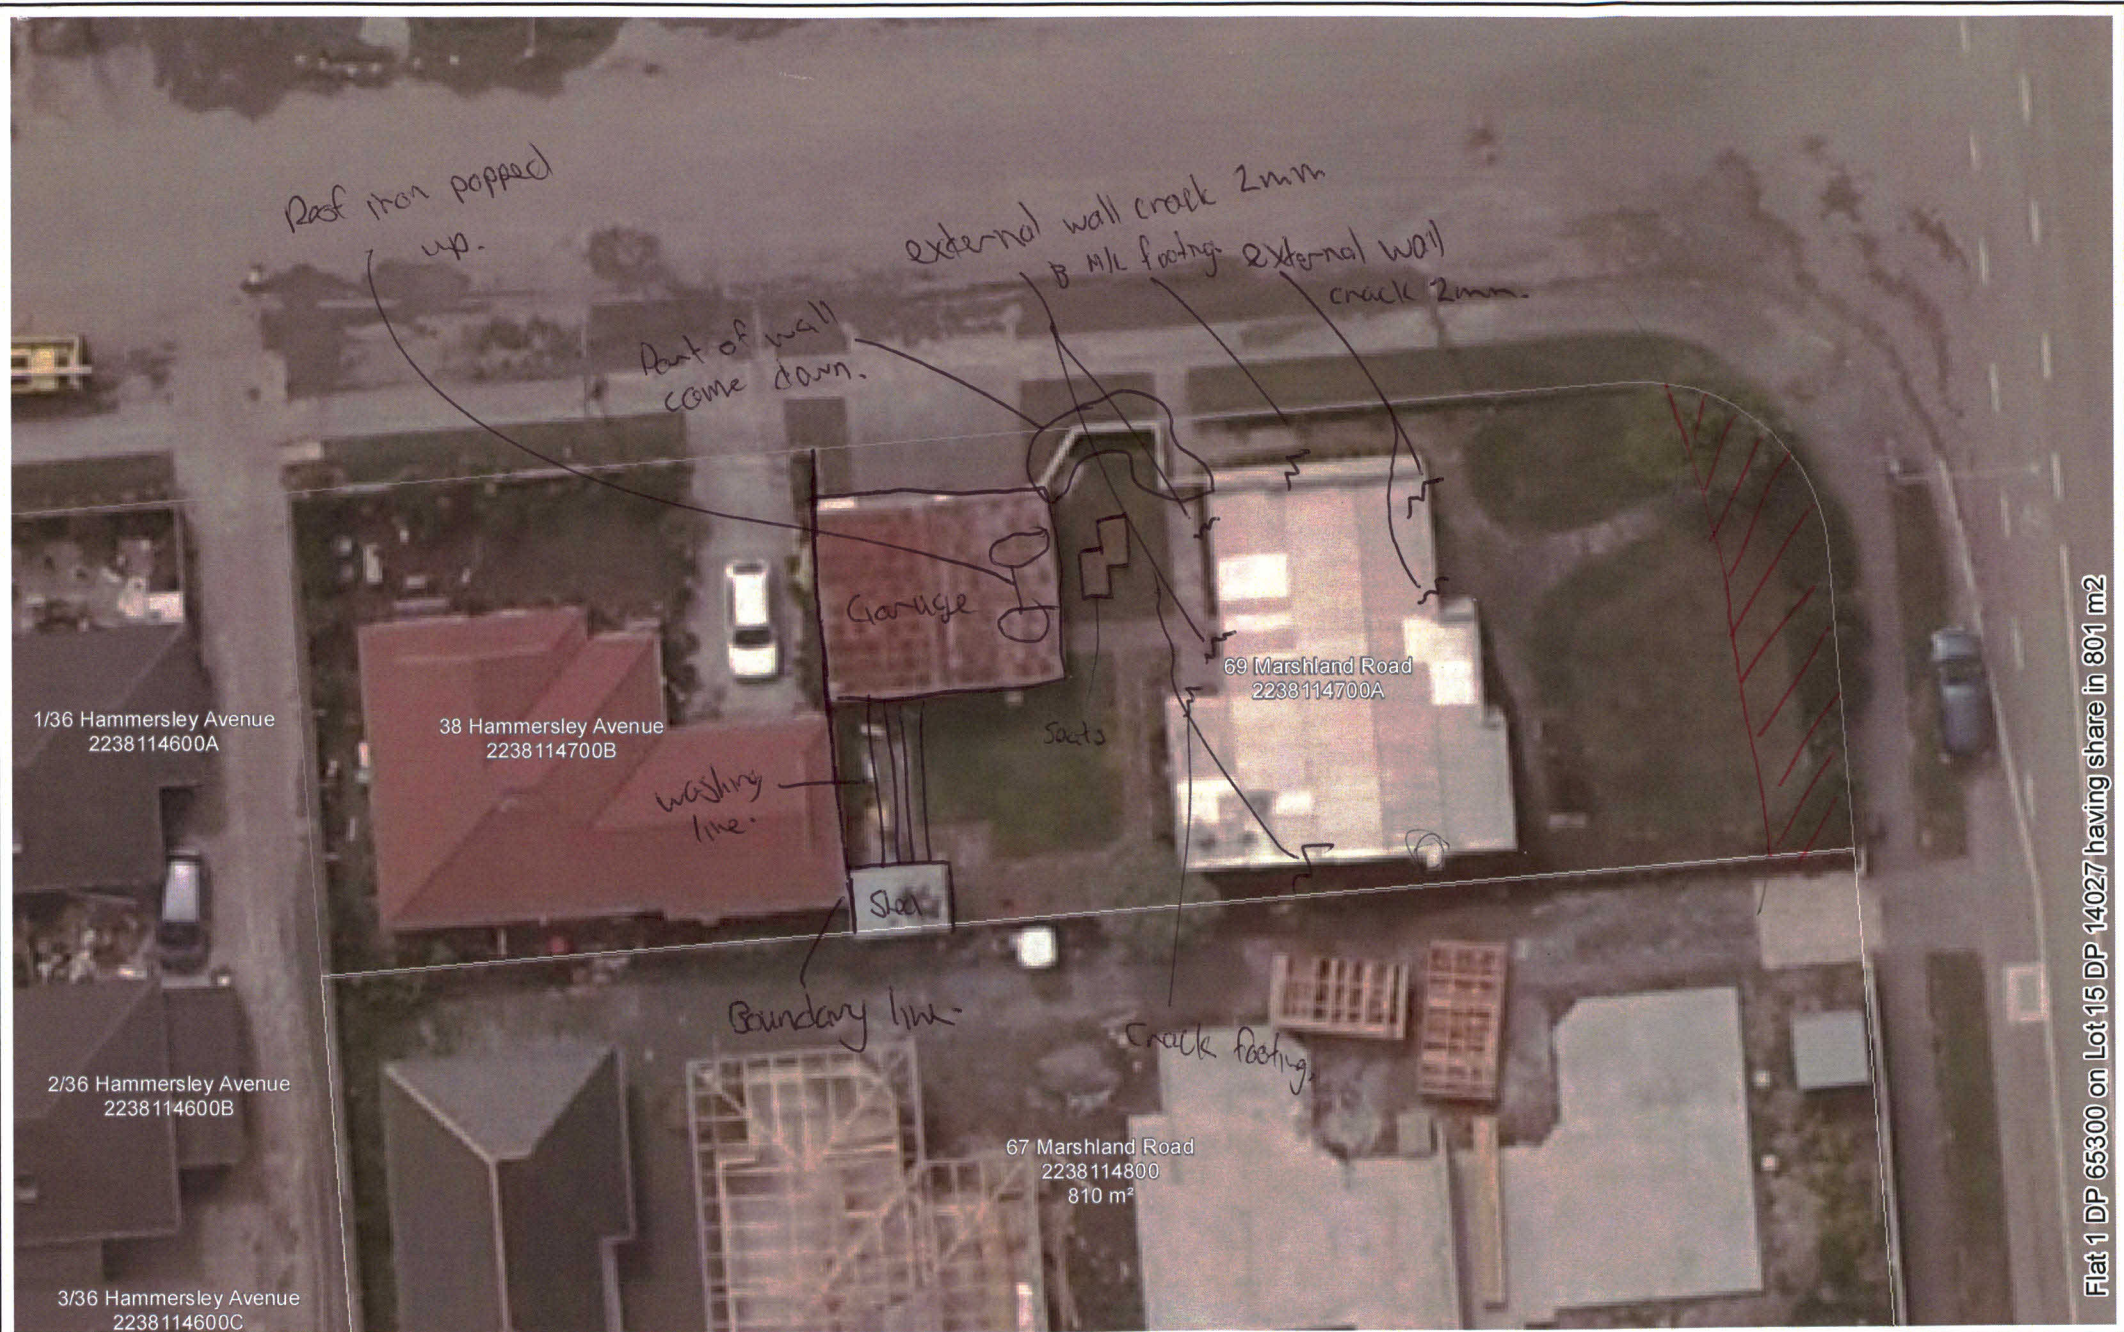
*No Land Damage.*
