## Building Report

21 Kanawa Street  
Waikanae

| <b>Date/s of inspection:</b> | 30-Apr-2026 |
| <b>Type of inspection:</b> | Building Inspection |

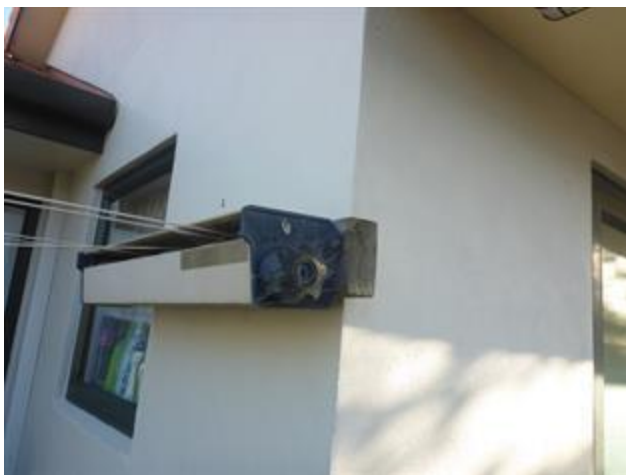
The gatepost to the fencing to the side of the dwelling and the clothesline have been direct fixed through the cladding, which is not recommended as it can be a weather tightness issue. Any wall penetrations can be a higher-risk area for ingress as moisture can find its way into the cladding through fixing penetrations. Post fixings can be modified.

Direct fixed clothesline

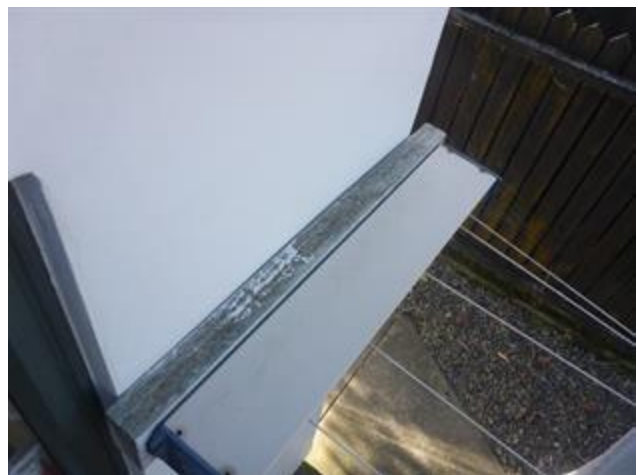
Direct fixed post

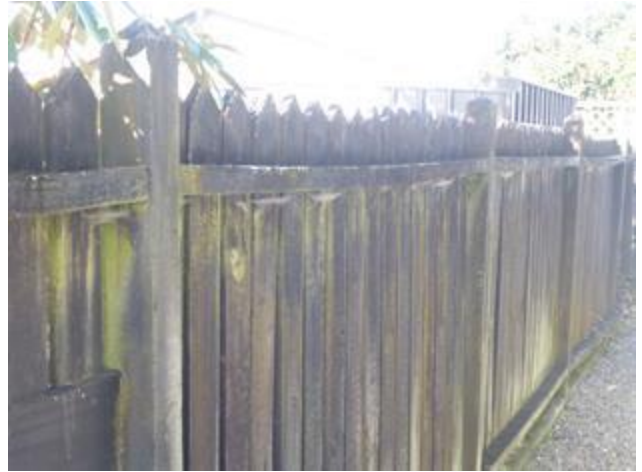
Post repair recommended

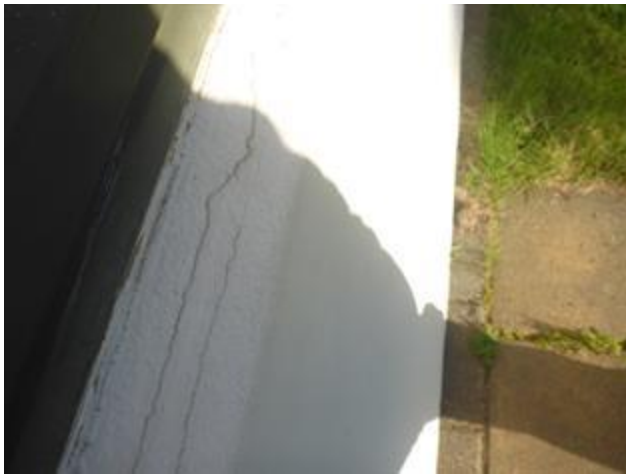
Front windowsill

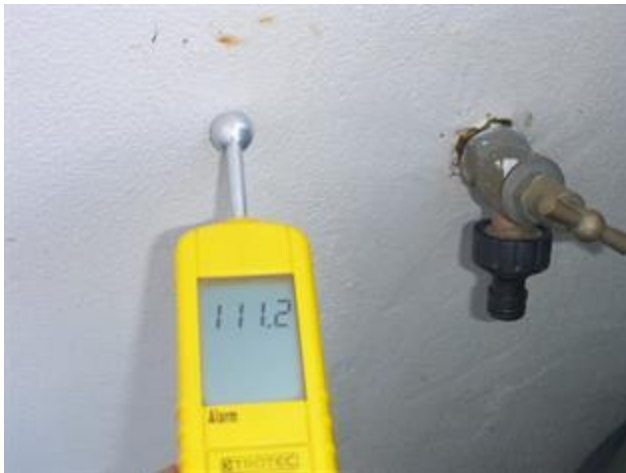
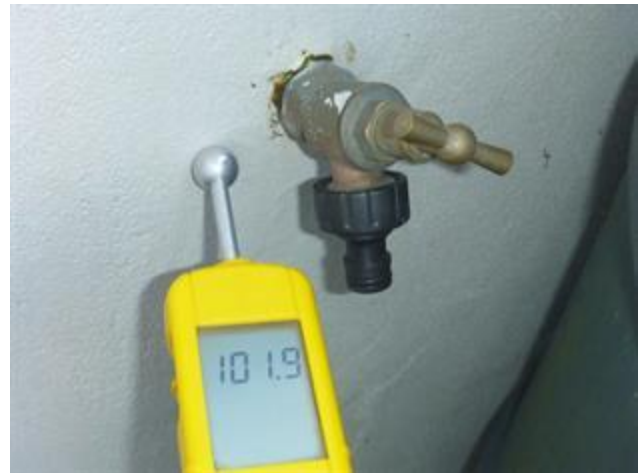
At the time of inspection moisture levels to the base and sides of the joinery penetrations and the hairline cracks were within acceptable parameters but high moisture levels were sighted to the cladding to the sides and base of the rear tap.

Rear tap high moisture levels

My recommendations are that the area to the exterior that indicated high moisture levels now have further invasive appraisal to ensure repairs can be fully carried out and any compromised material can be removed and replaced.

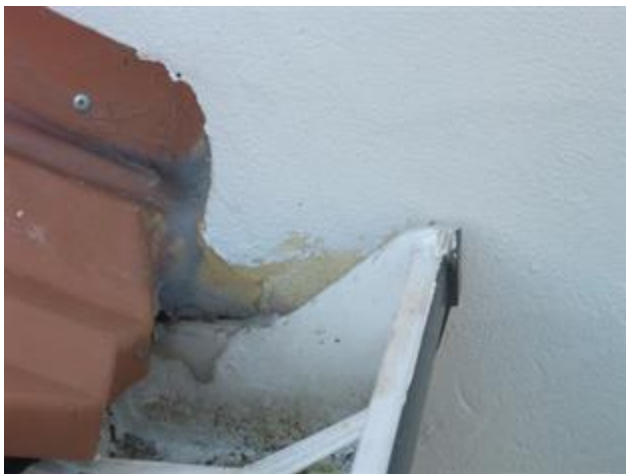
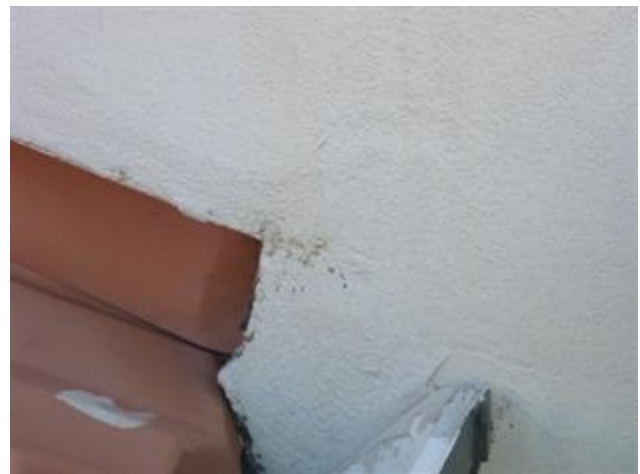
On this dwelling the roof to wall junctions don't have suitable kick out flashings installed and are relying largely on sealant for the weather-tightness. I recommend installing a kick out flashing to the roof wall junctions. The scope of work would require that the cladding at the roof to wall junction is removed and reinstated when the kick out flashing is installed. During this process the framing could be inspected and if there were any signs of moisture ingress, further invasive investigation could be carried out.

Kick out flashings recommended/ roof to wall junctions

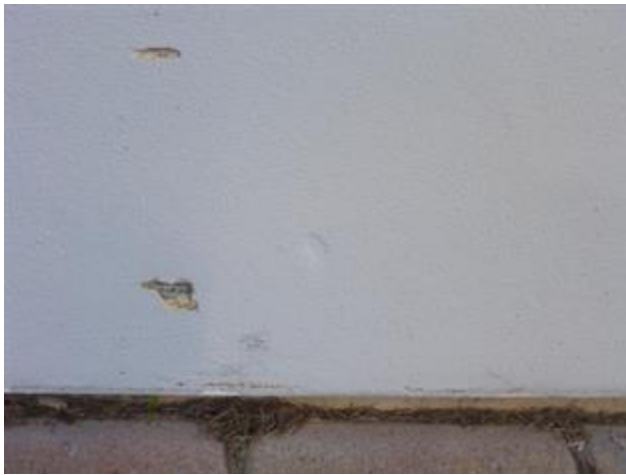
Hairline cracks were sighted to the cladding to the front and side of the dwelling and impact damage was sighted to the western side and to the front, with two hole penetrations sighted to the rear.

Impact damage side

My recommendation is that the EIFS now have further specialist invasive appraisal to give you advice about the cracks, hole penetrations, and impact damage repair requirements, for the installation of kick out flashings, for the area with indications of moisture retention, and for an indication of costs.

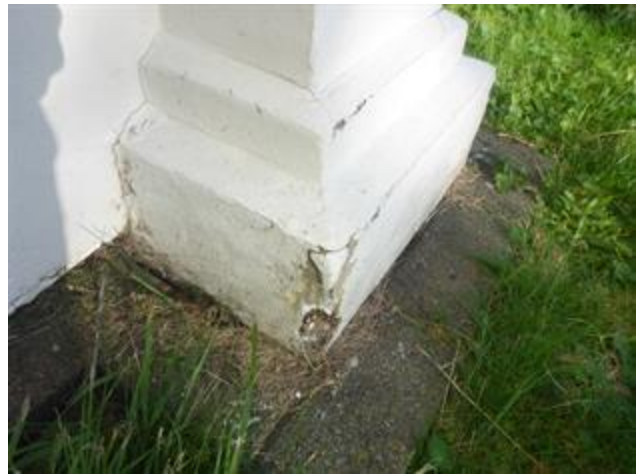
Impact damage front

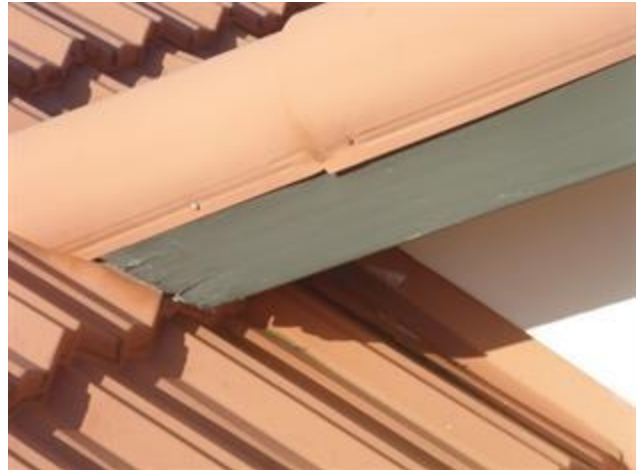
End-grain decay was sighted to the fascia where in contact.

End grain deterioration

I recommend further investigation for repair to prevent progressive damage.

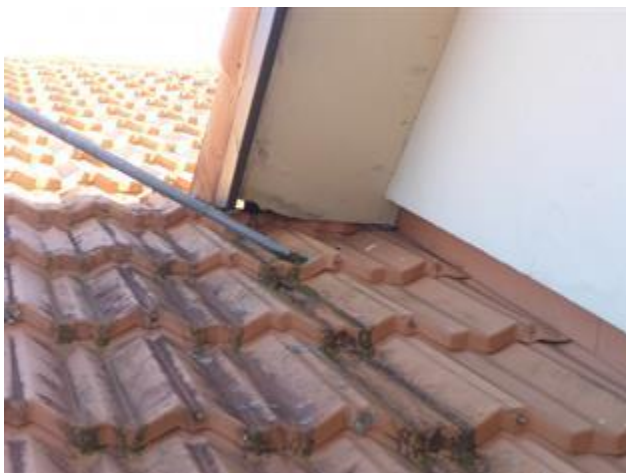
In contact/soffit deterioration

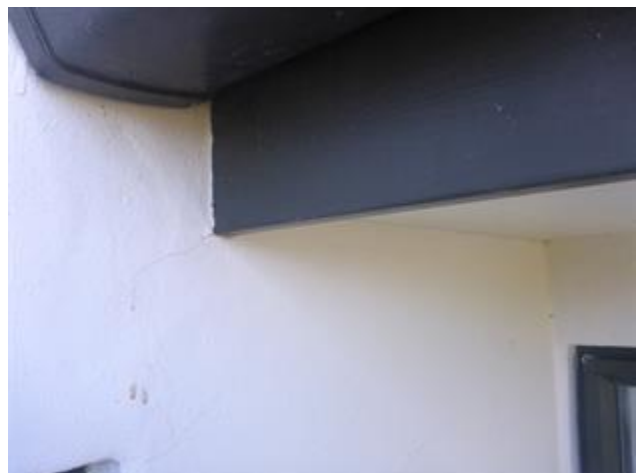
I also noted that the fascia is embedded in the cladding to the sides and rear of the dwelling. This construction can cause the small amounts of expansion and contraction to allow moisture ingress, and these areas are often modified to avoid this known issue. I recommend further investigation, modification and repairing the junctions.

Embedded fascia

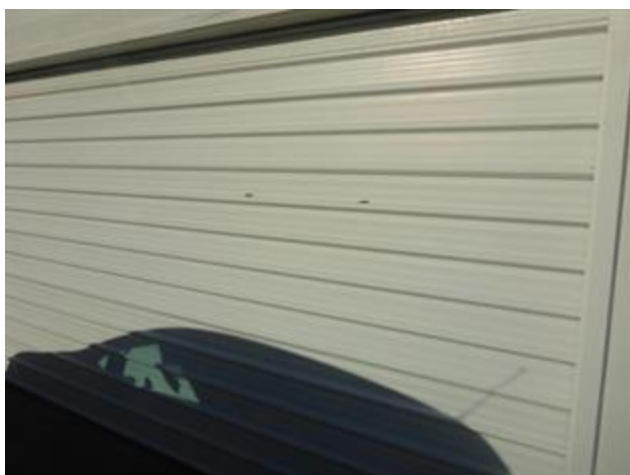
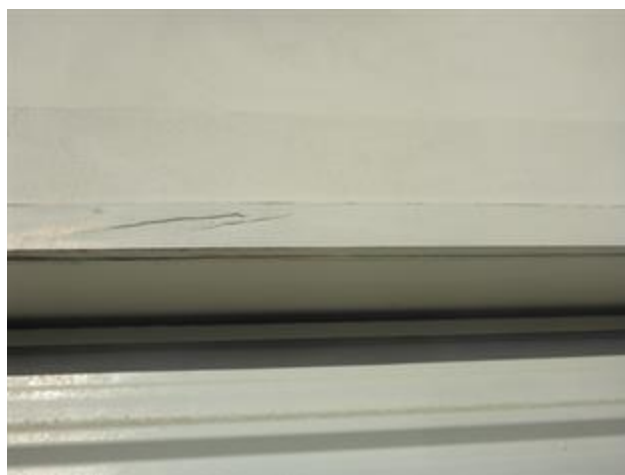
The timber batten to the garage door cladding junction had areas of decay with replacement required to prevent progressive damage.

Decay

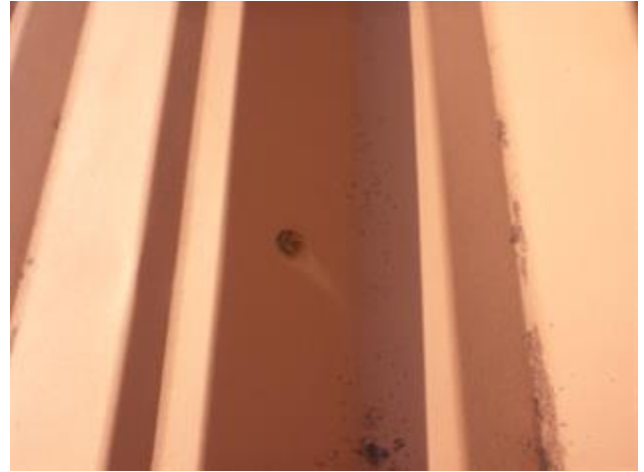
I did note that the tiles of the lower run above the spouting have been fixed through the tops of the tiles without rubber washers. This would have been compliant at the time of construction but does not meet today's standards as this can allow moisture ingress issues.

Direct fixed fastener

I recommend that the roofing material have further appraisal by a licensed roofer to give you advice on the degree of fastener / butynol / washer upgrades and potential costs.

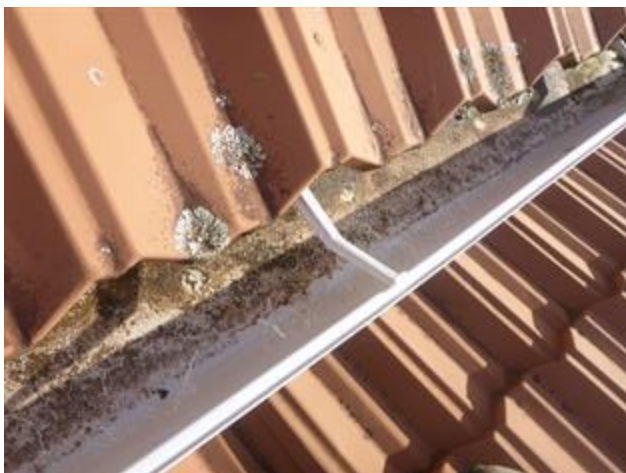
I noted one spouting bracket has popped to the side of the front door covered area and would benefit from being re-fixed.

Popped bracket

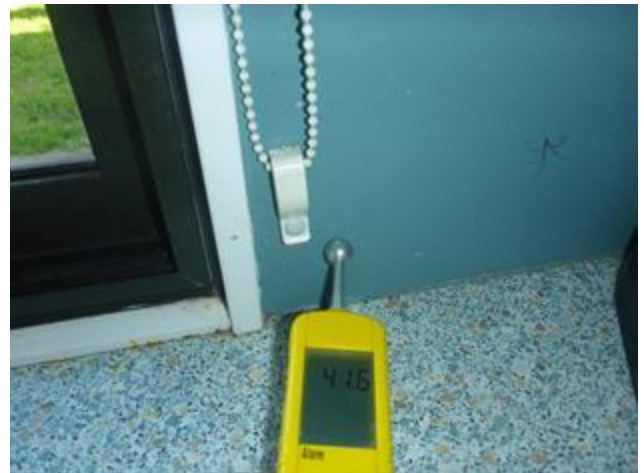
Moisture levels acceptable parameters
