## Vendor Supplied Building Report

## RED LBP WEATHERTIGHT REPORT

# CERTIFICATE OF INSPECTION IN ACCORDANCE WITH NZS 4306:2005

**Company:** Property Support Ltd Ltd trading as RedLBP Kapiti/Porirua  
**Client:** Carl and Jane Olsson  
**Date of Inspection:** 26th May 2026  
**Site Address:** 10 Edgewater Street Waikanae  
**Inspector:** Trevor Garrett  
**Qualifications:** MSc, LBP, Advanced Trade Cert Carpentry, Nat Diploma Construction Management. Member of NZIOB.

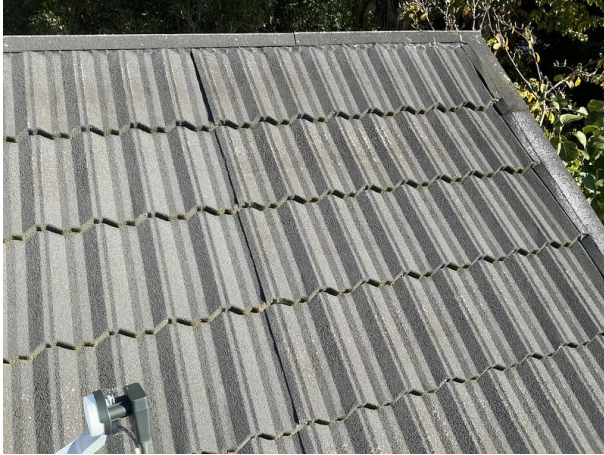
**Photo 3**  
Deterioration to the surface coating  
visible in places.

It is recommended to engage a Licensed Building Practitioner (LBP) specialising in roofing to undertake a comprehensive assessment of the roof's condition and provide a detailed report. Without proper evaluation and timely repairs, undetected or unresolved roofing issues could lead to leaks, water intrusion, and subsequent damage to the underlying structures, insulation, and interior spaces. Over time, this could result in costly repairs, reduced energy efficiency, and compromised structural integrity. A thorough inspection ensures potential issues are identified and addressed promptly, safeguarding the long-term durability and performance of the roof system.

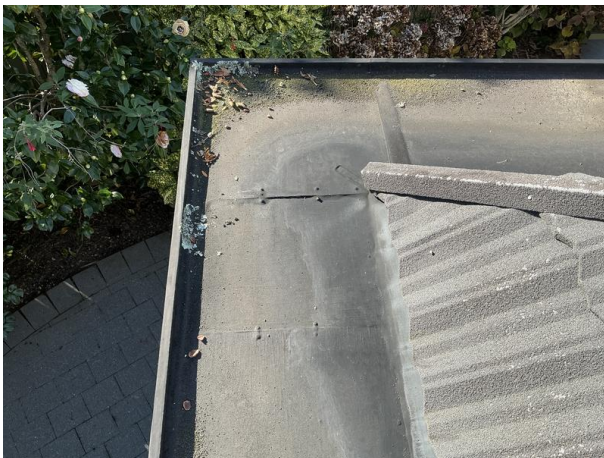
**Photo 4**  
North side split membrane and raised  
substrate fixings.

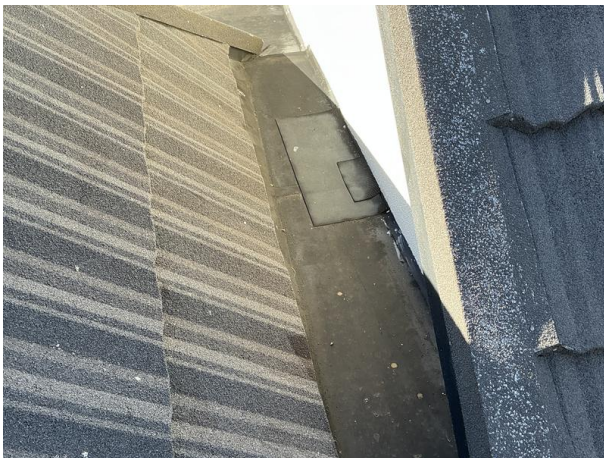
**Photo 7**  
Eastside repairs to the membrane.

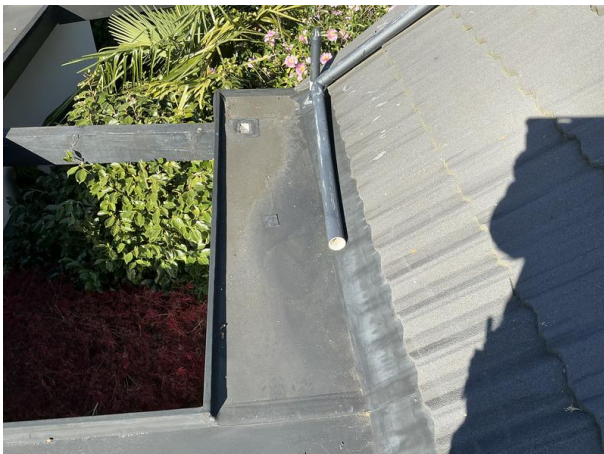
**Photo 8**  
Southside repairs and downpipe  
discharging onto membrane roof from  
upper level.

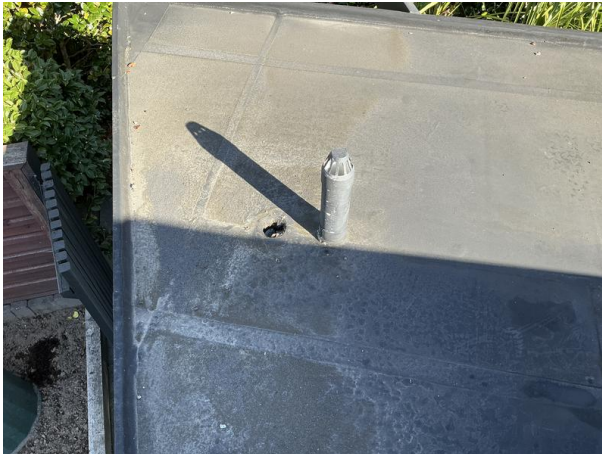
**Photo 9**  
Southside no overflows visible to the  
membrane roofing.

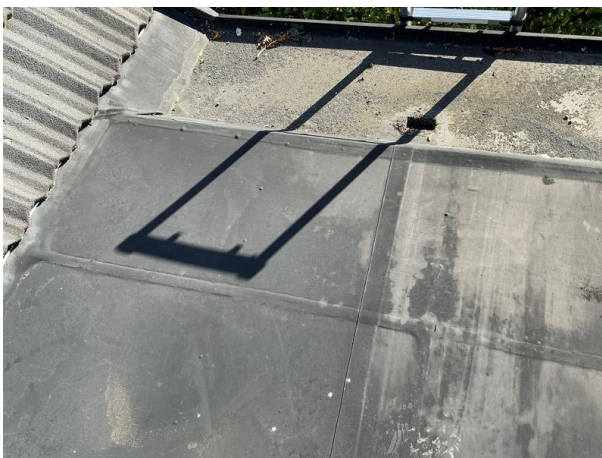
**Photo 10**  
North side raised fixings.

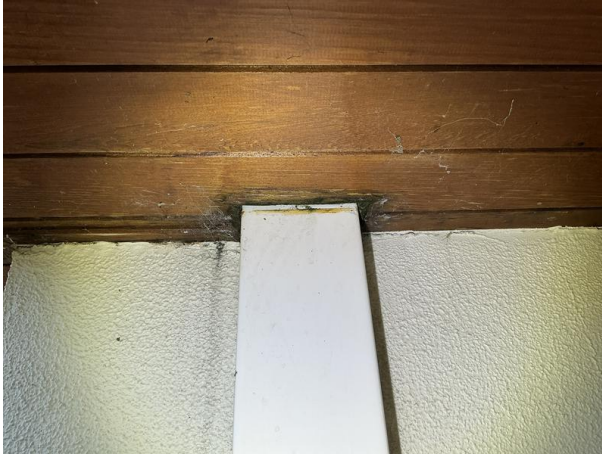
**Photo 12**

Visible moisture damage around the southeast downpipe.

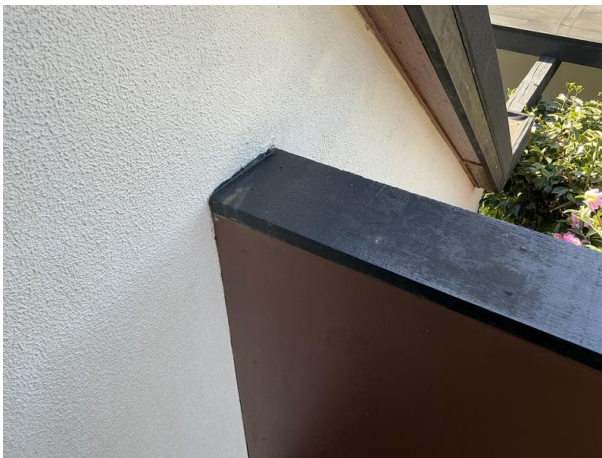
**Photo 16**  
Barrier wall has a timber top with no  
visible cap or saddle flashing.

Refer to the cladding and wall framing sections.

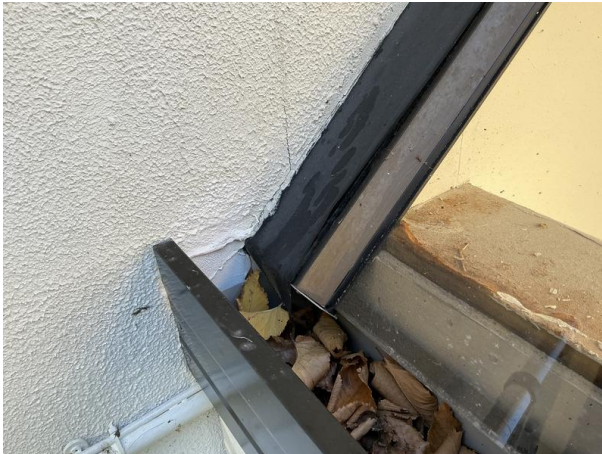
**Photo 17**

North side roof and wall junction has no kick out diverter flashing. Vertical crack visible.

There are cracks to the exterior cladding, in our view these need to be professionally repaired, as any cracks can allow moisture in behind the cladding and into the timber framing. Some of the cracking may relate to the lack of control joints and this can be determined by a exterior cladding specialist before carrying out the repairs.

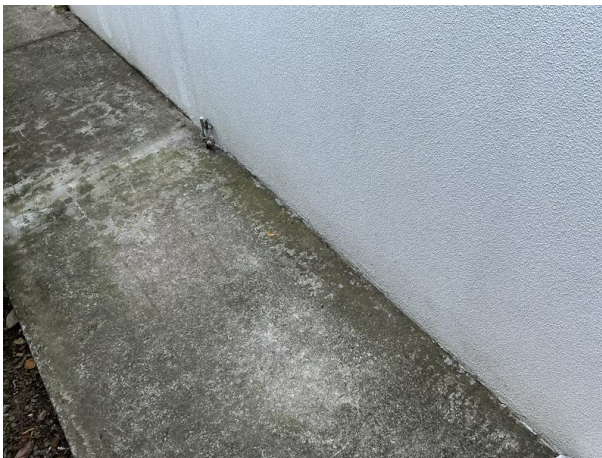
**Photo 18**

West side has reduced ground clearance.

Some areas around the dwelling, the minimum ground clearance have been compromised due to hard landscaping or gardens. This reduced clearance can lead to accelerated weathering of the cladding and increase the risk of moisture-related damage. To mitigate this, it is recommended to lower the ground levels where feasible or install strip or channel drains. These measures will help protect the cladding by minimising exposure to moisture.

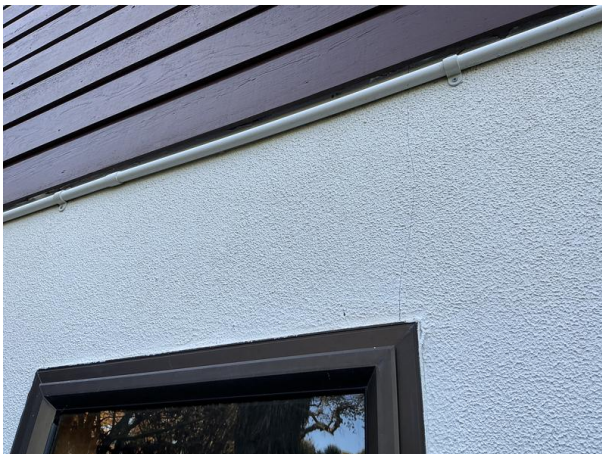
**Photo 19**

West side windows have no head flashing, crack visible to the corner and side of the window.

Head flashings are absent to sections of the exterior joinery, increasing the risk of moisture ingress at the junction between the joinery and cladding. It is recommended that suitable head flashings be installed by a suitably qualified contractor or Licensed Building Practitioner (LBP) to direct water away from the joinery and improve the weathertightness of the exterior envelope.

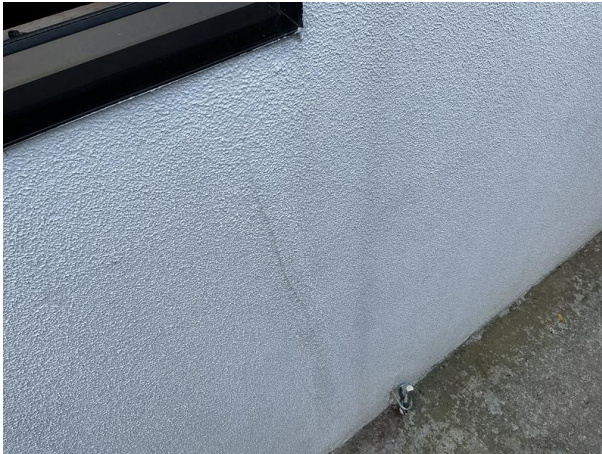
**Photo 20**  
West side crack repair.

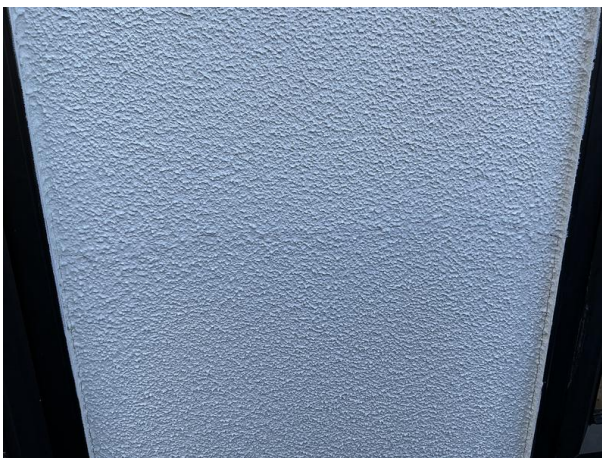
**Photo 21**  
Westside horizontal crack between windows.

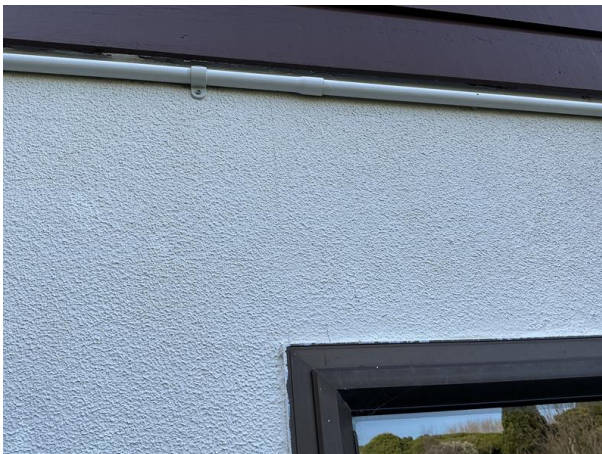
**Photo 22**  
West side vertical crack.

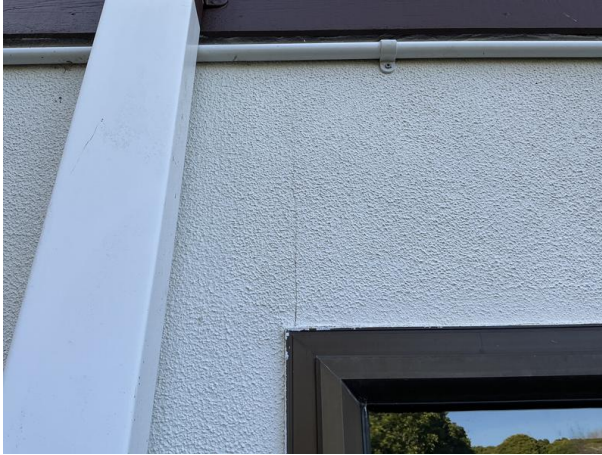
**Photo 23**  
West side crack.

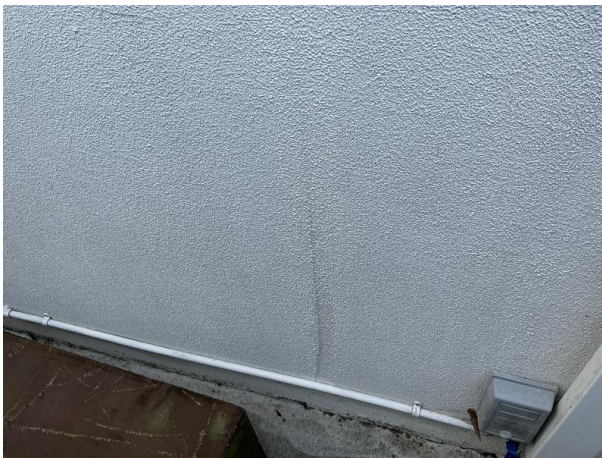
**Photo 24**  
West side crack repair.

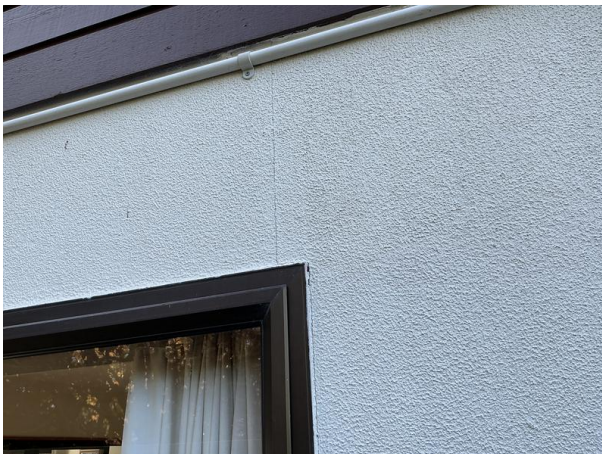
**Photo 25**  
West side crack to corner and side of window.

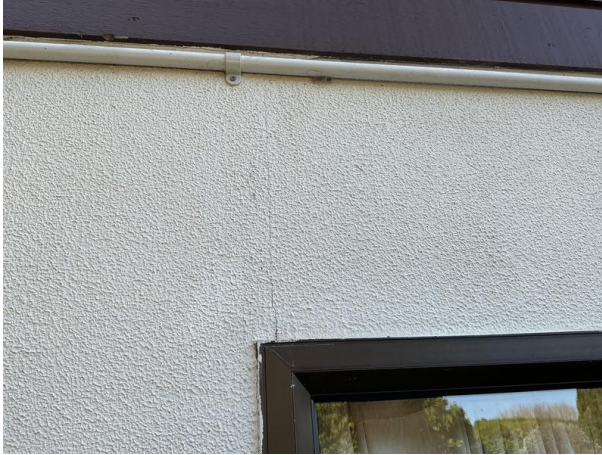
**Photo 26**  
West side crack.

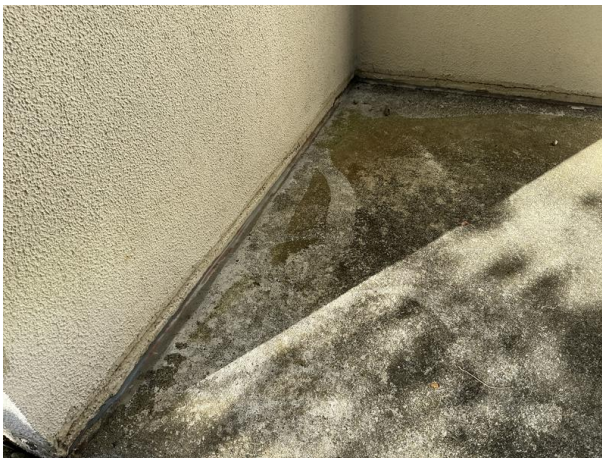
**Photo 27**  
Northwest side sealant repairs. Refer to wall framing section for moisture testing to this area.

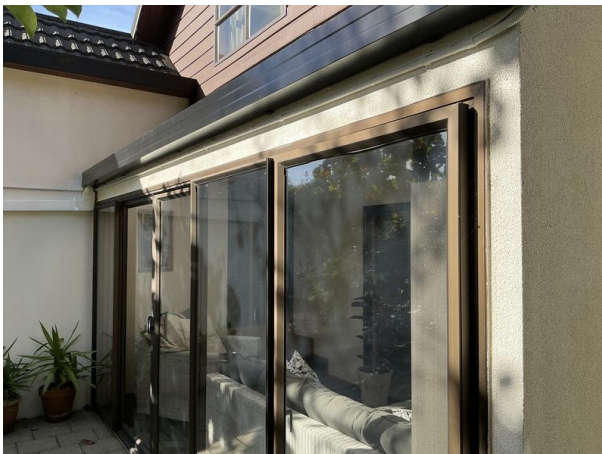
**Photo 28**  
North side window has no head flashing.

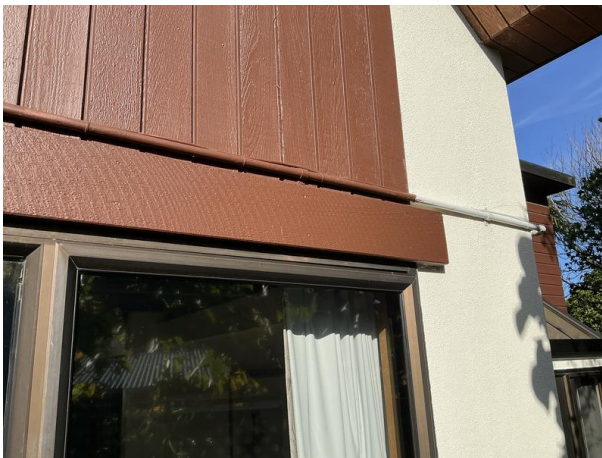
**Photo 30**  
Northside no head flashing to window.

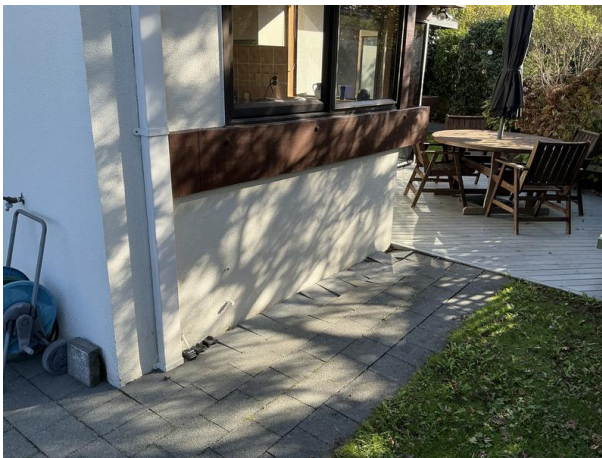
**Photo 33**  
Northside structure fixings penetrate the climbing.

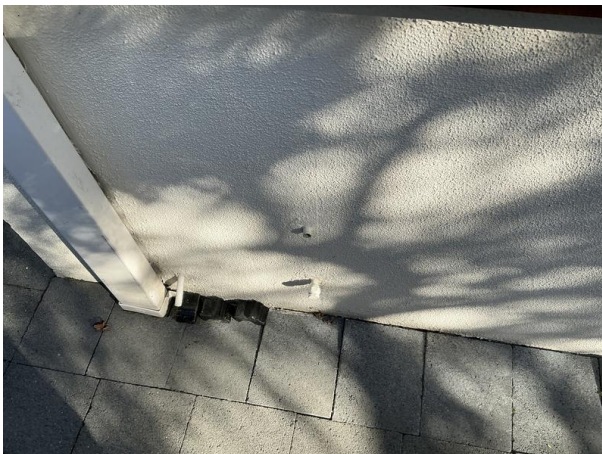
**Photo 34**  
Northside crack.

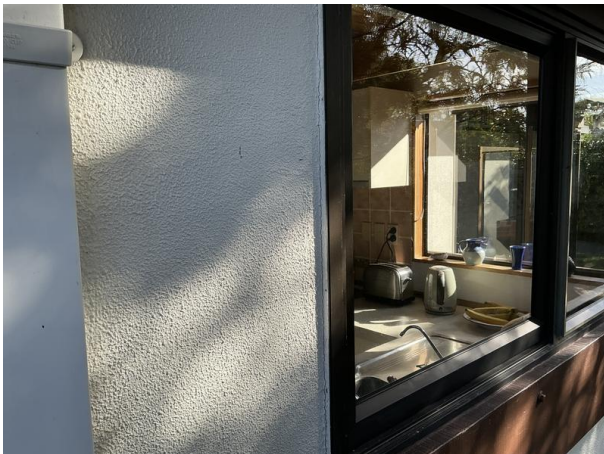
**Photo 35**

Northside crack to the side of the window.

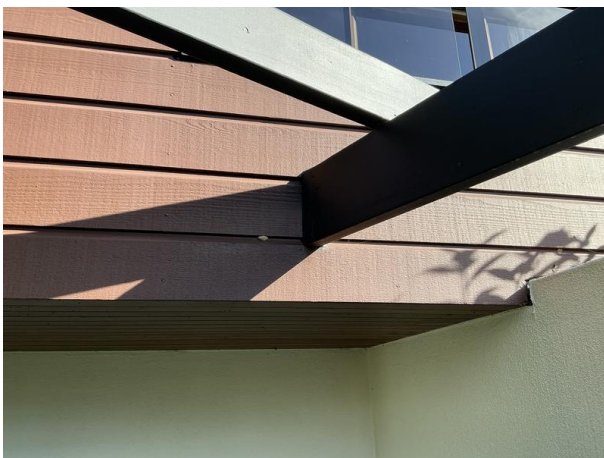
**Photo 38**  
Structure penetrating the cladding.

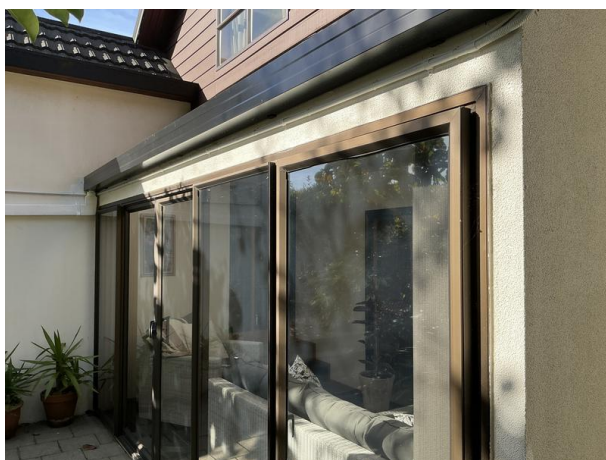
**Photo 41**  
North side no head flashing.

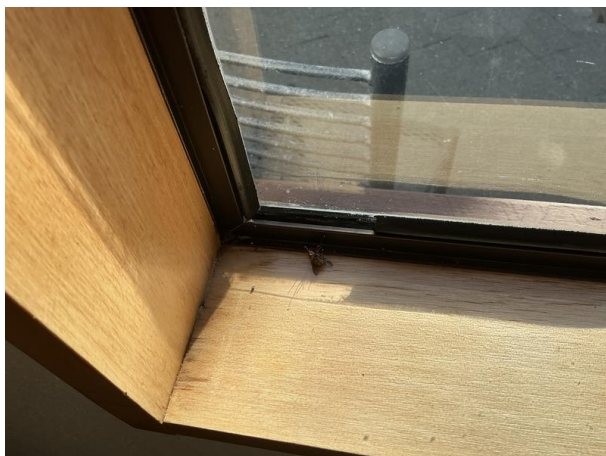
**Photo 42**  
Shrunk glazing rubber.

To prevent water & draughts from entering, it is recommended to replace or properly re-seat the rubber seals on the exterior of the joinery. By doing so, you can ensure a tight seal that effectively safeguards against water & draught ingress.

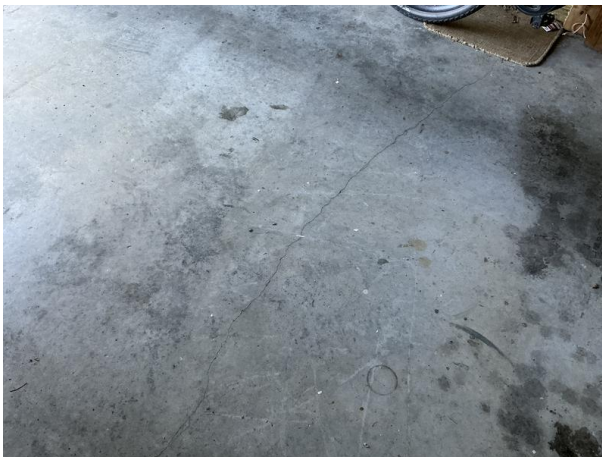
**Photo 44**  
Crack to the slab, no issue.

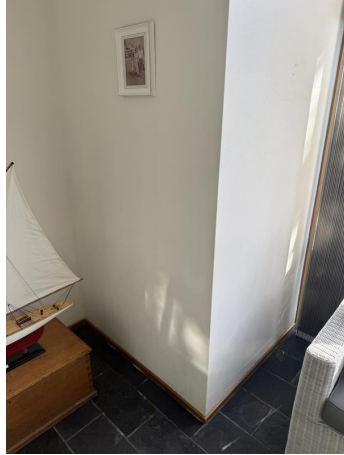
The indications of elevated moisture noted in the wall framing section highlight readings in the northwest corner of the conservatory and the balcony deck barrier wall, which could indicate a failure of weathertightness. Further investigation is recommended to establish the reasons for the indications of elevated moisture. Followed by suitable remediation work as required.

**Photo 45**  
Northwest corner of the conservatory  
has indications of elevated moisture.

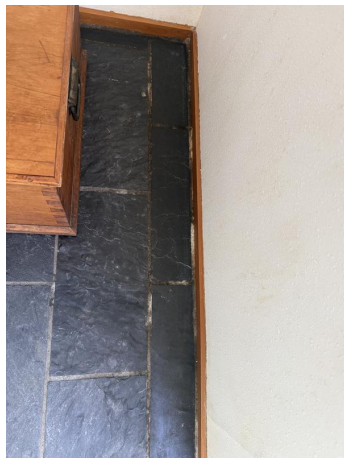
**Photo 46**  
Limescale visible to the tile mortar.

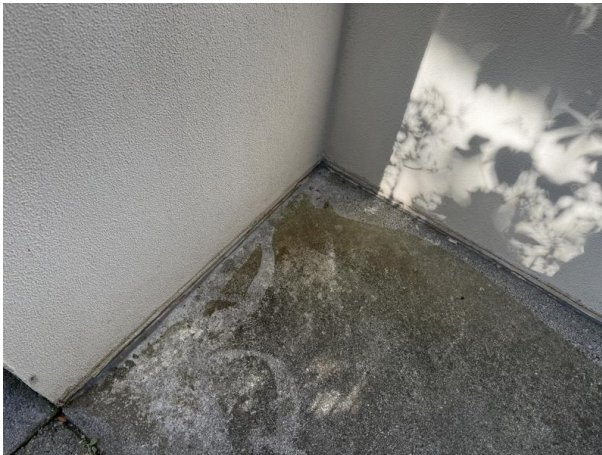
**Photo 47**  
Exterior of the conservatory has visible  
sealant repairs.

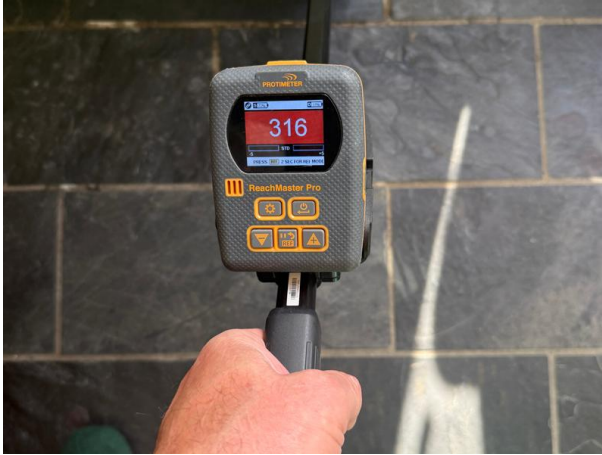
**Photo 48**  
Northwest corner of the conservatory  
has indications of elevated moisture.

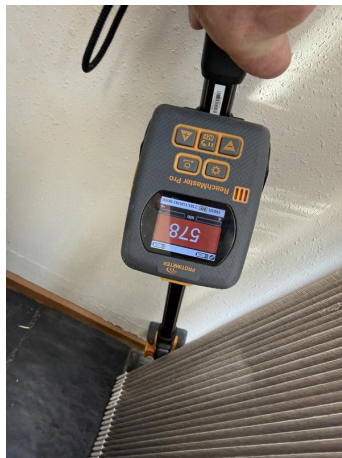
**Photo 49**  
Northwest corner of the conservatory  
has indications of elevated moisture.

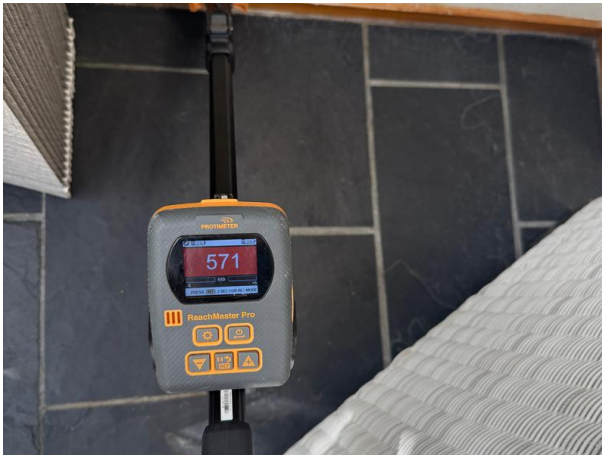
**Photo 50**  
Northwest corner of the conservatory  
has indications of elevated moisture.

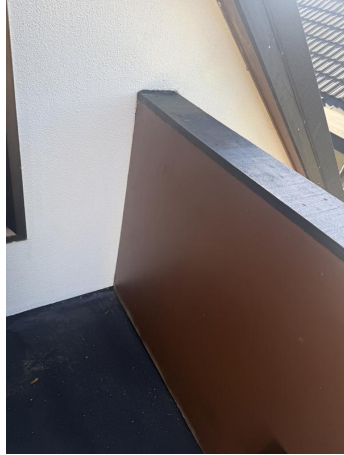
**Photo 51**

Balcony deck barrier wall has indications of elevated moisture.

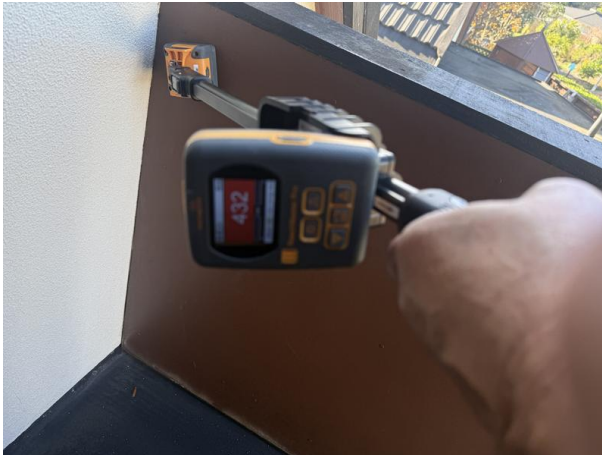
**Photo 52**

Balcony deck barrier wall has indications of elevated moisture.

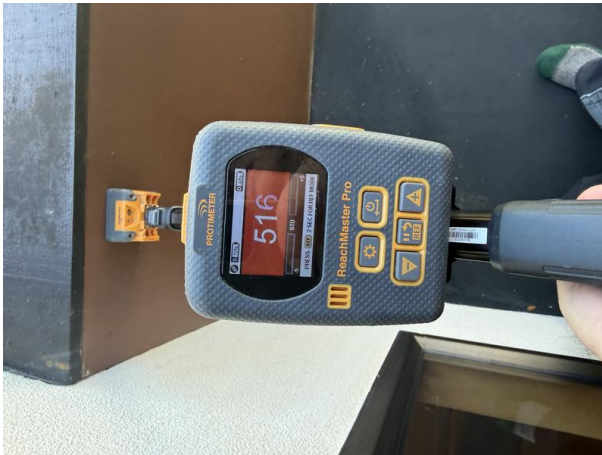
**Photo 53**

Balcony deck barrier wall has indications of elevated moisture.

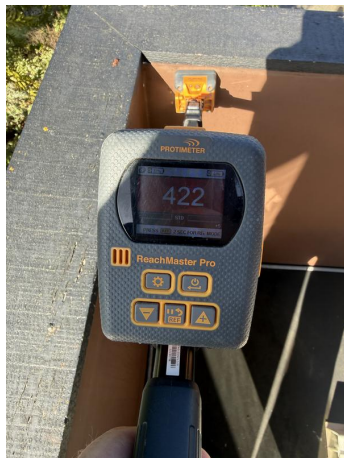
**Photo 55**

South corner of the balcony barrier wall has indications of elevated moisture.

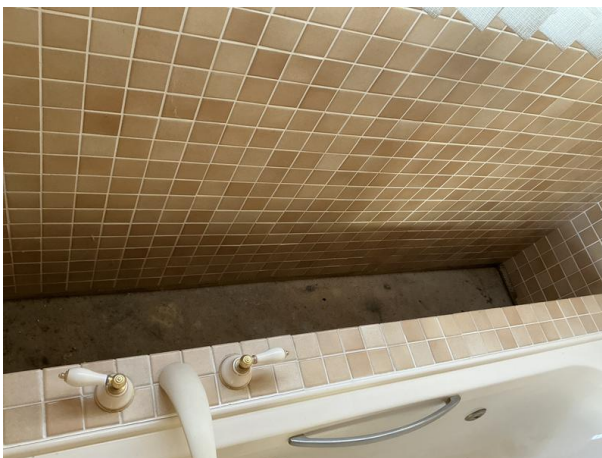
**Photo 60**  
Area of floor has no floor covering.

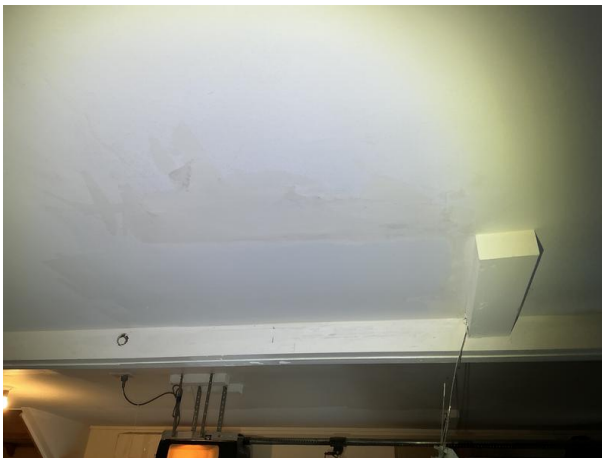
**Photo 69**  
Moisture stain. This was moisture tested and found to be dry at the time of inspection.

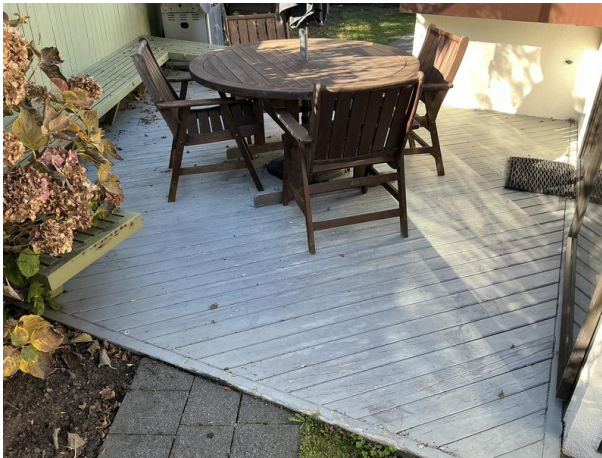
**Photo 92**

East side deck is in contact with the ground.

The timber deck is built very low to the ground, making the substructure inaccessible for inspection. If the timbers are in direct contact with the ground or lack a damp-proof membrane, moisture can penetrate the H3-treated timber, leading to prolonged exposure and eventual rot.
