# Independent Builders Report

Total Home Inspection Services Porirua City Ltd

Fri 29 May 2026

**75B Paremata Haywards Hill Rd, Pāuatahanui, Porirua,**  
**5381, New Zealand**

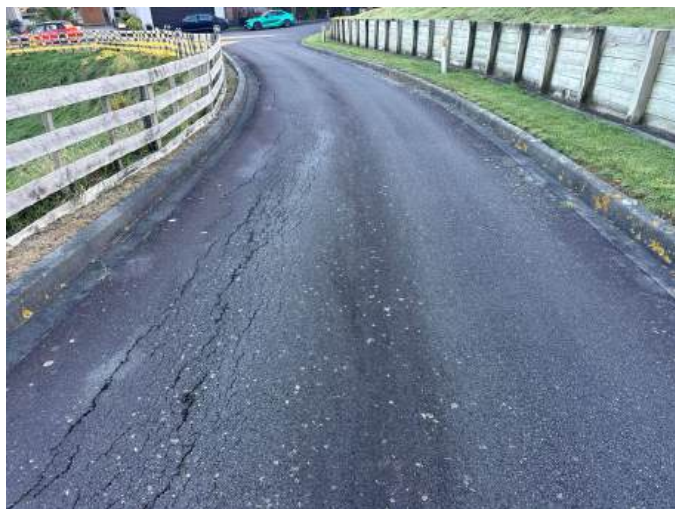
The surface condition of the sloping driveway is good overall. Isolated wear only.

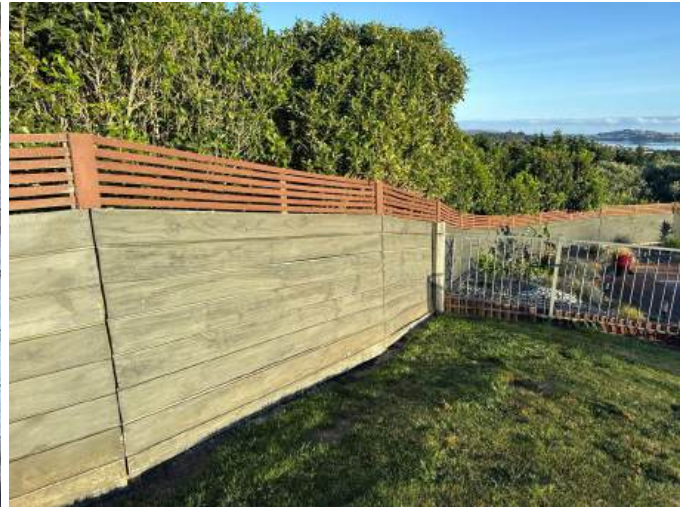
Example. It was not practical to inspect all fencing due to the size of the property. The fencing in the immediate vicinity was intact and secure at the time of the inspection.

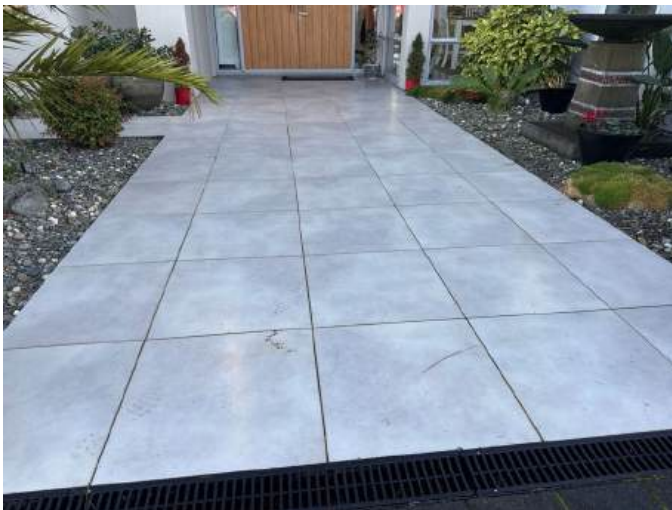
The paved areas are in good condition.

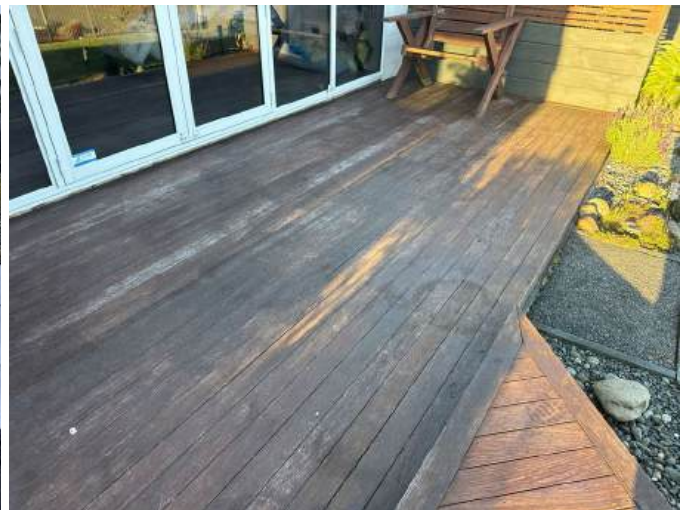
The low height hardwood decks are in an average condition

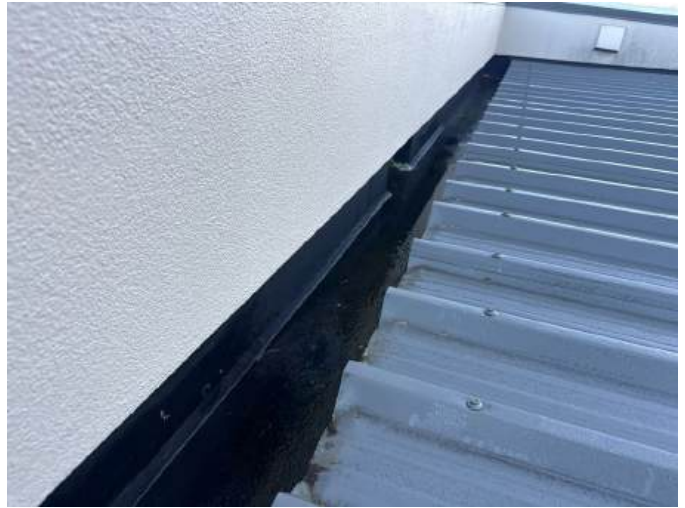
The waterproof membrane lined internal gutters are intact and showing no evidence of deterioration or failure

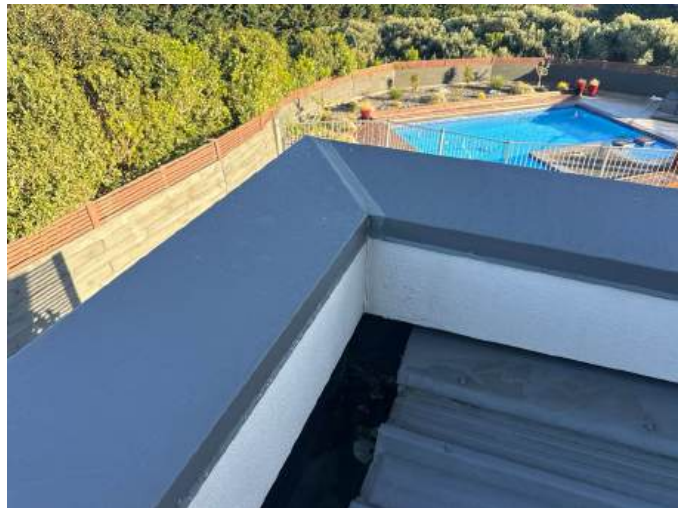
The roof flashings appear to be well detailed and are effective. No sign of failure could be found beneath where accessible to view.

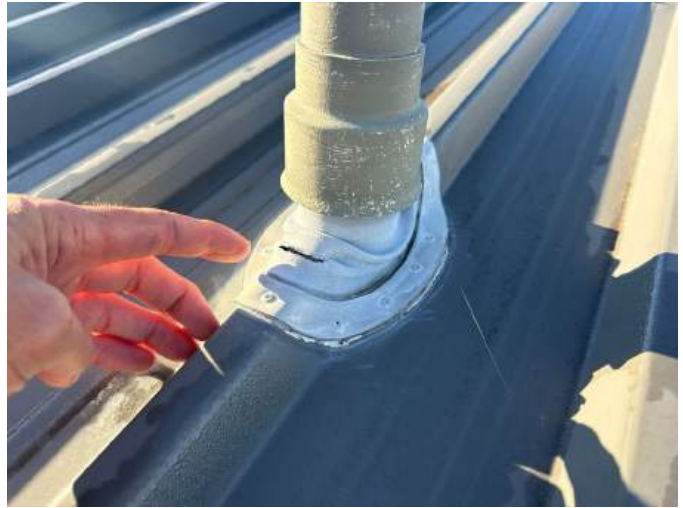
The roof is in good overall condition. There was no sign of significant faults or failure at the time of inspection. Regular cleaning and checks will help maintain the current condition. One terminal vent boot flashing on the top roof has split and should be replaced by a plumber.

One of the terminal vent flashings has split on the top roof and should be replaced by a plumber

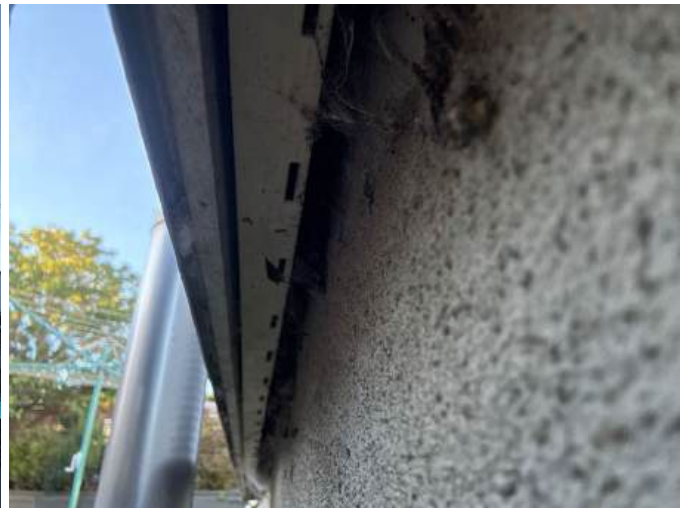
Cavity system detail clearly visible at the base of the metal cladding. The cavity system is a modern detail that allows moisture to escape and ventilation to the back of the cladding.

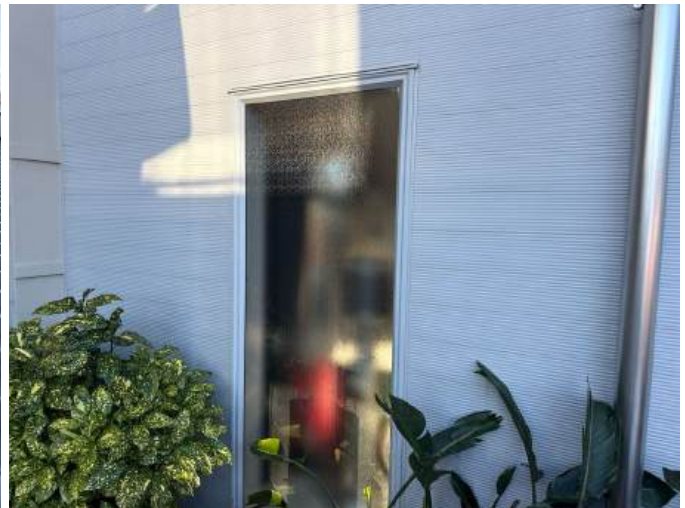
The typical double glazed aluminium window (metal cladding) detail has a specific flashing system for this cladding type. No evidence of failure could be found. Good visual condition noted.

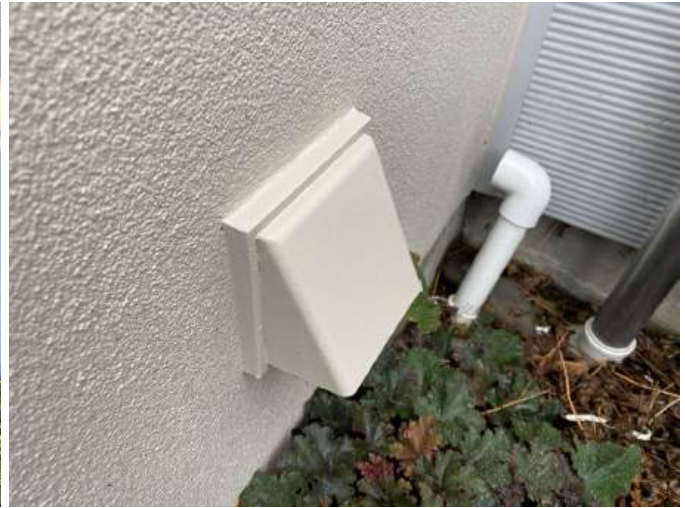
Cladding penetrations can sometimes become water entry points or weather tightness risk areas. Penetrations such as taps, screw fixings, gas or water pipes etc. Low risk with the cavity system and modern flashing detailing. No evidence of failure could be found.

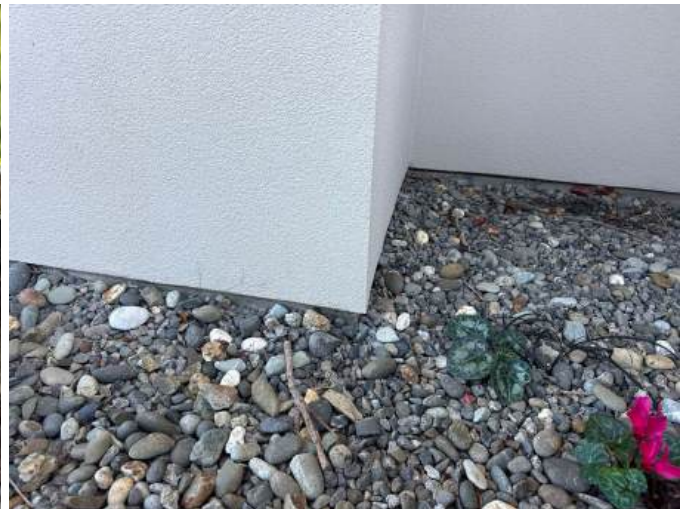
Poor ground clearance can sometimes result in moisture ingress via capillary action, a particularly high risk due to the bottom plate being at risk of decay. The current building code requires a 150mm clearance between the internal floor height and the sealed ground and 225mm to unsealed ground.

At the time of the inspection all non invasive moisture tests completed to the bottom plate at these locations presented within the acceptable range. T.H.I.S recommends maintaining the recommended ground levels to prevent unnecessary maintenance.

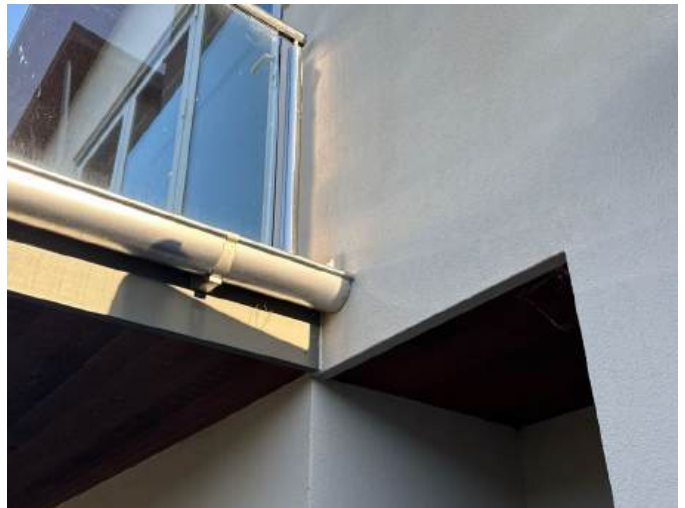
Good use of the diverter flashings at the roof/cladding junctions. These are an effective waterproofing detail that channels water away from common water tightness risk areas.

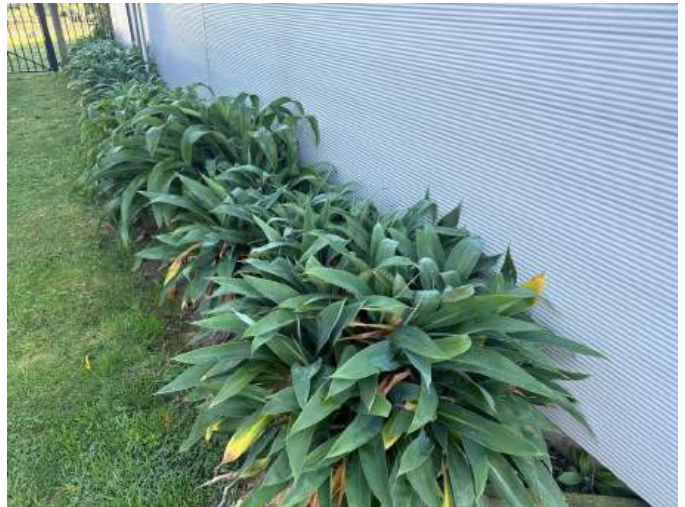
The Southwest side

Plants in close contact with the cladding should be trimmed back to prevent the risk of premature deterioration

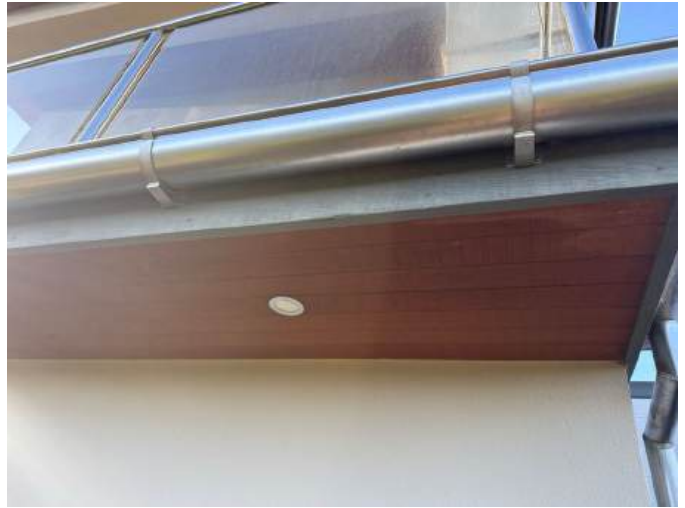
The Northwest side

The timber fascia and soffits are in an average/good condition

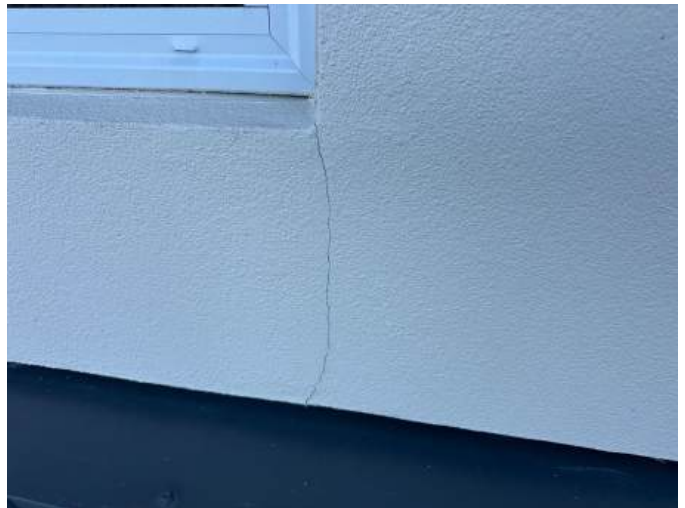
The house is clad with an Exterior Insulation and Finish System (E.I.F.S) installed over a cavity system. At the time of inspection, the cladding was generally in serviceable condition; however, hairline cracking was noted to sections of the cladding above the upper roof junction areas. Evidence of previous crack repairs was also observed, although these repairs have not been effective, with cracking reoccurring in the affected locations.

West/Southwest side above garage roof. Hairline cracking requires repair.

All cracking should be assessed and repaired in accordance with the recommendations of the cladding/coating manufacturer. Larger cracks should be repaired by a suitably qualified solid plastering professional to ensure the integrity and weather resistance of the cladding system is maintained. Failure to adequately repair and maintain cracks may increase the risk of moisture penetration into the wall structure.

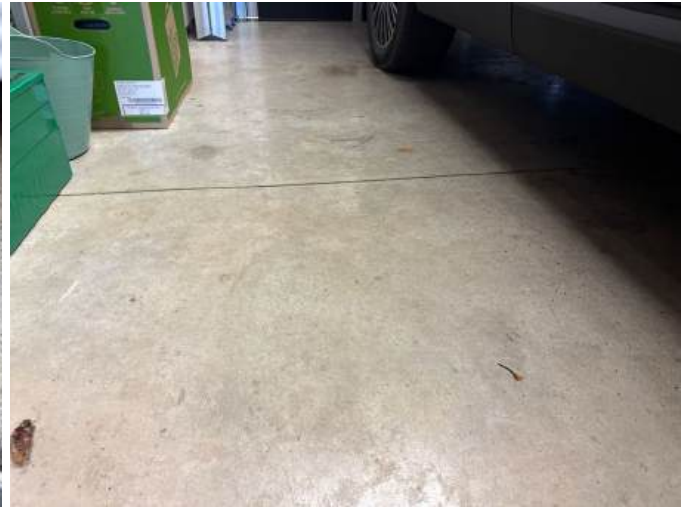
Example. The exposed concrete floor in the garages are in good condition.

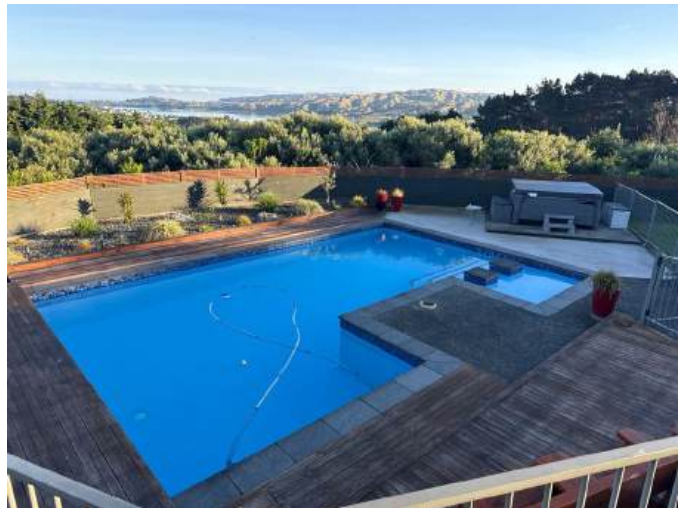
The pool and spa were not checked as part of the inspection process. New concrete pad around the spa noted.

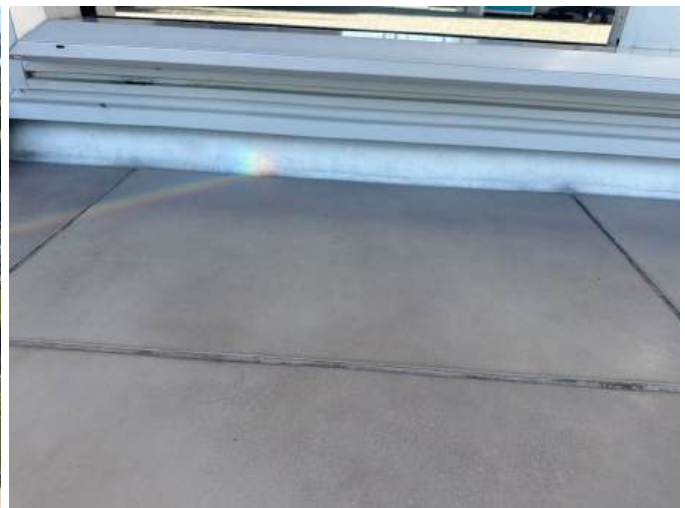
Since 2005, gluing tiles to membrane decks has been prohibited according to page 54 of the E2/AS1 compliance document of the New Zealand Building Code. There is no way of cleaning or inspecting the membrane beneath. If installed now this would require a removable raised surface. There was no evidence of significant deterioration or failure found at the time of the inspection. Ongoing monitoring is required.

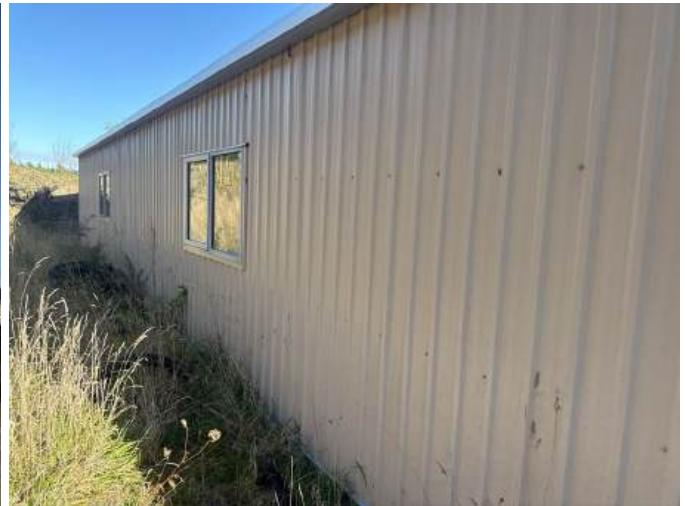
The lightweight metal exterior cladding is in good condition

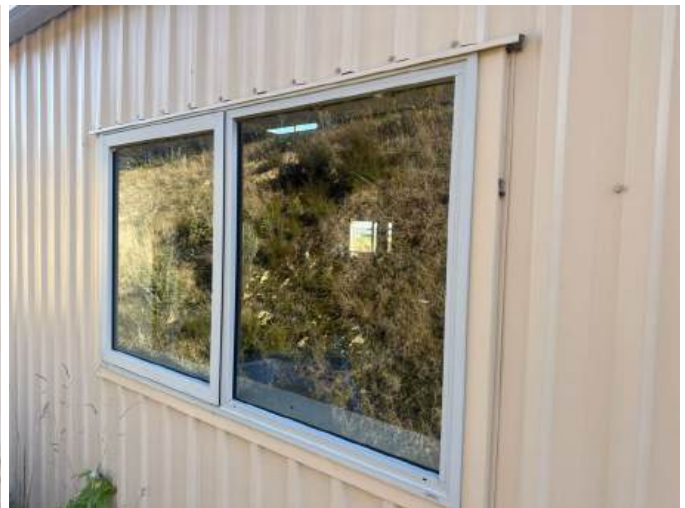
The single glazed aluminium windows to the garage are effectively sealed and in good condition
