# Independent Builders Report

Total Home Inspection Services Porirua City Ltd

Thu 16 Jul 2026

**22 Pinewood Gr, Paraparaumu Beach, Paraparaumu,  
5032, New Zealand**

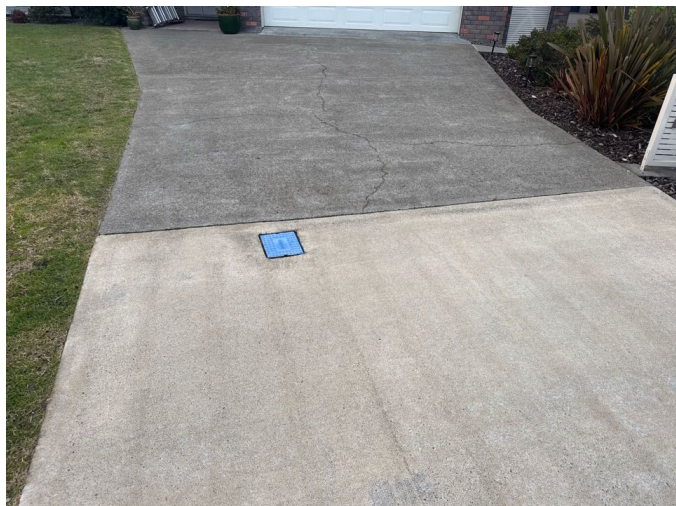
The driveway is well formed and slopes away from the garage. Minor shrinkage cracking to the driveway but no significant damage.

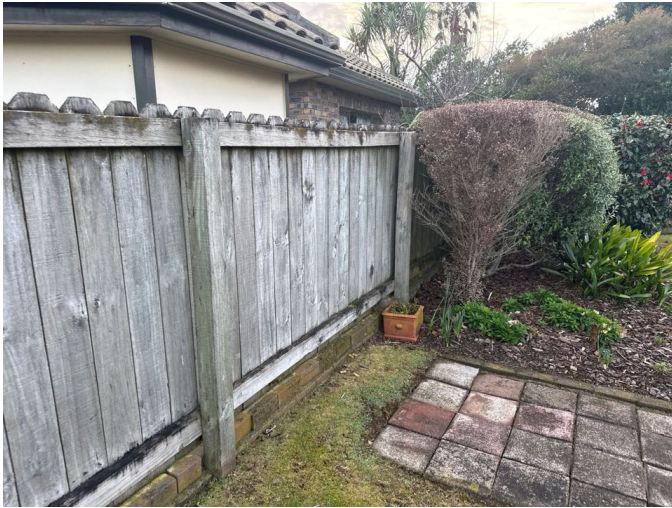
The perimeter fencing is solid and intact. T.H.I.S is unable to comment on the condition of fencing or retaining that are concealed by vegetation.

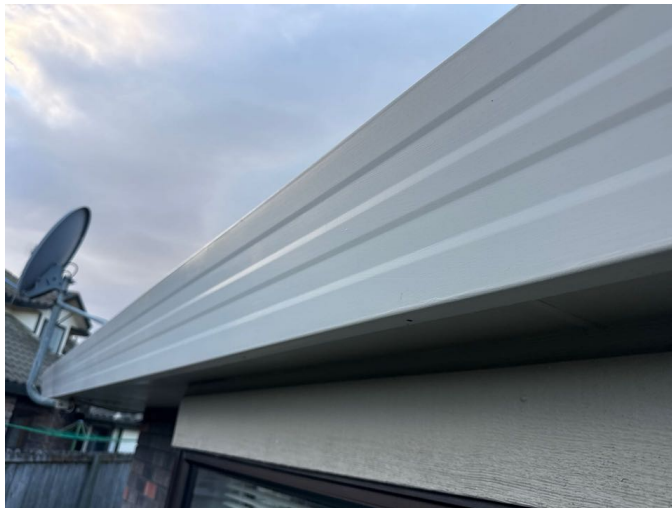
Klass is a brand of Fascia that came onto the market in the 90s and was developed to hide the spouting (internal gutter) behind a fascia to create a clean visual line. Five similar systems are also available in the market.

The system was popular on new builds for some time, but the system comes with some inherent design faults that can in some circumstances lead to water getting inside the house.

Klass Fascia is also prone to rusting on the bottom lip of the fascia due to the angle that its on reducing the natural effect of the rain washing the fascia. Ongoing monitoring recommended.

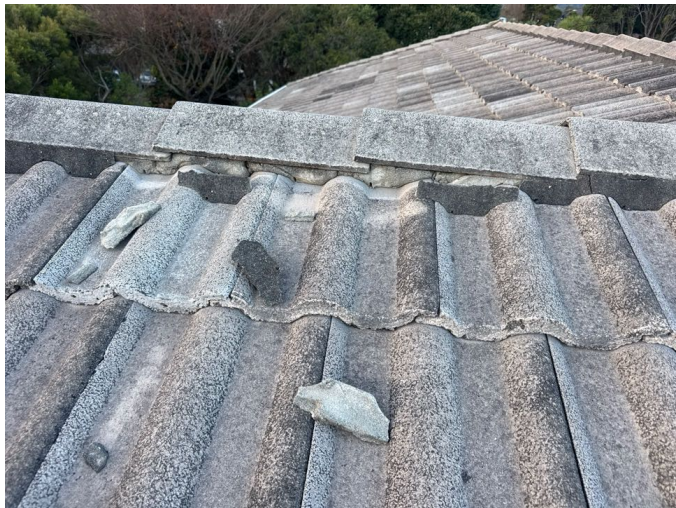
Cracks to the mortar seal indicate that maintenance is due. Re-pointing should be completed where necessary to ensure a watertight roof is maintained.

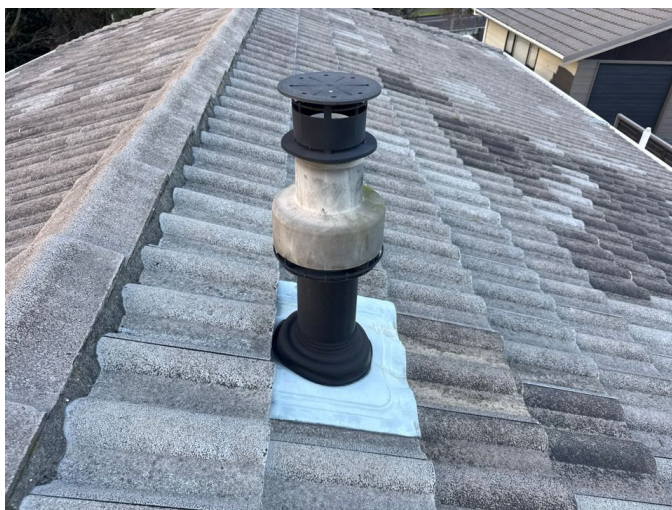
The flue for the boiler is in good condition and is effectively flashed.

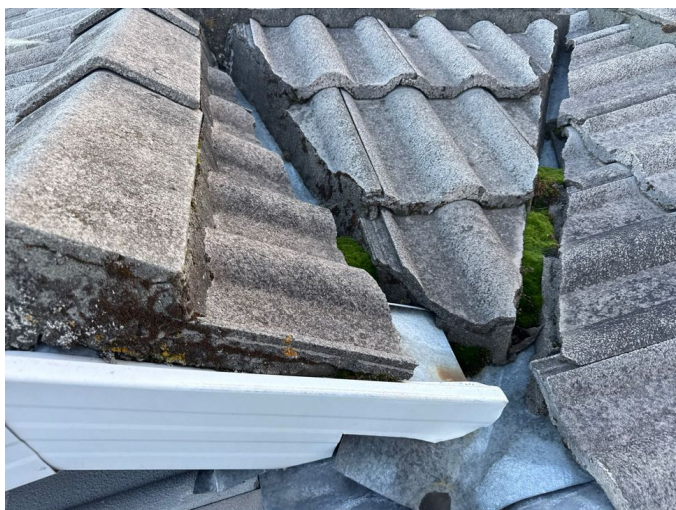
Example. The Moss should be chemically treated to prevent it spreading. A chemical treatment may be required every 2-3 years as part of ongoing roof maintenance. Moss can cause premature deterioration to the tiles and mortar and will need to be monitored and treated as required.

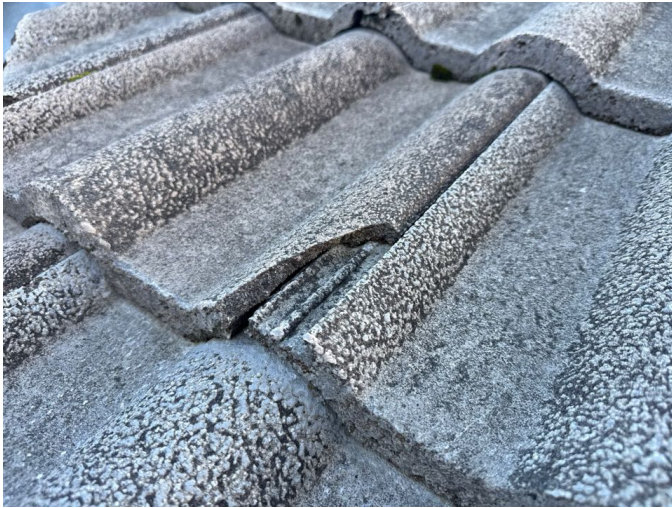
Example. Small sections of damage to the tiles like this are not a weather tightness risk.

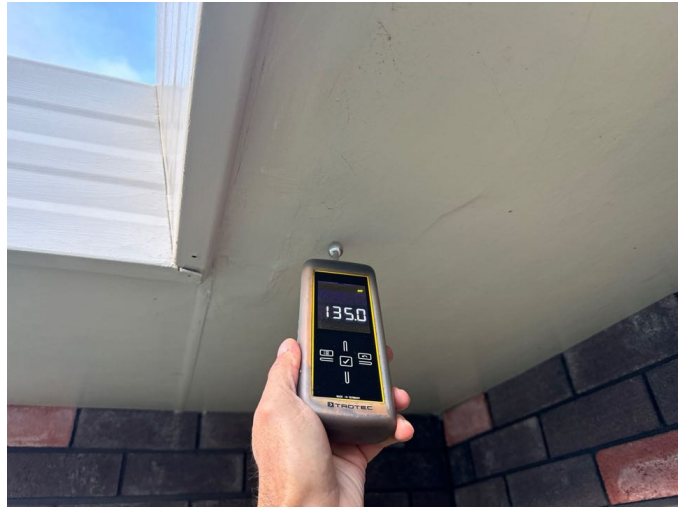
Any blockages to the internal gutters can result in water back flowing into the soffit and sometimes into the house. There has been at least 2 incidents of water entering into the soffit but not the walls (1 incident was disclosed by the owner when asked). This will be an ongoing risk with this system but note this can be mitigated by ensuring they are monitored and kept clear from debris. If the internal gutter system is to be replaced with an external type in the future, it will require modifications to the roof framing.

North side. Elevated moisture readings and bulge to the soffit. The owner disclosed a previous overflow which was caused by the failure of an expansion joint. There may still be moisture present in the soffit. A hole should be drilled to allow any pooling water to escape (if present).

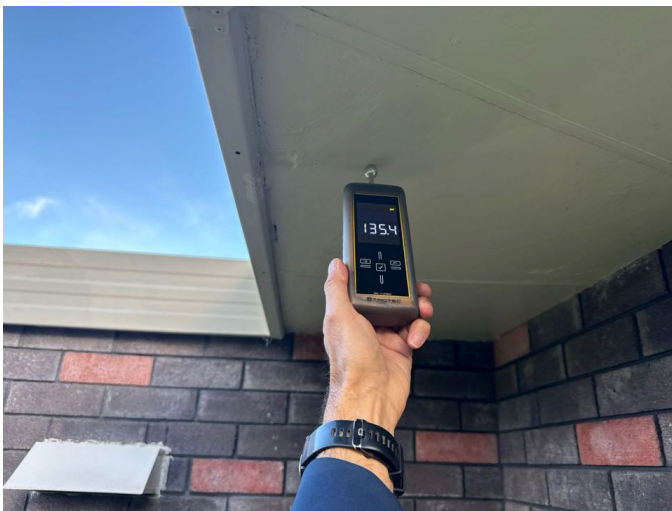
Northeast side. Bulging soffit and elevated moisture readings. As above.

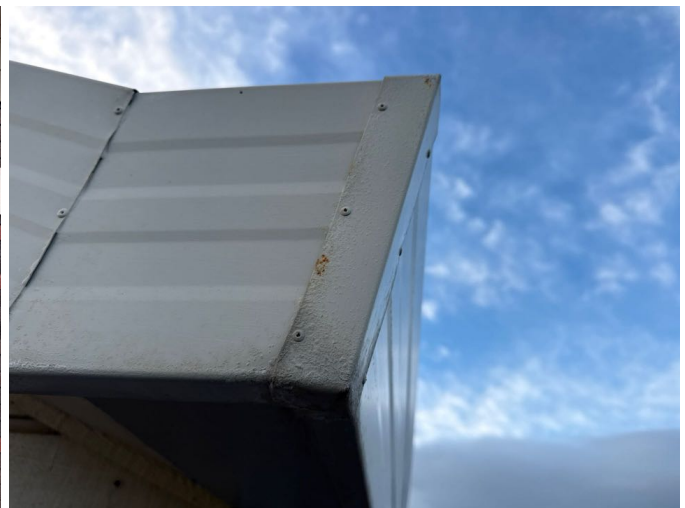
Example. There is surface rust to the steel fascia which requires attention

Any surface rust should be prepped, treated with rust converter and painted to prevent further deterioration.

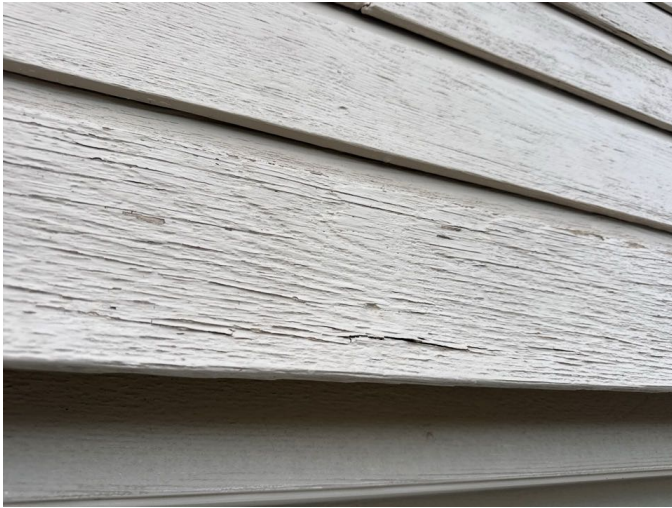
The timber weatherboards show general surface deterioration and isolated areas of damage to the box corners on the southwest side. General maintenance is recommended, including repairs to the damaged timber and a paint upgrade to protect the cladding and maintain weather tightness. Exterior cladding should be painted at approximately 8-10 year intervals in exposed UV areas. Intervals can stretch for low UV exposed areas.

The current paint system is nearing the end of its functional life. Paint improvements recommended in the near future.

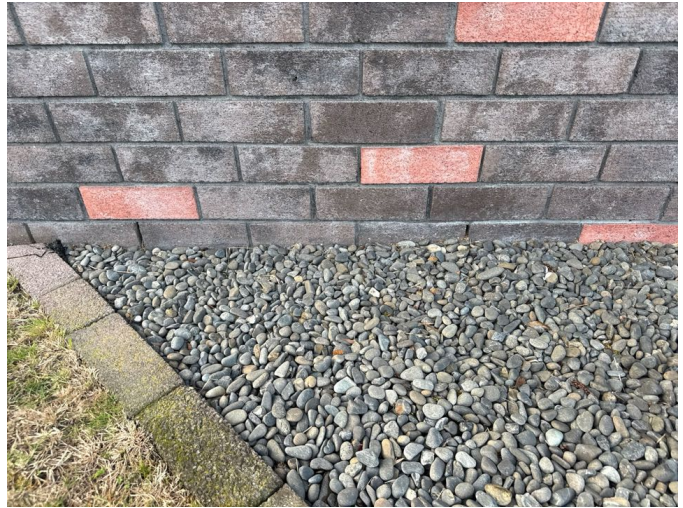
Reduced ground clearance in some areas. Current Acceptable Solution requirements of the Building Code set minimum clearances between concrete floors and ground levels. For brick veneer cladding, these are 150 mm to unpaved ground and 100 mm to paved surfaces. For other cladding types, the minimum clearances are 225 mm to unpaved ground and 150 mm to paved surfaces. The ground levels should be lowered where possible.

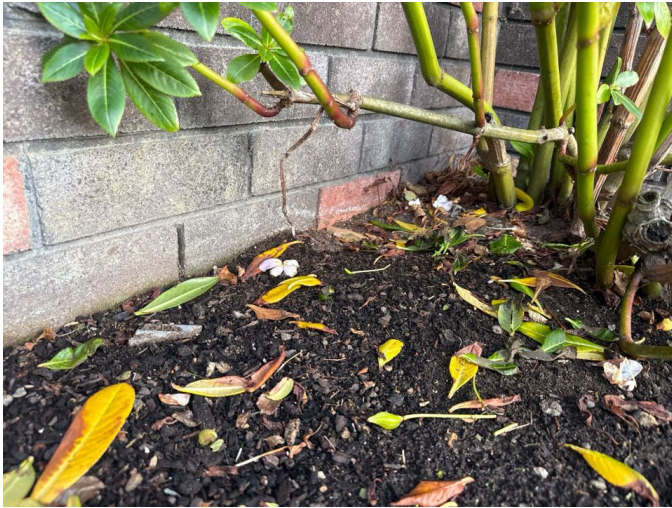
Elevated garden levels noted

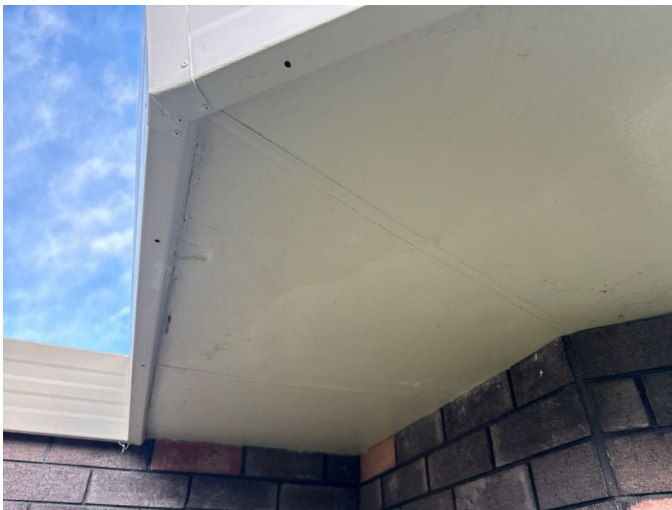
There is visible evidence of previous overflows into the soffit from the internal gutters. Replacing this system is the best long term improvement option (recommended by T.H.I.S).

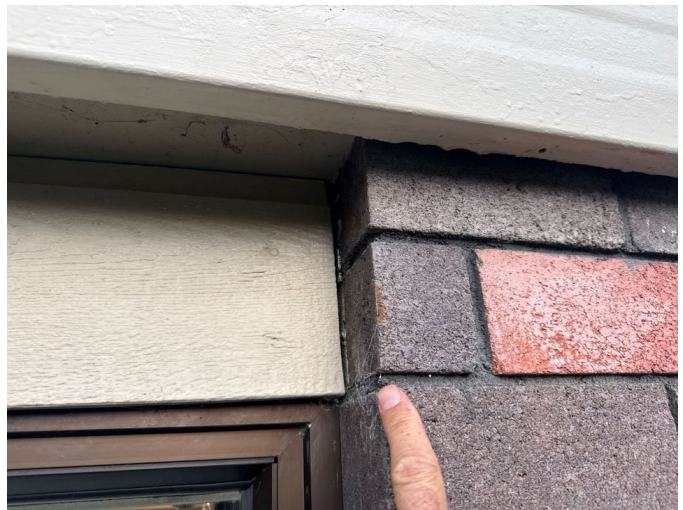
Gaps like this above the windows between the weatherboard and the brick should be sealed.

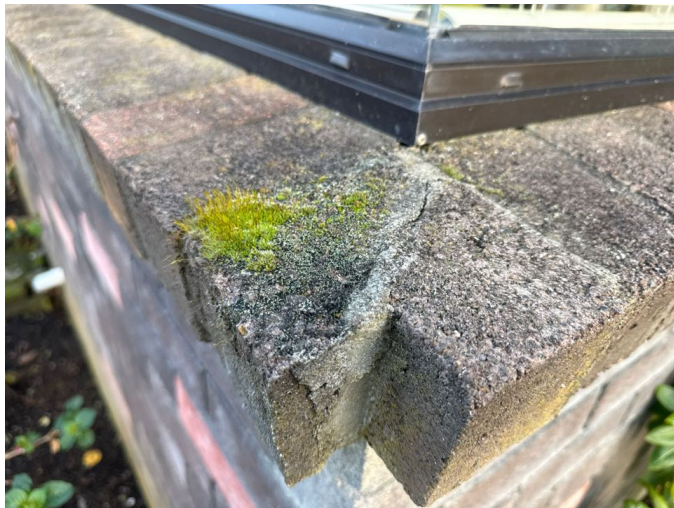
Moss should be removed regularly from the bricks to prevent premature deterioration to the mortar

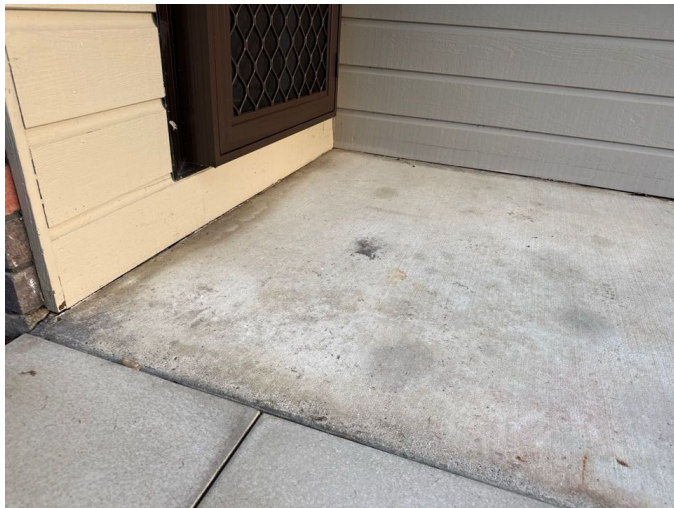
The timber weatherboard extend down over the foundation at this location and are in close contact with the ground. The roof cover should protect the area from the weather. Timber in close contact with the ground is at risk of premature deterioration and must be kept thoroughly sealed.

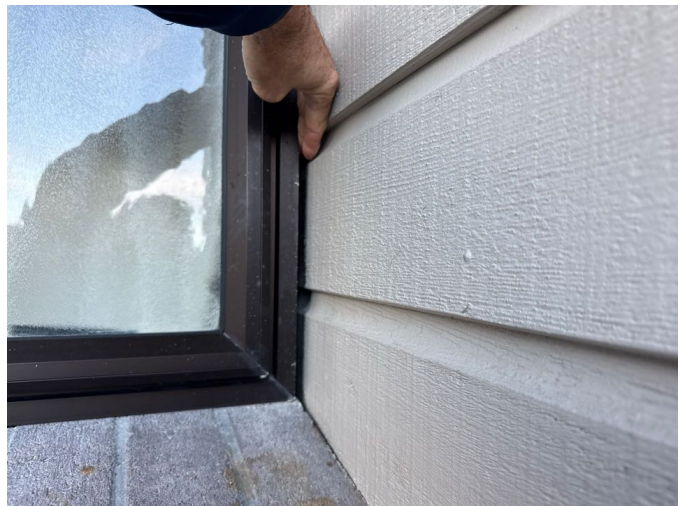
The large gap on the side of the bathroom window should be sealed off

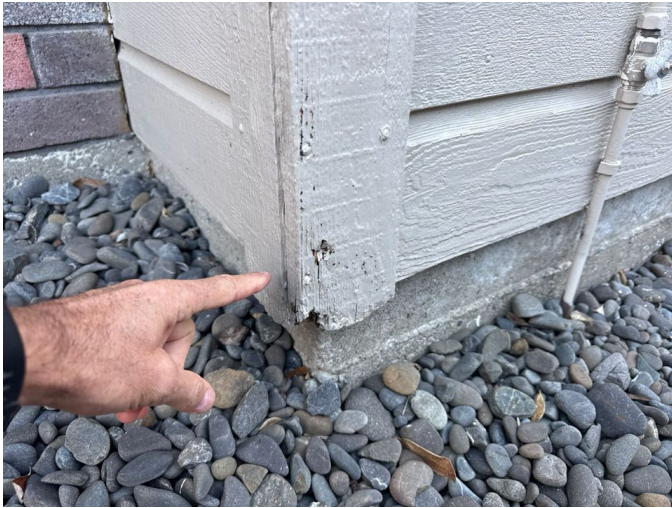
Rot damage to the bottom edge of the box corners on the southwest side. Damaged timber should be replaced. The end grain of the timber must be kept well sealed as it is more susceptible to rot.

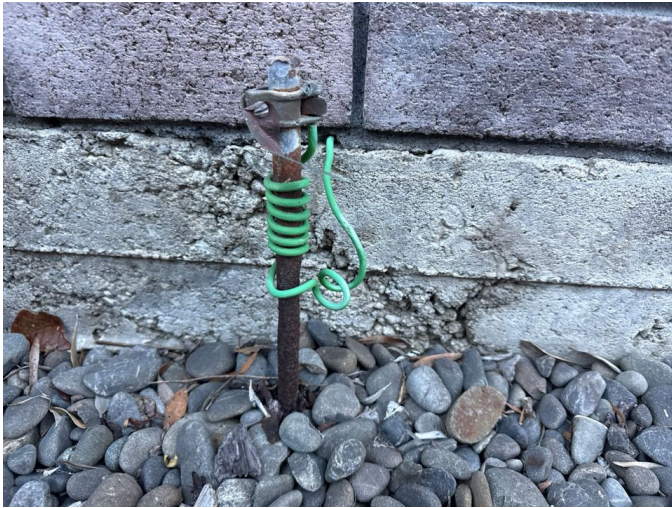
The electrical earth rod provides a safe path for fault currents to dissipate into the ground, helping protect people and equipment from electric shock and reducing the risk of damage during faults or lightning strikes.

An earth loop test should be considered to determine the earth's effectiveness.

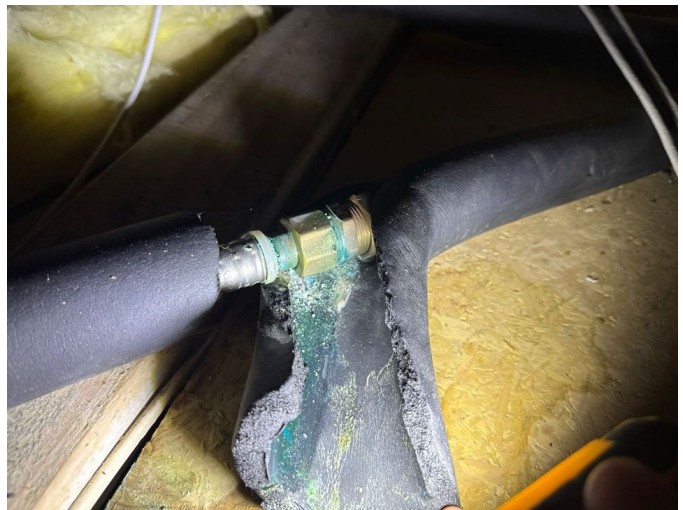
Oxidation to the pipe connections beneath the boiler and moisture staining. The owner advised that the system is to be serviced soon therefore the condition should be checked by the gas fitter/plumber then.

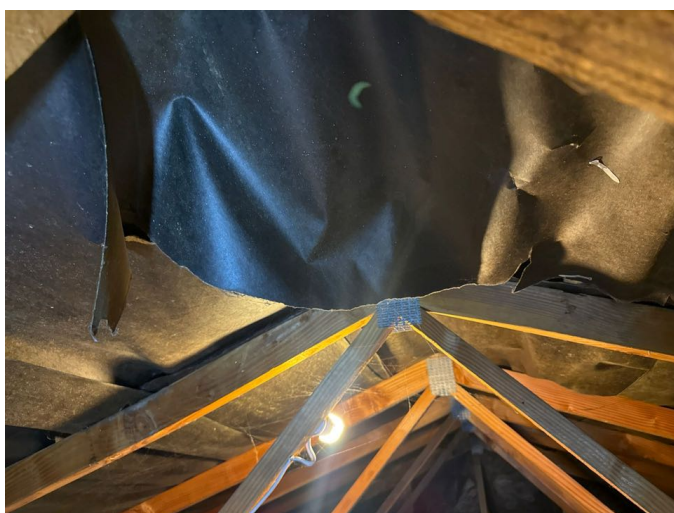
The roof underlay is damaged in a few locations. If water ingress was to occur it will enter directly into the ceiling cavity rather than diverted to the exterior. Damaged underlay is difficult to repair and usually involves removing some of the tiles and support battens. Note there was no evidence of water ingress found.

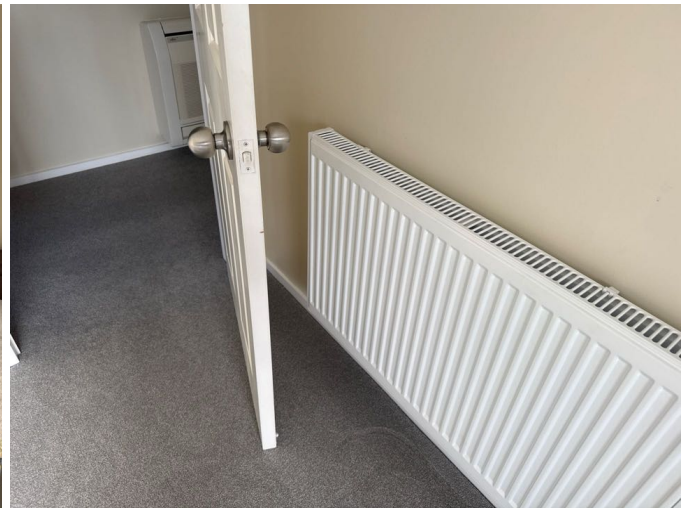
The internal doors are functioning well. Door stops installed behind the doors.  
Door stops should be installed where missing to prevent the door hitting the radiator.

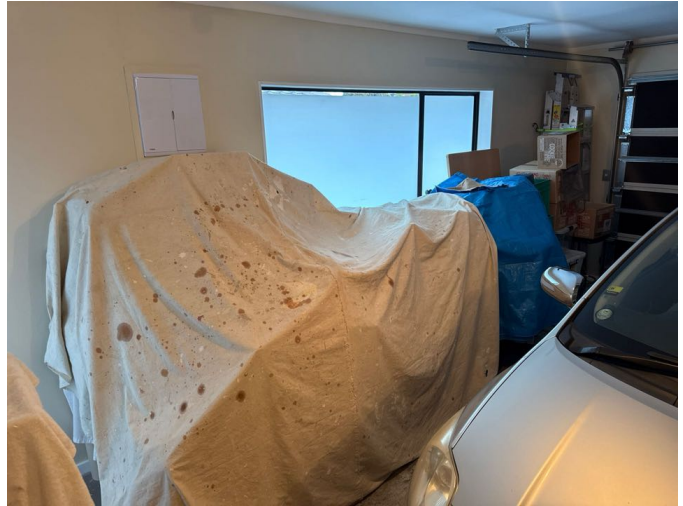
Not all areas of the garage could be fully inspected due to the presence of stored items. A full inspection is recommended once cleared. This applies to all concealed locations throughout the house.
