# EARTHQUAKE RECOVERY (EQR) DOCUMENTATION

# EQR Property Overview Report

**MULTI-UNIT STRUCTURAL ASSESSMENT REPORT (DRAFT)**

**54 Devon Street, Sydenham**

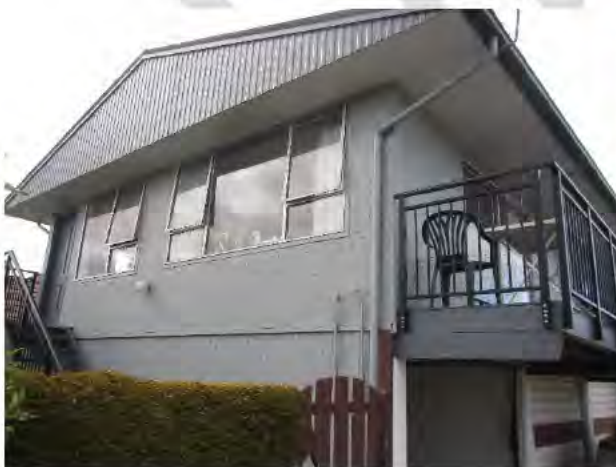
Figures 1: Northwest view of 2<sup>nd</sup> level Unit 1, with garages underneath

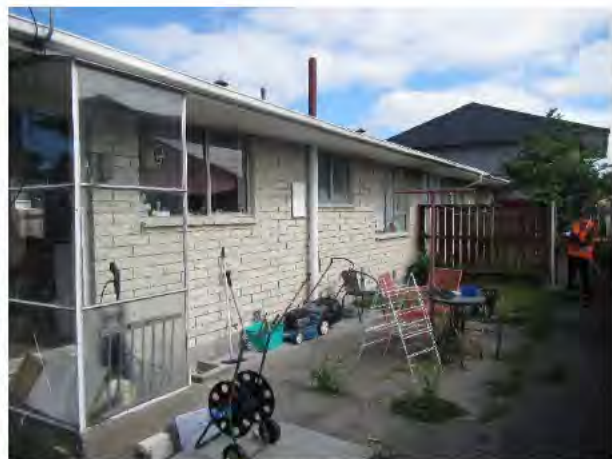
Figure 2: Southeast view, Unit 3, with Unit 1 in distance

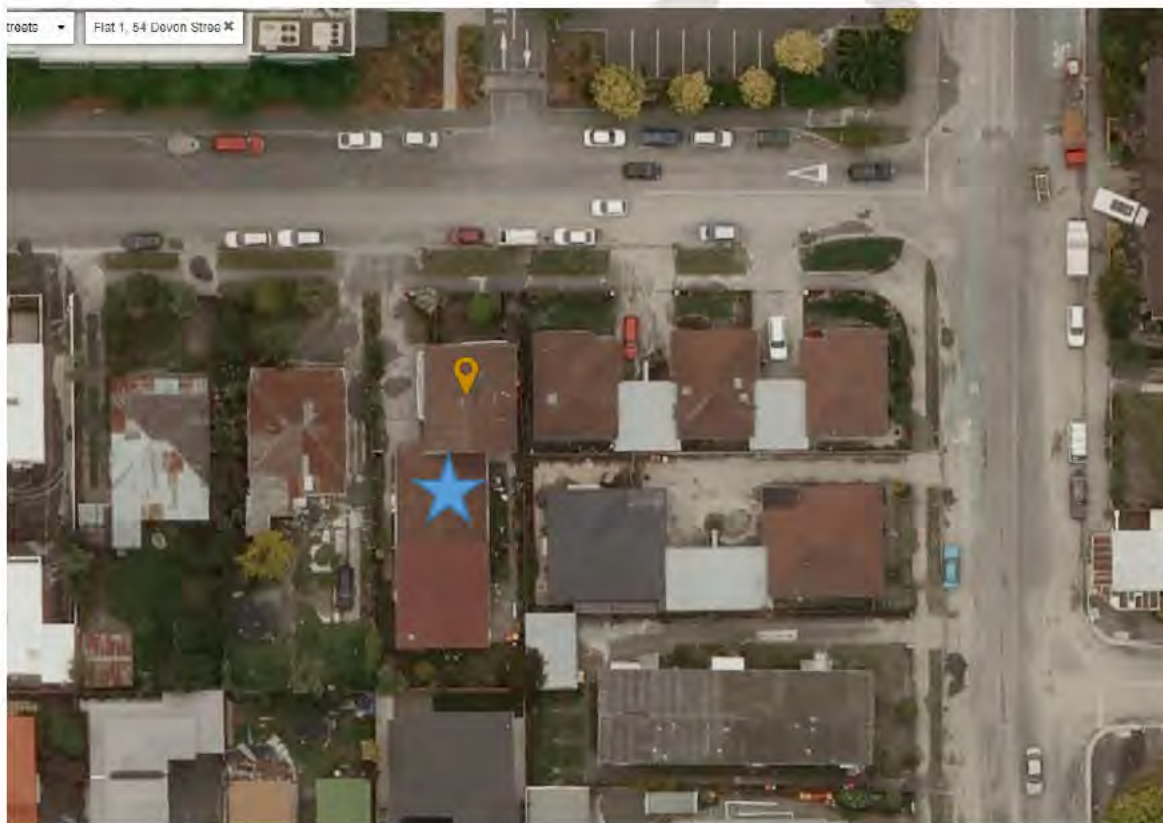
Figure 3: Aerial photo taken 24 Feb. 2011; note liquefaction deposits on driveway and nearby

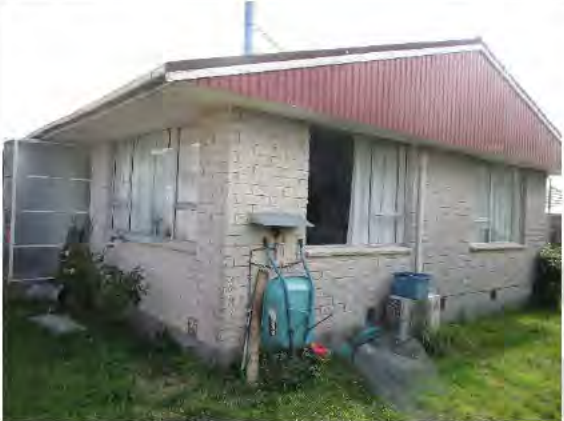
| Photo | Comments |
|---|---|
| | <p>7. Unit 3</p> <p>Southwest view.</p> |

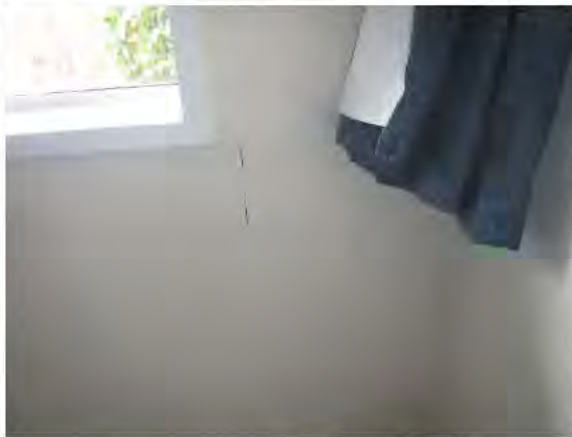
| Photo | Comments |
|---|---|
| | <p><b>19. Cracking at Plasterboard Junctions</b></p> <p>As stated under Photo 18, such crack damage between adjacent wall sheets should be re-addressed. (BMC are recommending additional re-levelling and this may promulgate some additional cracking such as this, and re-repair should await re-levelling of the floor, before completing).</p> |

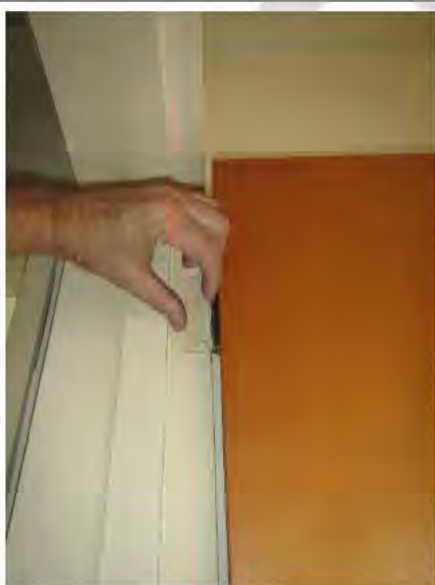
| Photo | Comments |
|---|---|
| | <p><b>20. Verticality</b></p> <p>A vertical 'red' laser line can be seen. This was positioned at the bottom door hinge and deviation at the top can be seen. Observations generally accorded with rotation of framing as may have been expected with the floor settlement (which should be corrected once re-levelling reinstates building components to square/plumb).</p> |

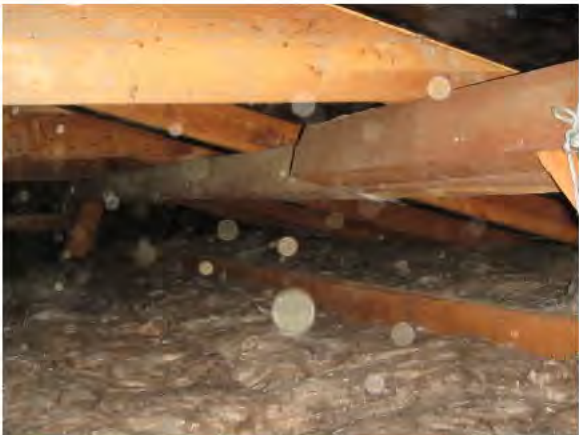
| Photo | Comments |
|---|---|
| | <p><b>21. Ceiling Framing</b></p> <p>The lightweight roof is supported on timber framing, including underpurlins. We did not observe any significant damage in this area, such as to fixings.</p> |

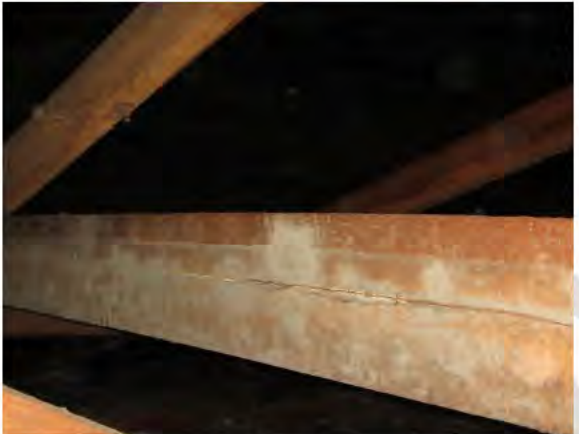
| Photo | Comments |
|---|---|
| | <p><b>22. Collar Tie in Roof Space</b></p> <p>This timber element appears to incorporate a lengthwise split at approximately half-depth. This is considered to be a natural defect as opposed to an earthquake effect.</p> |

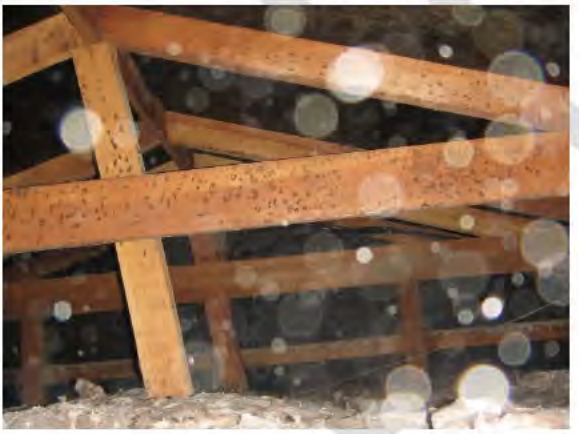
| Photo | Comments |
|---|---|
| | <p><b>23. Timber Condition</b></p> <p>Pock marks on timber appear surficial and are not an earthquake effect.</p> |

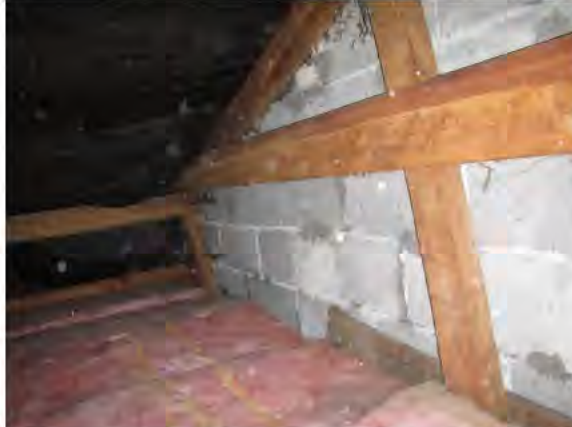
| Photo | Comments |
|---|---|
| | <p>25. Firewall from Unit 3 Roof Space</p> <p>Comments of Photo 24 apply.</p> |
