# Land information memorandum here

## Land Information Memorandum

| Location | 47 Cam Road KAIAPOI |

# Geotechnical Report

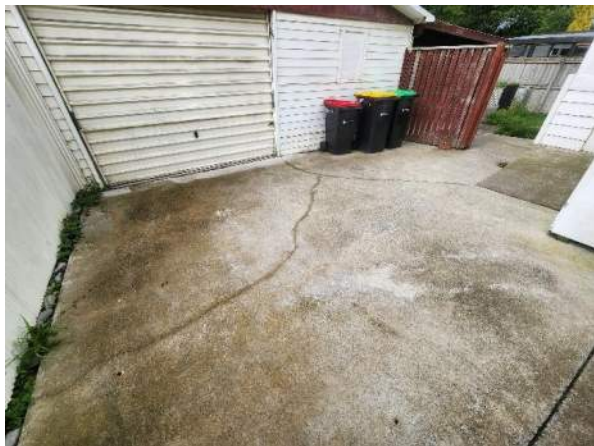
Other than minor cracking to the concrete driveway (Figure 4) no ground damage was evident at the time of Subterra's visit (27/01/2026).

Figure 4: View of minor cracking to the concrete driveway adjacent to the garage looking southwest

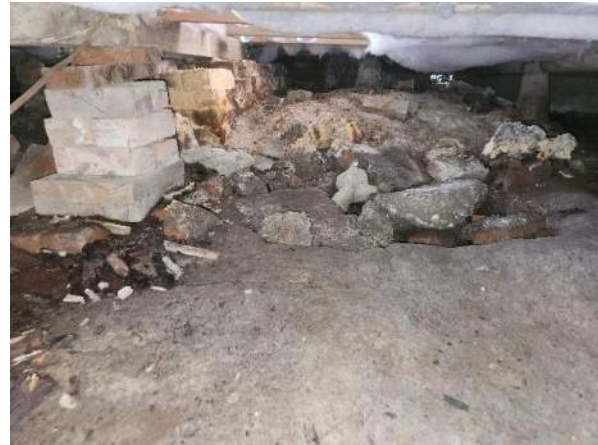
Figure 7: View of fill material (inferred construction waste) in the subfloor

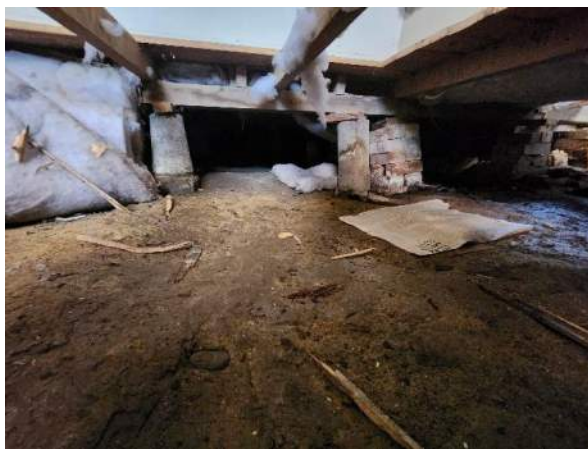
Figure 8: View of the mismatched piles in the subfloor

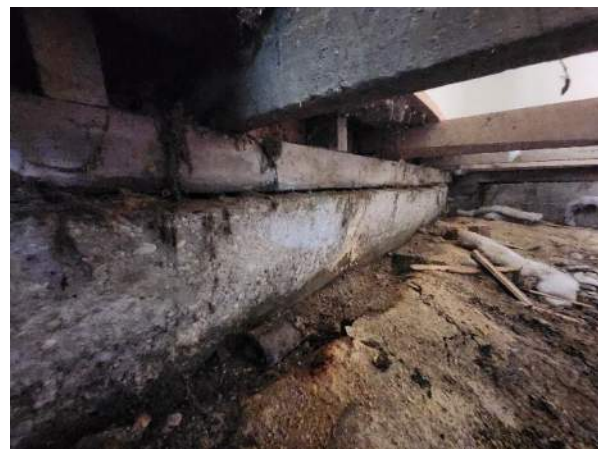
Figure 9: View of the overturned perimeter foundation in the subfloor

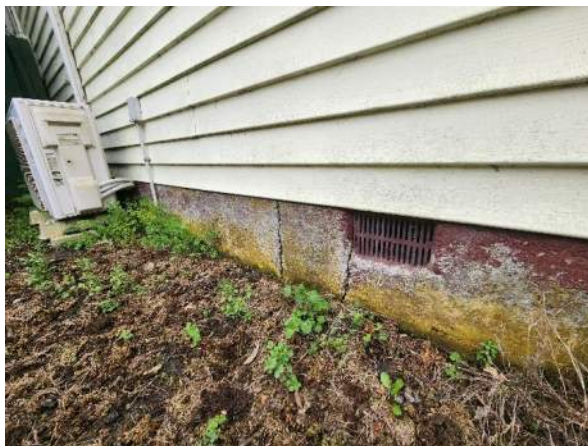
Figure 10: View of cracking to the perimeter beam on the west elevation

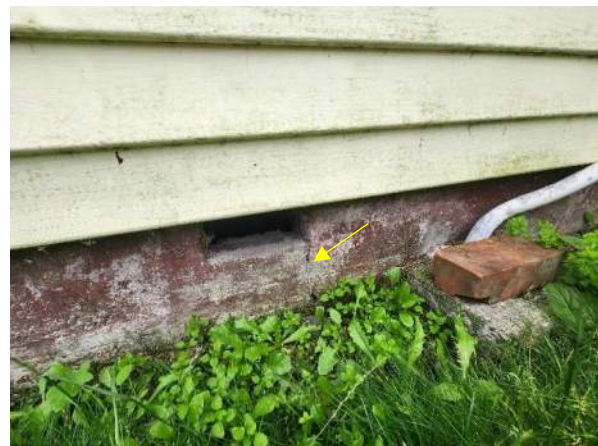
Figure 11: View of cracking to the perimeter beam on the south elevation

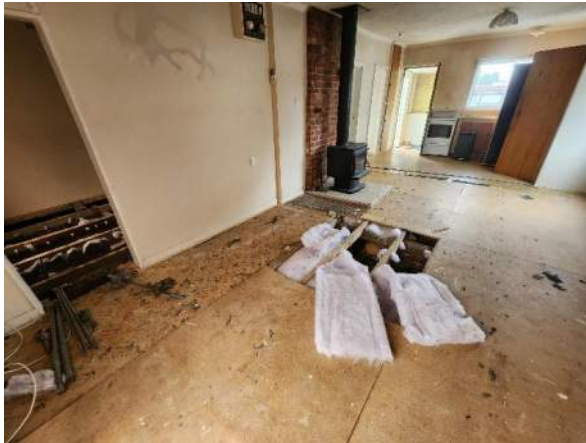
Figure 12: View of the lifted floorboards in the lounge area (below this void is the fill material shown in Figure 7)

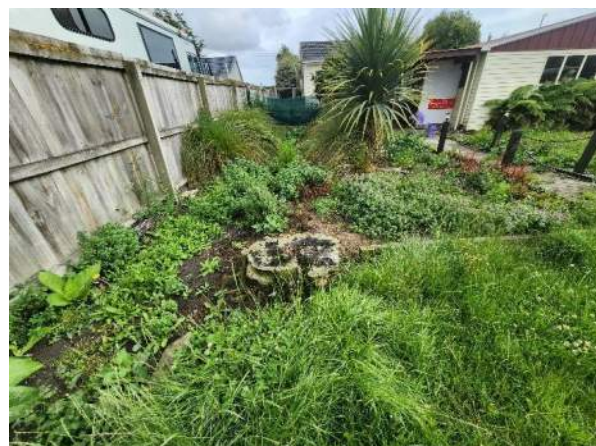
Figure 17: View of a tree stump near the west boundary in the south half of the site

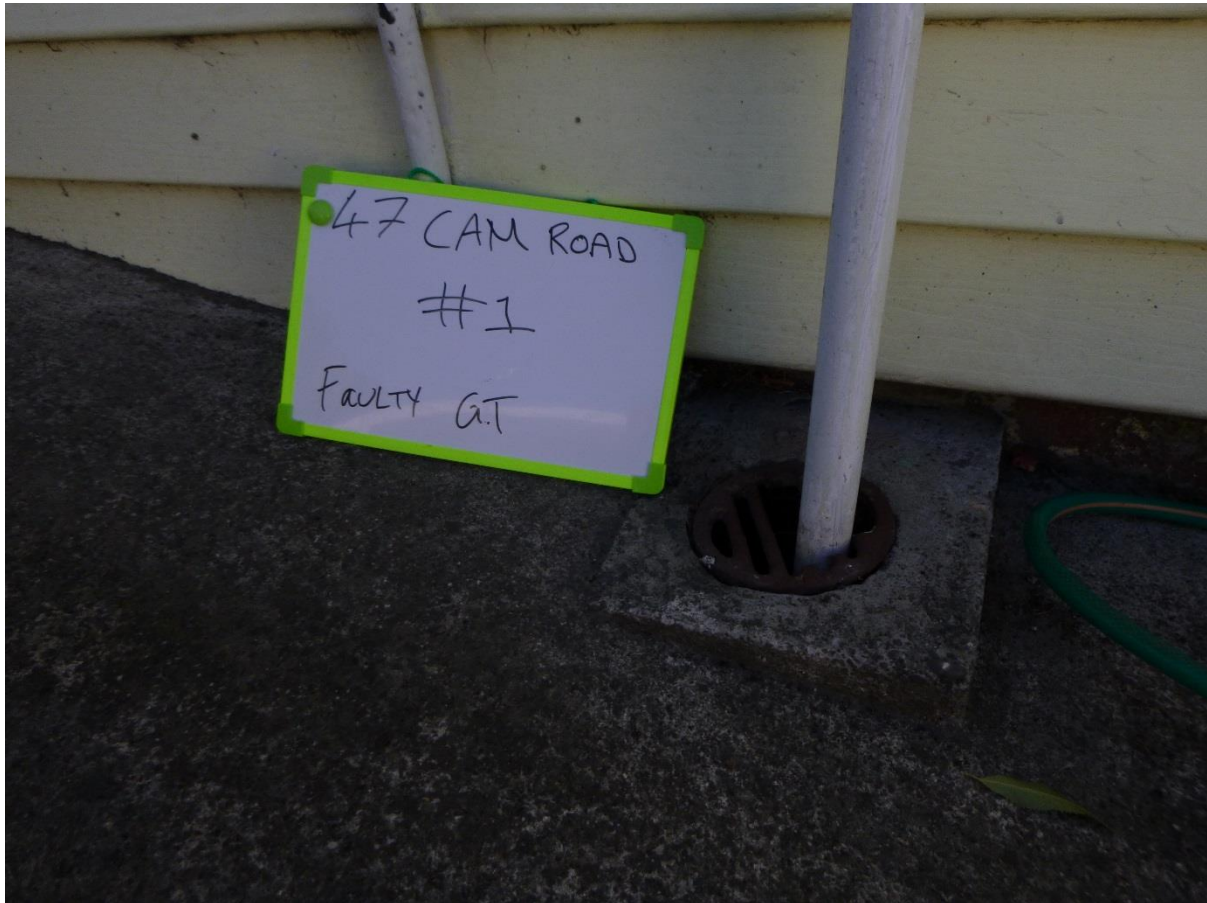
**TECHNICIAN:** Cameron Sole**PICTURE:** #1

| ADDRESS | DEFECT | PHOTO # |
|---|---|---|
| 47 Cam Road, Kaiapoi | Dropped entrance to doorway, water can run off to gully trap | 1 |
