## 2.4 Site Description

The western slopes are grass or scrub covered with some trees with the dominant landform comprising two arcuate features, separated by a minor spur (annotated on Figure No. 822-S2-004 in Appendix A). The northern and southern arcuate features are located to the north and south of Titiro Street. These areas are referred to herein as Northern Stage 2 and Southern Stage 2, respectively.

## 4. Site Walkover Observations

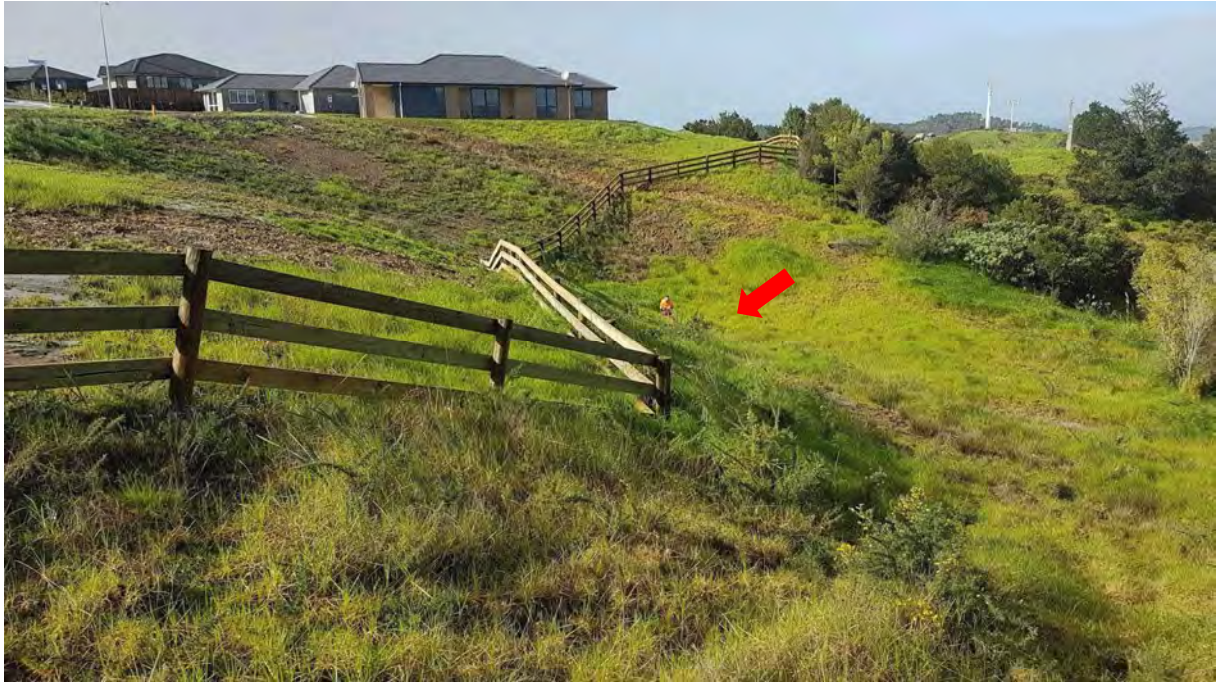
- Some of the timber piles for the palisade wall constructed in 2017 were visible in the Northern Stage 2 area. During the site walkover, the ground immediately below the palisade wall was waterlogged, with surface water from the development above appearing to be discharged onto the slope. A tension crack, approximately 10-20 mm wide, with no apparent vertical offset was observed in this area. The GPS surveyed extents of this tension crack are shown on Drawings 822-S2-004 (Appendix A).

Figure 4-1: Northern Stage 2 Looking South. Arrow shows approximate Tension Crack Location

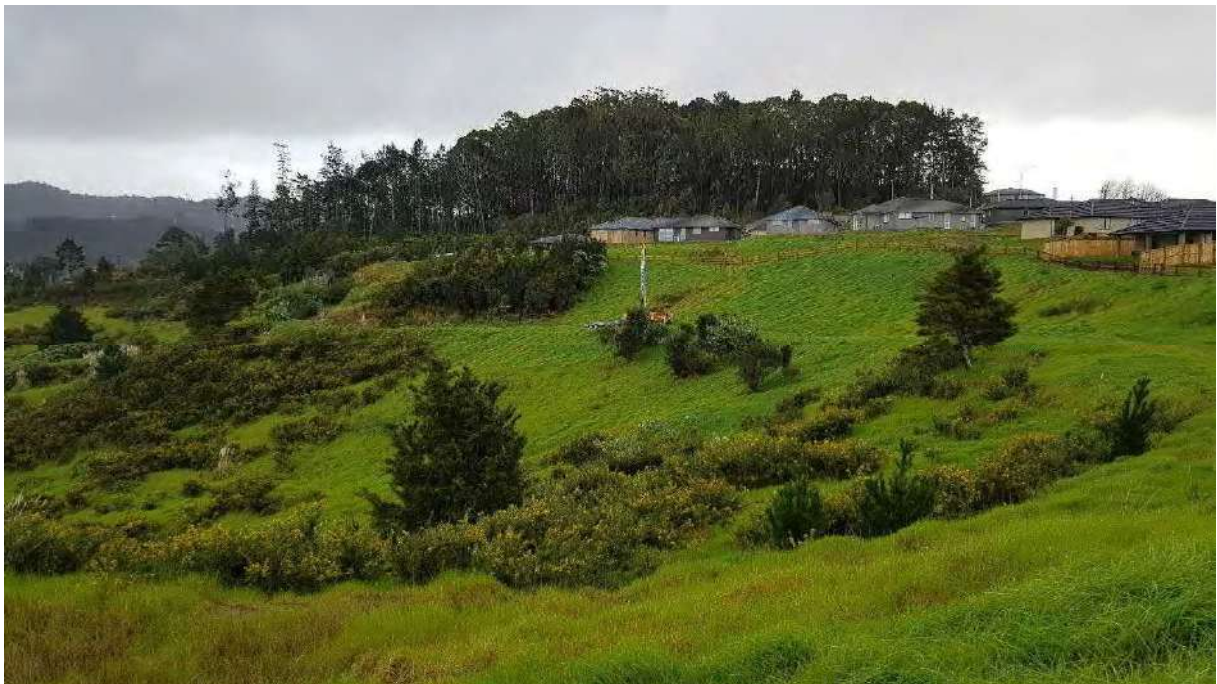
- No surface cracking or notable signs of active instability were observed on the Southern Stage 2 slopes; however, it was noted that surface water discharge did appear to be occurring onto the slope from stormwater outlets that service the lots and roads within Stage 2 (see **Error! Reference source not found.** below).

Figure 4-2: Southern Stage 2 Looking North.

As described in Section **Error! Reference source not found.**, stormwater discharge and runoff appear to be occurring over the western slopes below both Northern and Southern Stage 2. It is recommended that stormwater flows be diverted away from the slope / or formalised / piped to the base of (and beyond) the slopes to reduce the risk of instability associated with surface water infiltration. Similarly, it is recommended that all subsoil drainage be conveyed in sealed piles to the base of the slopes.

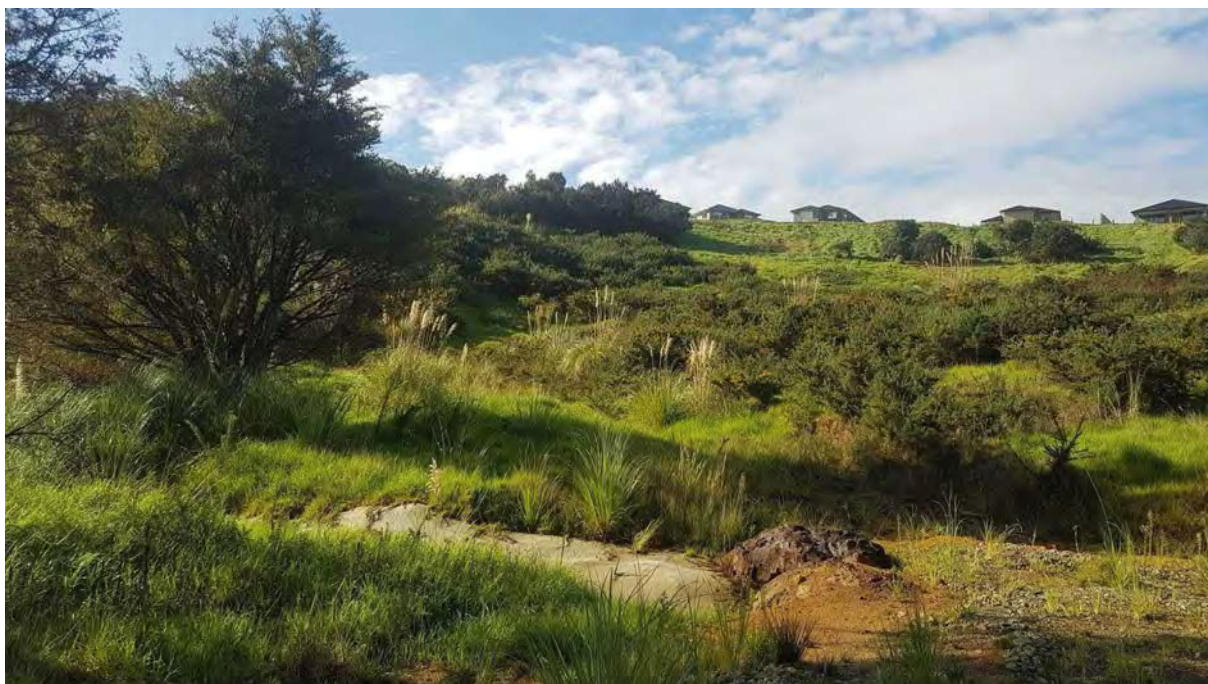
- The lower parts of the Stage 2 slopes are visible from the Semenoff property to the west. These were observed on a separate site walkover on the 5<sup>th</sup> May 2020. The lower parts of the slopes lead down to an undeveloped platform/yard area on the neighbouring Semenoff property. These areas are relatively gently sloping and appear waterlogged and “hummocky”; however, it is not clear if these areas have been subject to historic earthworks (i.e. the hummocky appearance may in part be due to earthworks).

Figure 4-3: Southern Stage 2 Lower Slopes Looking East from Semenoff Site.

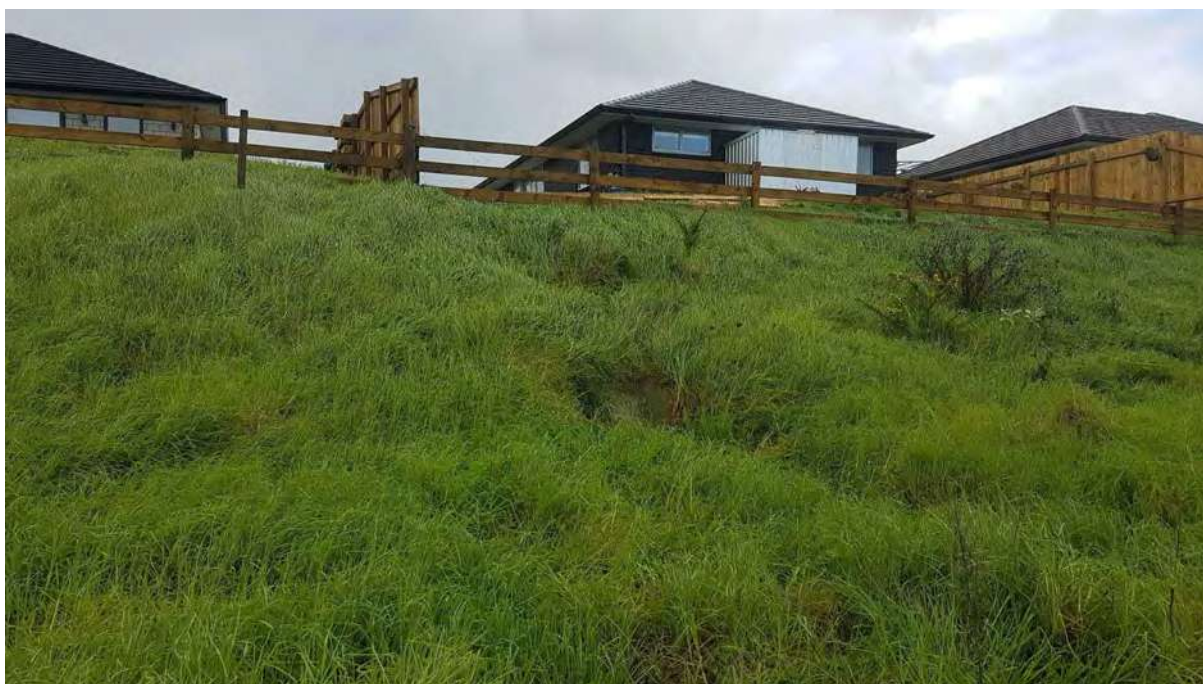
Figure 4-4: Stormwater Outlet on Slope Below Southern Stage 2

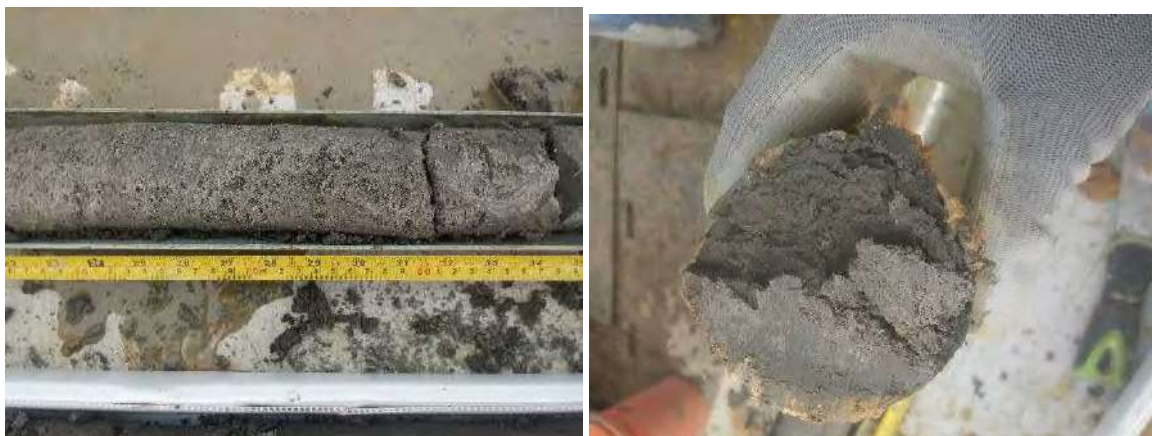
The Mudstone Mélange encountered within borehole core in Stage 2 is typically extremely weak (sometimes approaching soil strength) with a highly disturbed and frequently pervasively sheared fabric. Mudstone Mélange was identified in significant thickness in MBH20, below the residually weathered material (from approximately 6 m below ground level) to a depth of approximately 13 m. Mudstone was also encountered in MBH33 below the residually weathered soils (from approximately 6 m depth to an end depth of 7.8 m) and in limited thickness in MBH19 (a 300 mm thick bed at approximately 7.5 m depth).

Typically, the mudstone exhibits a “shear fabric”, with frequent fabric parallel polished / slickensided defects. The fabric parallel shear surfaces within the mudstone, generally had a dip magnitude of approximately 30° from horizontal. Within borehole MBH20, broken/crushed zones were identified within the mudstone.

Figure 7-2: Typical Extremely Weak Mudstone Mélange within MBH20 – approx. 7 mBGL, with fabric (left) defect surface (right).

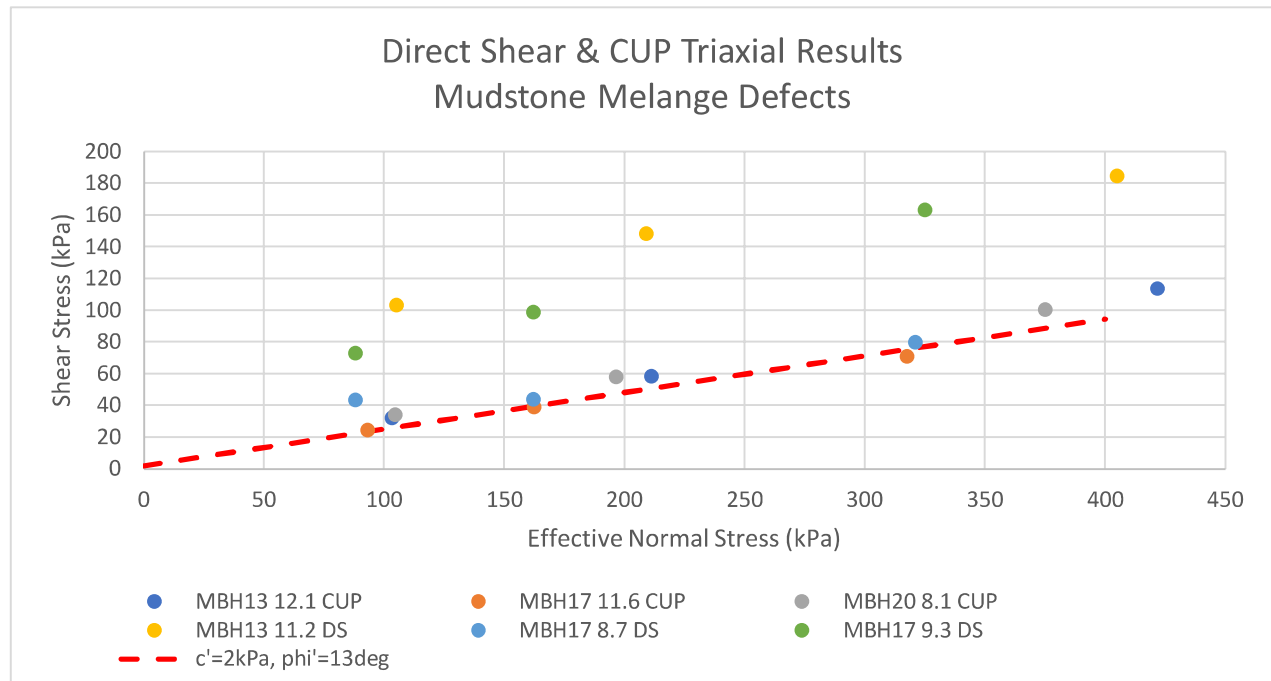
The direct shear tests on MBH13 at 11.2 m and MBH17 at 9.3 m show significant cohesion likely associated with failure plane roughness. However, all of the triaxial tests, as well the direct shear test on MBH17 at 8.7 m (other than the high first stage result), are inferred to have failed along relatively smooth defects given the low cohesion and friction. The red dashed line is an assessed lower bound fit to this data, which is considered a reasonable reflection of the residual shear strength of defects within the Mudstone.

Figure 7-3: Mudstone M lange shear strength testing
