# Building inspection report here

## RED LBP PRE-PURCHASE REPORT

**Company:** JBC Builders Limited Ltd trading as RedLBP Christchurch North  
**Client:** Ana Paula da Silva & Luis Fernando da Silva  
**Date of Inspection:** 25th May 2026  
**Site Address:** 69 Marshland Road, Shirley, Christchurch 8061  
**Inspector:** Jamie Chapman  
**Qualifications:** National Certificate in Carpentry

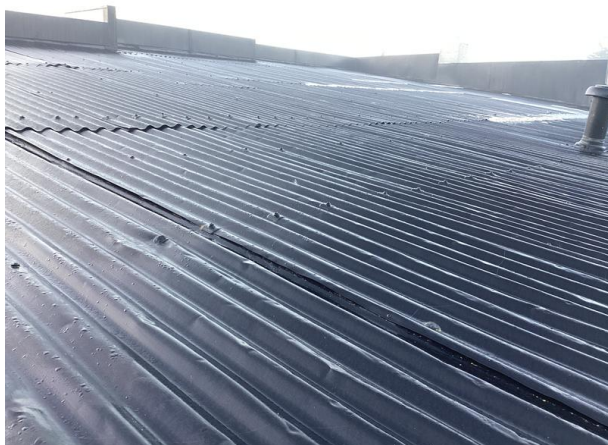
**Photo 3**

A profiled metal roof with nail and screw fixings is located over the dwelling.

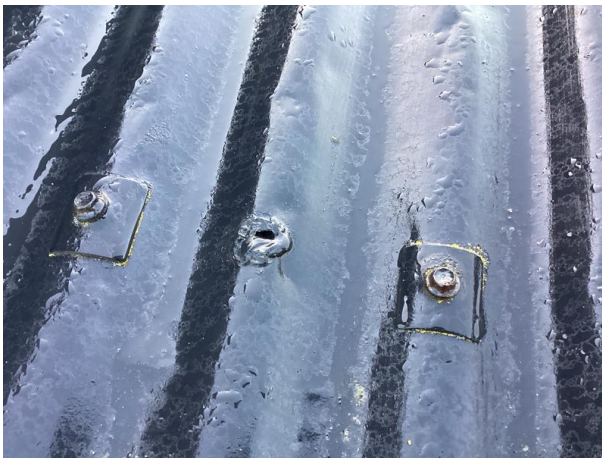
**Photo 5**

A couple penetrations filled with silicone were noted over the roof system. Some areas had visible holes.

As viewed in the photos below, signs of tape repairs and silicone over some nail fixing holes were noticed around the roof system, as well as lifting lap joins. The tape repairs are more of a short-term, temporary fix, not a long-term solution. It is recommended to have a licensed roofer advise further on the roof system.

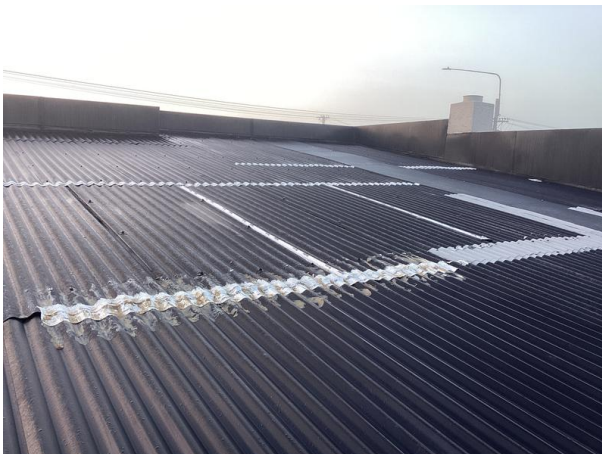
**Photo 6**

The profiled metal roof system has had some repairs done with tape installed over some corrugated sheet join laps and screw fixings installed in a few locations. The tape repairs are more of a temporary fix and not a long-term solution. It is recommended to have a licensed roofer advise further on this roof system. Detailed further in the roof system section of this report.

Signs of tape repairs were visible on the roof system mainly on the south side.

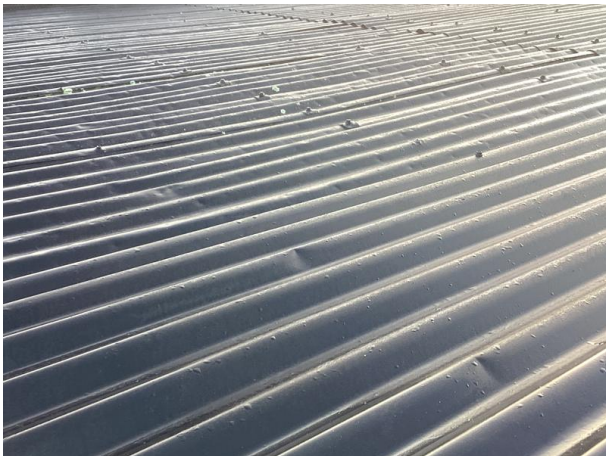
**Photo 7**

A few areas of dented corrugated metal sheeting were noted around the roof system. This is commonly caused by people walking on the roof.

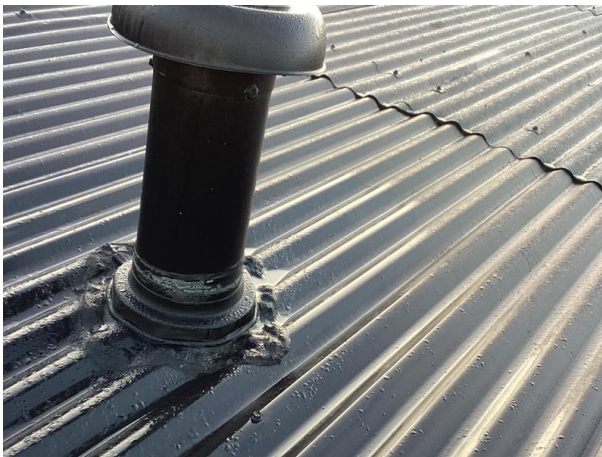
**Photo 10**  
Vent penetration with boot flashing.  
Note, the water ponding behind the  
roof penetration. Installing a watershed  
back flashing is recommended.

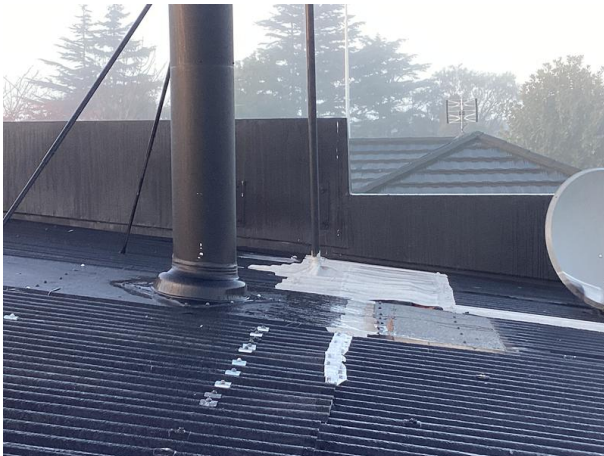
**Photo 11**

East side flue and overflow penetrations with visible repairs noted around the overflow penetration.

As previously detailed, it is recommended to have a licensed roofer to advise further on this roof system.

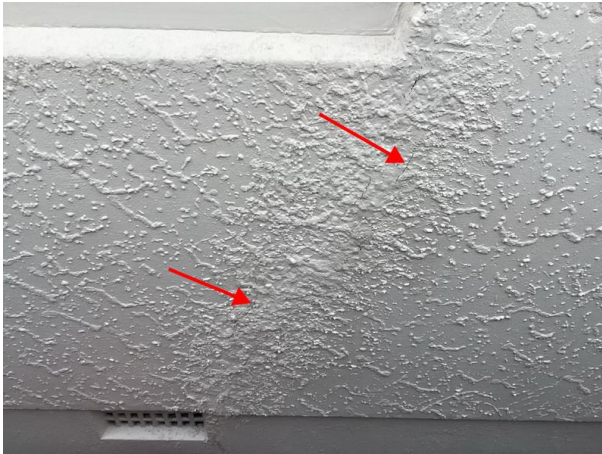
**Photo 16**

Signs of stucco plaster crack repair work were noticed and common around the dwelling. However, areas of re-cracking were noted. It is recommended to have an exterior plastering specialist advise further. Detailed further in the exterior plastering section of this report.

Stucco plaster repairs and re-cracking were noticed around the dwelling. Photo of the south facing elevation.

As viewed in the photos below, stucco plaster repairs were noted around the dwelling; however, areas of re-cracking were noticed as well. It is recommended to have an exterior plastering specialist advise further on repairing the cracked stucco plaster.

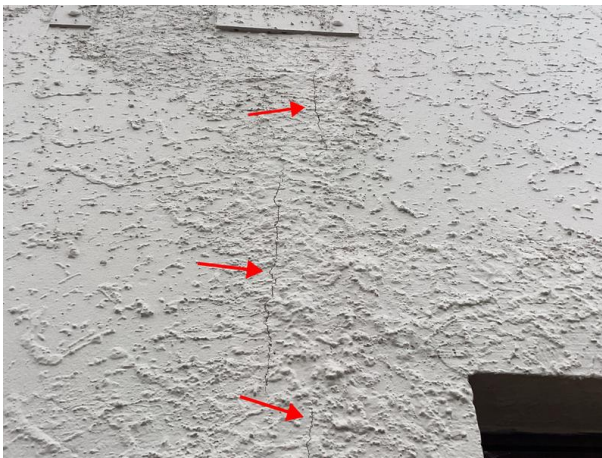
**Photo 17**

Example of a stucco plaster crack noticed around the dwelling.

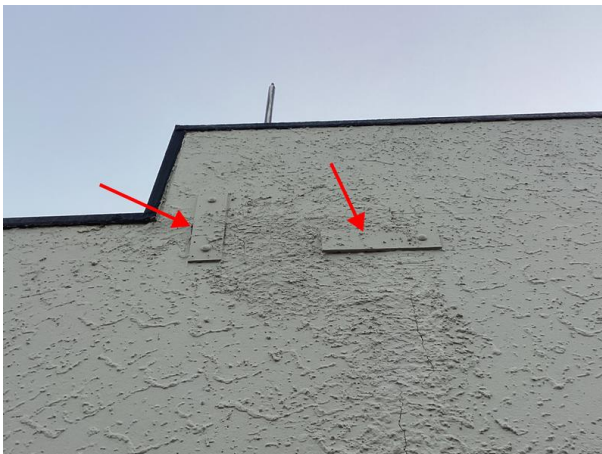
**Photo 18**

It is unknown why these brackets have been installed on the south facing elevation.

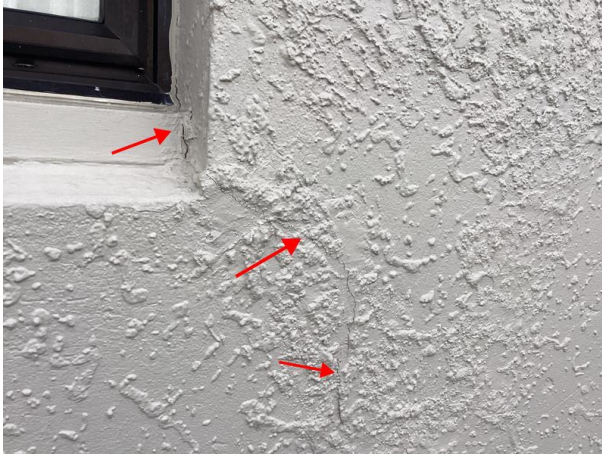
**Photo 19**  
West facing stucco plaster crack.

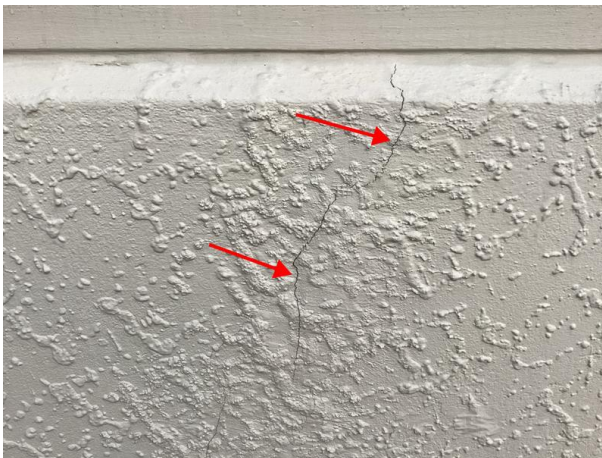
**Photo 20**  
Stucco plaster repairs and re-cracking were also noticed on the north and east side.

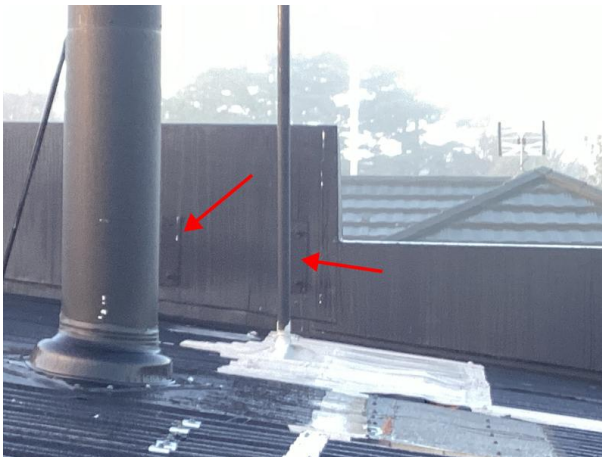
**Photo 21**  
Metal brackets were also visible on the inside of the parapet wall. Indicating repairs.

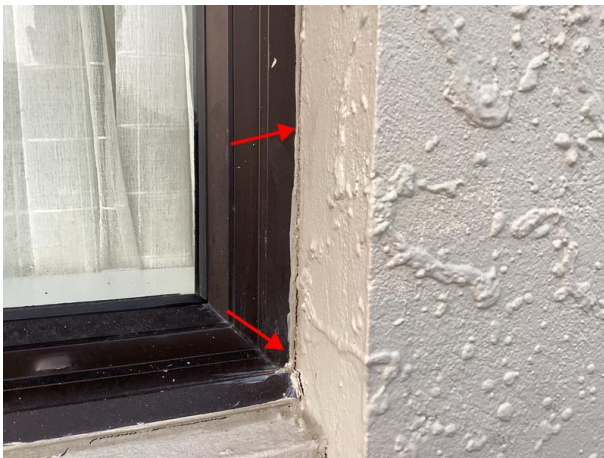
**Photo 25**

Cracking at the aluminium to plaster junctions were noticed in a couple locations. It is recommended to keep these junctions well sealed and maintained.

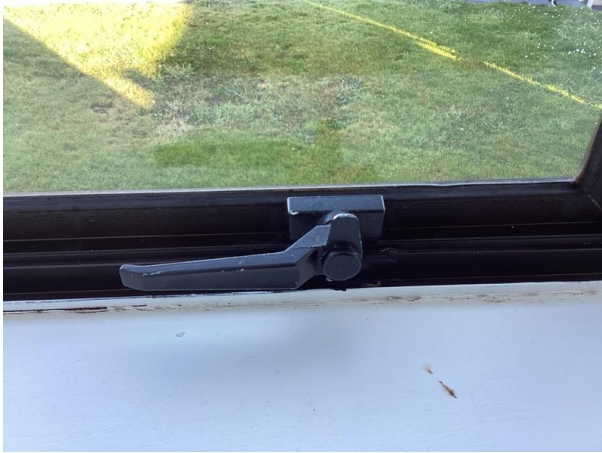
**Photo 27**

A couple of the window hardware latches were slightly loose. Recommend tightening.

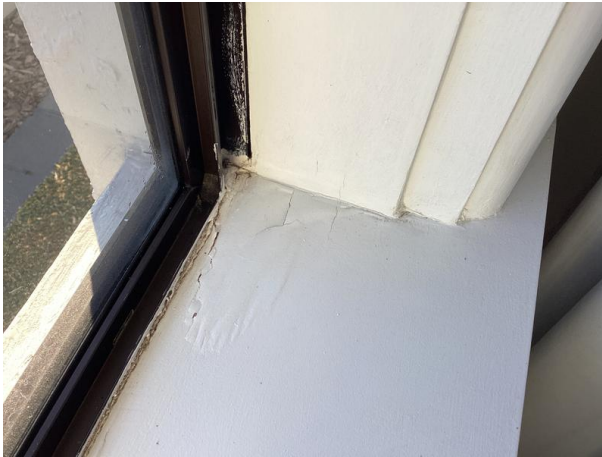
**Photo 28**

A couple areas of timber revealed defects noted. Keep up regular maintenance.

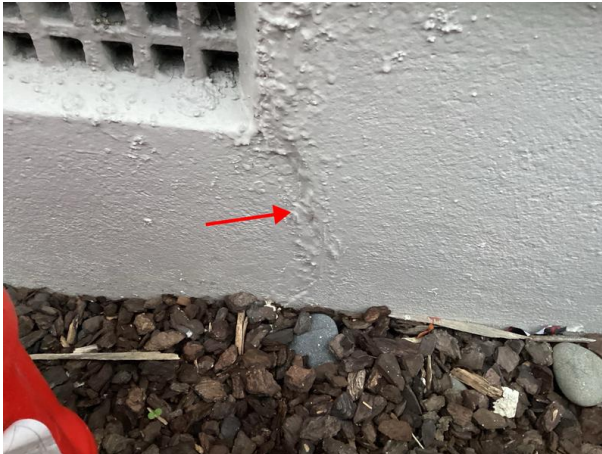
**Photo 29**

Concrete ring foundation repairs noticed on the south side.

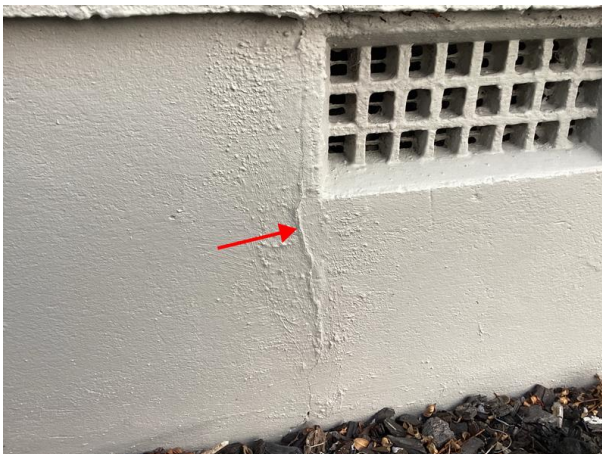
**Photo 31**

East side concrete ring foundation repairs with hairline re-cracking visible.

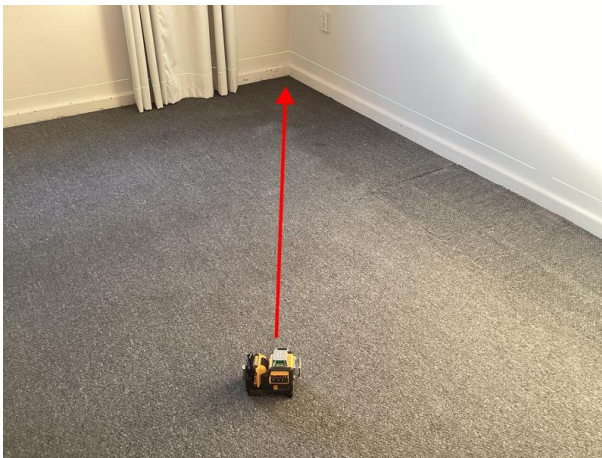
**Photo 33**

A 35 mm deviation was noticed in the living room over an approximate 3 m distance.

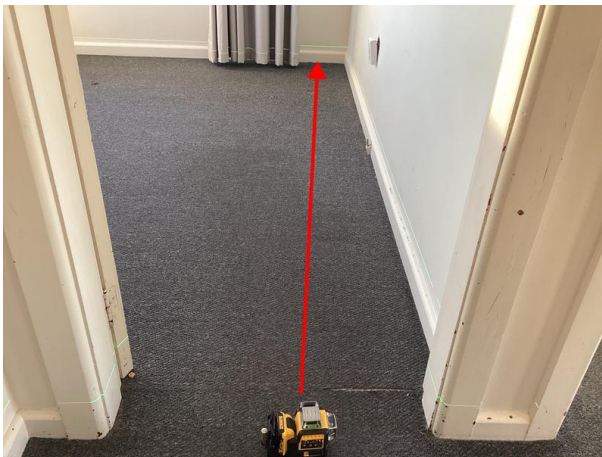
**Photo 34**

A 15 mm high point over a 3 m distance was noted in bedroom three.

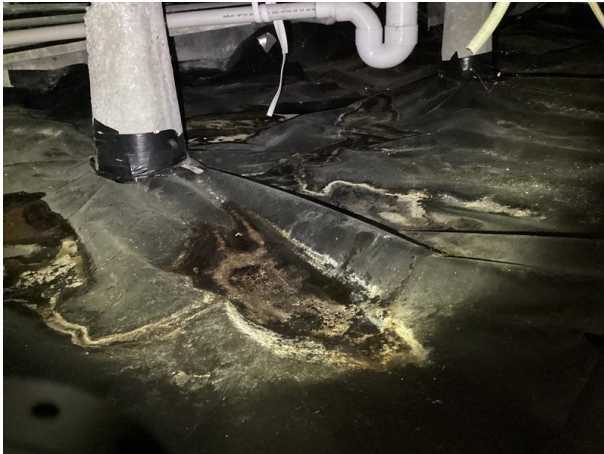
**Photo 41**

Water ponding on top of the ground moisture barrier in the subfloor, and timber staining were noticed approximately below the bathroom area. The heat pump overflow pipe also discharges around this area. It is recommended that a suitably qualified professional investigate and provide further advice. Detailed further in the foundation section of this report.

Water ponding on top of the ground moisture barrier was noticed approximately below the shower.

Water ponding on top of the ground moisture barrier was noticed below the bathroom area and below the heat pump overflow pipe. With timber staining visible as well as indications of elevated moisture readings detected inside the bathroom on the timber door, which is detailed further in the bathroom section of this report. It is recommended to have a suitably qualified and licensed professional to investigate and advise further in this area. It is also recommended to ensure the heat pump overflow pipe discharges to the exterior of the dwelling.

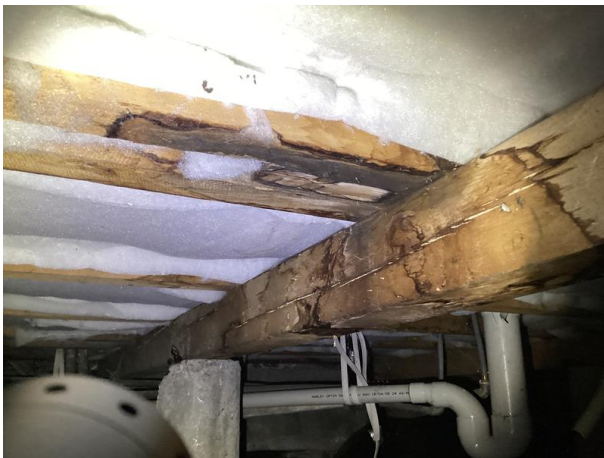
**Photo 42**

Timber staining was noted around this area.

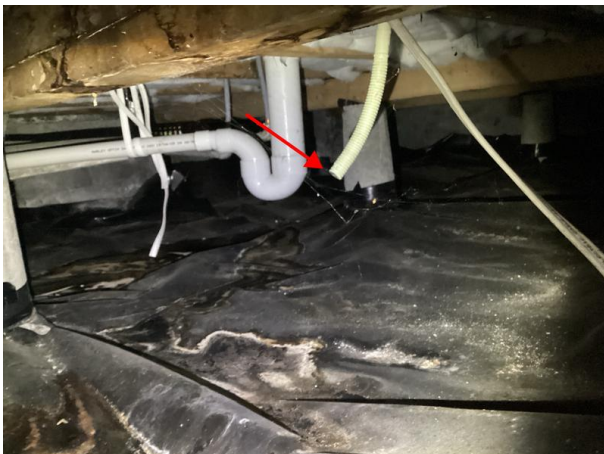
**Photo 43**

The heat pump overflow pipe also discharges into the subfloor around this area.

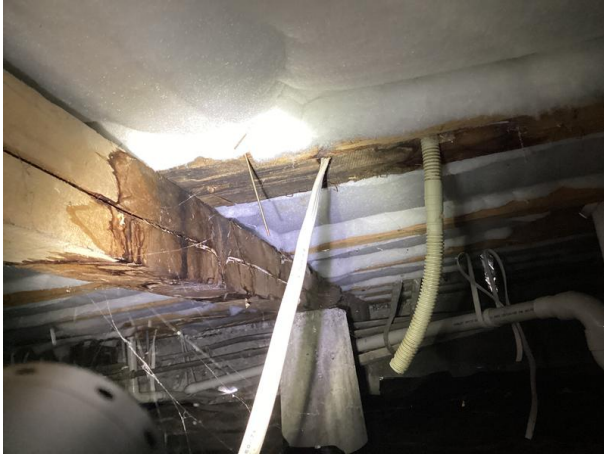
**Photo 44**

Example of the timber staining visible around the bathroom and heat pump overflow pipe.

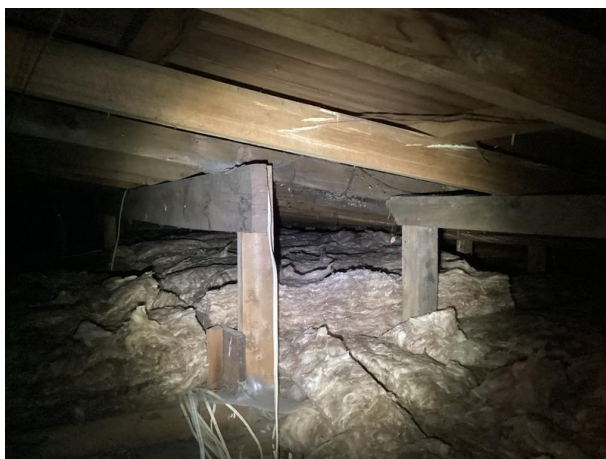
**Photo 45**

Due to the limited access and visibility in this roof space, under some areas of tape repairs and lifting lap joints were not able to be viewed from inside the roof space that were noted on the roof system.

View of inside the roof space. Note, the limited access and visibility.

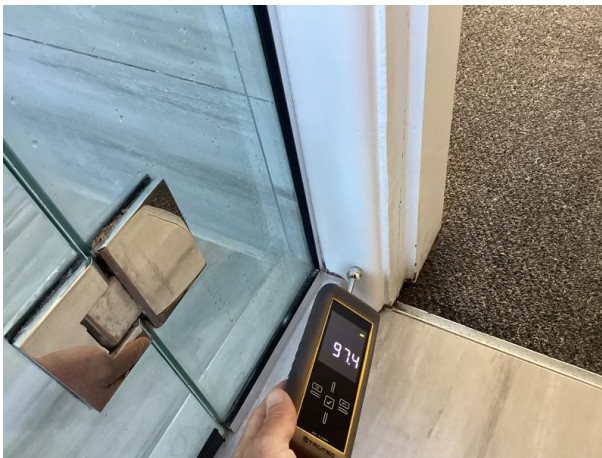
**Photo 53**

With indications of elevated moisture readings detected beside the tiled shower. Detailed further within this report.

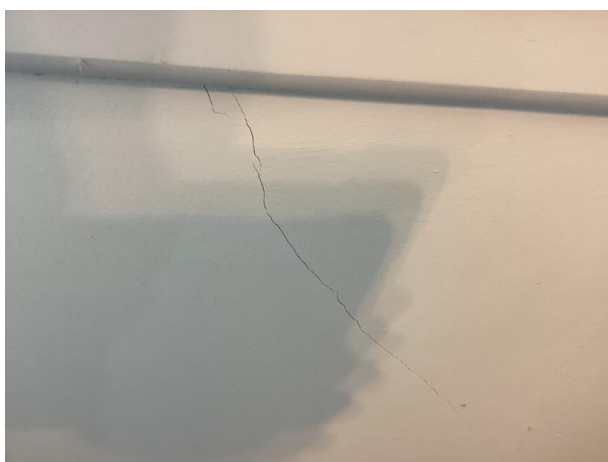
**Photo 54**

Wall lining cracking was noted around the dwelling. This is not fully commented on within this report.

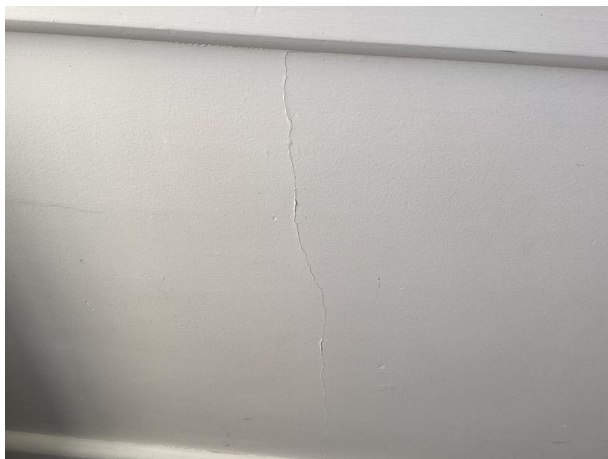
**Photo 55**

Example of the cracking noted on the wall linings.

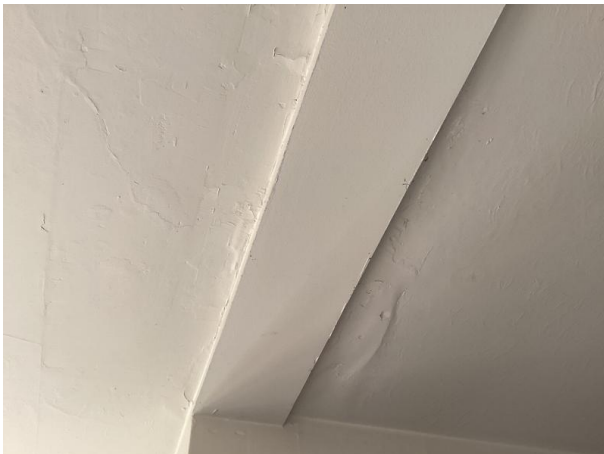
**Photo 56**

Ceiling defects are also noticed around the dwelling.

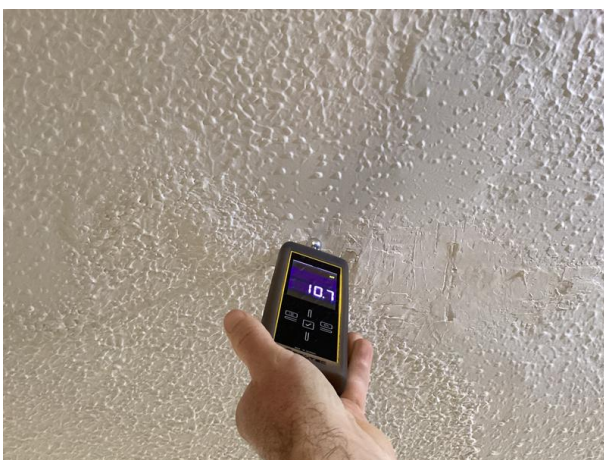
**Photo 57**

The defects noted on the ceilings returned dry/normal moisture readings during the inspection.

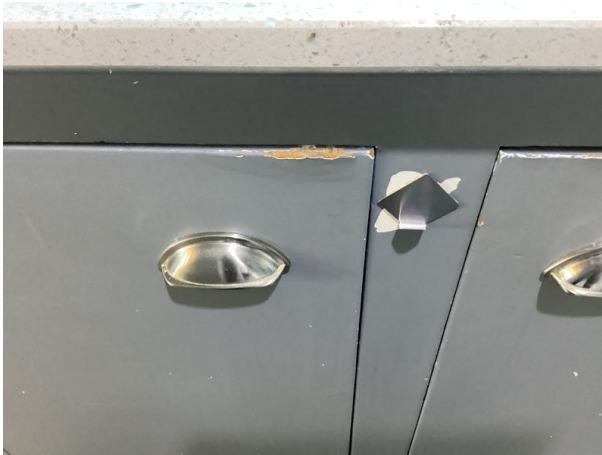
**Photo 64**  
General wear and tear noted on the kitchen cabinetry.

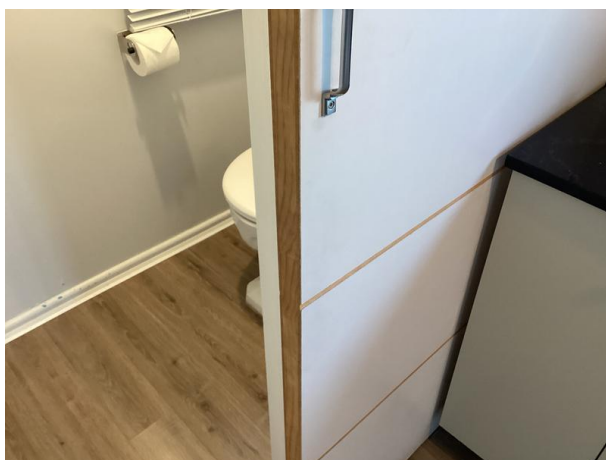
**Photo 68**  
Unpainted internal toilet door.  
Recommend painting.

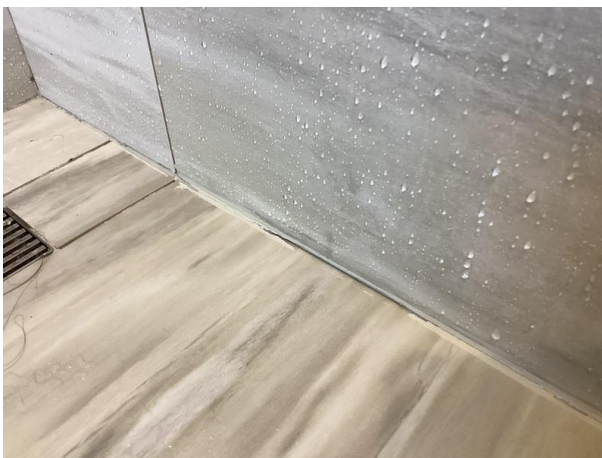
Following inspection by a builder and tiler, the shower leaks (noted on page 28) were found to be caused by deteriorated grout and silicone. This has since been redone in full — see attached invoice on the following page.

**Photo 70**  
Areas of missing silicone were noted in the tiled shower. Recommend keeping up regular maintenance of the silicone and grout.

As viewed in the photos below, indications of elevated moisture readings were detected on the internal door reveal and architrave that is located directly next to the tile shower. Moisture readings were then done on the opposite side of the shower in the hallway and bedroom with no elevated moisture readings detected during the inspection. And as detailed in the foundation section of this report moisture staining was noted below the bathroom area in the subfloor. It is recommended to have a suitably qualified and licensed professional to advise further on this tile shower.

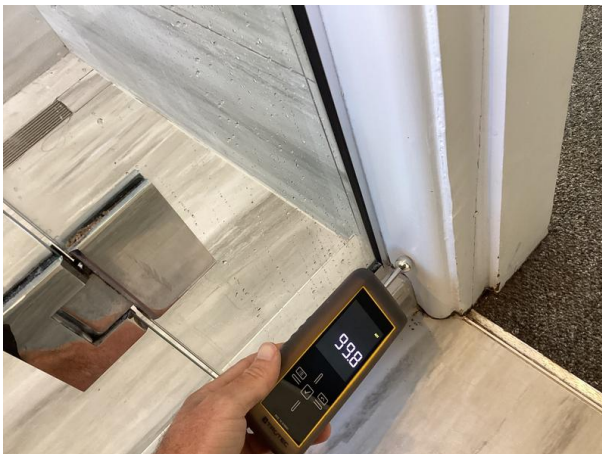
**Photo 71**  
Indications of elevated moisture readings were detected on the internal door reveals and architraves beside the shower.

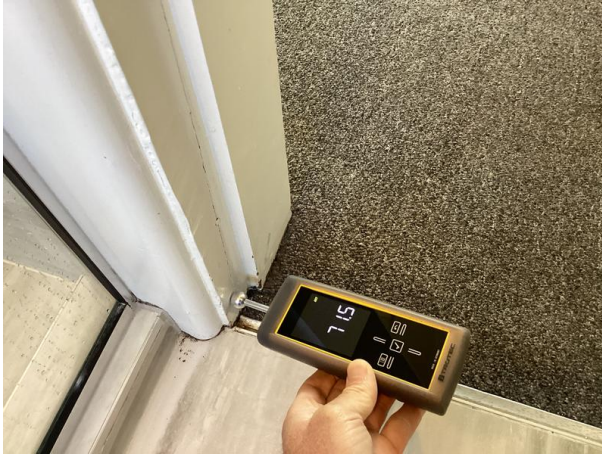
**Photo 72**

Example of the elevated moisture readings detected on the internal door reveal.

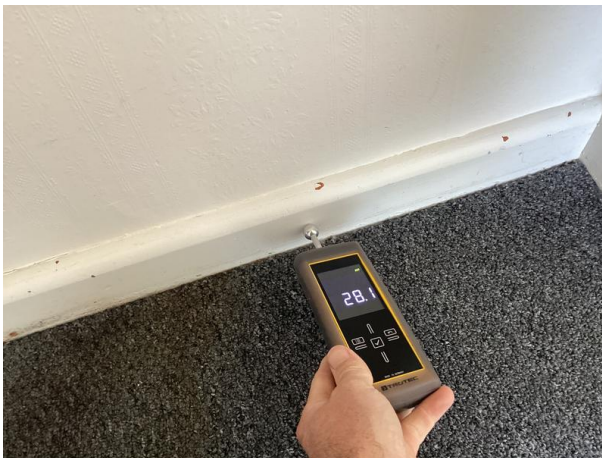
**Photo 73**

Moisture readings were then done on the opposite side of the shower in the hallway and bedroom with no elevated moisture readings detected during the inspection.

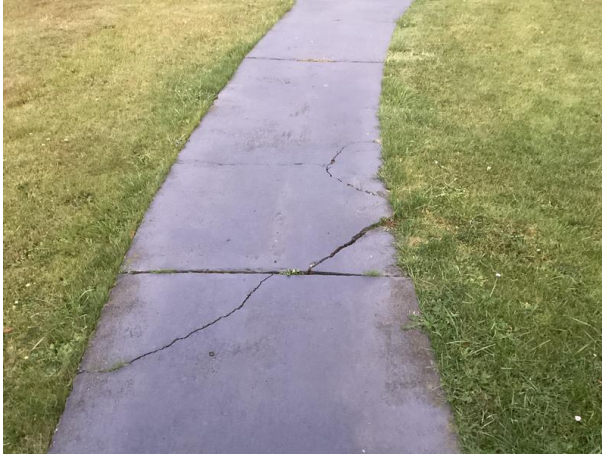
**Photo 78**  
Concrete paths with cracking noticed.
