# RESIDENTIAL PROPERTY INSPECTION

**Inspection Address:** 47 cam rd. Kaiapoi

**Inspection Date:** Tuesday, 28 July 2026

**BuildQual NZ Ltd**

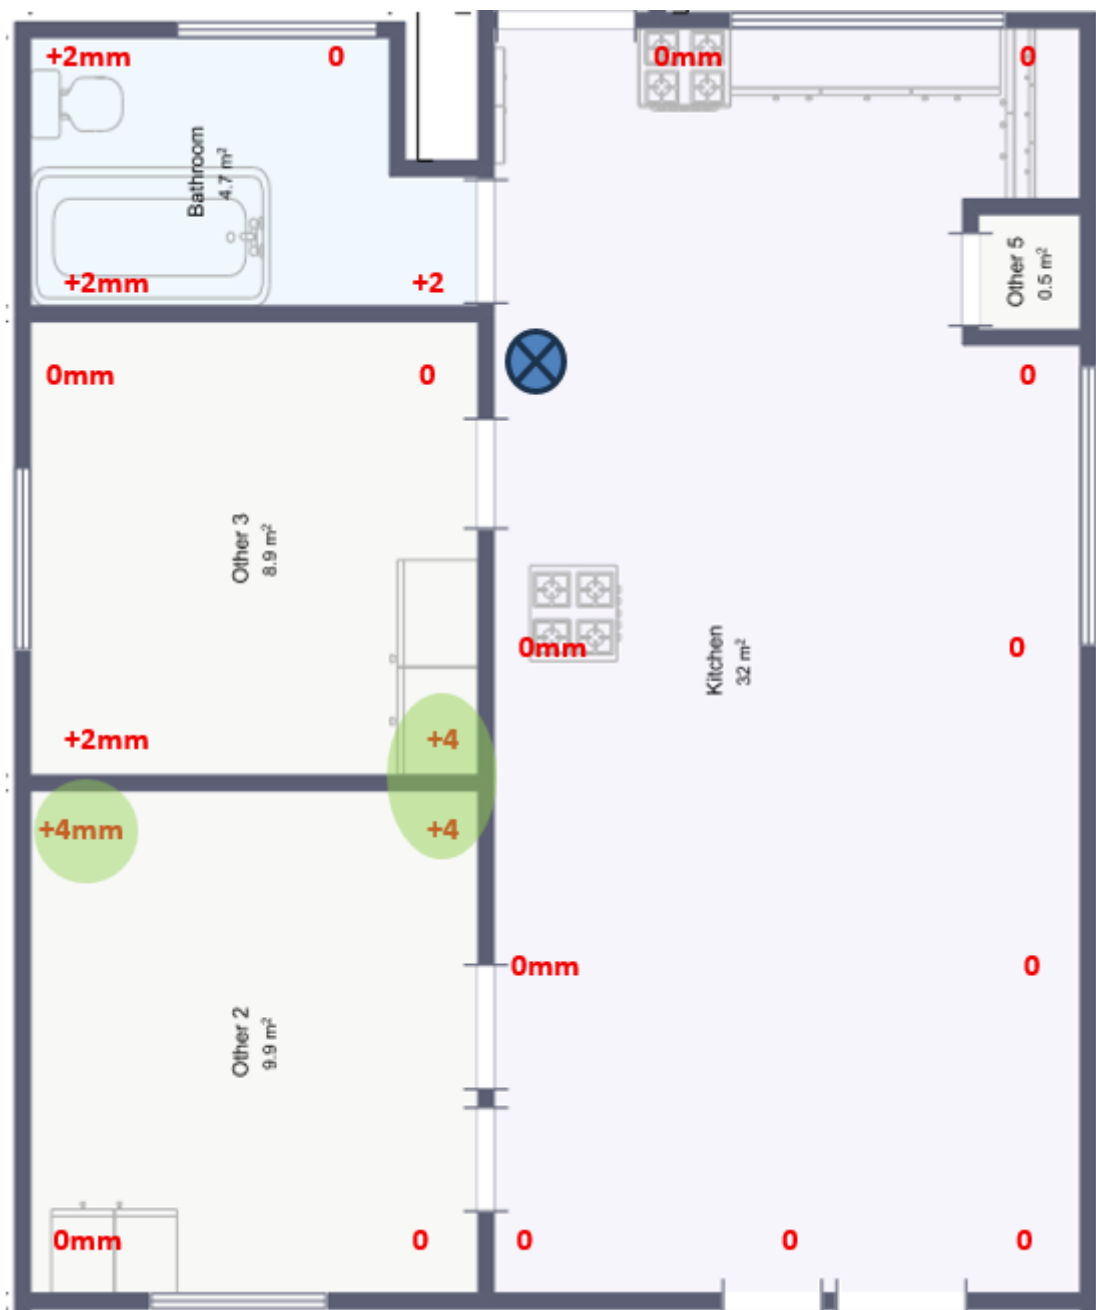
## FLOOR PLAN

The datum was placed in the lounge adjacent the second bedroom door. The point measured as highest above the Datum was in the primary bedroom, along its southern wall, and in the northwestern corner of the second bedroom – at **plus 4mm**.

The lowest point measured against the Datum was the Datum and almost all of the other measurements – **0mm**. The total variation is **4mm**.

This indicates that a **No Foundation re-level is considered necessary**.

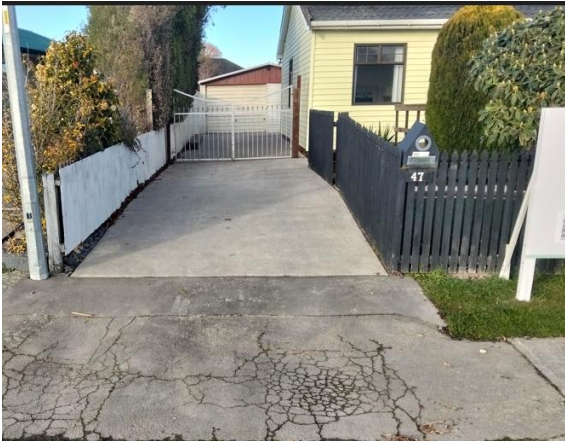
| ITEM ASSESSED | DEFECT | COMMENTS/NOTES |
|---|---|---|
| Steps, Handrails, Paths, Driveway | Minor | Cracking of the asphalt noted at the curb, Cracking noted on the concrete driveway, paths and parking areas, uneven slab joins, |

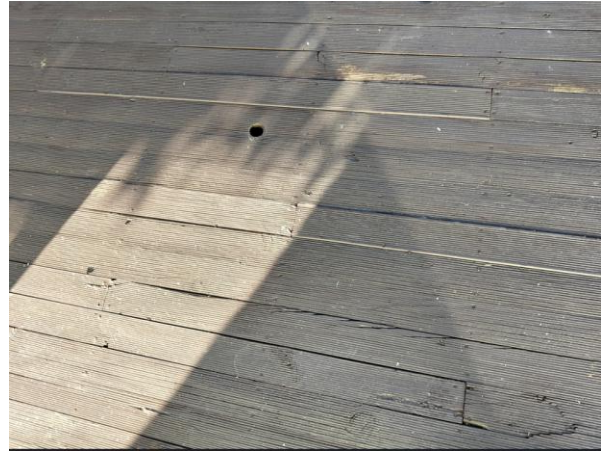
Deck

| ITEM ASSESSED | DEFECT | COMMENTS/NOTES |
|---|---|---|
| Balconies, Verandas, or patios etc. | Minor | The timber deck at the front of the dwelling has no gaps between the boards for drainage. There are split boards, knot holes, exposed nails sticking out of the timber adjacent to the steps leading up to the door at the front of the dwelling |

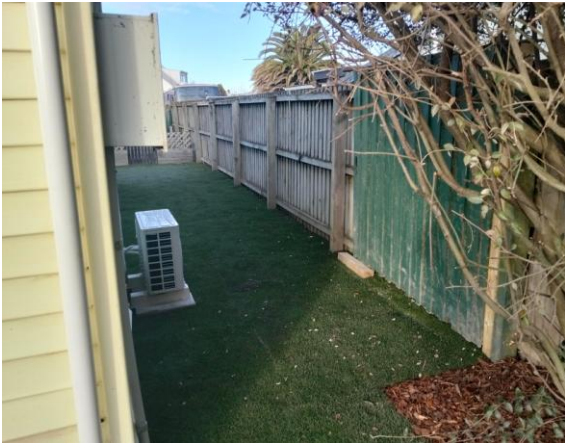
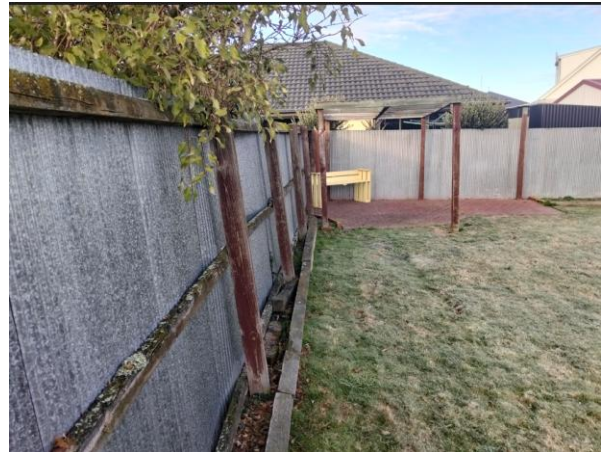
Fences

| ITEM ASSESSED | DEFECT | COMMENTS/NOTES |
|---|---|---|
| Fencing | Minor | Varied heights and varied materials, and reasonable condition. The fence on the eastern boundary has a lean |

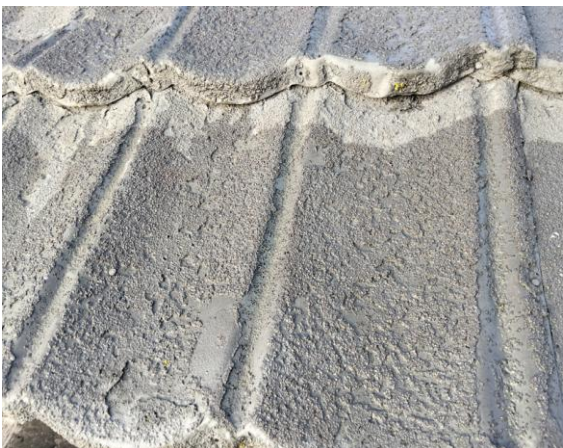
| ITEM ASSESSED | DEFECT | COMMENTS/NOTES |
|---|---|---|
| Roof condition | Minor | Some denting and loss of coating noted on the roof tiles |

Dented tiles

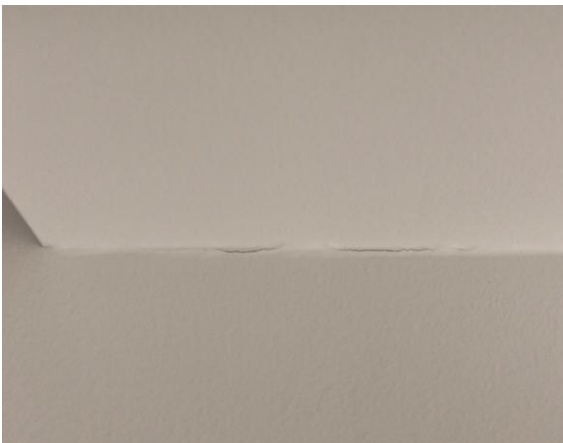
| ITEM ASSESSED | DEFECT | COMMENTS/NOTES |
|---|---|---|
| Walls – condition, defects. | Minor | Only minor interior imperfections noted |

Minor blemish

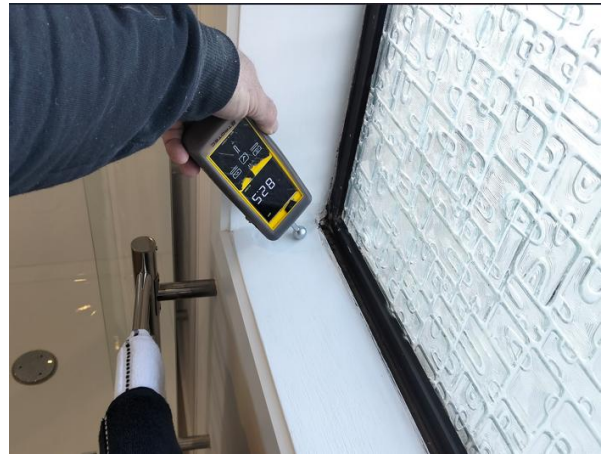
The moisture readings were between **24.1** and **96.9** – these are in the **dry through to wet ranges**.

| ITEM ASSESSED | DEFECT | COMMENTS/NOTES |
|---|---|---|
| Inside of Windows- Single or double glazed | Moderate | Wet moisture readings on the bathroom windowsill. |

Elevated and wet moisture readings

Further investigation should be undertaken to determine the cause of the elevated and wet moisture readings and any remedies.

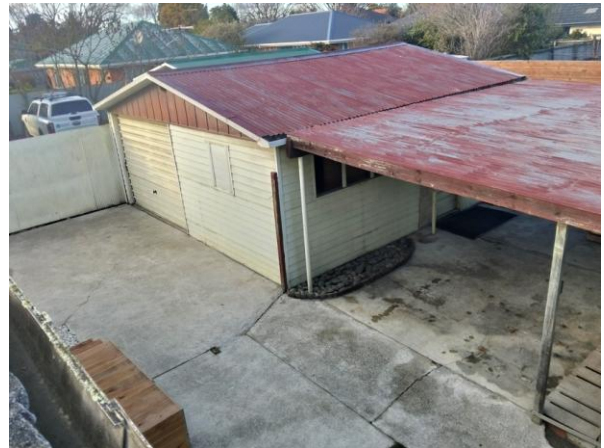
Carport roof

| ITEM ASSESSED | DEFECT | COMMENTS/NOTES |
|---|---|---|
| Garage – opener, doors. | Minor | Garage and carport roofs have some rust noted on the inside of the garage roof, roof underlay is deteriorated in the garage and carport<br>The gutter and down pipe on the garage roof is rusted<br>Water staining on the garage roof purlins. Garage door opening/locking mechanism is damaged. |
