CONSTRUCTION MONITORING SUMMARY

Producer Statement 4 (PS4)

| Project | 47 Cam Road, Kaiapoi |
| Project Number | J26004 |

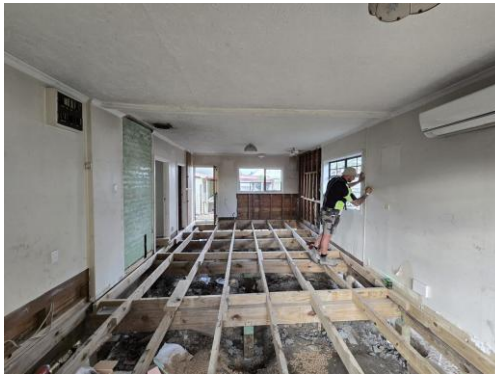
Photograph 1 – view inside house with lifting complete

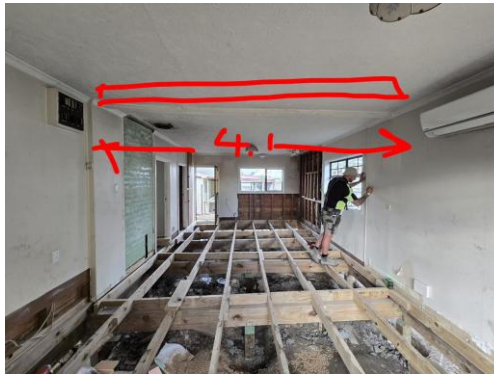
Photograph 2 – location of proposed new beams

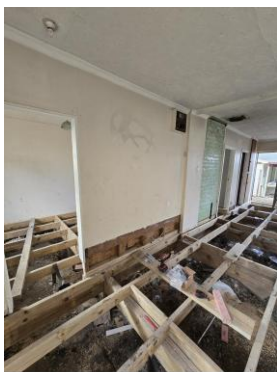
Photograph 3 – view of strengthened floor

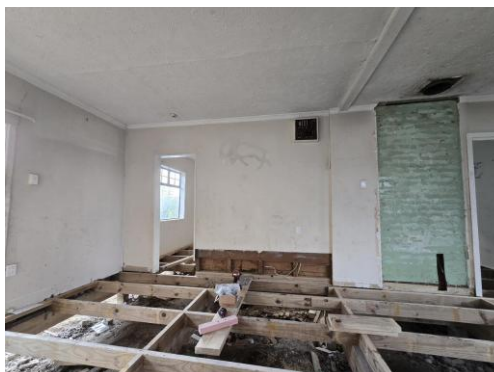
Photograph 4 – view inside dwelling

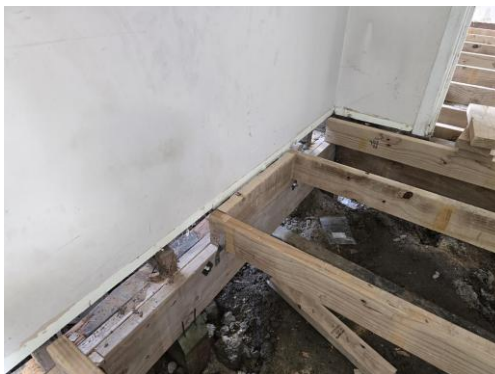
Photograph 5 – perimeter timber framing

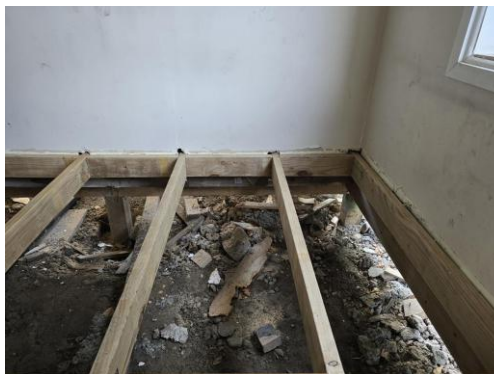
Photograph 6 – joists on new bearers and piles

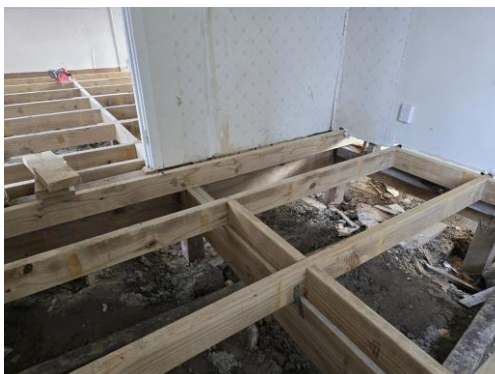
Photograph 7 – internal subfloor framing

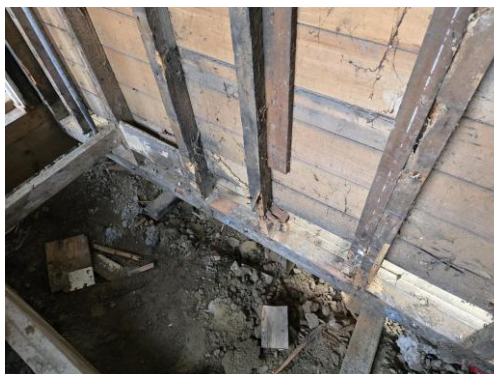
Photograph 8 – original rotted timber to be removed

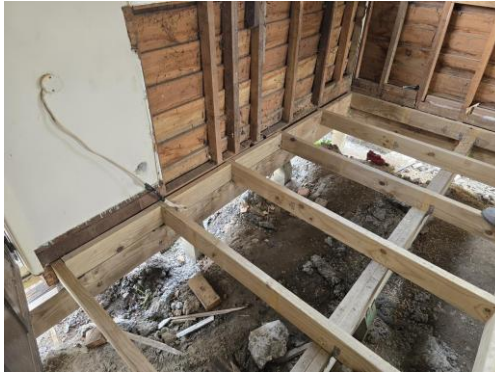
Photograph 9 – new timber subfloor

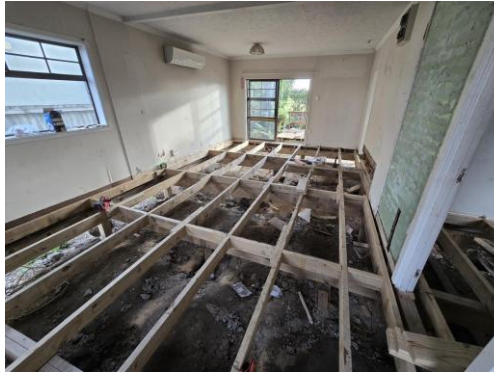
Photograph 10 – view towards front of house

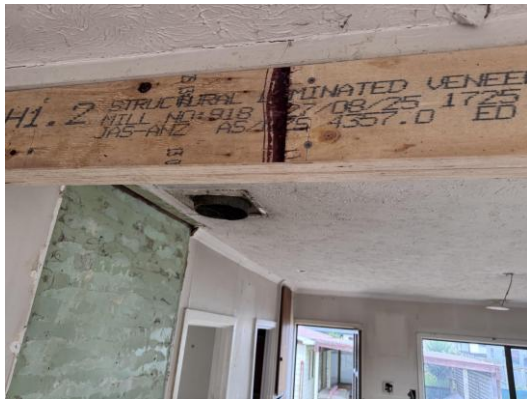
Photograph 11 – New living-area beam: LVL grade stamp confirming H1.2-treated structural laminated veneer lumber to AS/NZS 4357.0 (Mill No. 818)

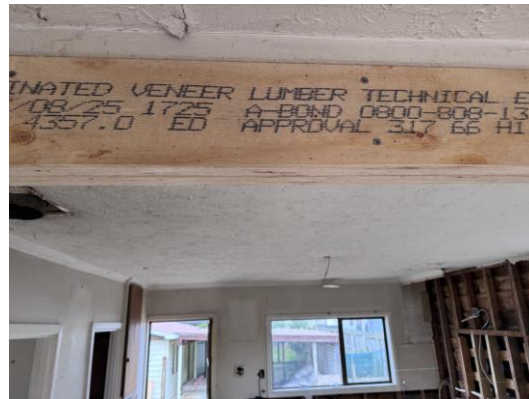
Photograph 12 – New living-area beam: LVL product stamp (A-bond structural laminated veneer lumber)

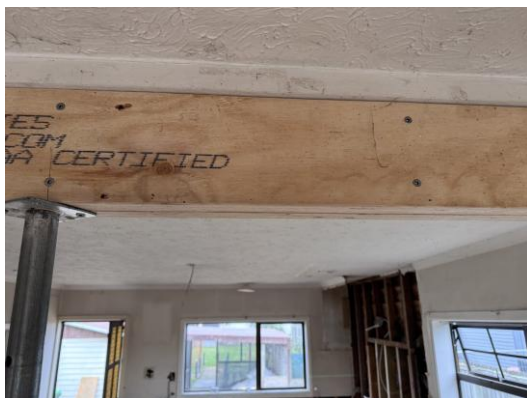
Photograph 13 – New living-area beam: installed directly below the retained original living-area beam (Beam 1 of 2)

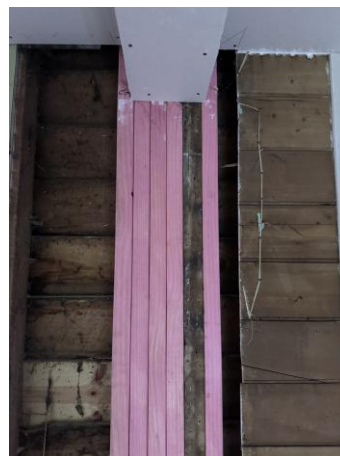
Photograph 14 – New 2/200x90 hySPAN living-area beam installed and wrapped (approx. 180 mm overall width)

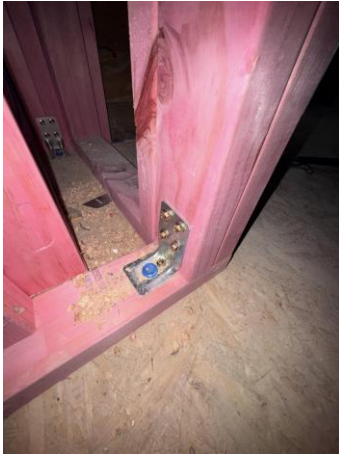
Photograph 15 – Proprietary angle bracket (handibacket) fixing at the beam support in wardrobe area

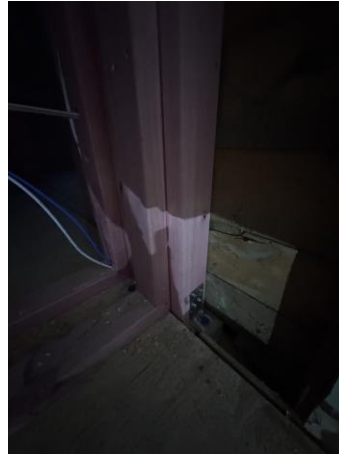
Photograph 16 – Angle-bracket connection at post base

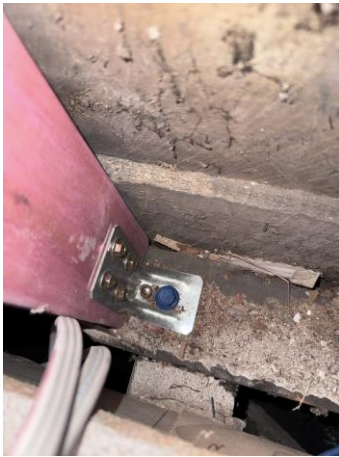
Photograph 17 – Angle-bracket connection to bearer (subfloor)

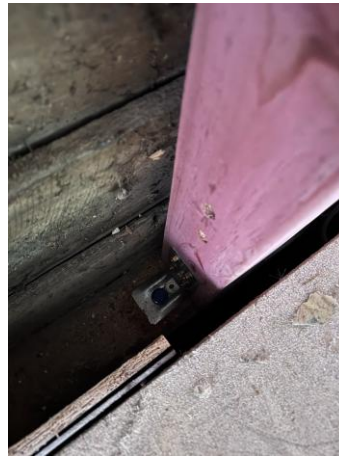
Photograph 18 – Angle-bracket base connection (subfloor) typical throughout

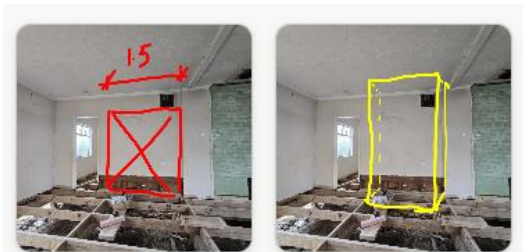
Photograph 19 – Contractor location mark-ups: TV bracing wall (BL1, shown red) and wardrobe lintel (2/190×45 SG8, shown yellow)
