## RED LBP PRE-PURCHASE REPORT

# CERTIFICATE OF INSPECTION IN ACCORDANCE WITH NZS 4306:2005

**Company:** JBC Builders Limited Ltd trading as RedLBP Christchurch North  
**Client:** [REDACTED]  
**Date of Inspection:** 2nd February 2026  
**Site Address:** 19 Tirangi Street, Hei Hei, Christchurch 8042  
**Inspector:** Jamie Chapman  
**Qualifications:** National Certificate in Carpentry

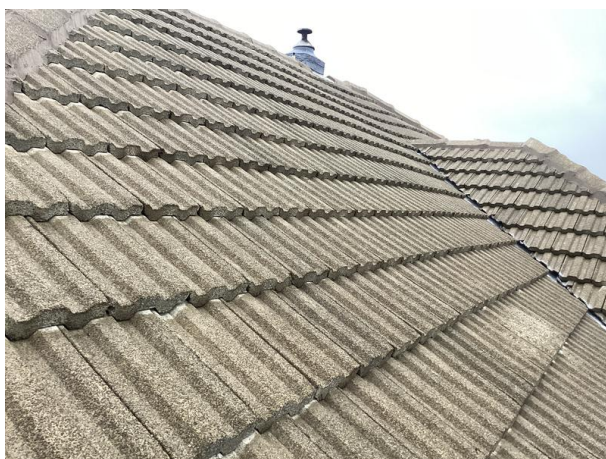
**Photo 3**

Masonry tiles are located around the dwelling.

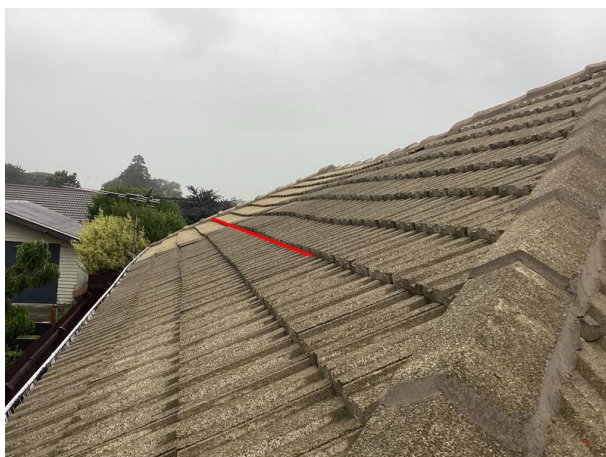
**Photo 4**

A couple areas of deflections were noticed along the roof. Mainly on the east side of the dwelling.

Deflections in a masonry tiled roof can be caused by various factors. Addressing deflections in a masonry tiled roof is essential to ensure its long-term stability and prevent potential damages. Regular inspections and proactive maintenance are key to identifying and addressing issues early, helping to extend the life of the roof system. The roof may benefit from extra timber bracing being installed to help straighten and support some areas. A licensed builder can advise further on this.

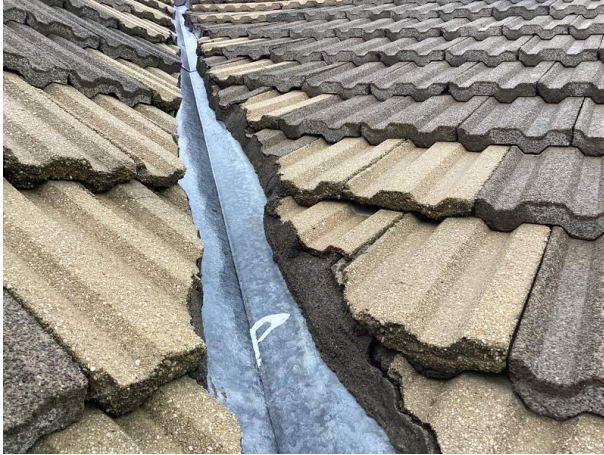
**Photo 5**

The valley tiles have been cut relatively short and mortar filled between the metal valley and tile system.

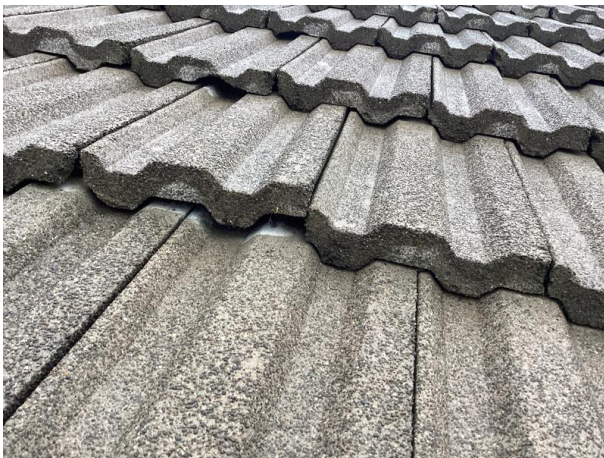
**Photo 6**

Tile alignment - Slipped tiles observed.

Some tiles on the east side were slightly out of alignment. Recommend adjusting these back into place.

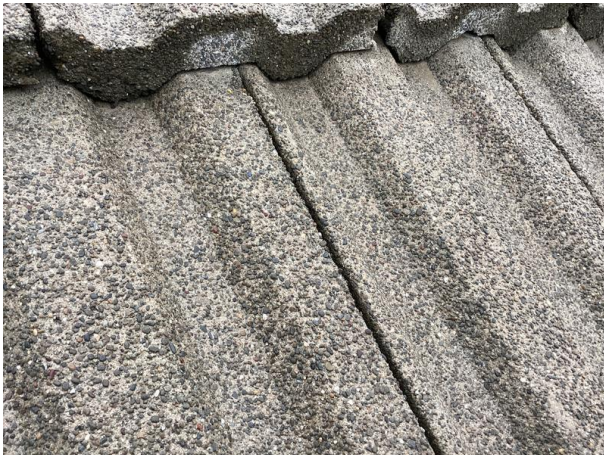
**Photo 7**

Condition of surface - Deterioration of the surface coating.

Close-up view on the condition of the masonry tiles. Note the rough surface. See the next photo.

The masonry tiled roof system is in a condition expected for age however, due to its age, surface deterioration has occurred over time on the masonry tiles. It is recommended to have a licensed roofer specialized in masonry tiles advised further on maintenance and repairs.

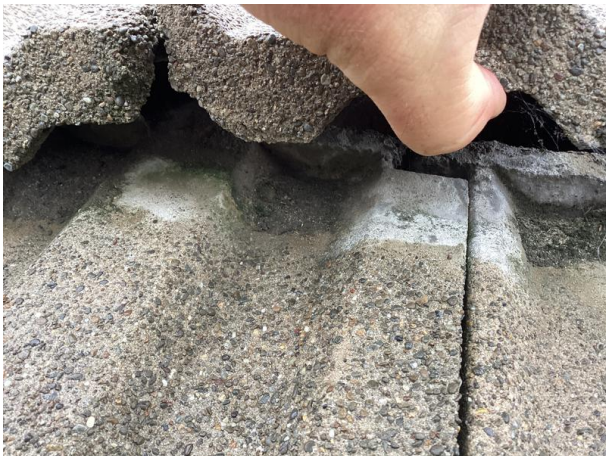
**Photo 8**

When lifting up the masonry tiled lap, that exposes a smooth surface underneath. This was the original condition of the tiles.

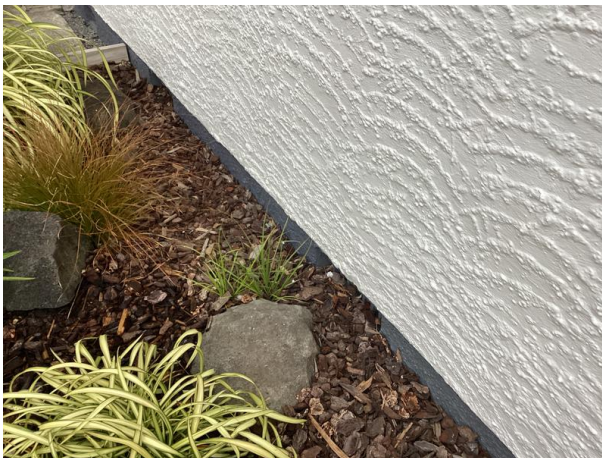
**Photo 22**

Some ventilation holes were partially blocked due to raised garden beds.

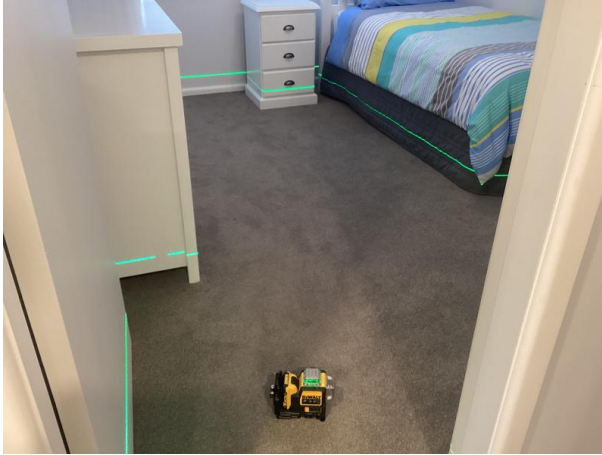
**Photo 24**

No significant deviations identified during the inspection. The approximate overall floor level difference was 25 mm.

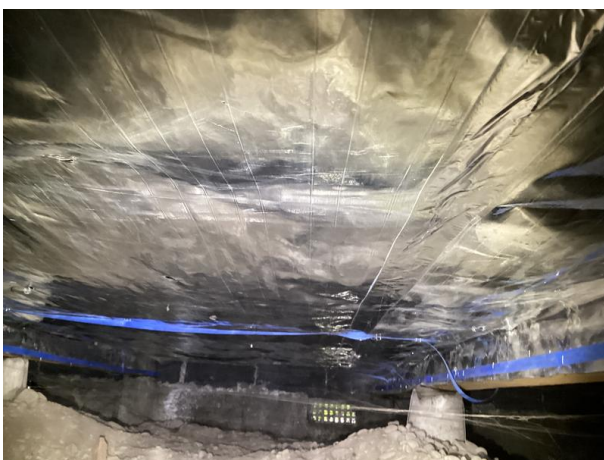
**Photo 28**

Silver foil insulation was visible in the subfloor. In a relatively tidy condition.

A ban has been declared on the installation and/or repair of foil insulation in residential buildings with existing electrical installations. This ban is due to safety concerns associated with the method of attaching the foil to the building. It relates to Building Code Clause G9 Electricity. This ban is declared from 1 July 2016.

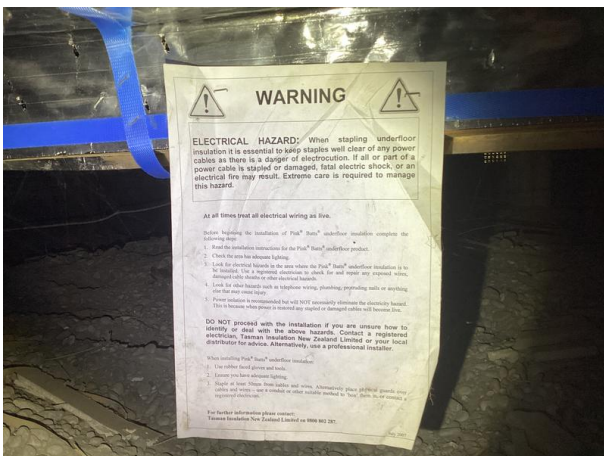
**Photo 29**

Due to the silver foil insulation being in the subfloor there is a warning electrical hazard sign.

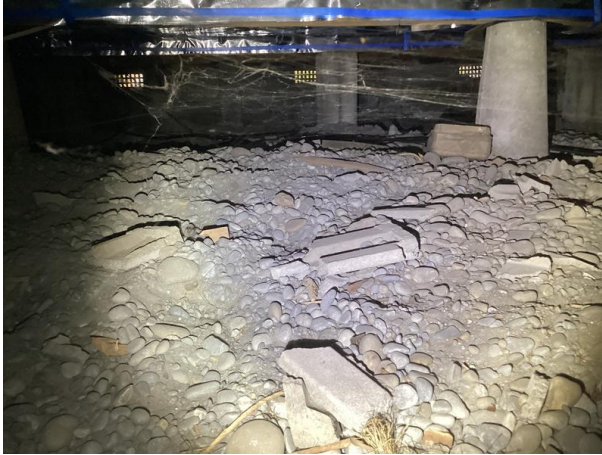
**Photo 30**

Future maintenance could include installing a ground moisture barrier in the subfloor.

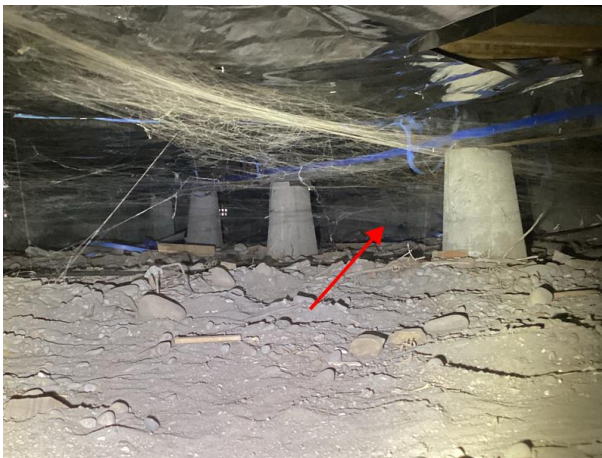
**Photo 31**

Under the extended section of the dwelling was not visible due to the original ringing foundation blocking access and visibility.

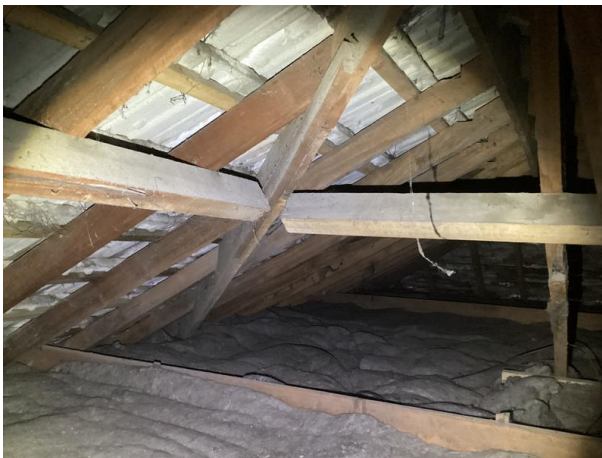
**Photo 33**

Photo of where the main deflection was noticed on the roof. This is where the extended section of the dwelling starts on the south side.

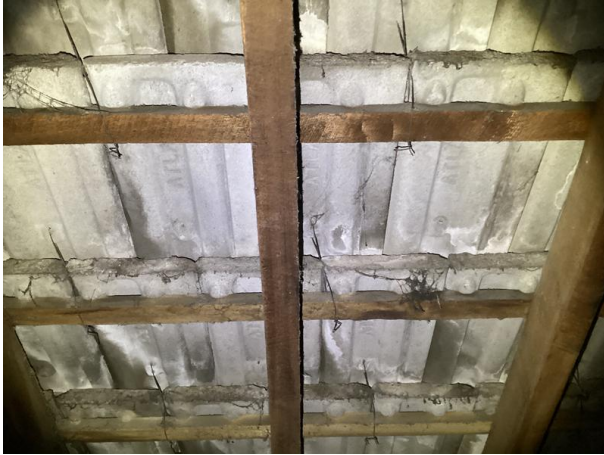
**Photo 35**

Efflorescence refers to the crusty white deposits of mineral salts that form on the surface of masonry materials such as concrete, render, brick, or mortar. This phenomenon occurs when moisture travels through the substrate, dissolving soluble salts within the material. As the moisture evaporates at the surface, it leaves behind these salt deposits. Efflorescence is a common issue and often serves as an indicator of moisture movement within the masonry.

Signs of efflorescence were noticed on the underside of the masonry tiles. Refer to the roof system section of this report to view the condition of the roof.

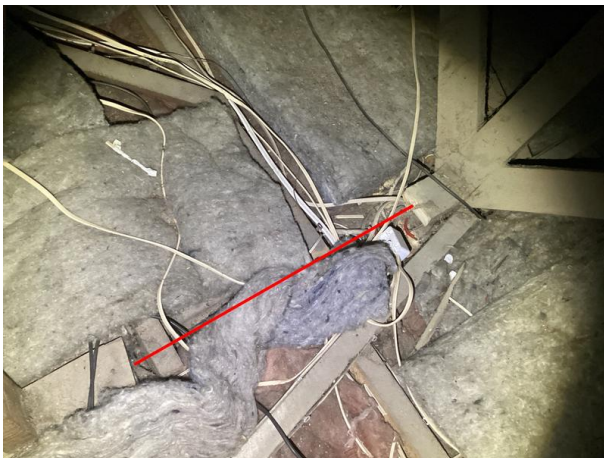
**Photo 36**

It appears a timber has been cut in the roof space possibly to allow for electrical wires. This cut timber is what the roof space bracing attaches to.

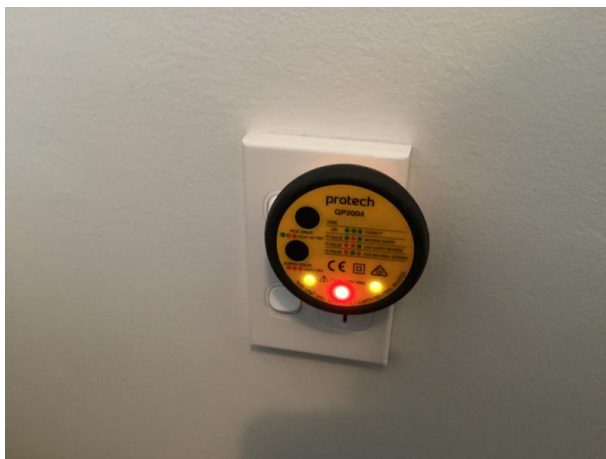
**Photo 60**

A plug in bedroom two indicated the Earth is missing. Recommend having a registered electrician to advise further.

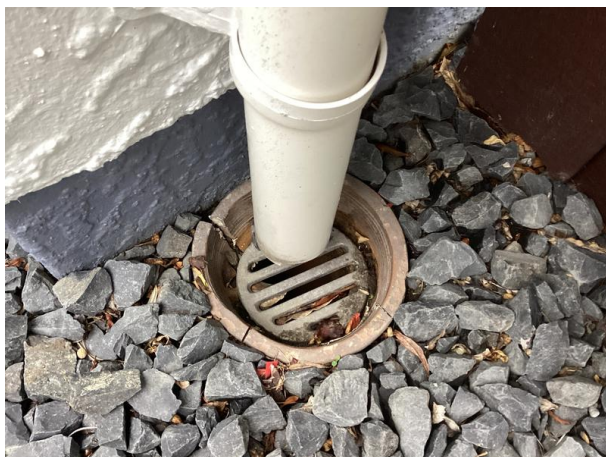
**Photo 61**

Cracking in the south/West stormwater riser was visible.

Earthenware drains were noted at the property. These are prone to tree root blockage. It is recommend that these drains be CCTV inspected and cleared if required.
