## RESIDENTIAL HOUSE INSPECTION

12 Kirk Rd

03/08/2026

Kiwi House Inspections

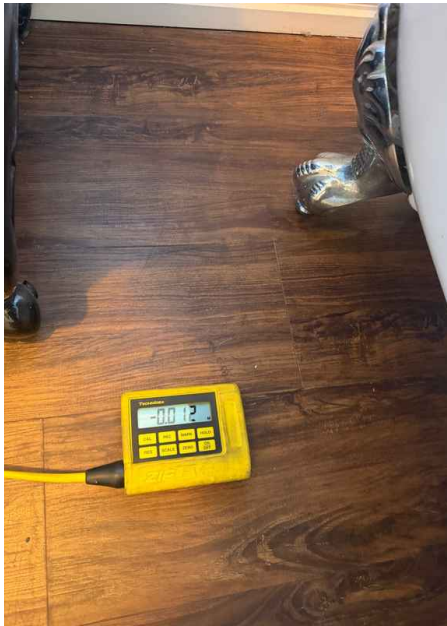
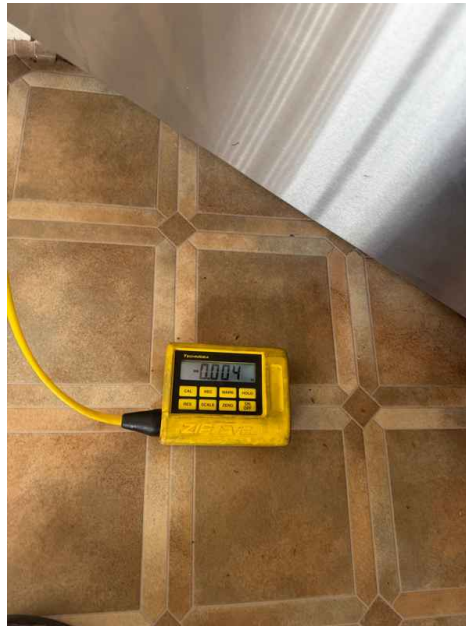
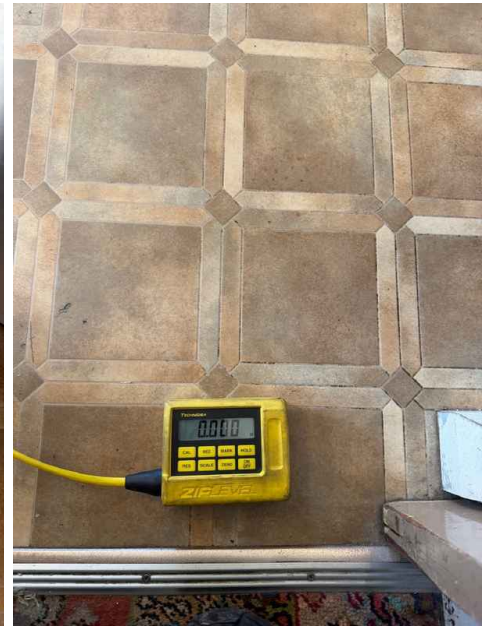
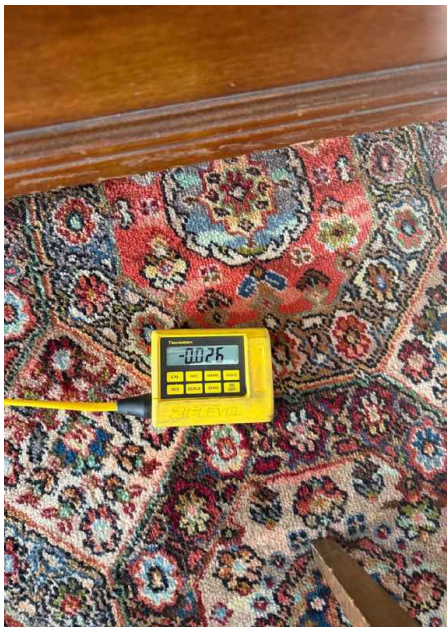
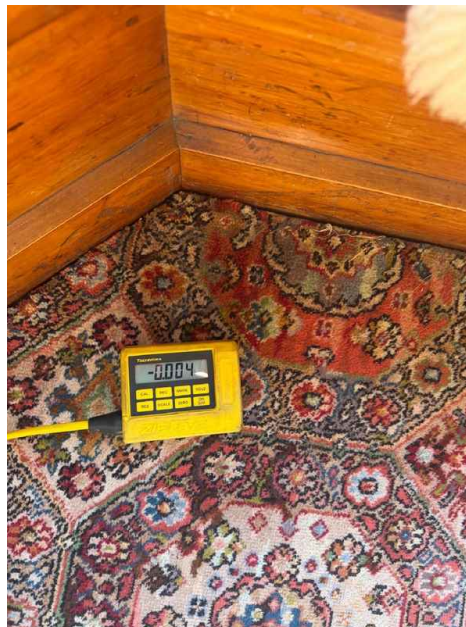
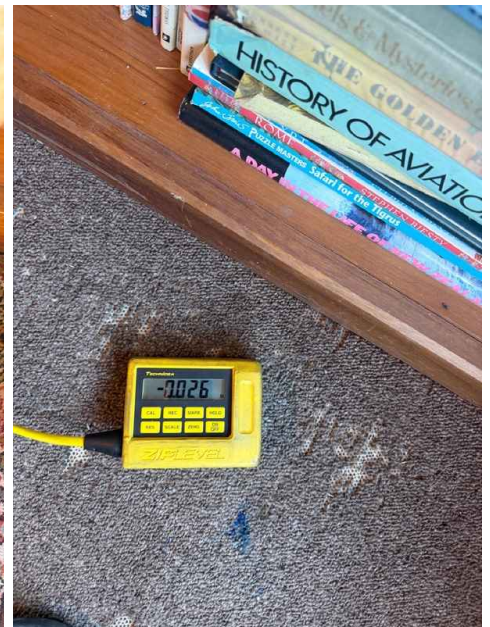
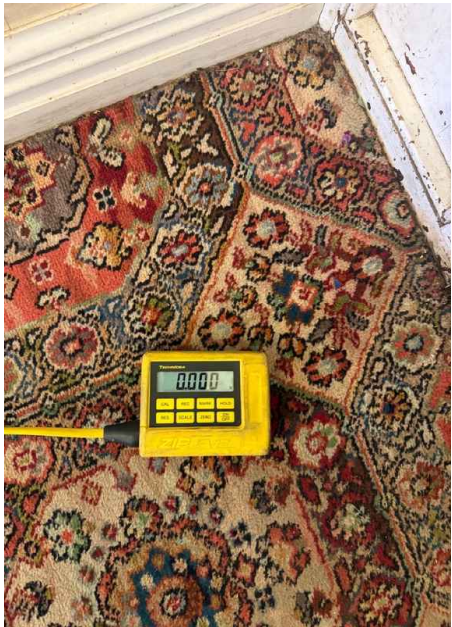
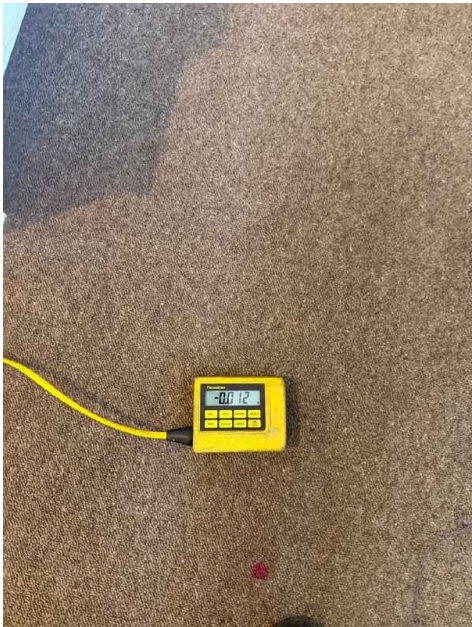
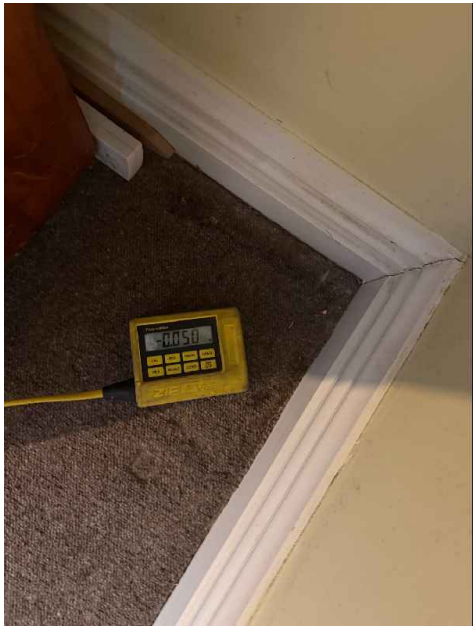
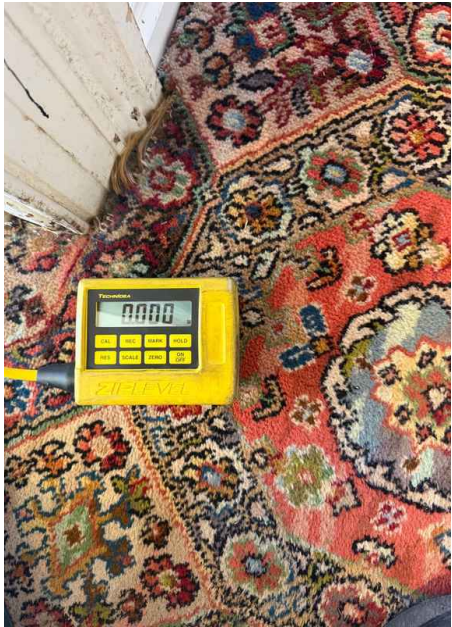
**Floor Levels: Deviations in floor levels are noted.**

Deviations in floor levels are noted, it is in our professional opinion that these are of an historical nature when the age of the dwelling and construction methods and alterations are taken into account. Further investigation could be completed by a suitably qualified person to confirm our opinion. This exceeds Mbies canterbury earthquake guidance of 50mm, however this is document is a guidance only for eqc related damage where damage is earthquake related.

Settlement to the north west and south west corners has occurred, the tree and downpipes discharging to the ground are contributing factors of this. Approx. 50mm noted

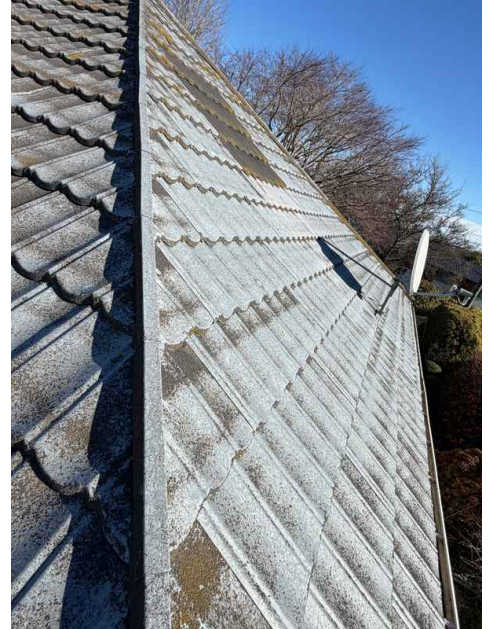
**DETERIORATION OF ROOF COATING NOTED**

The coating has deteriorated, this is consistent with age and color of the product, a new coating system would improve aesthetics and durability.

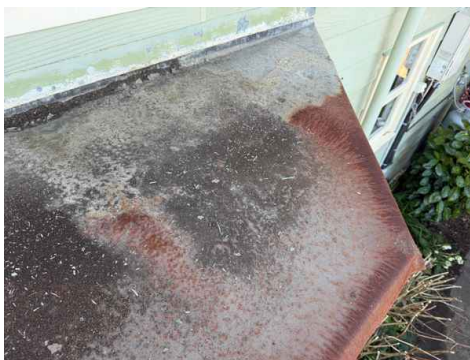
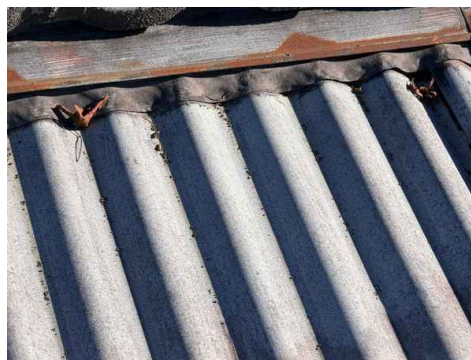
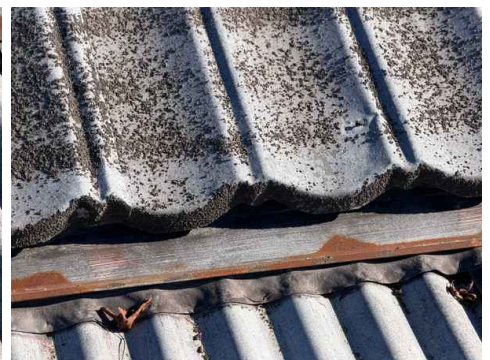
**SURFACE CORROSION TO ROOF SYSTEM OBSERVED**

Surface corrosion is noted to the roof system, Maintenance required, as a minimum the areas should be prepared and treated, any significant rust may require iron to be replaced. The roof is of an older age and will require regular maintenance.

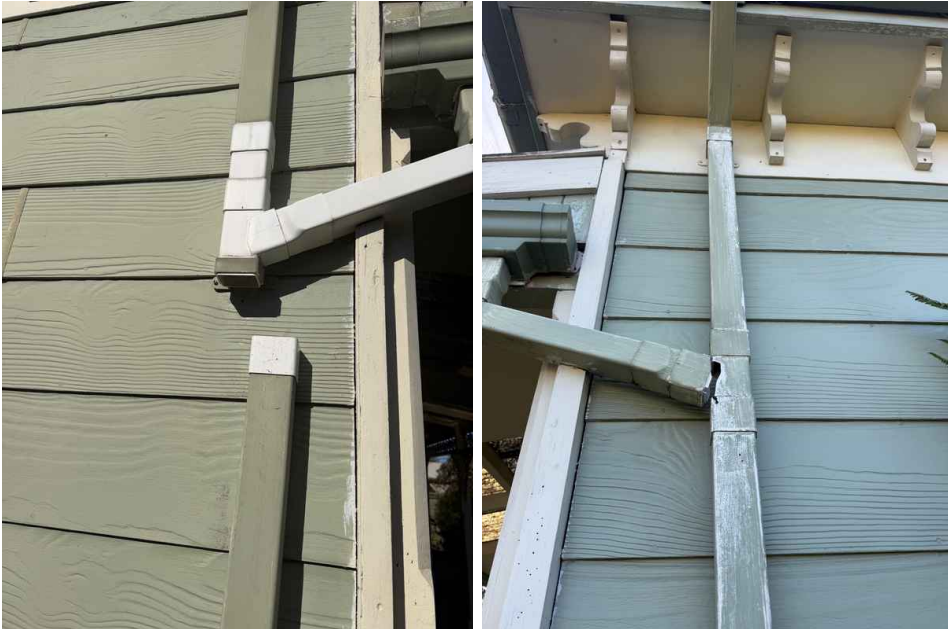
**LOOSE DOWNPIPES**

A loose or damaged down pipe is noted, repairs recommended.

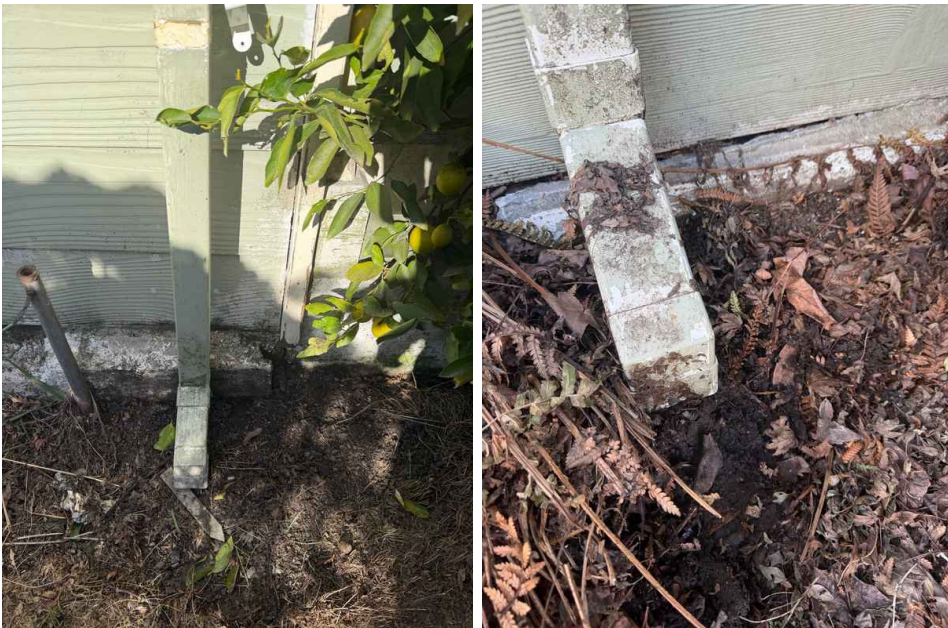
#### **DOWNPIPE DISCHARGES TO GROUND**

The stormwater discharges to the ground, it is recommended that this is installed to a designated discharge point.

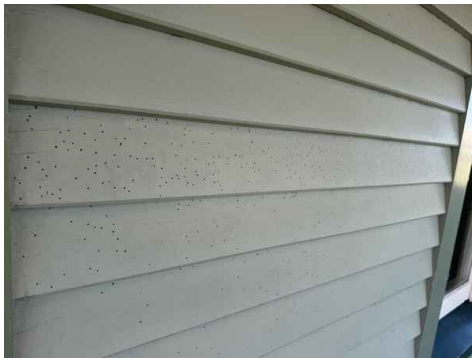
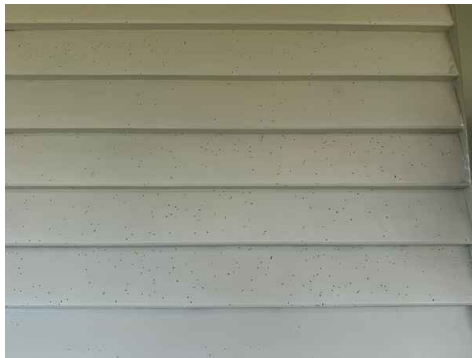
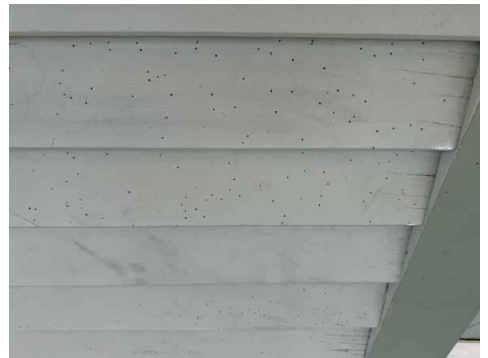
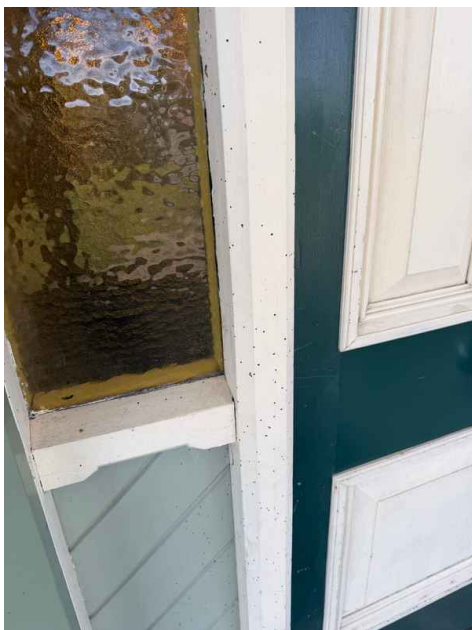
#### **BORER NOTED**

Treatment is recommended.

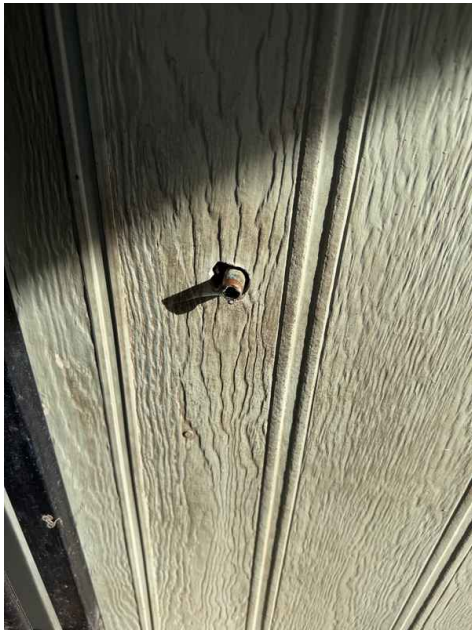
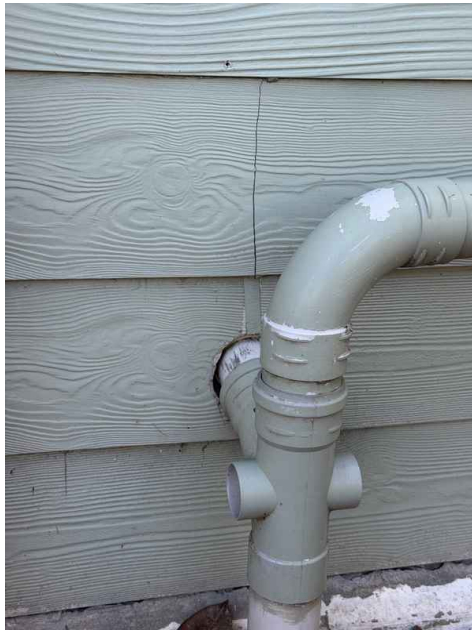
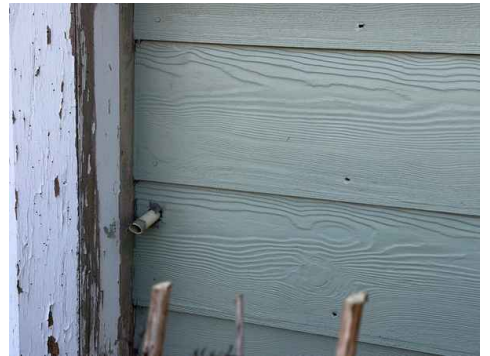
**UNSEALED PENETRATIONS**

It is recommended that penetrations are sealed.

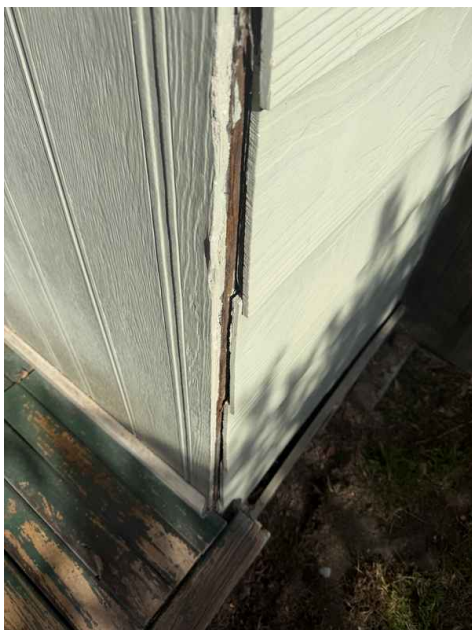
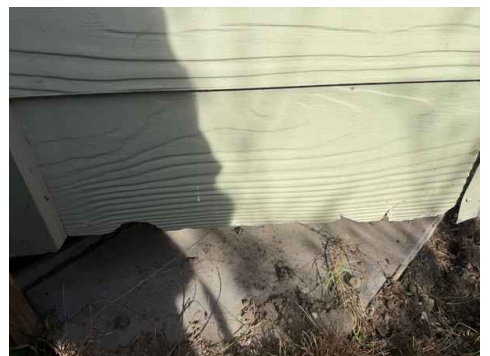
**MINOR CRACKING TO THE CLADDING NOTED**

Repairs and or replacement of damaged boards are recommended to prevent water ingress into the cladding system. The corner is missing the correct flashing.

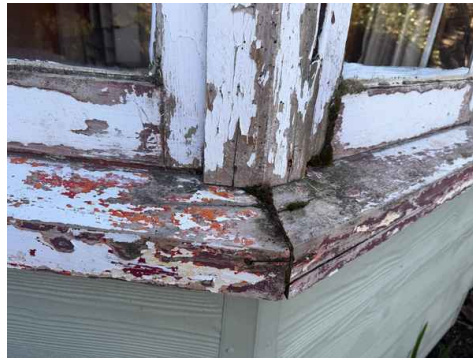
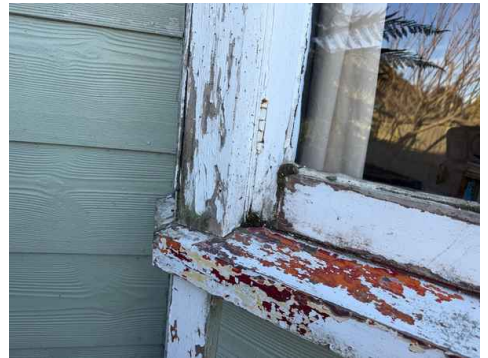
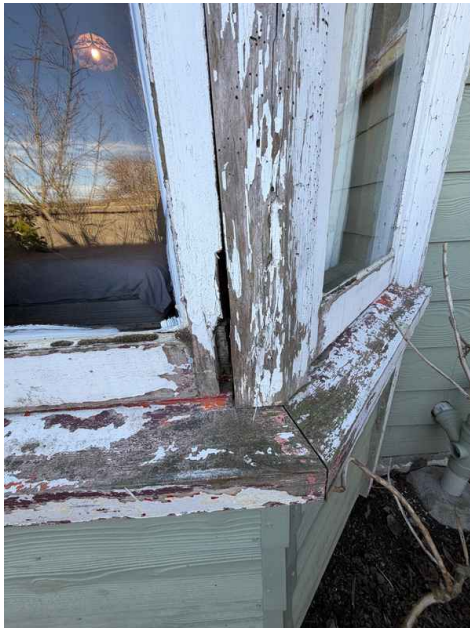
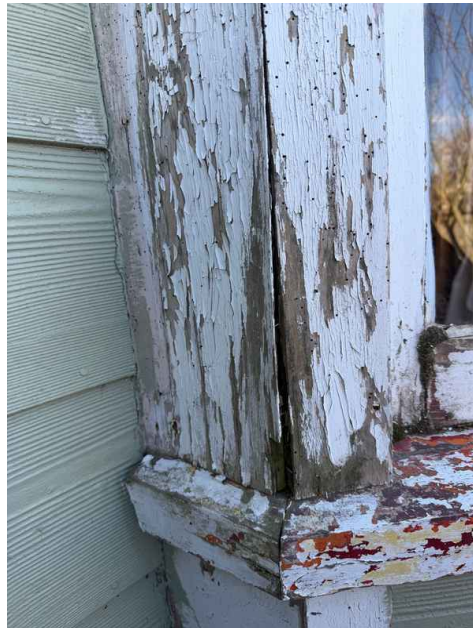
##### **DECAY TO TIMBER WINDOW FRAME**

Decay is noted to the timber window frame, maintenance to the damaged area should be completed.

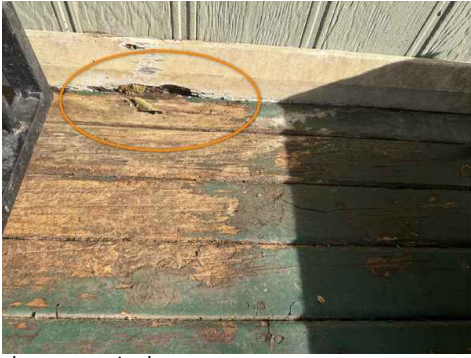
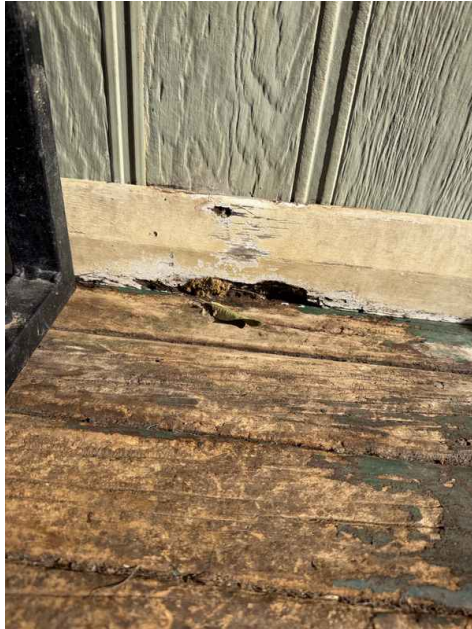
**DECKING IS CONSTRUCTED AGAINST THE CLADDING SYSTEM**  
It is recommended that decks have a minimum of a 12mm gap between the cladding and decking timbers to minimize the risk of water ingress into the cladding system.

decay to timber

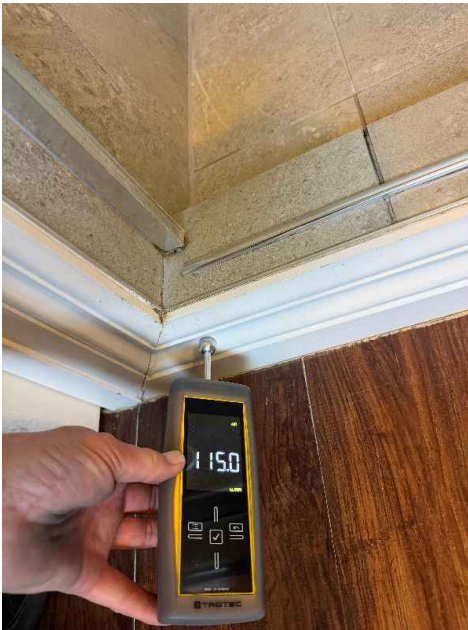
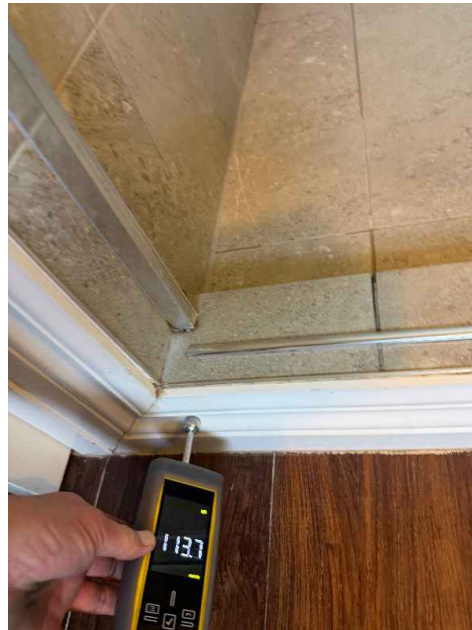
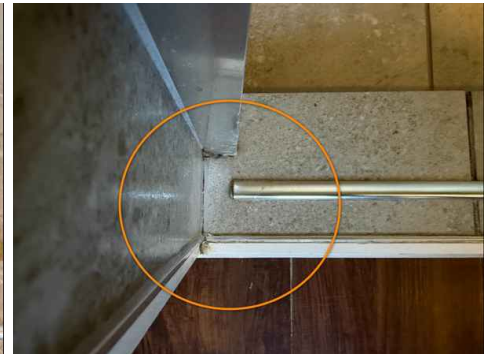
#### **ELEVATED MOISTURE**

Elevated moisture was located to the shower area. Improvements to the area to prevent water escaping the enclosure are recommended.
