## Presale Building Report.

300 Rosetta Road, Raumati Beach, Paraparaumu 5032

Date: 28/07/26

Building Inspector: Simon Murray

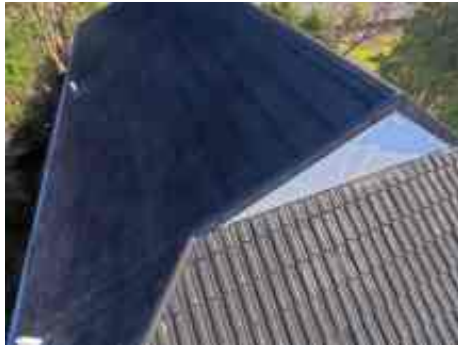
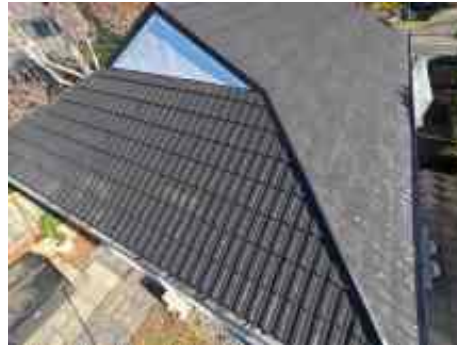
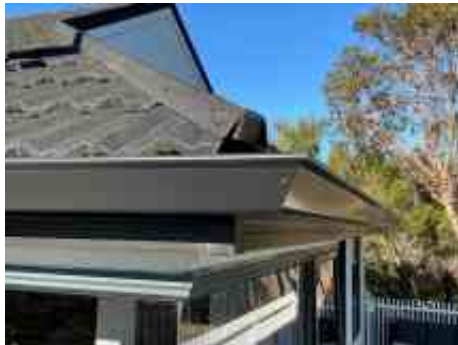
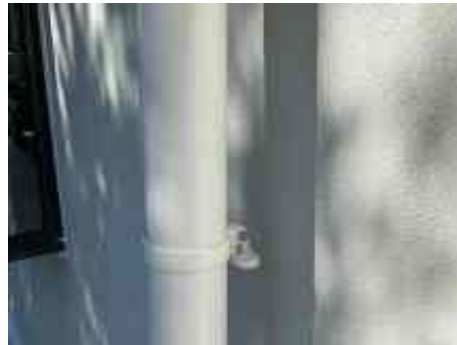
The roofing is decromastic tile, all tiles flashings and fixings are in place, there are a few dented tiles where tradesmen have accessed the upper gable ends of the roof, these dents should be pushed out or replaced. The upper gable timber facias appears to have been repaired with bog at the apex. The patchy coating appearance to the tiles is probably reminiscent of old lichen that has been killed off. All metal spouting is in working order, just the PVC down pipes need to clip fixed as per manufactures specification.

Clips need fixing.

The dented roof tile should be pushed out or replaced and upper facias monitored where they have been filled at the apex.

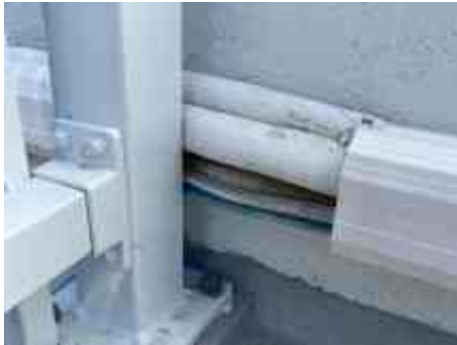
Pipe adjustments and clips required.

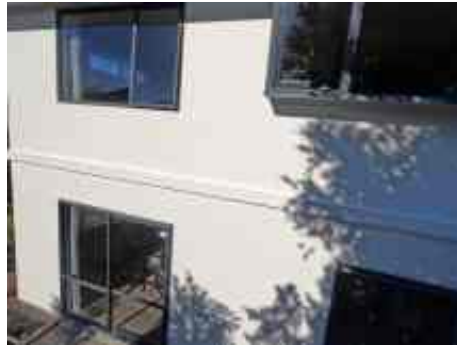
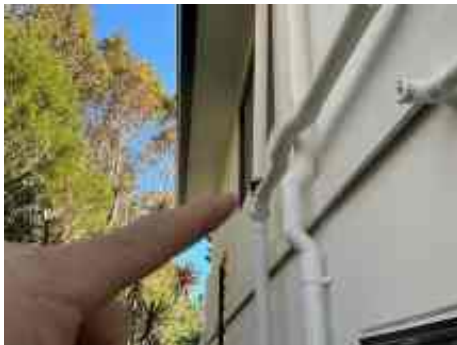
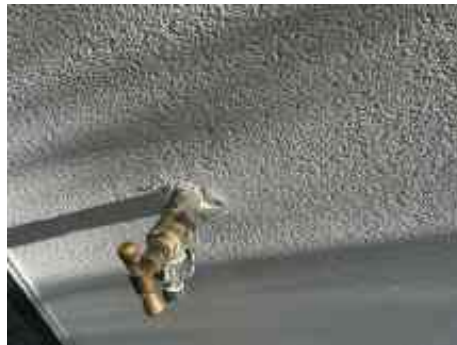
Recommend additional PVC flanges.

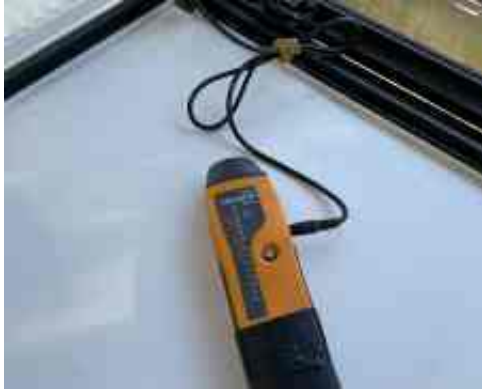
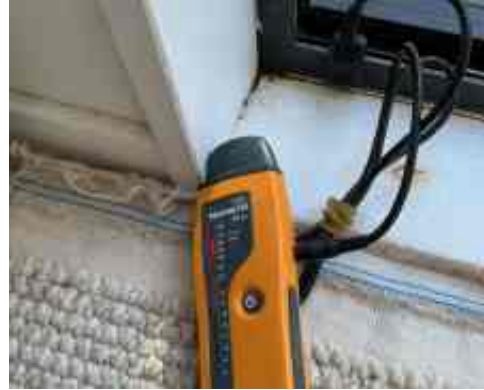
The joinery is single glazed aluminium units, the kitchen window left sash is not fully closing which is probably why we found high moisture readings in the inner sill, we also found high reading in the lower bedroom ranch slider, the inner channel of the frame needs cleaning out and may have blocked the drainage holes causing the inner sill to get damp, both of these issues are common with old aluminium joinery and we recommend a joinery maintenance company check and replace seals, hinges and latches as required to ensure they function properly.

We have tested all joinery opening, penetrations and roof connections, also, lower ground level bottom plates, the only high readings of 50-55% came from the kitchen window and lower ranch slider door; all other areas of the property had normal readings between 6-12.5% at the time of inspection.

A joinery specialist is required to complete maintenance to seals, hinges and latches, also, unblock the drainage holes in the lower ranchslider.

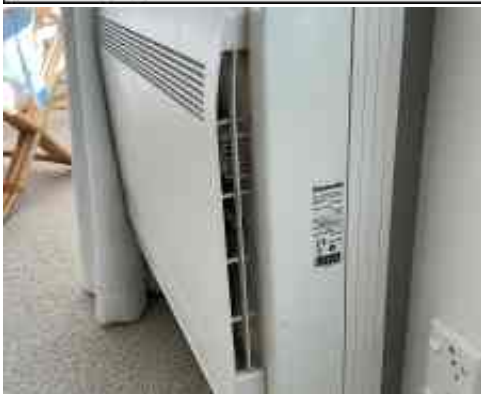
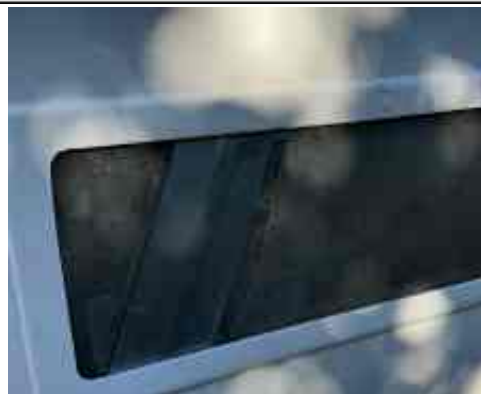
Electrical systems have been inspected however this is not a detailed assessment with testing carried out, but rather a visual inspection, checking wiring, fuse age, condition and support, also switching on fittings if possible, the exterior mains power box has a cracked window, tape is not an acceptable solution.

The exterior mains power box has a cracked window, tape is not an acceptable solution.

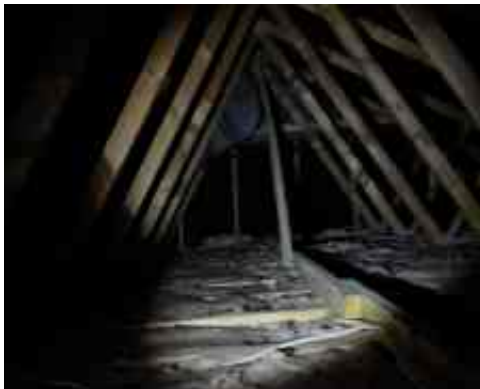
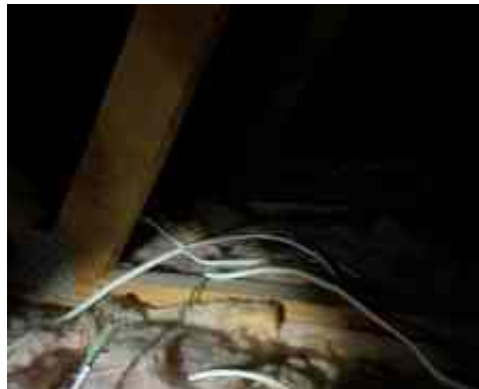
The roof space is dry insulated with Pink Batts and shows no visual sign of any structural or weathertightness issues, all timber trusses and connections are in place and good condition. There are a couple of areas where roofing paper has ripped, these could be taped back in place, there are electrical cable off cuts that should be cleared.

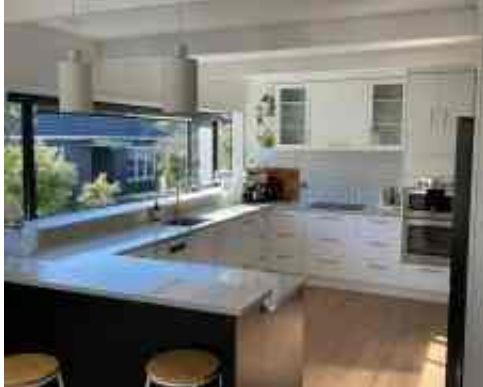
The kitchen is tidy, well-presented and in good working order, the cook top range hood is ducted to the exterior, the bench top join to the left of the sink requires sealant, and as reported in the joinery section the window needs maintenance to ensure it shuts tight to its seals.

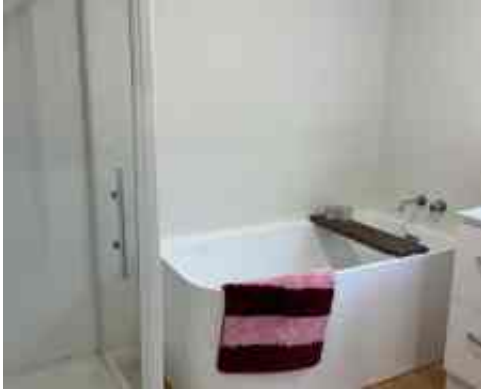
We have tested the bath, shower, vanity and toilet for leaks, none found. The bath requires sealing to the floor and the shower is missing the lower door seal.

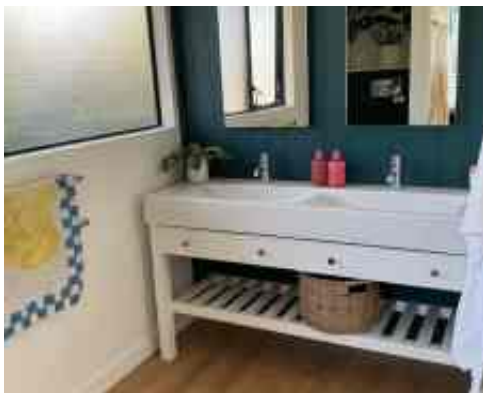
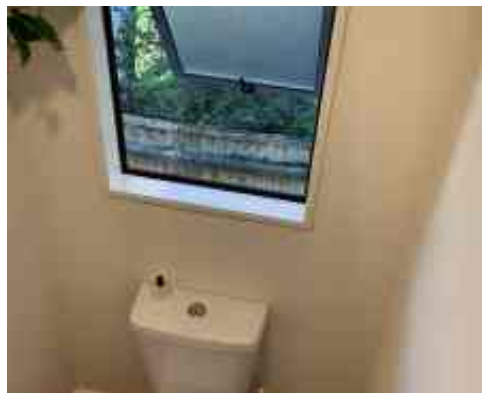
We have tested the shower vanity and separate toilet for leaks, none found, the vanity has some hairline cracking and requires sealing to the wall, also the shower liner along the top edge, we recommend the toilet window has a restrictor stay to prevent children climbing and falling from height.

Restrictors to 100mm max opening.

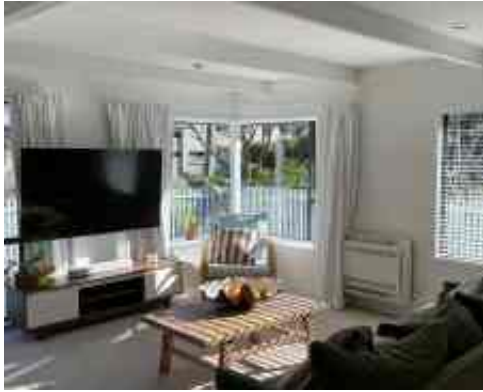
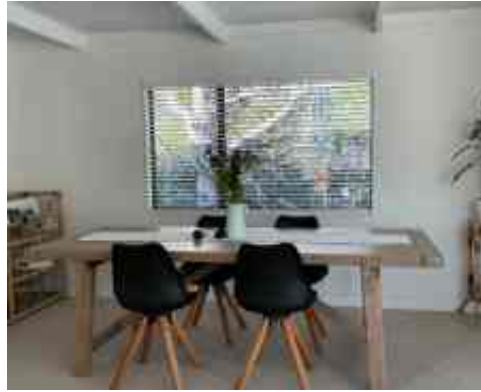
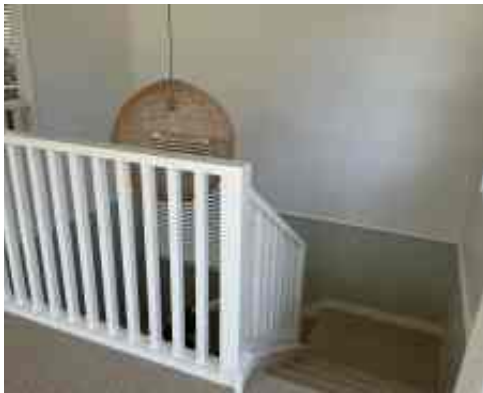
The living areas are tidy and well presented, heated by floor mounted air conditioning, we recommend installing a compliant hand rail to the stairs..
