# EQC claim documentation here

# EARTHQUAKE RECOVERY (EQR) DOCUMENTATION

# EQR Property Overview Report

| EQC Property ID | Property Address | Vulnerable? | Property F Status | Property Finalisation Indicator | | |
|---|---|---|---|---|---|---|
| 2010136496 | 48 NORTH AVON ROAD, RICHMOND | | F3 - Complete & Finalised | Some Finalisation has taken place | | |

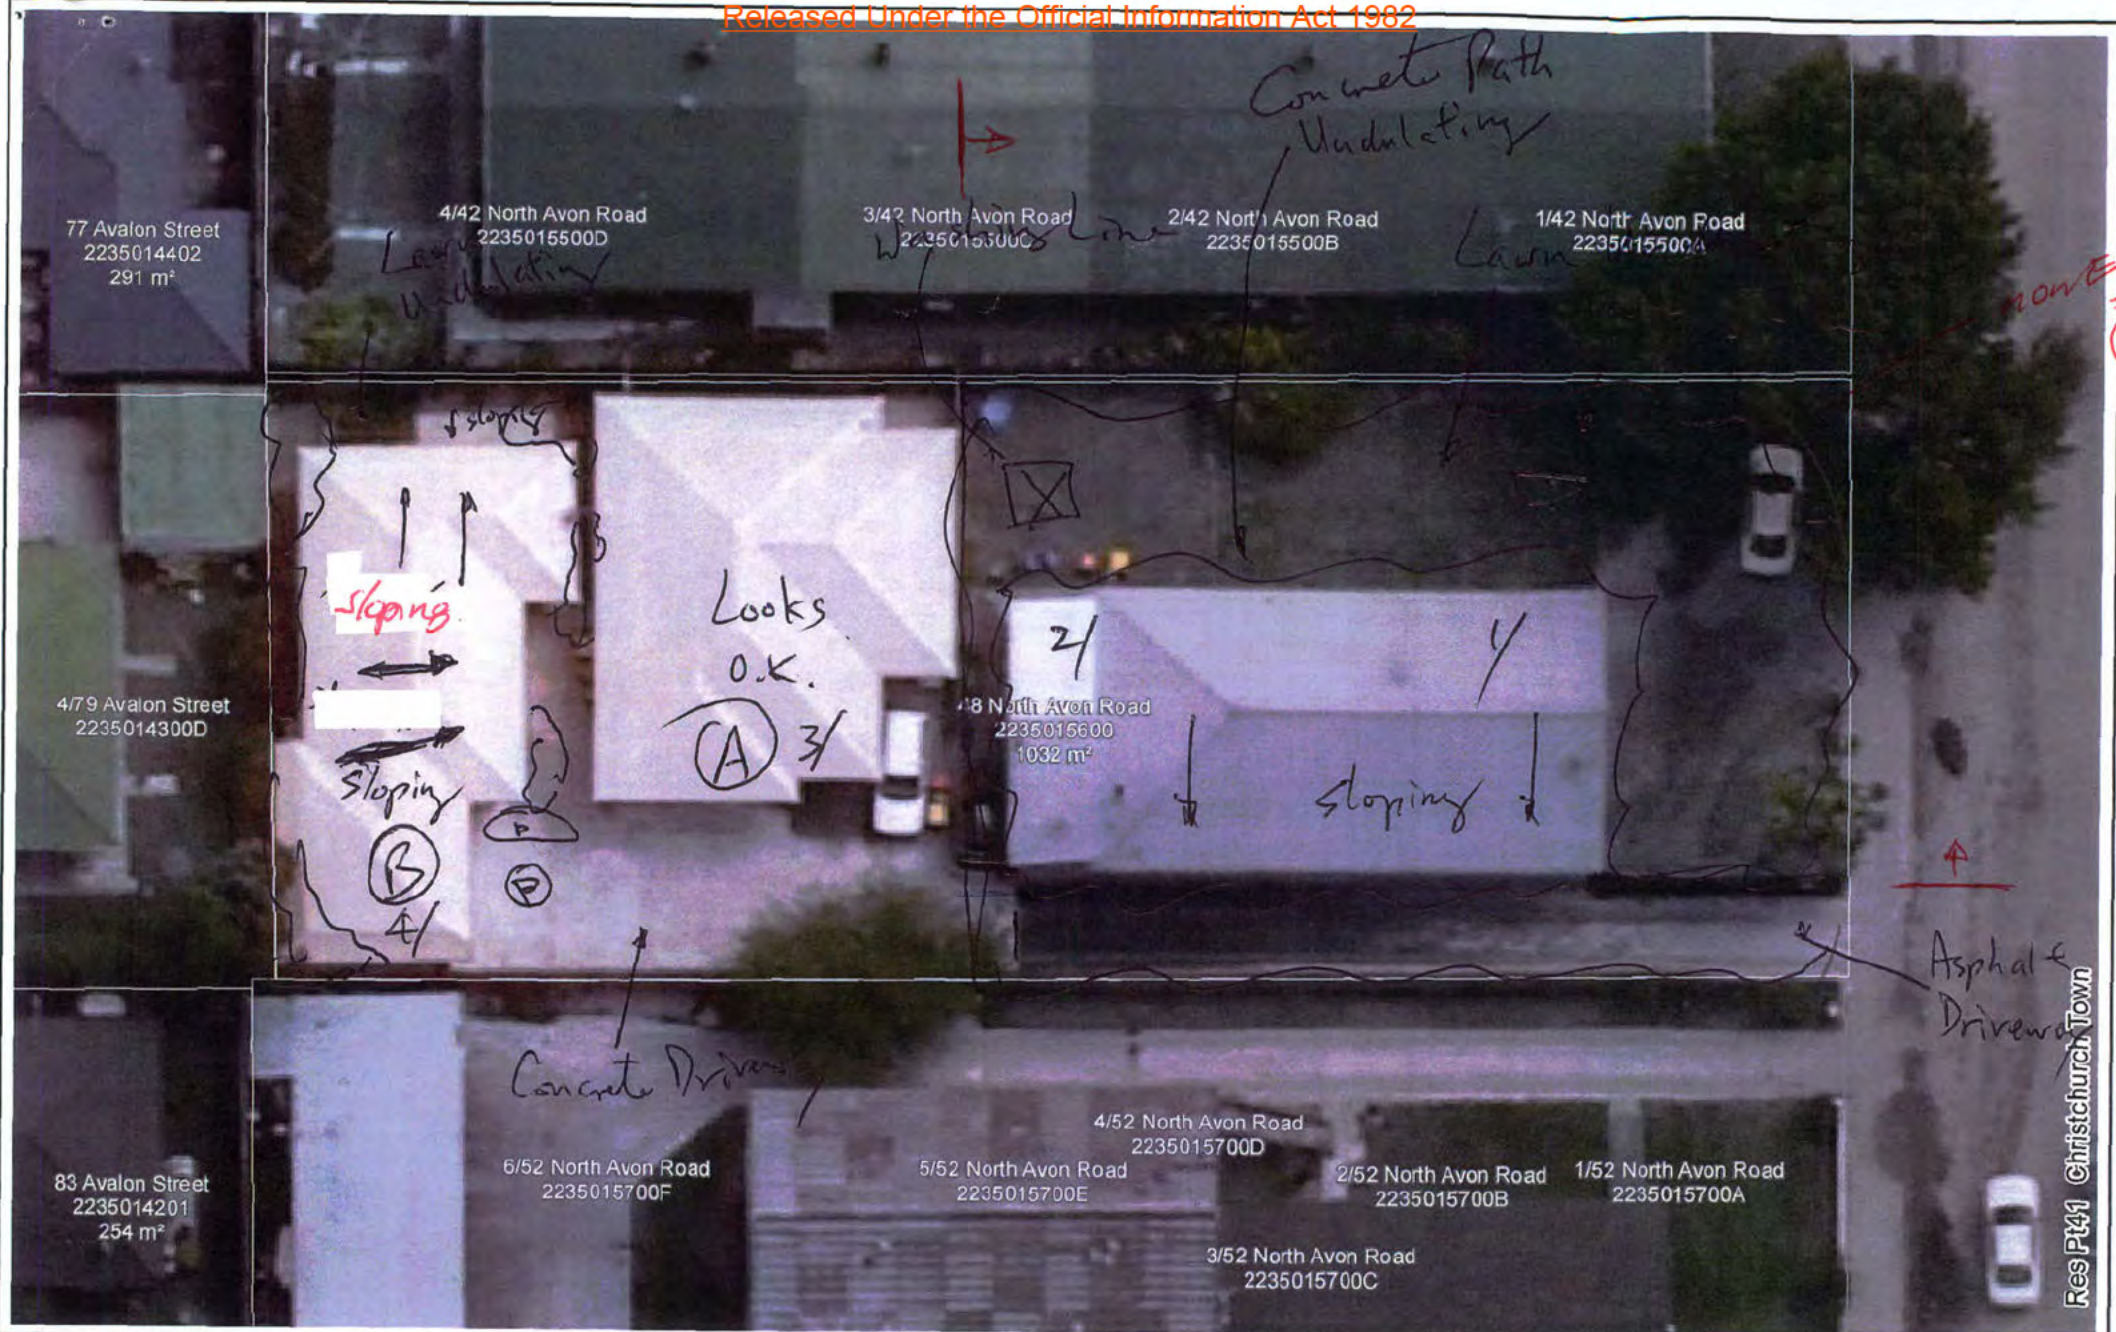
Notes: Ejected sand  
A4 SCALE 1:250 Ponding  
0 2 4 6 8 10 (m)

| <b>Remedial Option:</b><br>Description..... <i>Earthworks / releveling</i> | TBC<br>(excluding GST) |

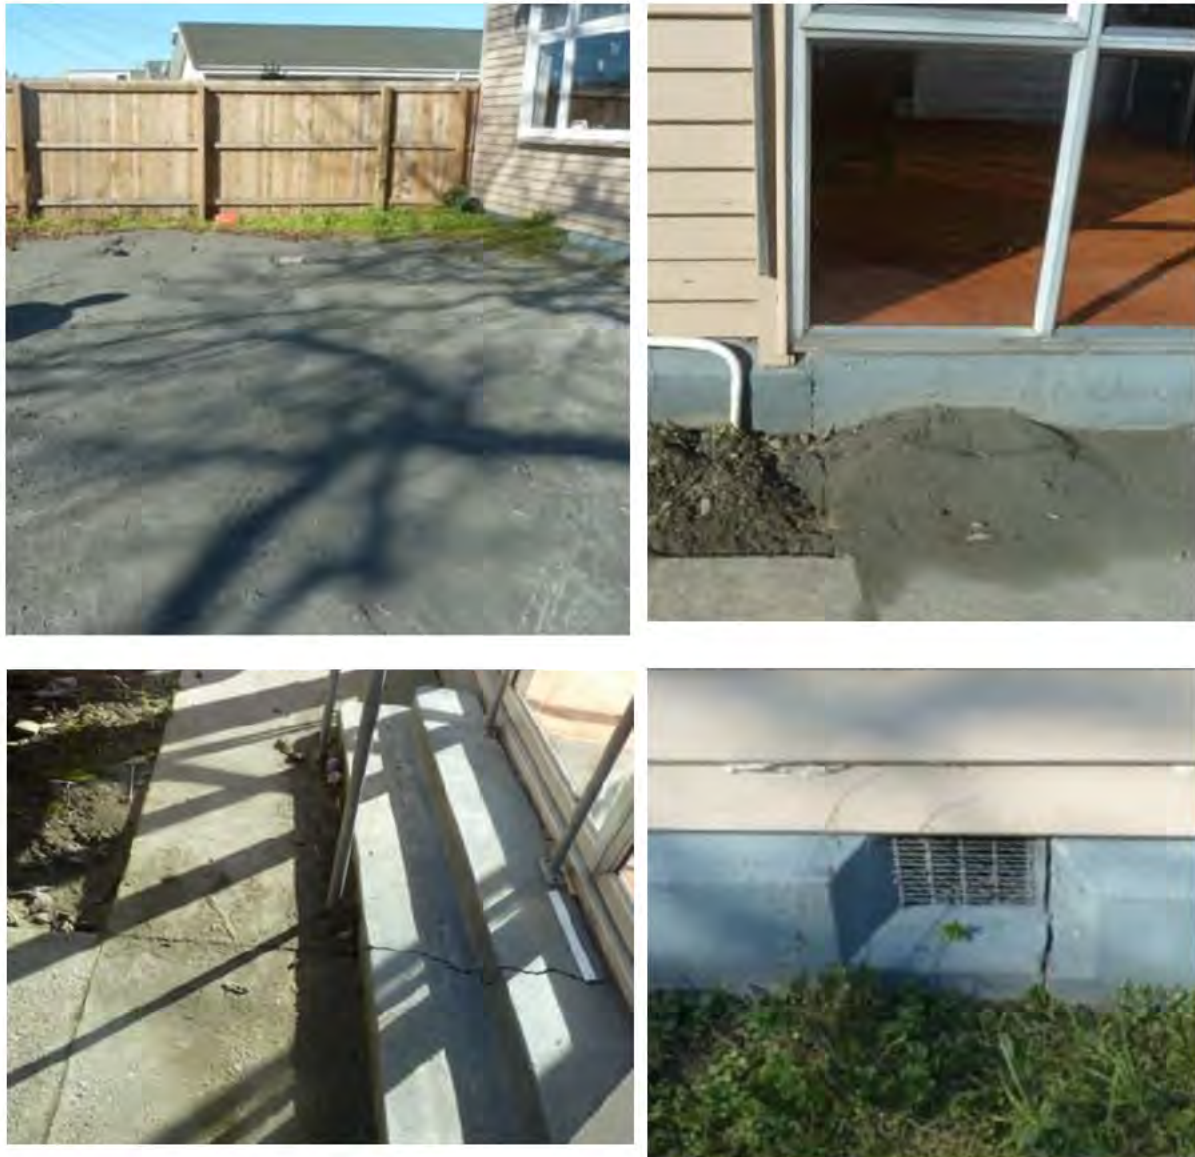
- [8] The land engineering report indicated liquefaction ejecta, ground undulations, and foundation damage were observed around the property as shown within Figure 2 and Figure 3.

*Figure 3 Sample photographs from EQC land team showing liquefaction ejecta around property and foundation damage*

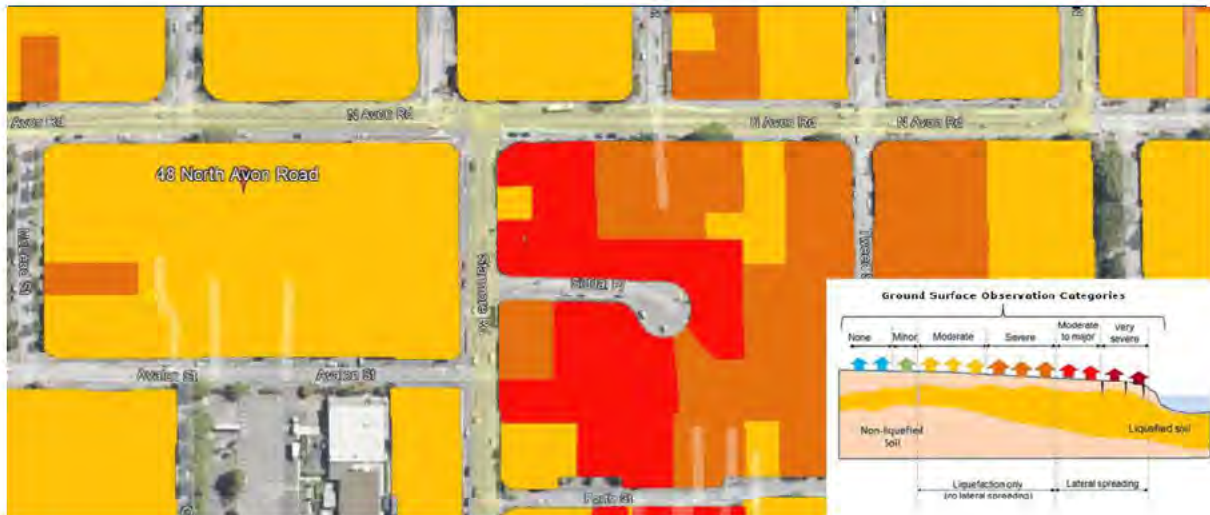
- [9] The NZGD EQC liquefaction and lateral spread observation map indicated that the observations of liquefaction ejecta were moderate after the February 2011 earthquake event.
- [10] The NZGD mapping indicated that the site experienced high peak ground accelerations in the order of 0.42g from the February 2011 earthquake event.

Figure 4 NZGD map of liquefaction ejecta observation category from February 2011 event

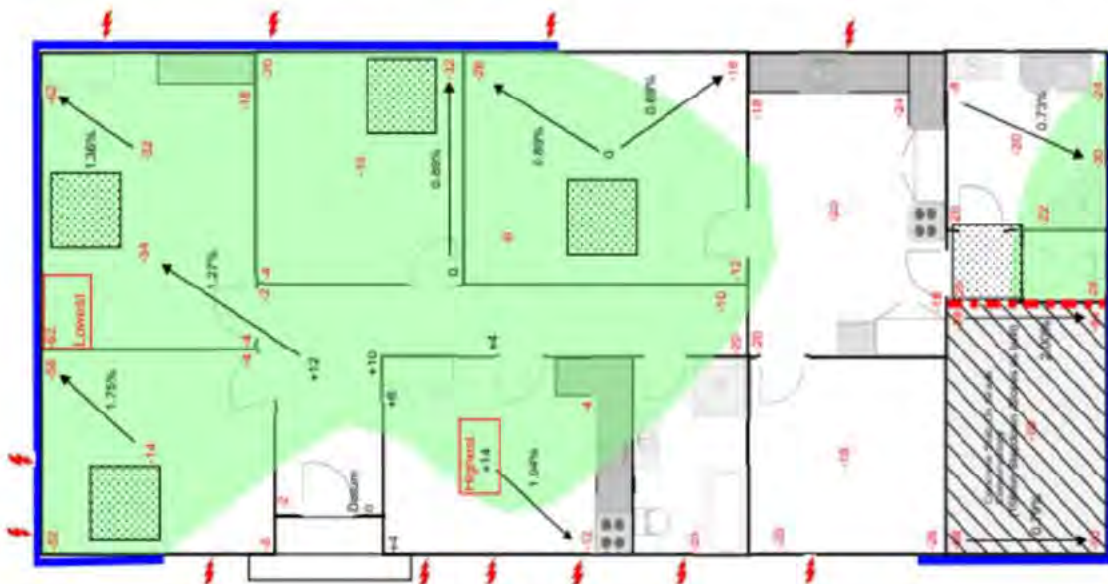
- [11] The assessment report included a desktop review of the claim documentation, a site visit, and a level survey.
- [12] The Precision Relevelling quote included a floor plan showing the extent of relevelling proposed (refer to Figure 5). The assessment report noted approximately 60% of the northern end and part of the south end was proposed to be relevelled.

Figure 5 Precision floor plan with foundation crack locations indicated

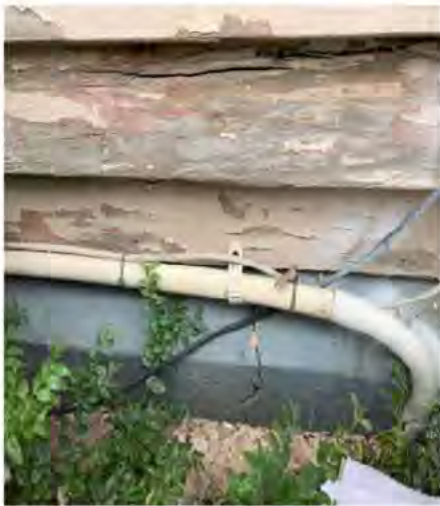
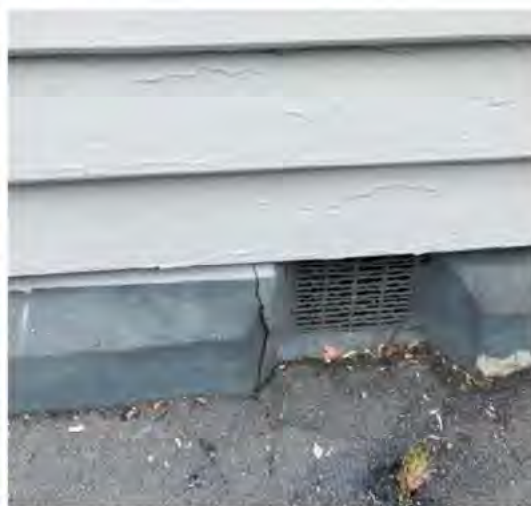
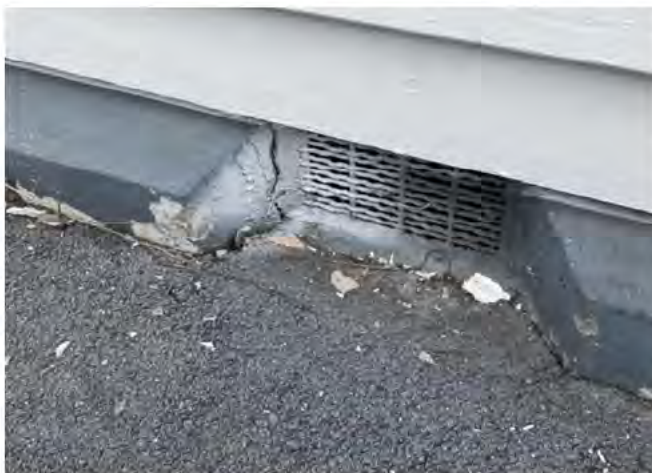
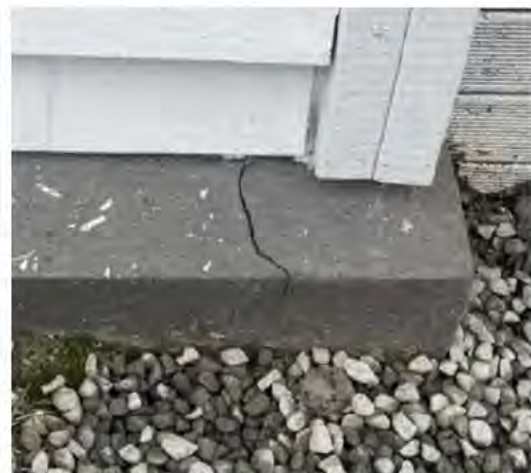
- [14] The assessment report noted that the amenities and linings within the house experienced earthquake damage. The exterior, kitchen and toilet door were originally scoped to be eased.
- [15] A later scope change removed easing of all three doors, and added easing of the lounge door on the north side of the house. The reason for removing door easing was not stated.
- [16] The report assessor conducted a site visit and noted that the house has been renovated extensively, masking or removing damage indicators.
- [17] The assessment report indicated that the weatherboards were original, and are sloping towards the north elevation which reflected the floor level trend.
- [18] The assessment report noted foundation cracks around the house, and indicated that there was evidence of cracks caused by the Canterbury Earthquake Sequence (CES), and also cracks that pre-date the CES.

*Figure 6 Sample of new foundation cracks*

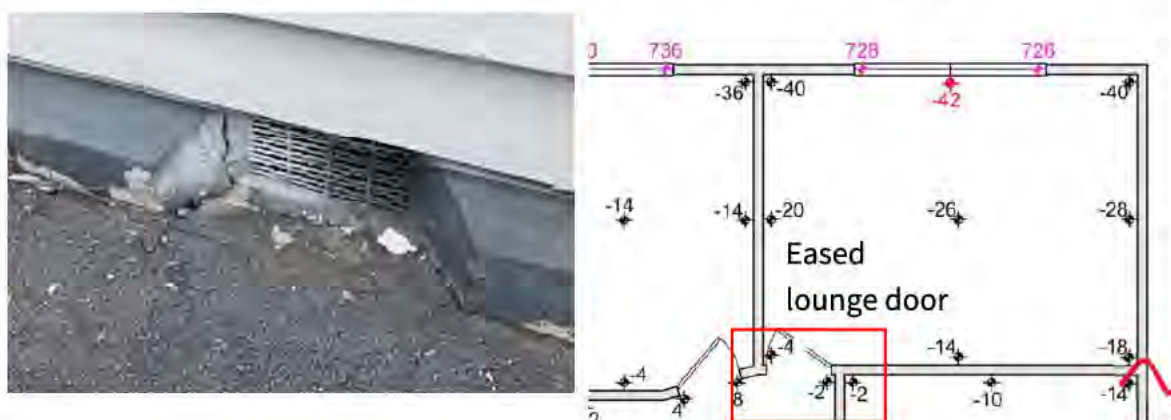
- [20] The homeowner engaged NHC with regards to floor dislevelment that they believed was earthquake related damage, and provided a quote from a levelling specialist to remediate. An NHC internal Technical Specialists reviewed the earthquake damage indicators and provided a report documenting the visual damage and claim documentation damage indicators.
- [21] The floor level survey conducted by NHC shows a level variation of 54mm with large slopes falling towards the north elevation. The survey shows that the floor, ceiling, and windowsills follow the same trend.
- [22] The house was in a repaired state which masked damage indicators but, the concrete perimeter foundation was left unrepaired. The perimeter foundation photographs show new foundation cracks, and cracks that align with hinge points in the foundation with floor level changes (refer to Figure 7 for sample).

Figure 7 New foundation crack coincides with hinge point in floor levels. Red marker indicates crack location.
