# COMPLETION REVIEW ENGINEERS REPORT 48 NORTH AVON ROAD, CHRISTCHURCH

Ref 260712 REV1

Date: 2/8/2026

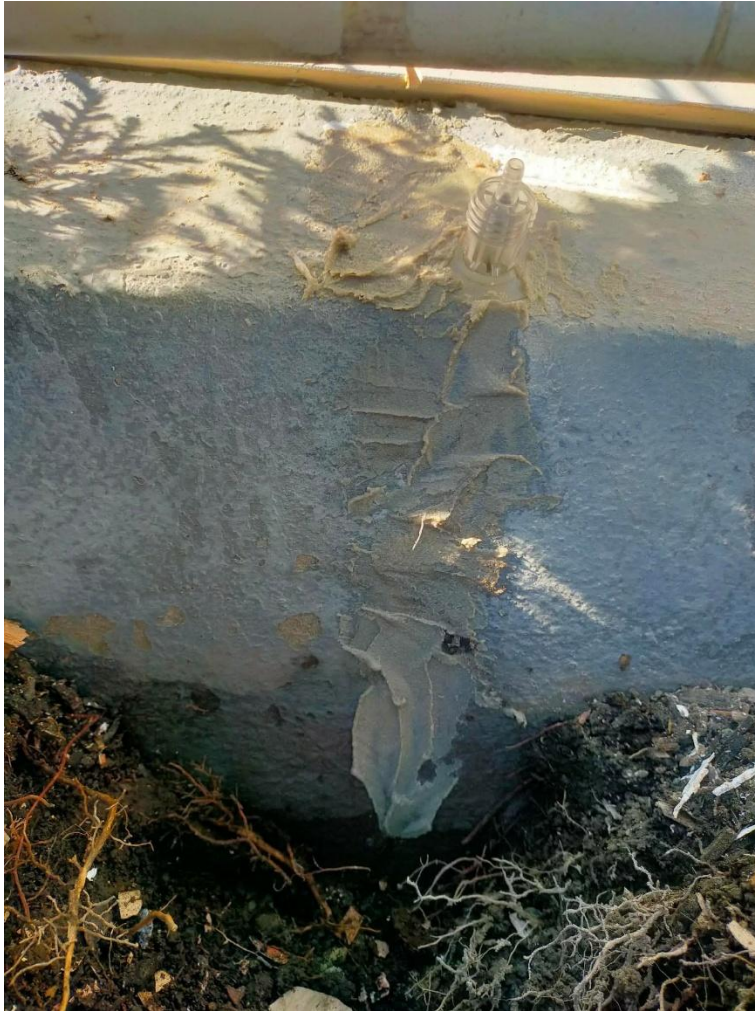
Epoxy Repair to ring beam crack

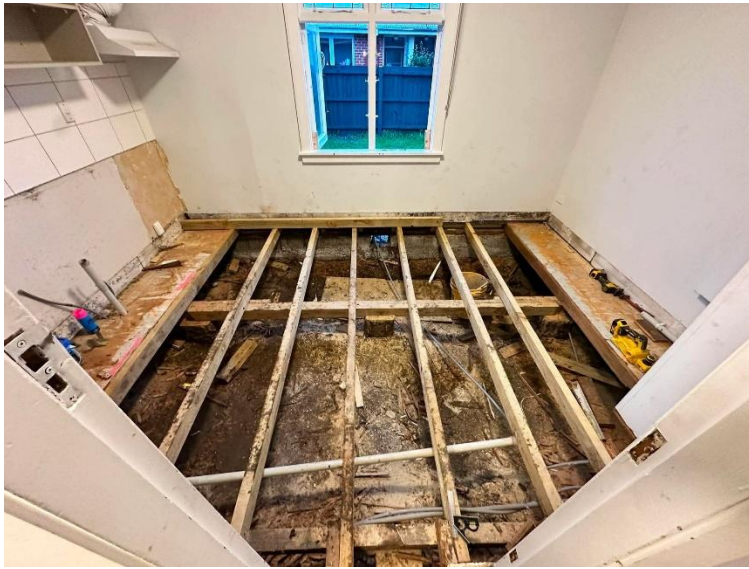
Ground level too close to floor – damaged joists replaced floor level adjusted to level

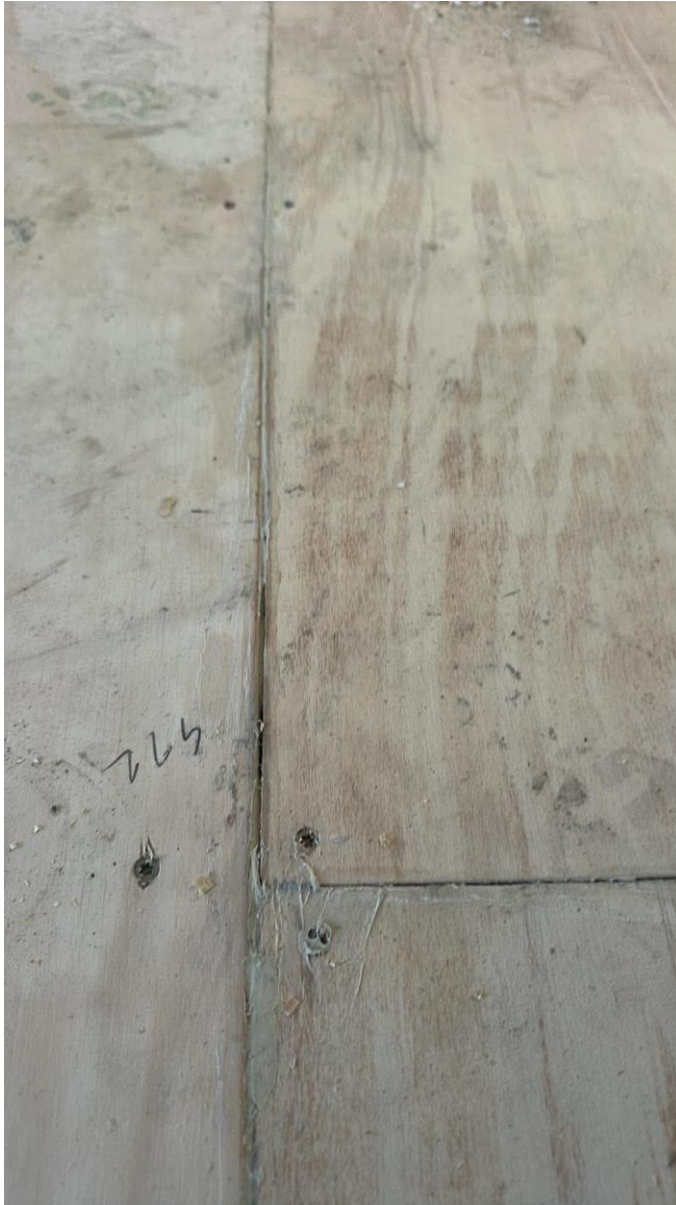
Sealed floor – minor gaps in floor sheet sealed.

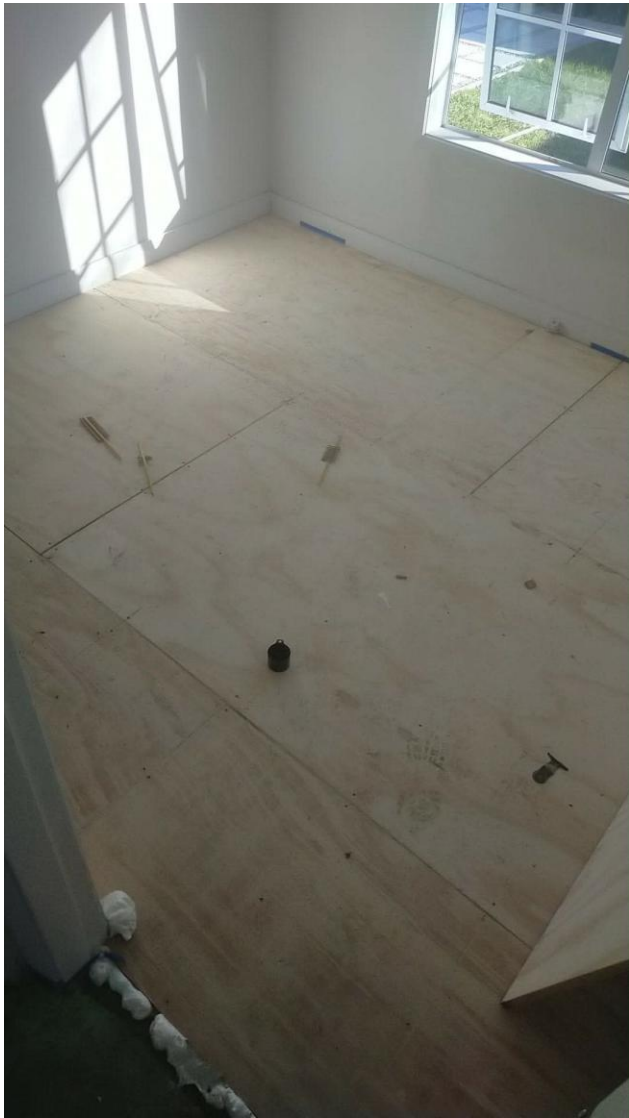
Completed floor

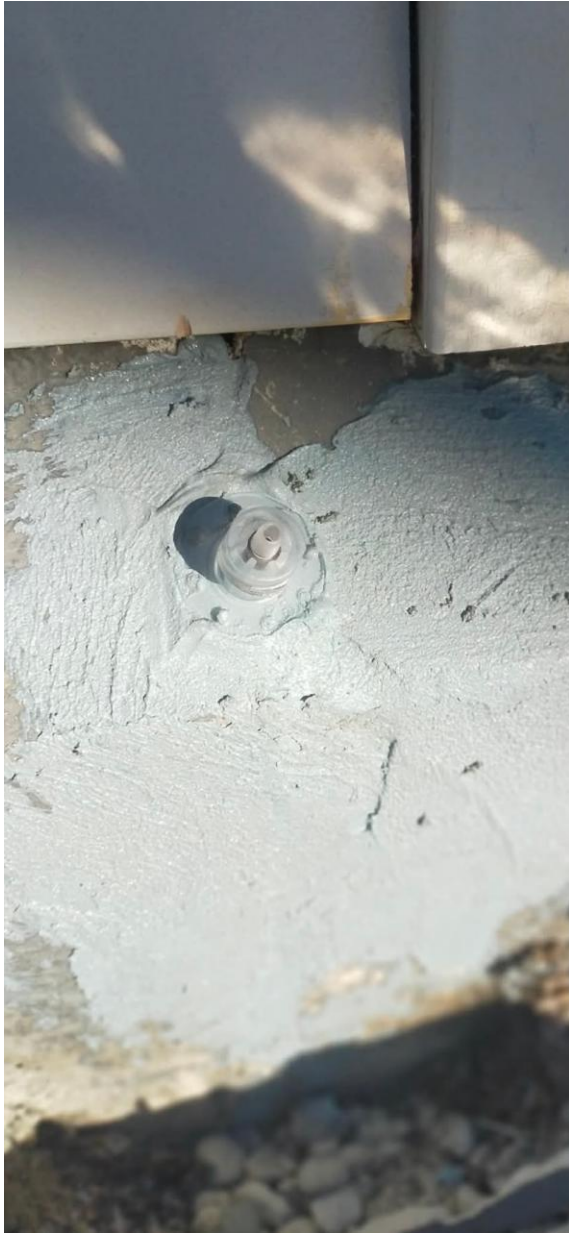
Nipple for epoxy injection (cracks to ring beam)

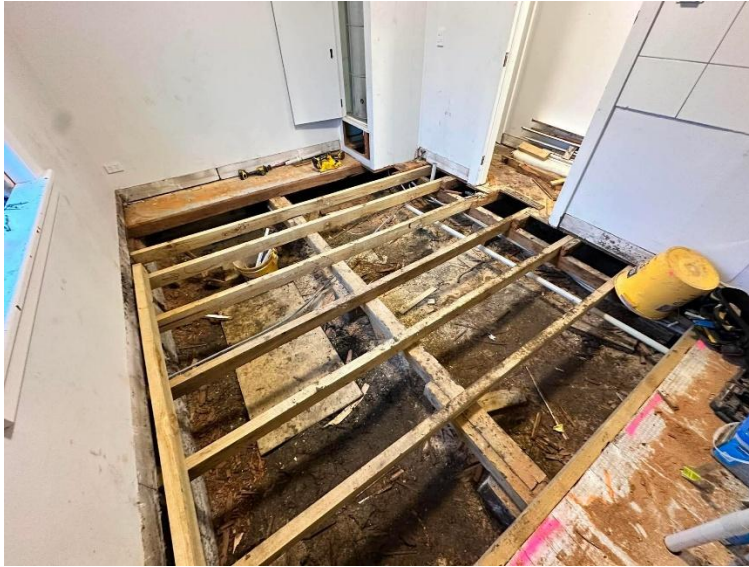
Typical under floor

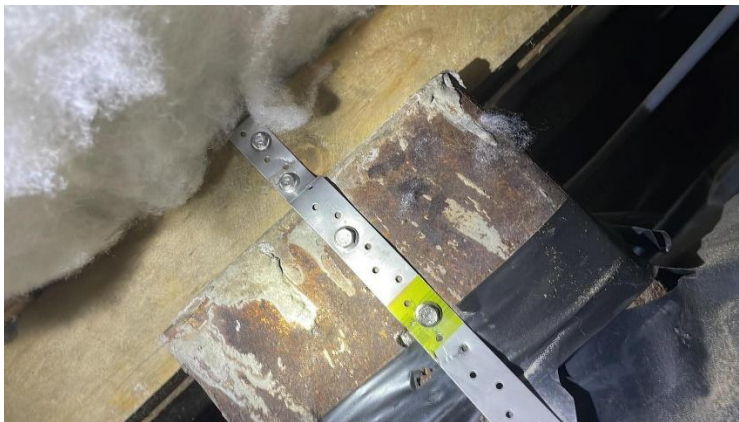
Stainless steel strap to existing "kerosene tin" Pile typical of age of house

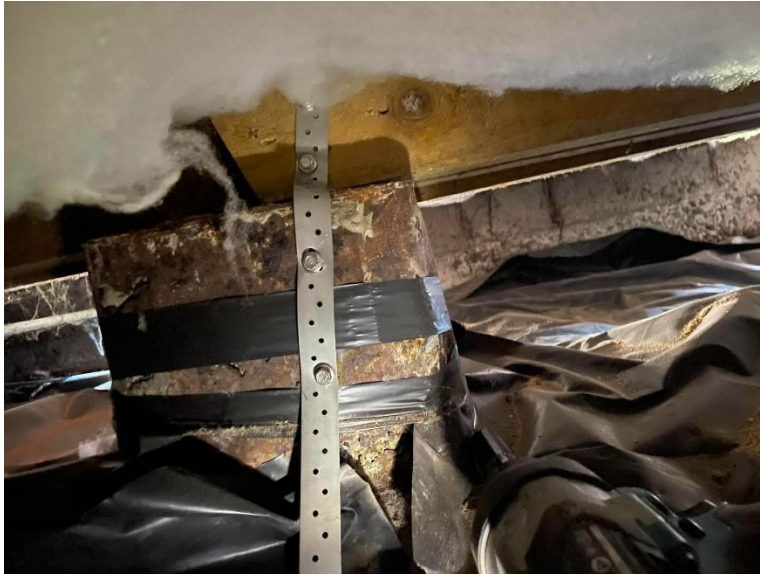
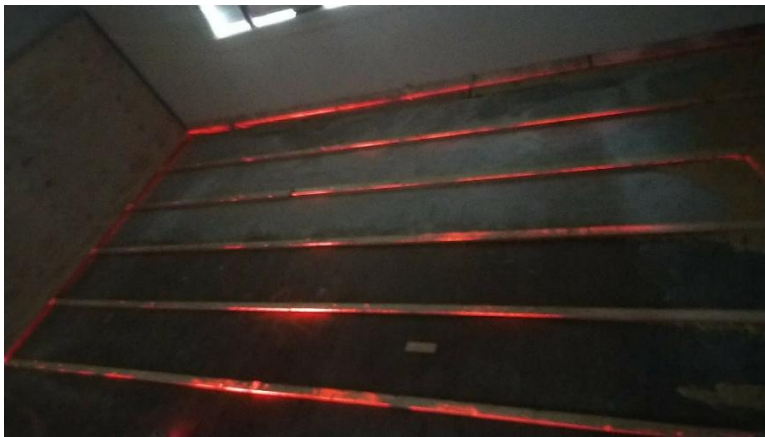
Laser over floor to demonstrate level
