# Inspection Report

## Certified Building Inspection Services

**9 Michael St, Cardiff, NSW, 2285**

### Pest And Building Inspection

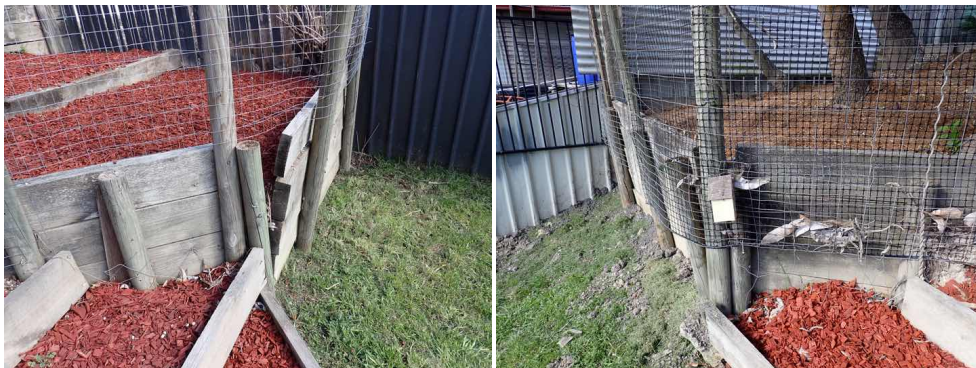
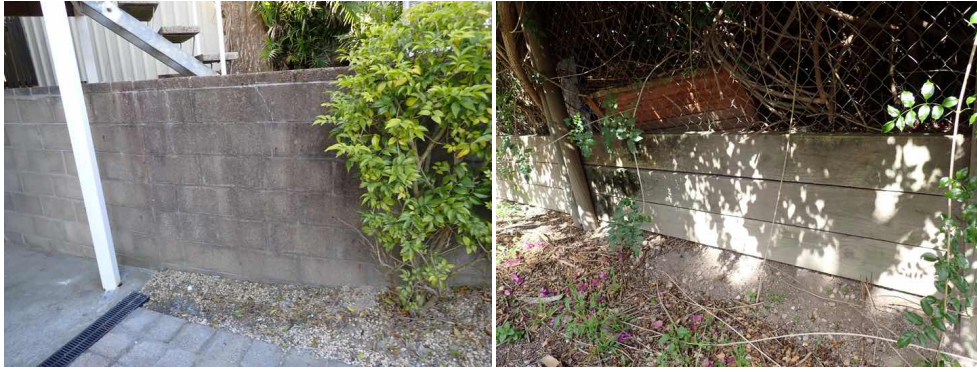
Timber Retaining wall leaning due to deterioration and age. Recommendations: A qualified landscaper should be engaged for advice and recommendations.

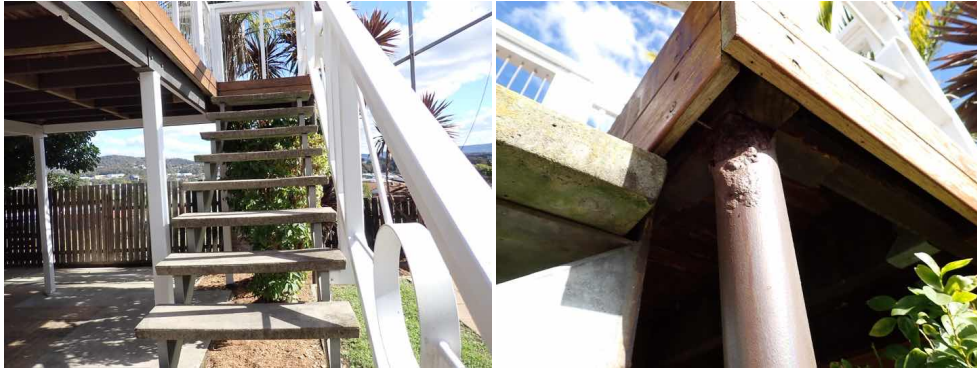
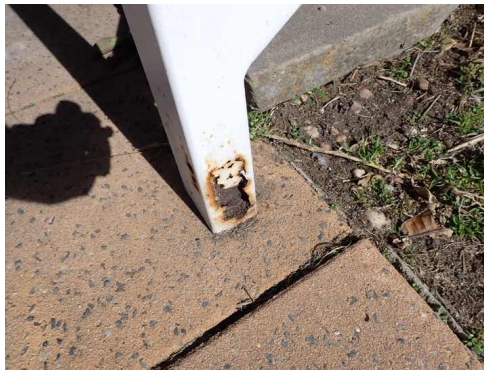
Rust in sections of framing - Recommendations: A qualified carpenter should be engaged for advice and recommendations.

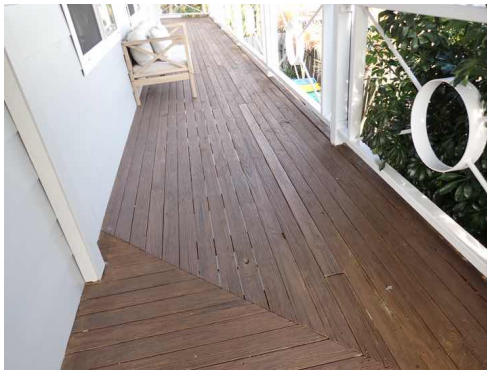
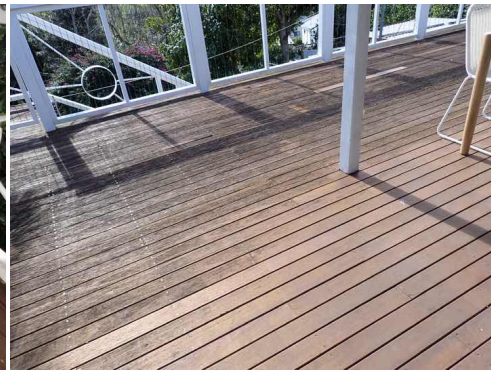
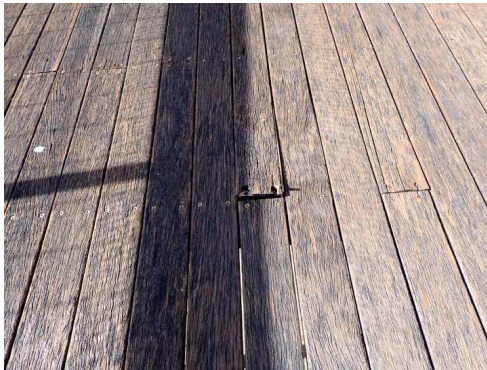
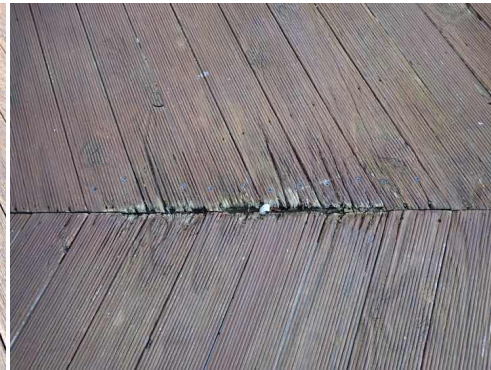
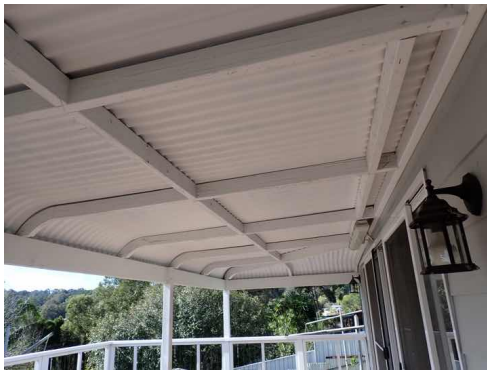
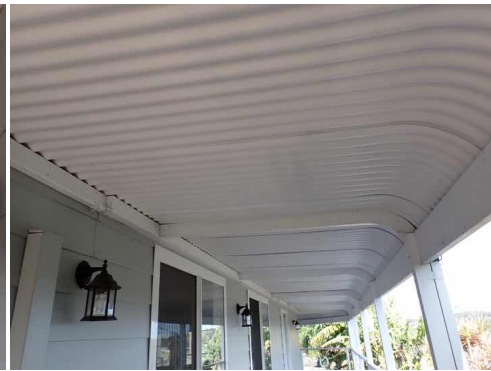
Timber fungal decay in section of the frame and posts. Recommendations: A qualified carpenter should be engaged to replace all affected timbers.

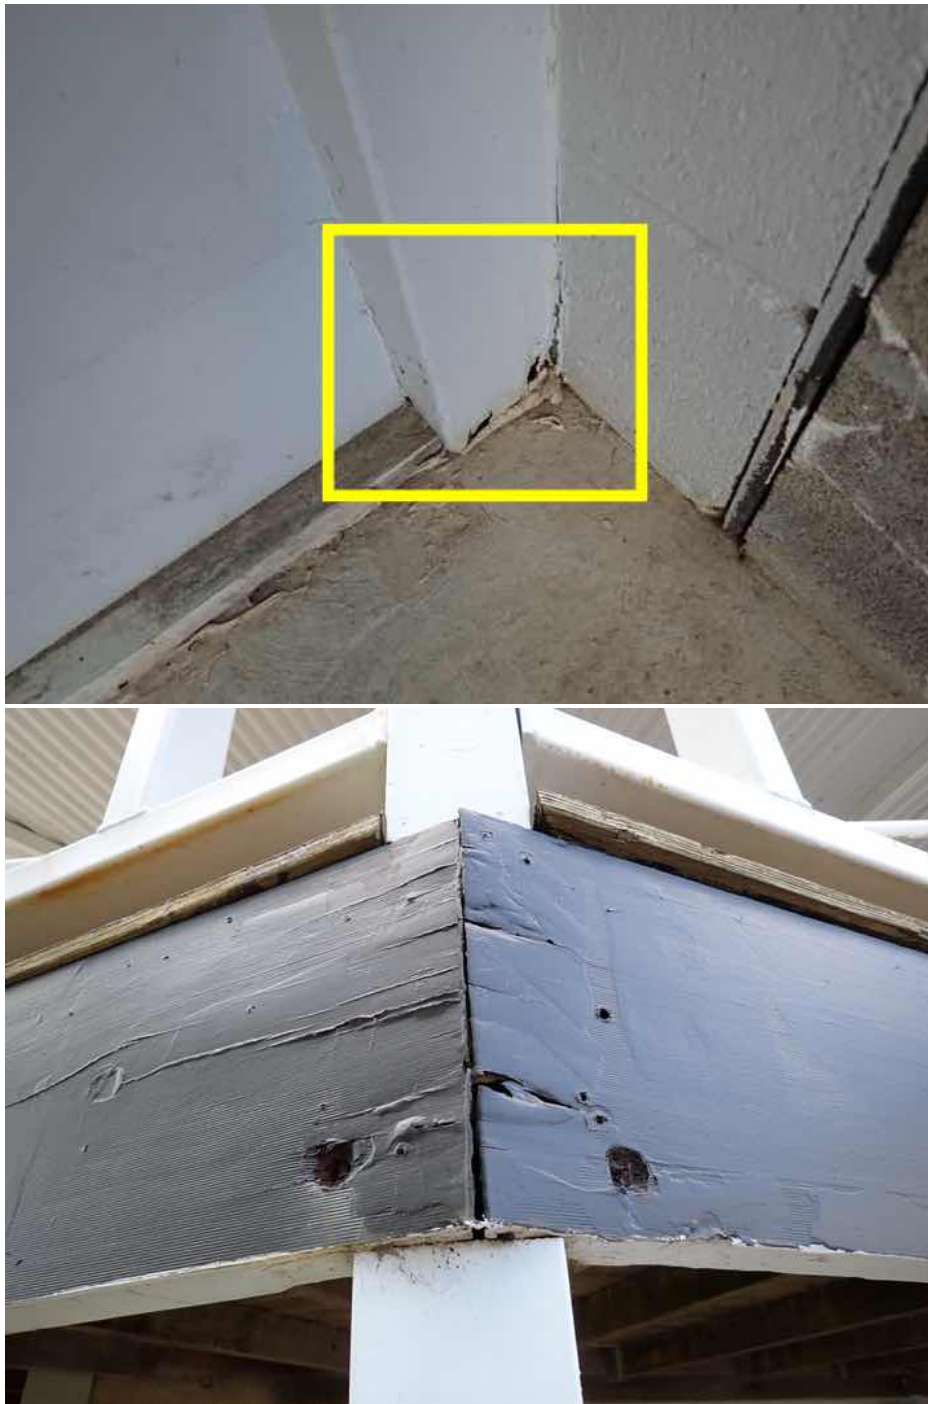
Moisture damage was observed on deck boards - Recommendations: Evaluation and repairs by a qualified decking contractor.

Deck board have been laid upside down which was common some time back for grip reasons. As is, the grooved face will expedite rot due to water in the grooves. Recommendations: Upkeep / maintenance or turning.

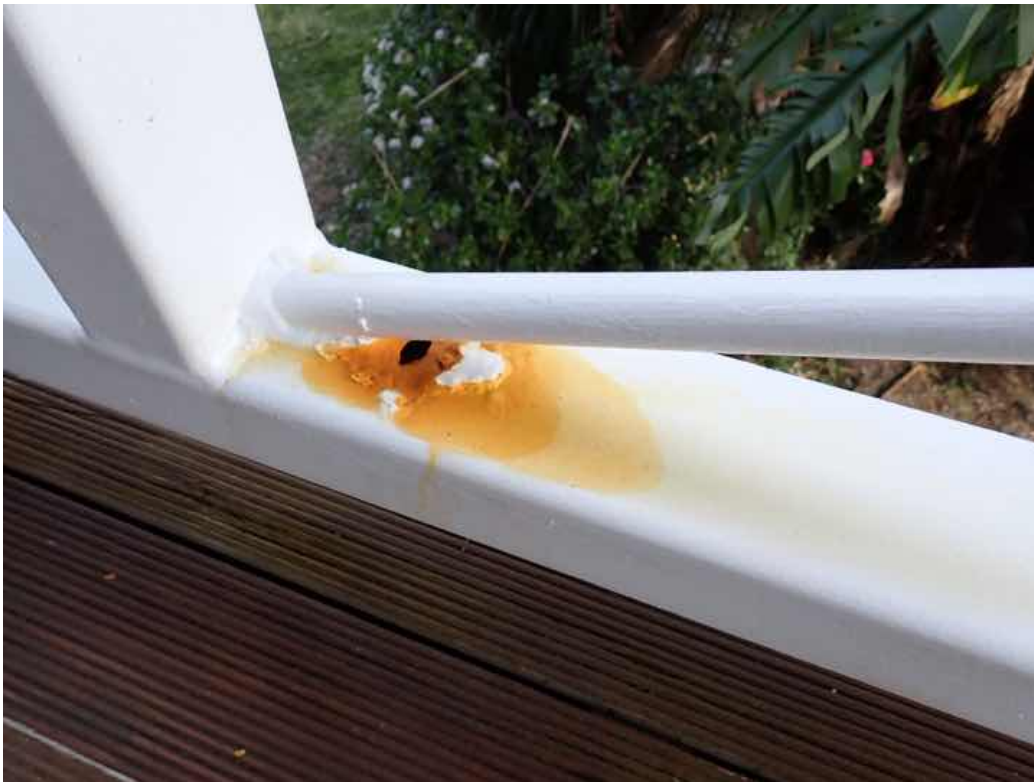
Rust present in balustrade/railing. Recommendations: Have assessed by contractor with view of restricting/repairing and sealing affected areas.

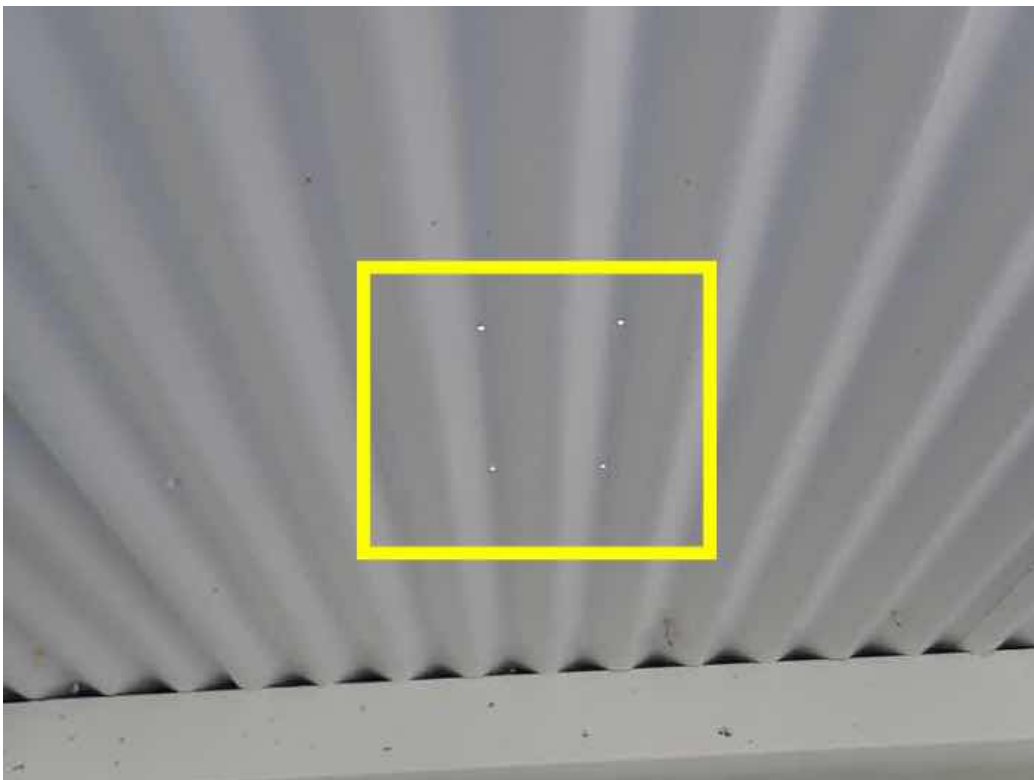
Holes noted in roof cladding - recommendations: Repairs as required.

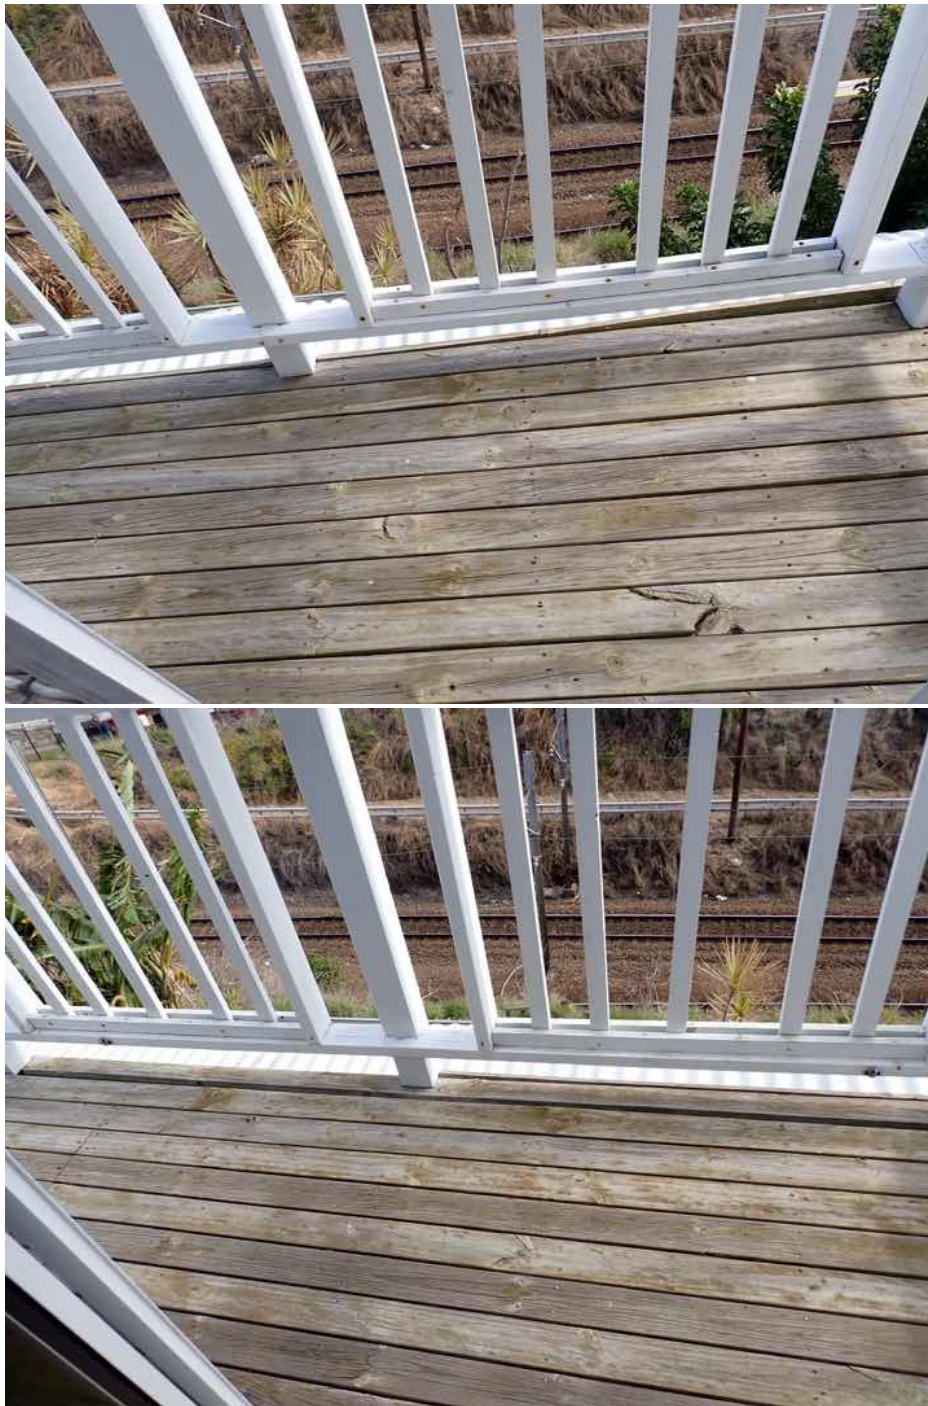
Decking boards are weathered

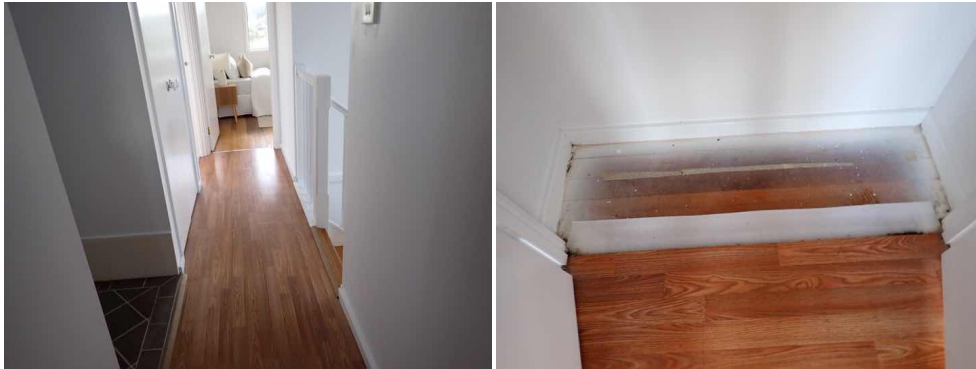
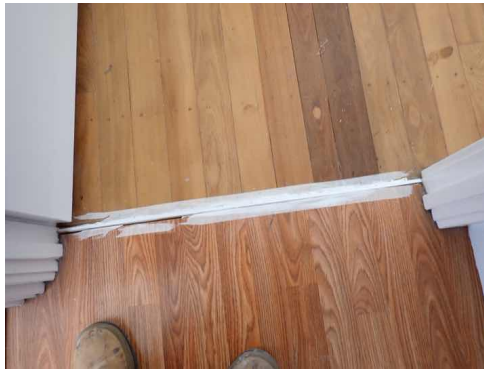
Incomplete flooring noted. Repairs required

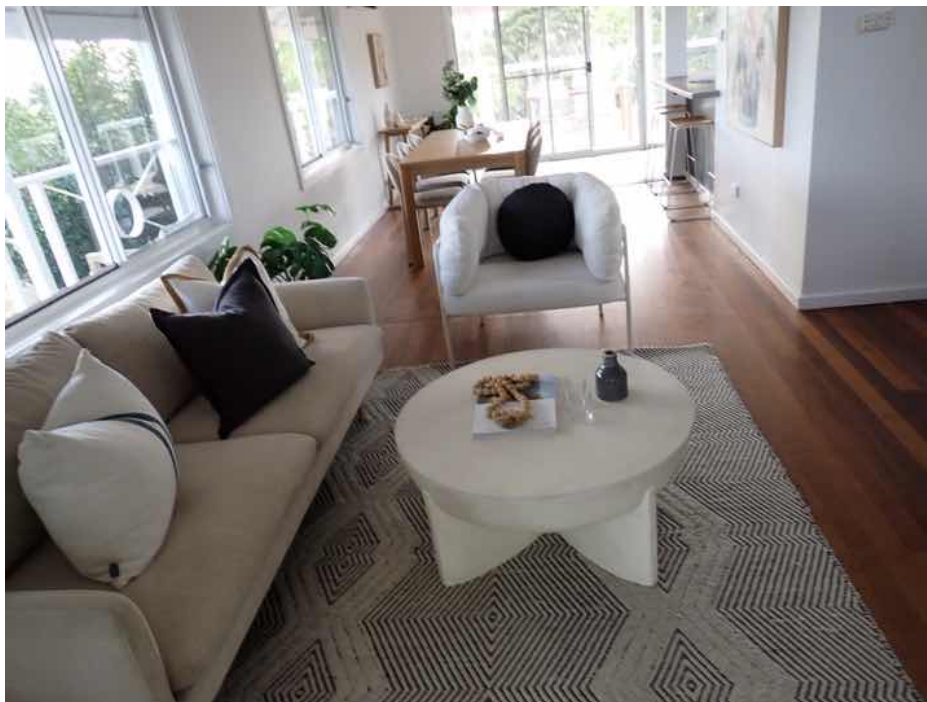
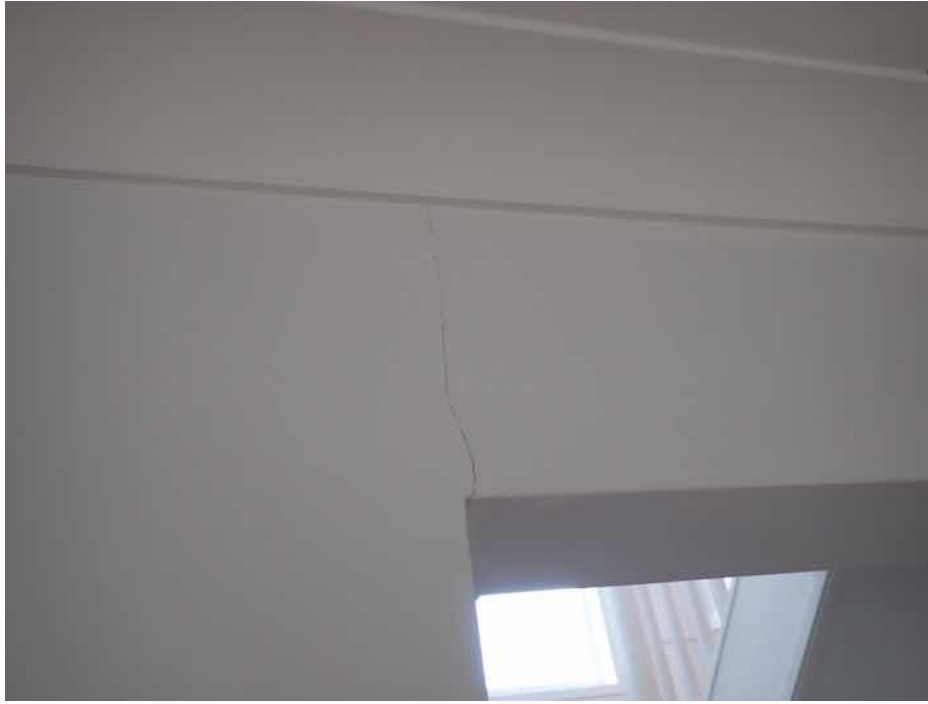
Settlement Cracks Noted. These are typical and generally patch and paint will suffice, however we recommend monitor these cracks and if become wider or longer, you will need to contact a structural engineers to assess.

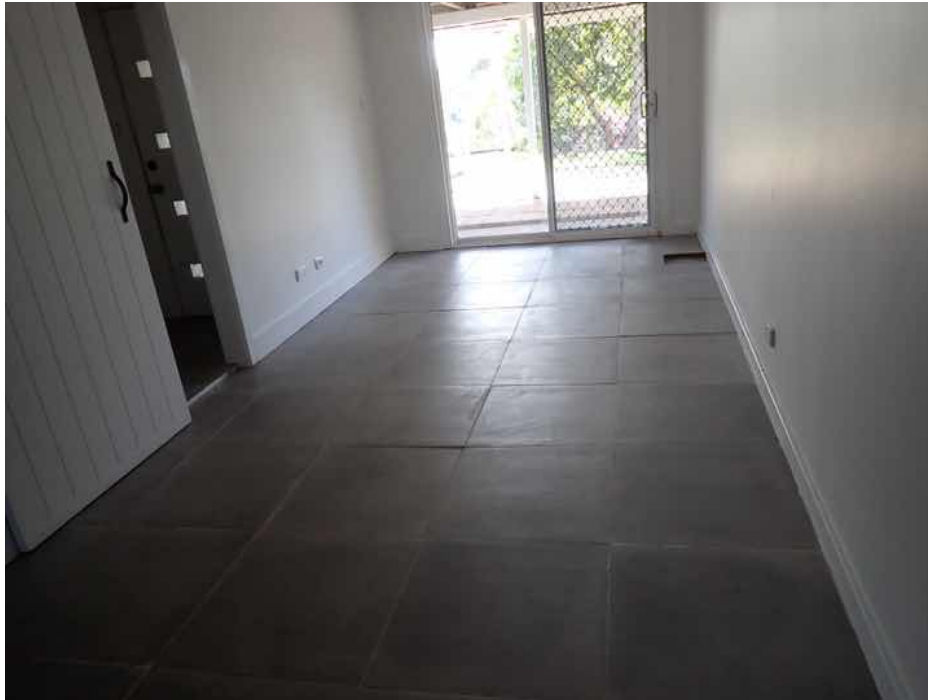
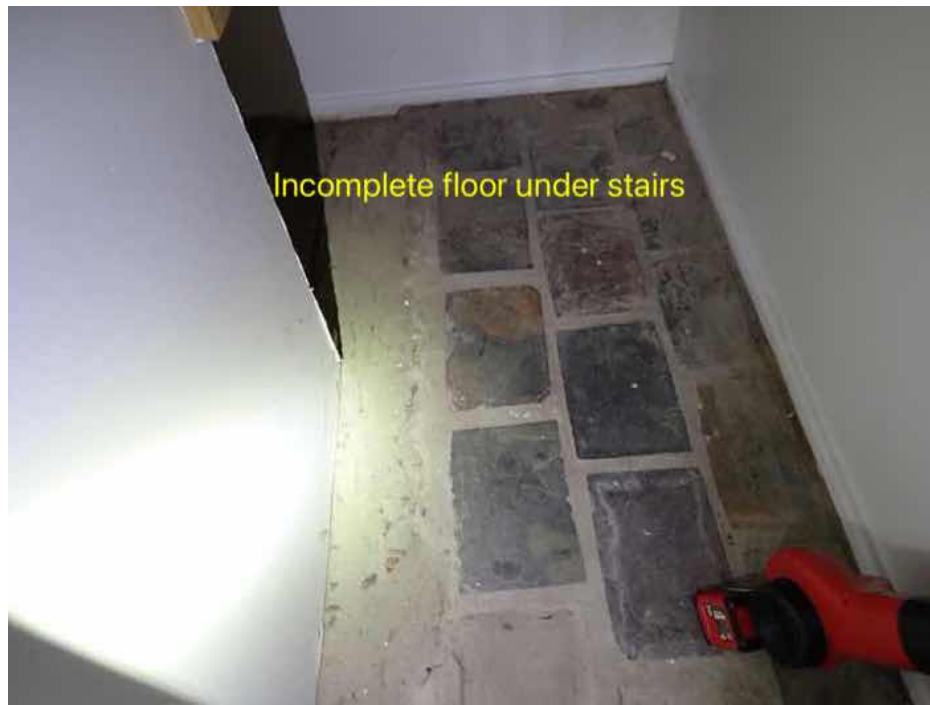
Drummy / loose tiles observed. Tile lift and further deterioration likely. tiles not laid to a tradesman standard. Contact a licensed tiler for repairs.

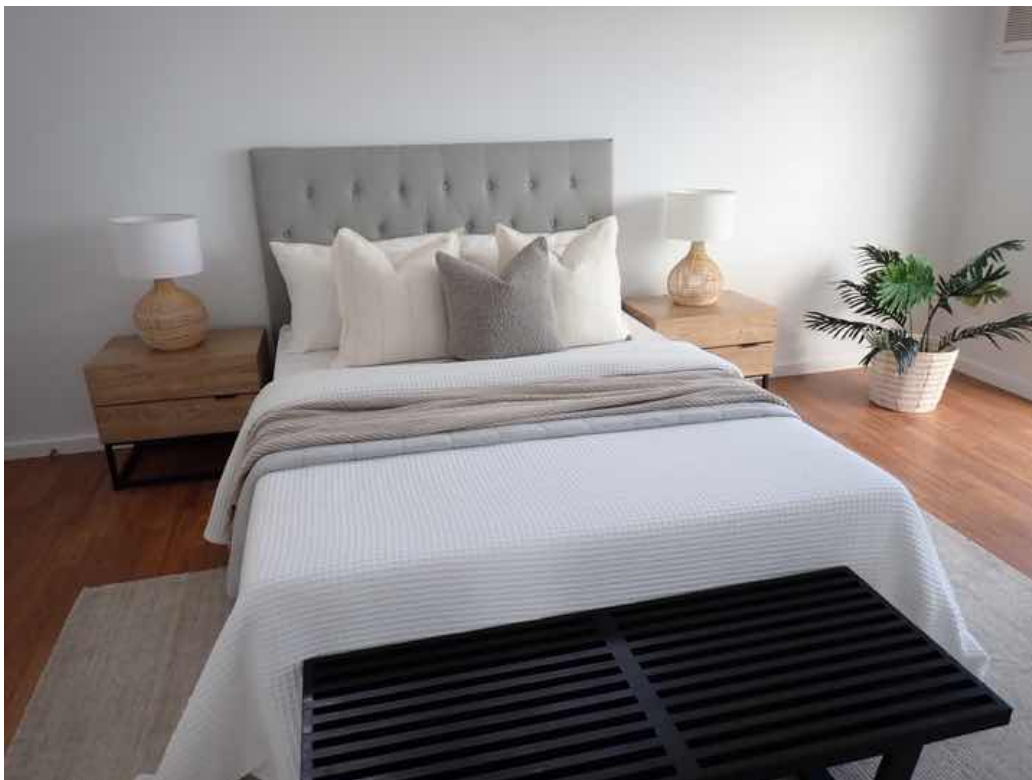
General deterioration near the door

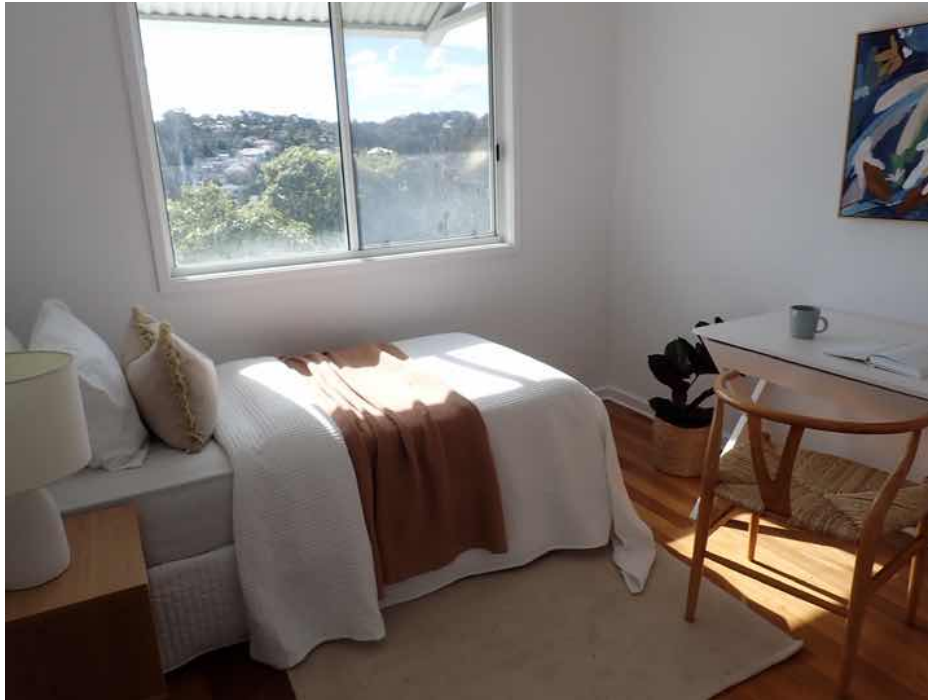
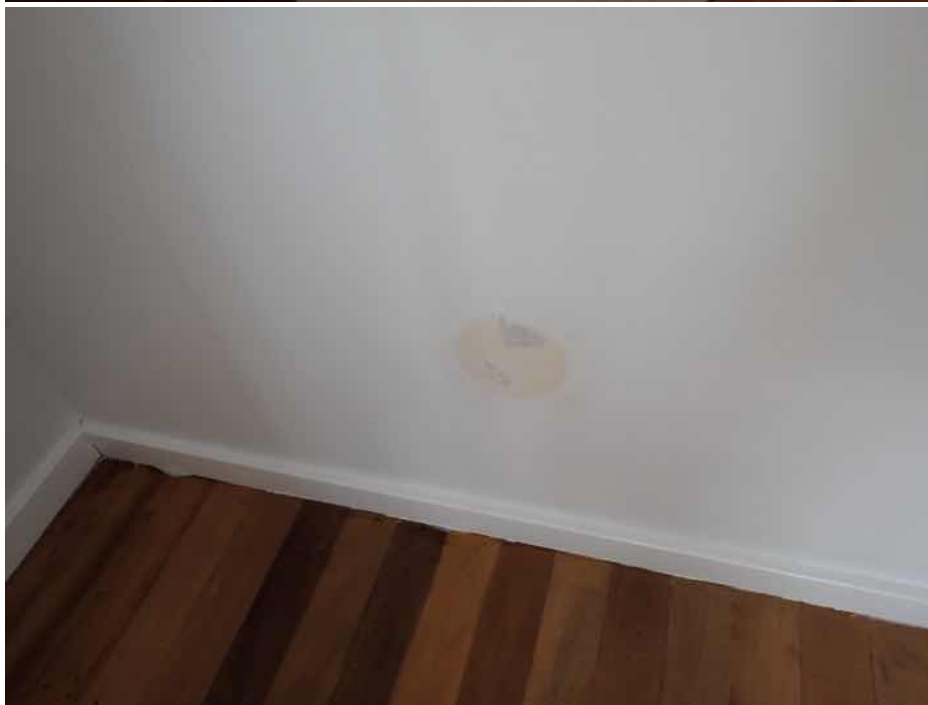
Incomplete Patch/Paint repairs noted. Call a licensed painter for repairs

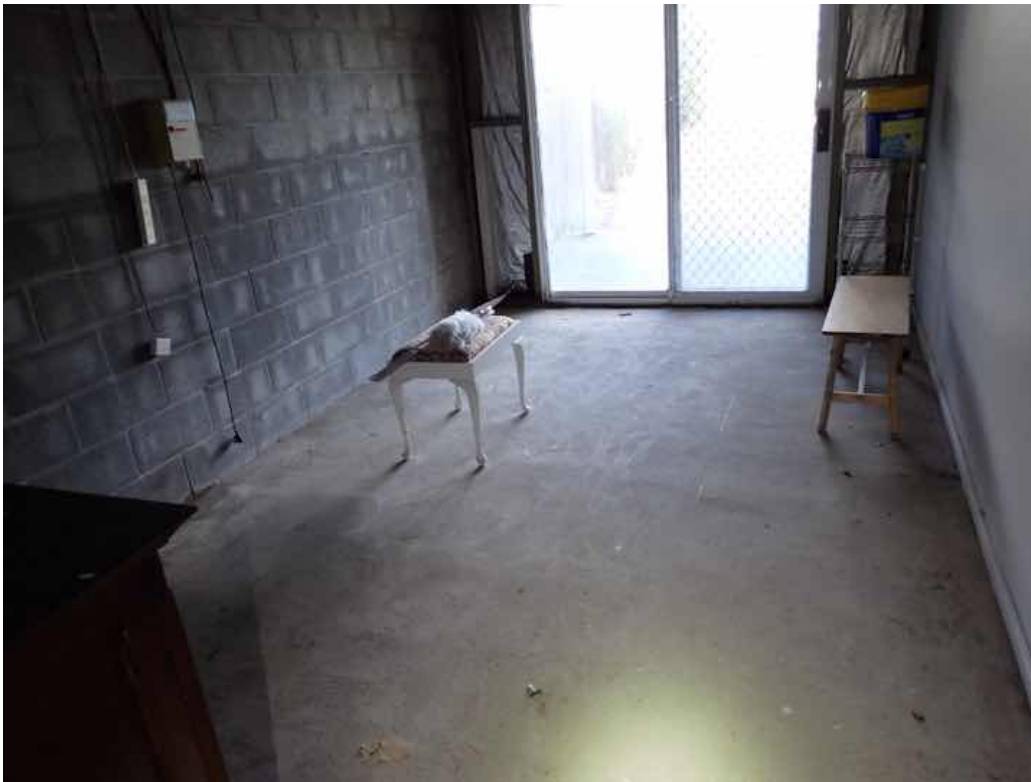
Previous water damage noted to wall sections. No moisture present now. This will have to be monitored in heavy rain. Contact a drainage plumber if seepage is noted

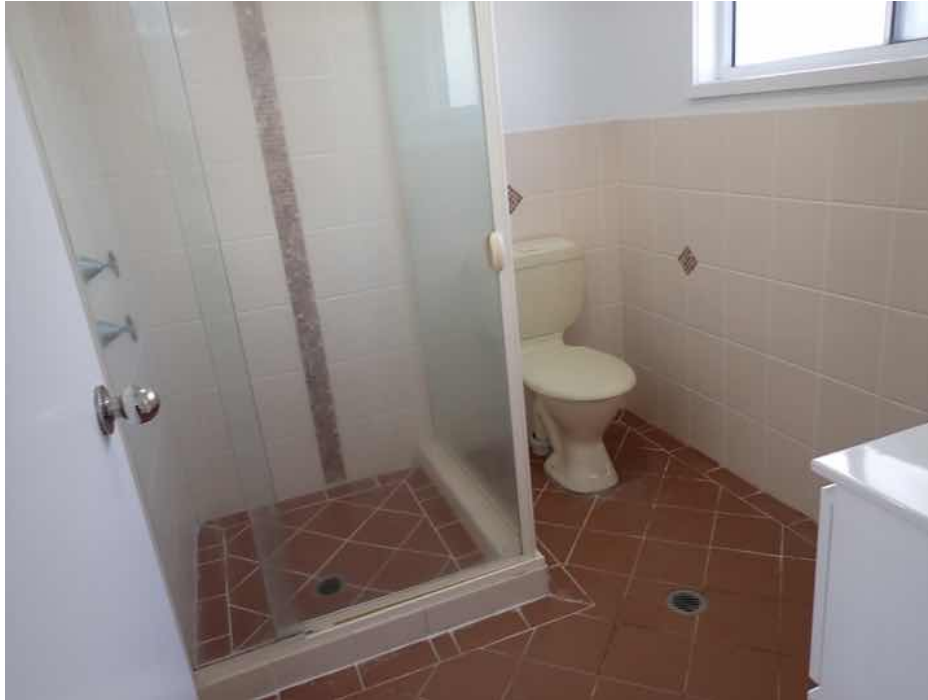
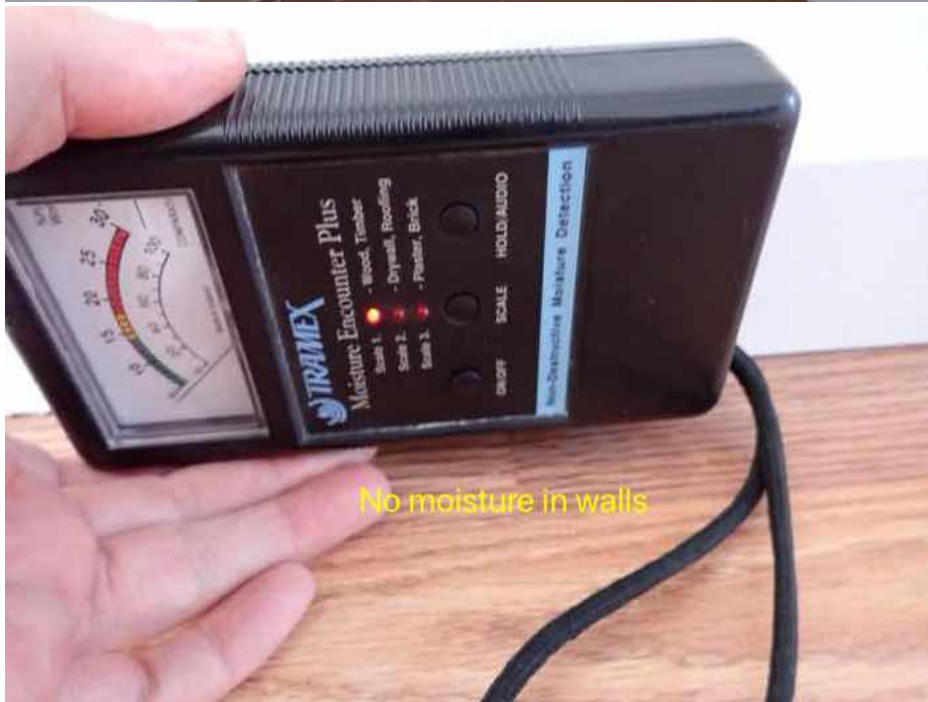
Cracked tile/s noted.. A qualified tiler should be engaged for advice and recommendations.

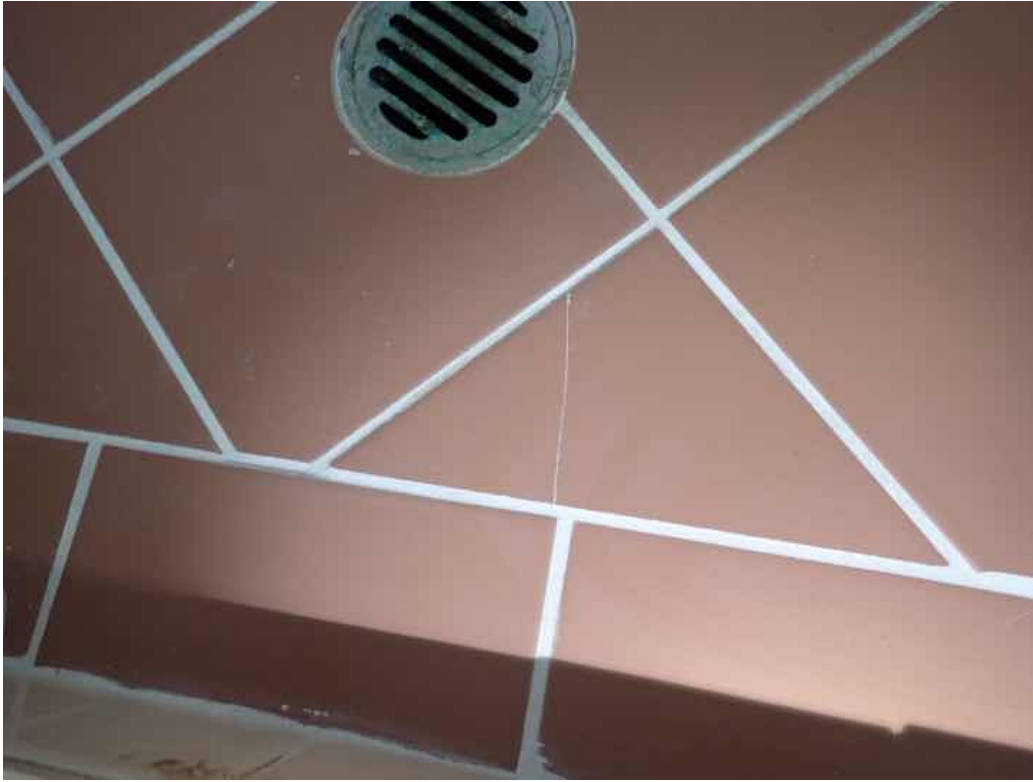
The shower screen door requires adjustment, maintenance or repair to operate properly.

Cracked tiles. Currently not causing any leaks but this should be repaired at the earliest as this has the potential to lead to many related issues such as damp, water ingress to other areas. Contact a licensed tiler for repairs and recommendation

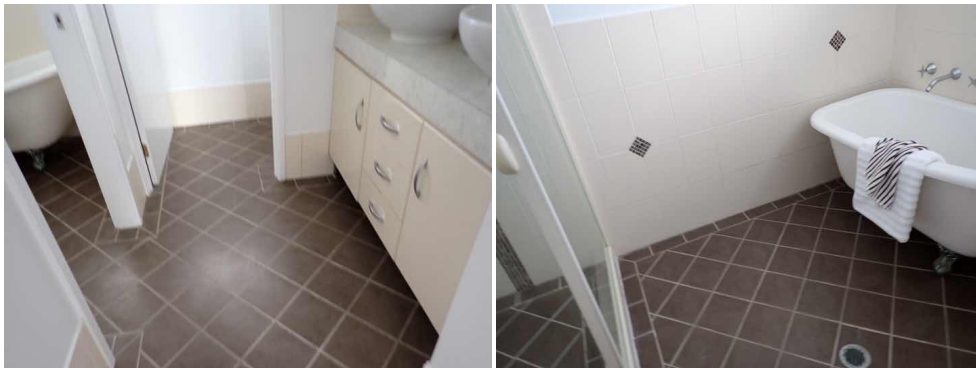
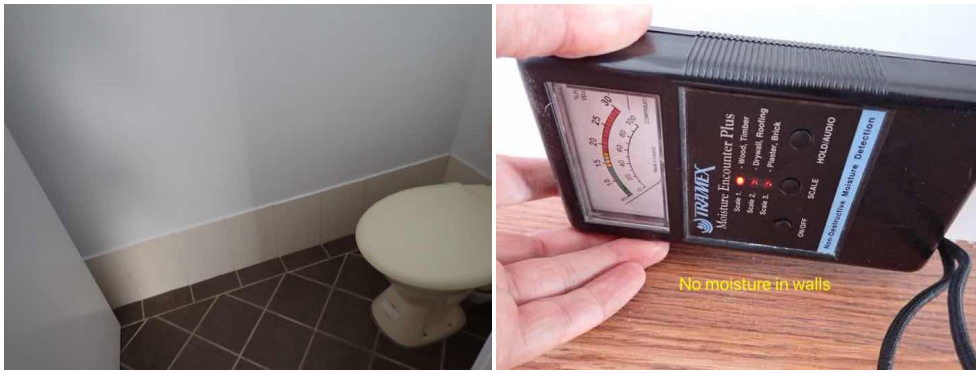
Taps at one sink not working . A qualified plumber should be engaged for repairs.

The trap under the sink is leaking. A qualified plumber should be engaged for advice and recommendations.

Deterioration and wear to sink, cupboards and benches.

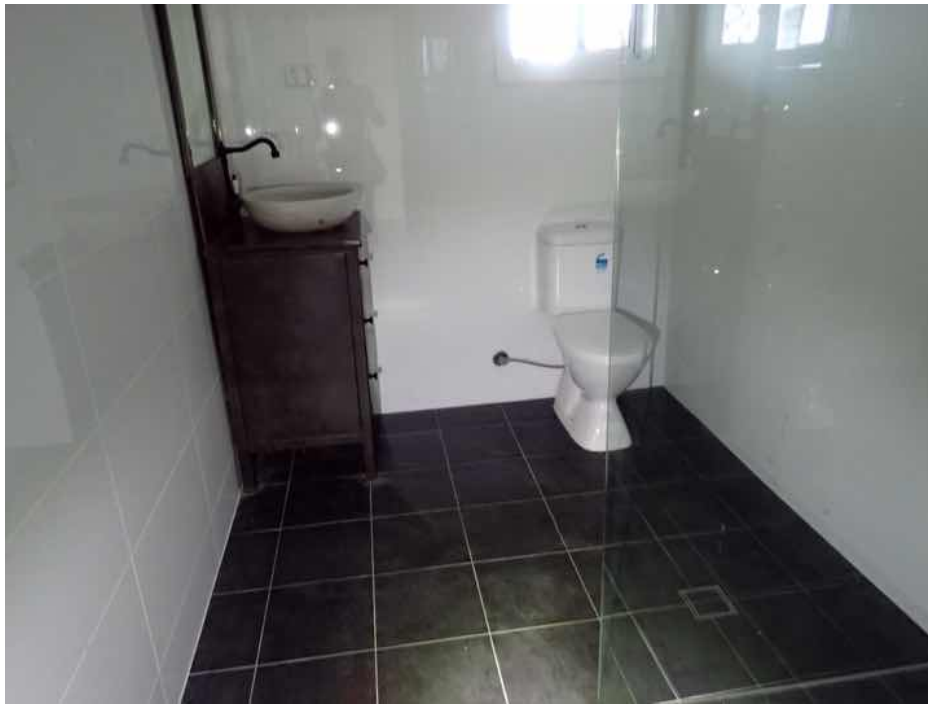
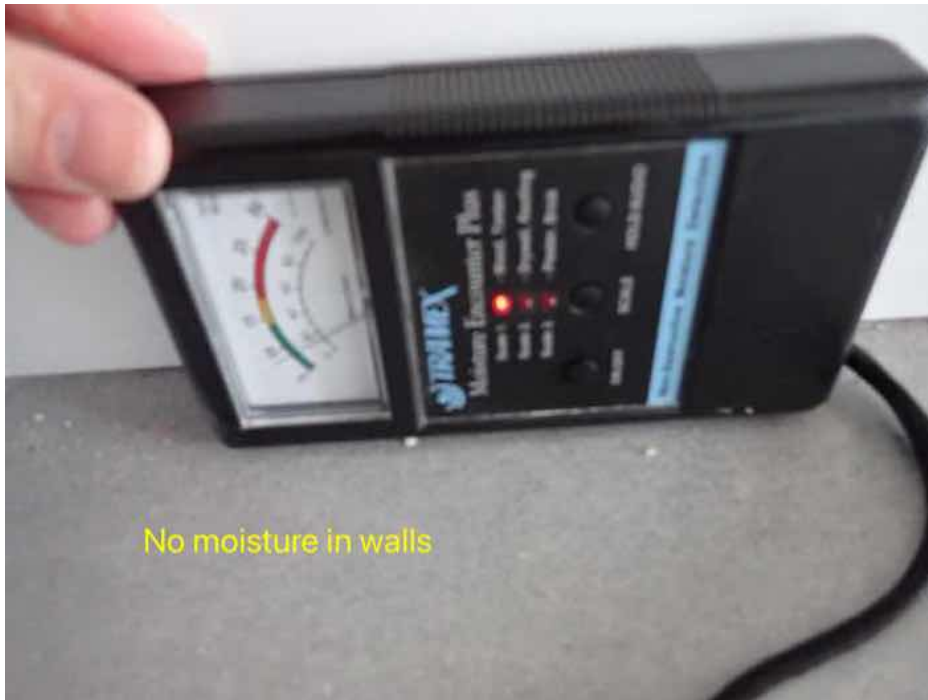
General ageing and deterioration and the like is evident on ceiling linings - Recommendations: A qualified painter should be engaged to assess and repair as required.

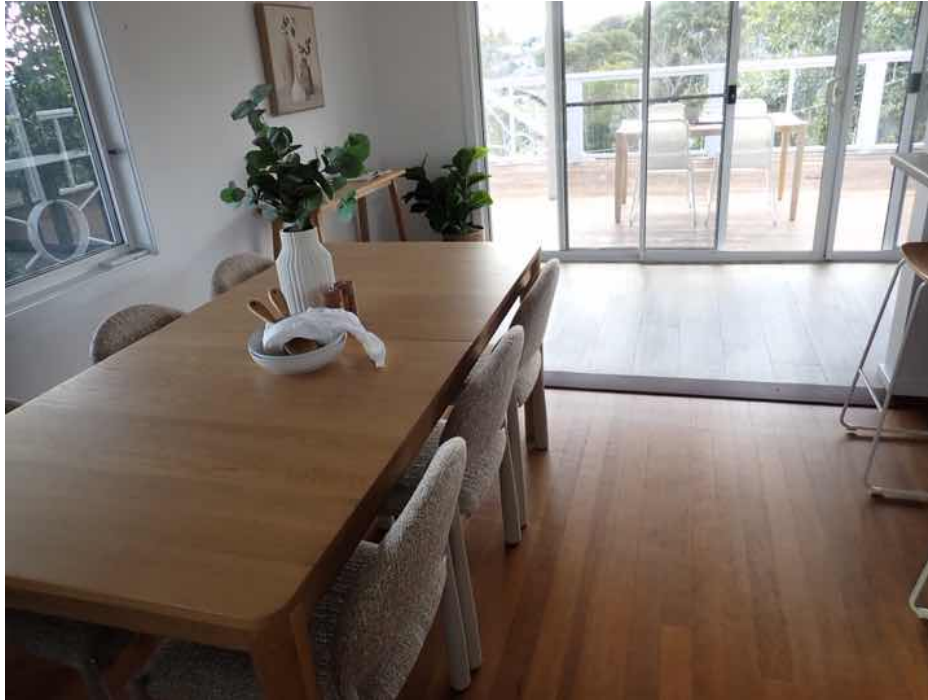
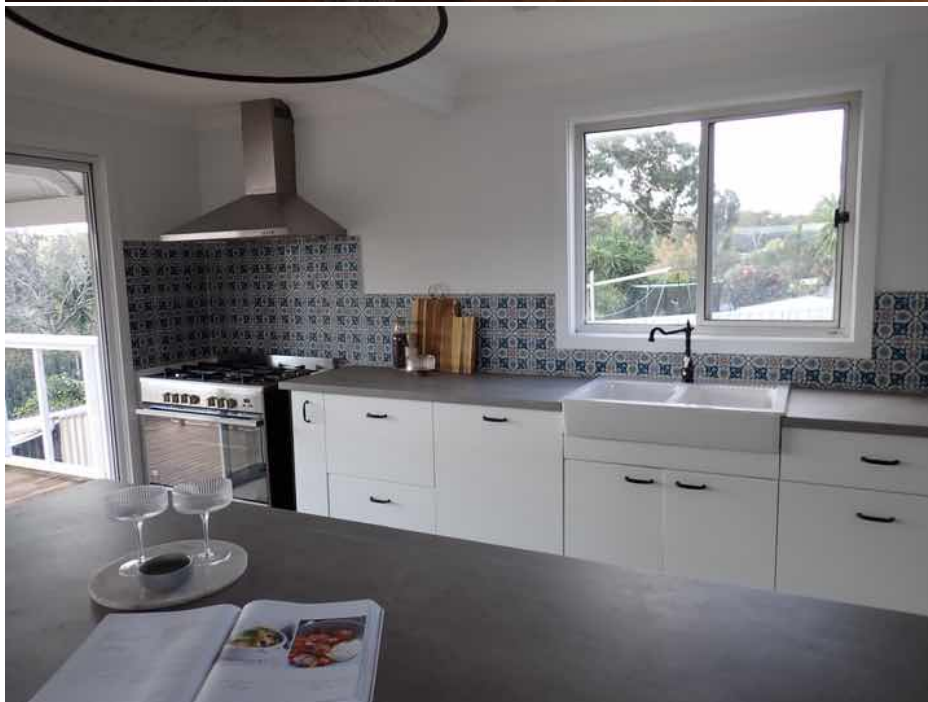
Settlement Cracks Noted . These are typical and generally patch and paint will suffice, however Monitoring these cracks advised for 12 months and if become wider or longer, you will need to contact a structural engineers to assess.

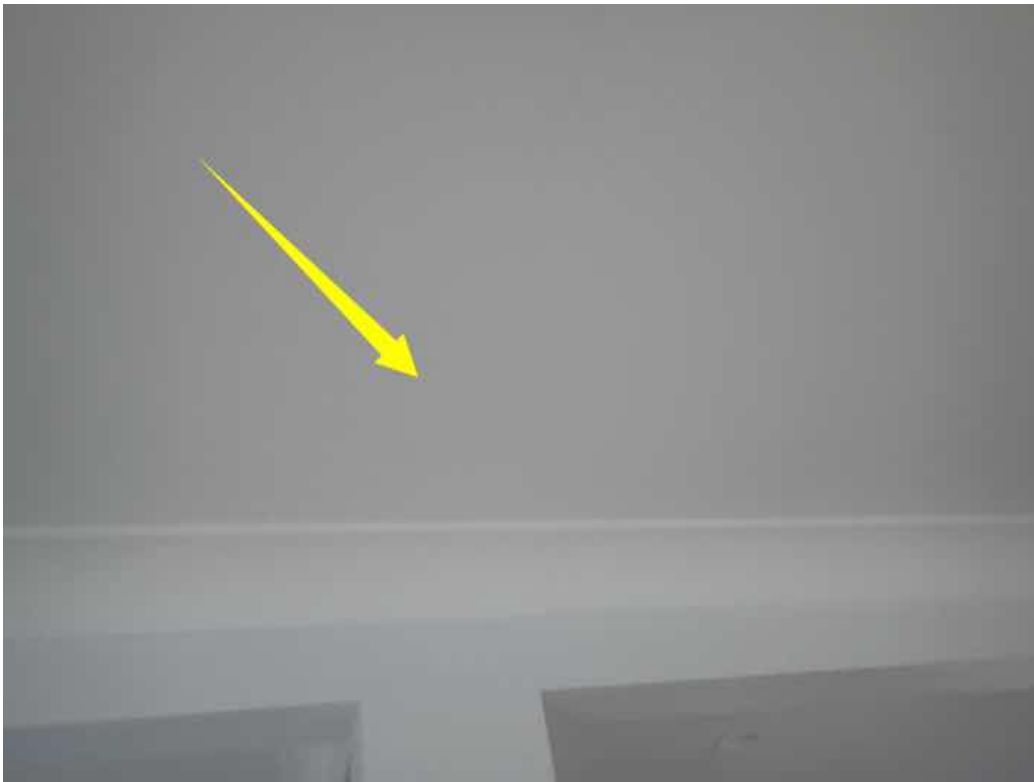
General age, wear and tear - Recommendations: General repair and maintenance advised.

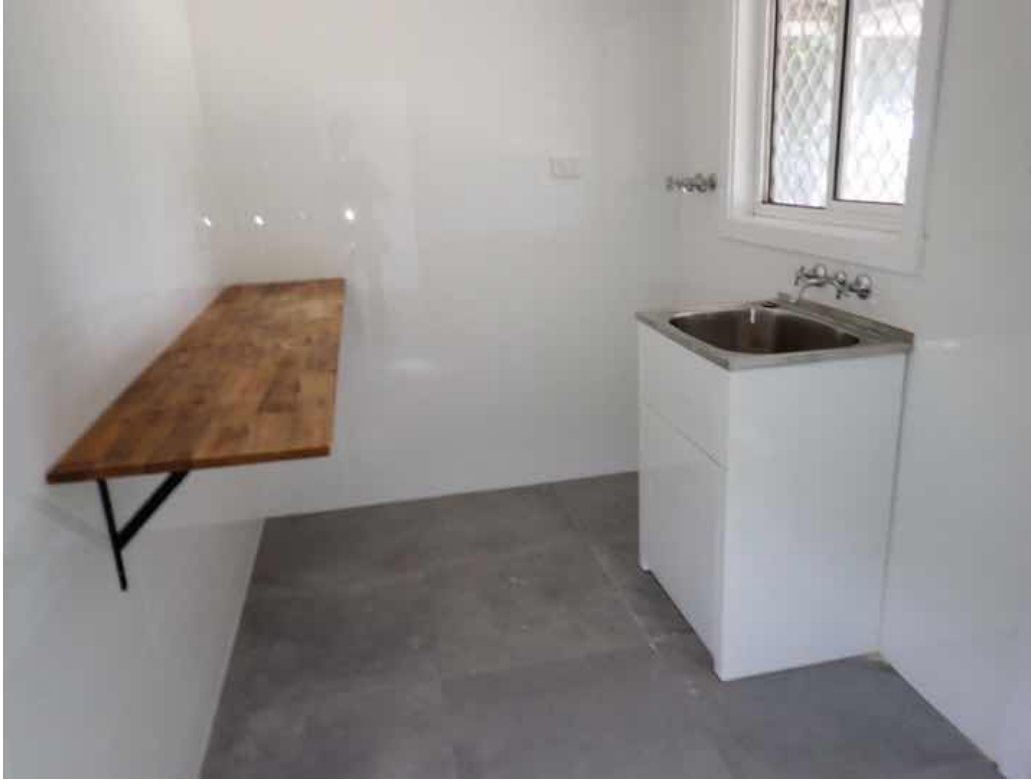
General deterioration and wear to sink, cupboards and benches. Recommendations: General maintenance works required.
