# House Inspection at

29 Mamaku Street, Paraparaumu

## Summary of report

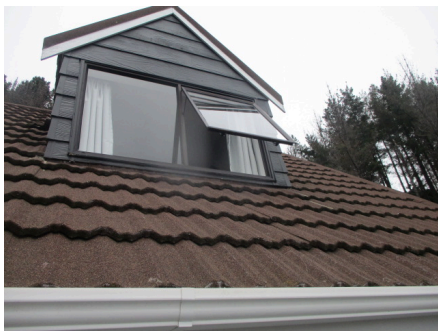
roof cleaned

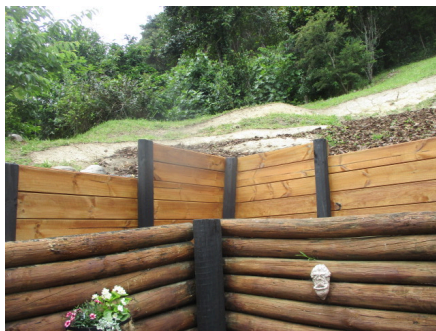
extensive retaining walls done at rear to a good standard

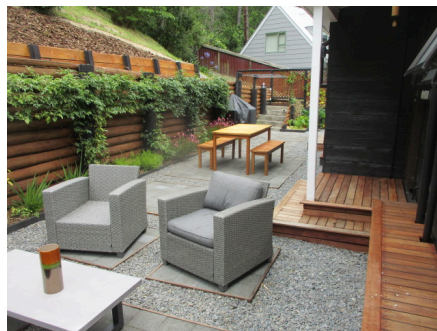
patio area at rear

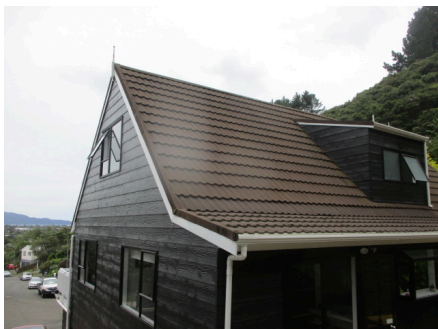
exterior painting completed

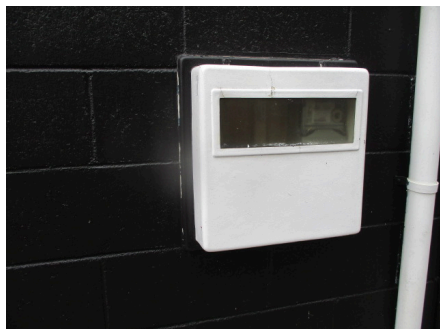
| CONDITION OF METER BOARD | yes appears to be good |

meterboard

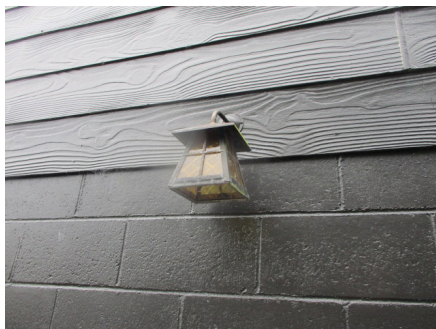
exterior lighting noted

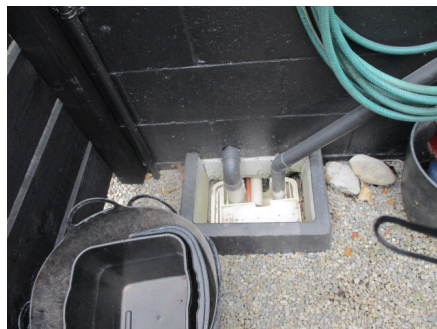
gulley traps good

| GULLEY TRAPS | all appear to be in good condition |

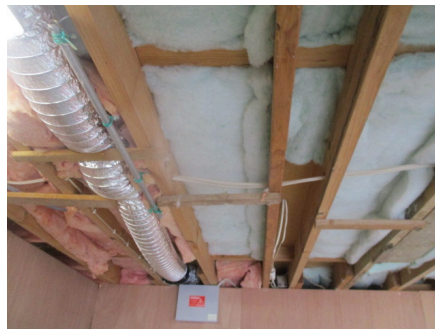
insulation noted to garage ceilings

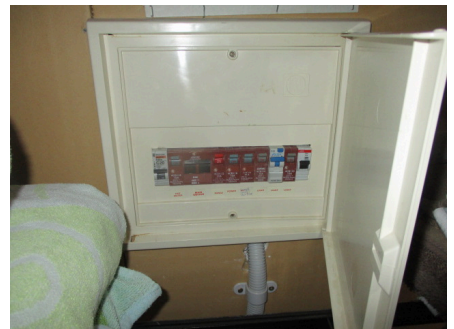
circuit breaker board

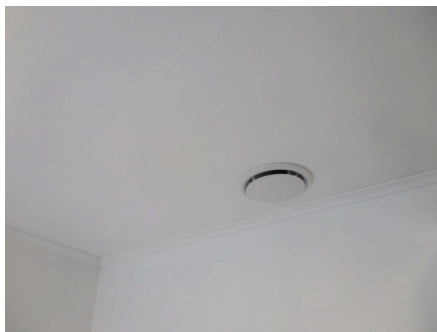
ventilation system downstairs

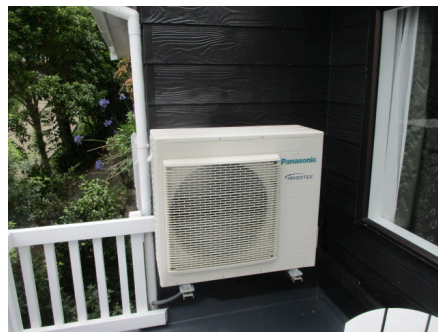
exterior air conditioning unit

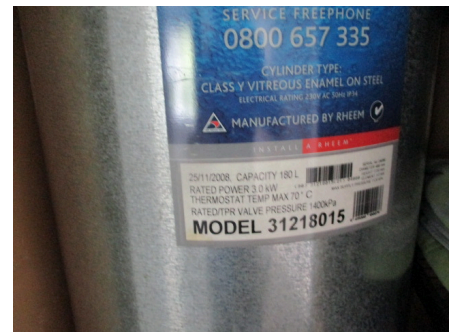
hot water cylinder

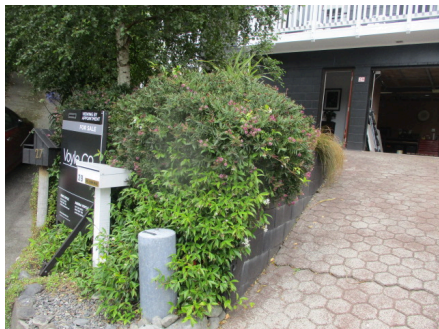
letterbox and concrete driveway

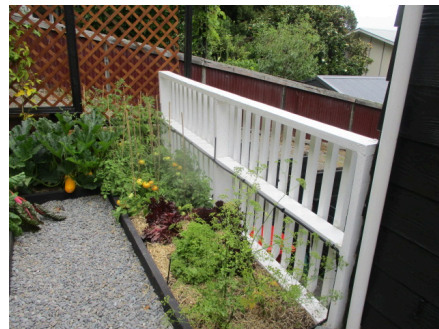
timber fencing

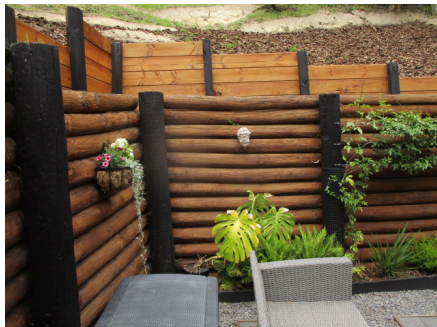
various timber retaining walls

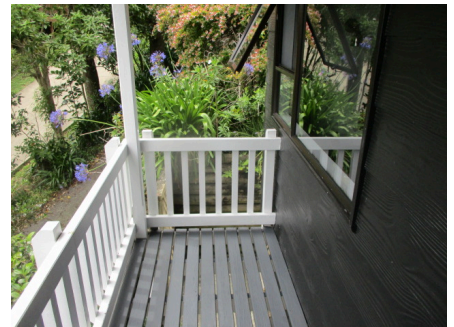
verandah at front

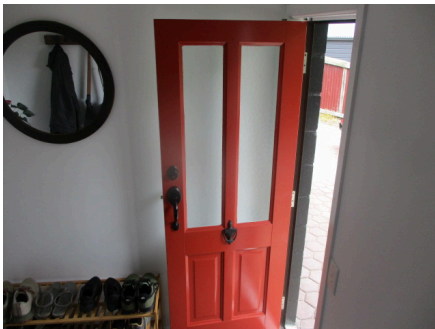
front door

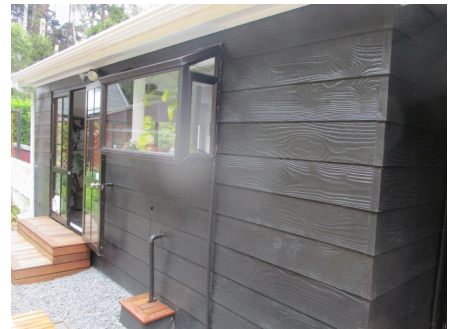
doors to back area
