# Your Building Inspection Report

CONFIDENTIAL REPORT FOR  
Russell Black  
ID 172753  
Wednesday, August 19, 2026

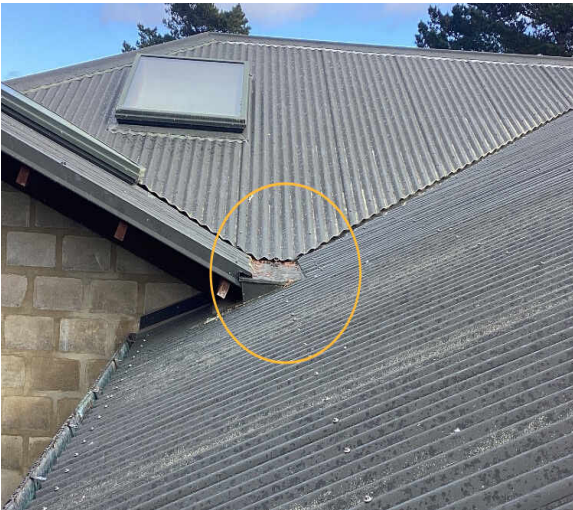
Approximate location above where stains were noted.

water staining was noted on the roof framing. This would indicate water ingress. We recommend this is further investigated by a registered roofer.

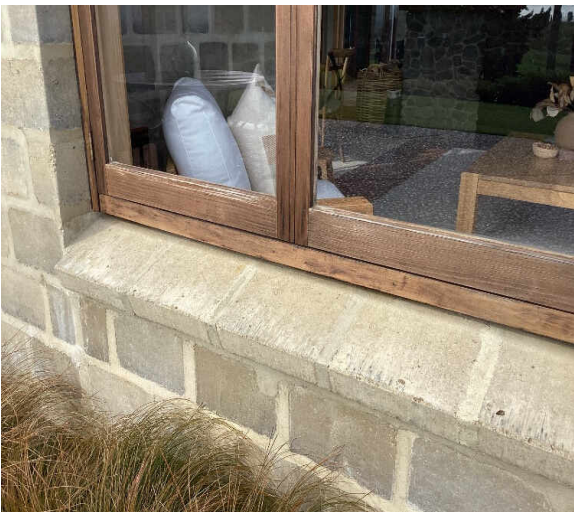
The window stain is looking weathered in areas. We recommend these are stained to prevent deterioration.

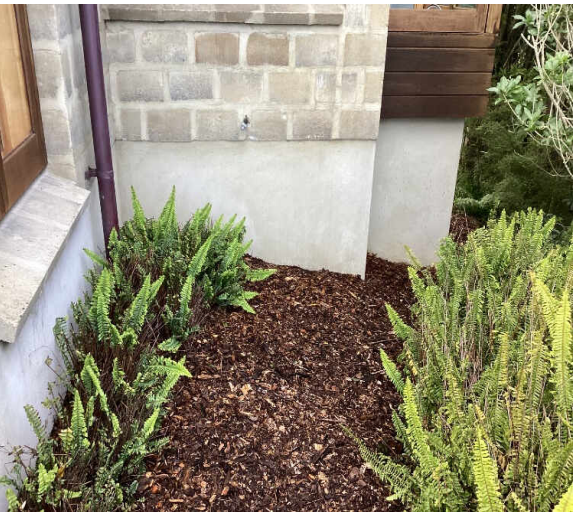
Due to the concrete slab there is no sub-floor space. We are unable to confirm the condition of the concrete slab or the soil beneath. For more detailed information and specification on the concrete floor slab we recommend that a search of the council building files be undertaken.

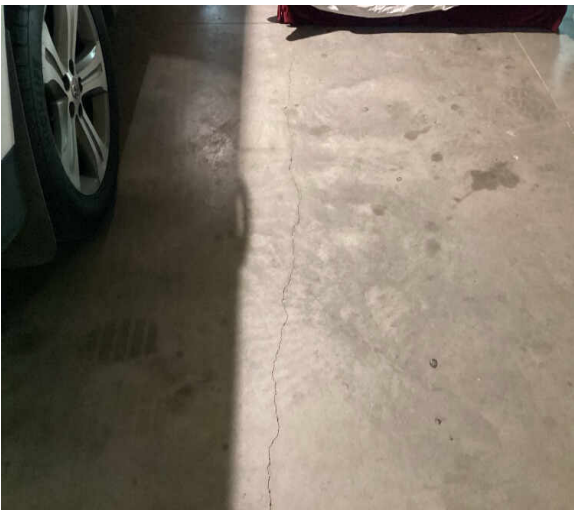
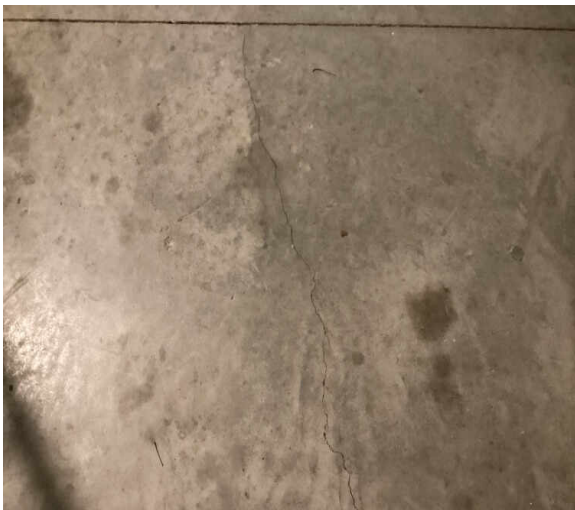
There is some movement cracking in the foundation concrete slab. This type of cracking is not uncommon in properties of this age and type and on the balance of probability is unlikely to change or cause a problem. Reinforcing mesh typically incorporated in the concrete slab is designed to prevent any shearing of the slab or excessive cracking. We recommend this is monitored, and if it worsens, we recommend investigation by a structural engineer.

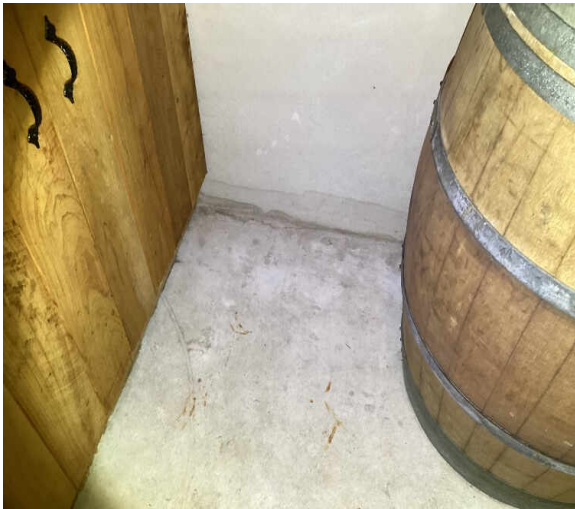
Some minor staining was noted in the basement floor to wall junction. This would appear to be efflorescence. We recommend this is monitored. Any further staining should be further investigated by a suitably qualified professional.

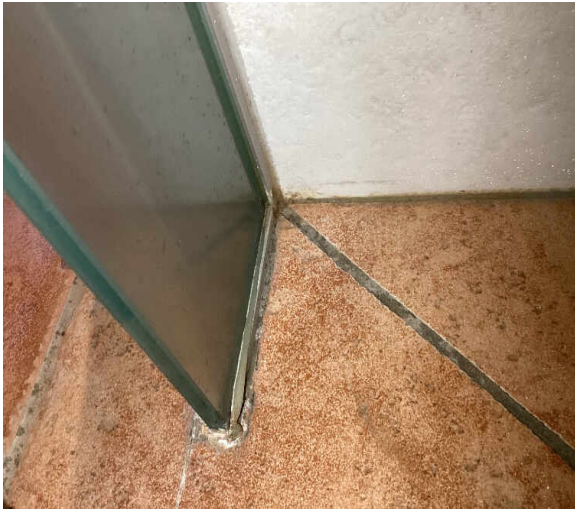
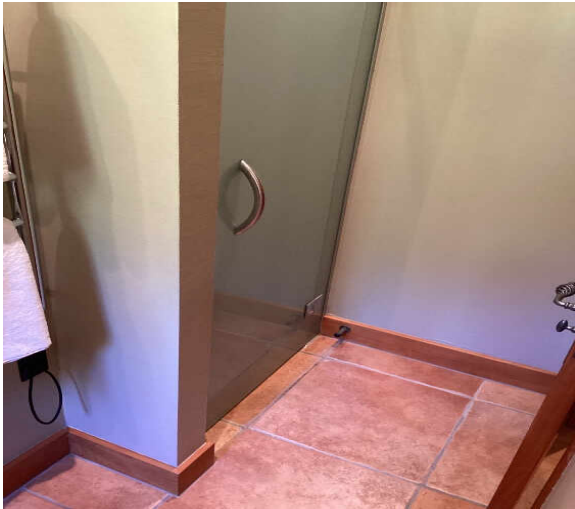
The grout and sealant has begun to deteriorate around the shower junctions. This may affect the water tightness of the shower. We recommend this is further investigated by a registered tiler.

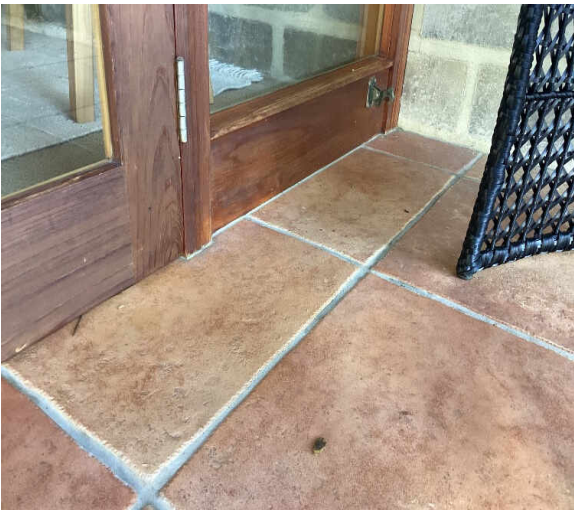
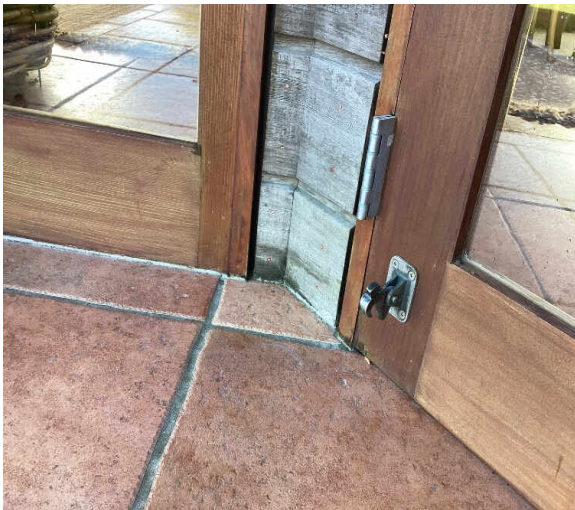
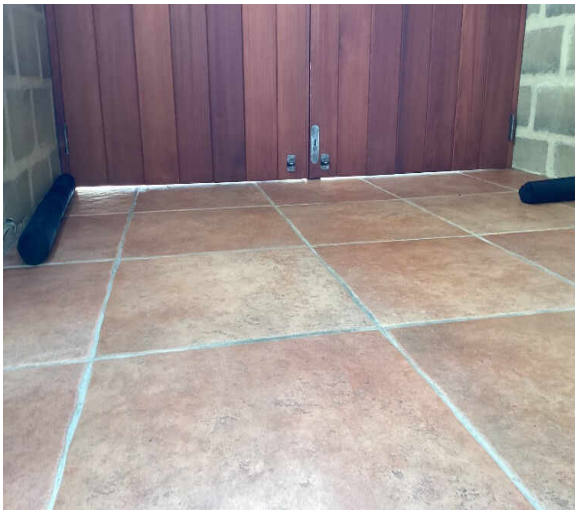
There is a high risk junction installed that has raised concern to the inspector. These junctions are where the cladding and ground meet. The high risk junction such as the one on this dwelling has the potential to allow water entry and deterioration through poor application and installation, lack of maintenance, poor detailing and complexity. This tends to occur particularly on buildings built between 1990 and 2006. We suggest that a thorough examination is completed bi-annually (ideally at the end of winter and end of summer), and any sealant breakdown, water pooling or any signs of deterioration of the junction should be investigated by a weather tightness specialist.

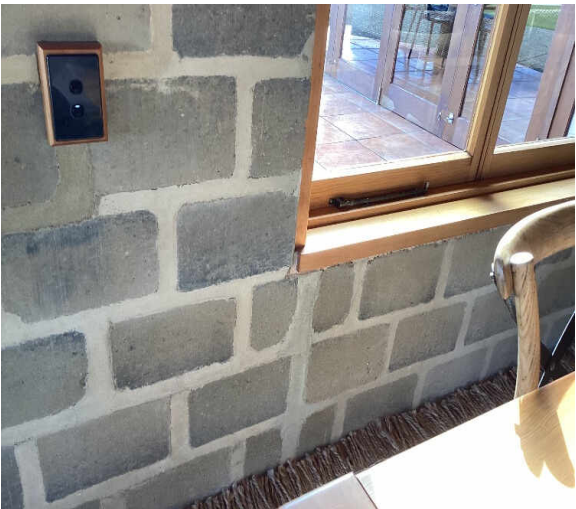
The exterior walls are constructed of masonry block. Because of this we are unable to conduct moisture testing on exterior walls.

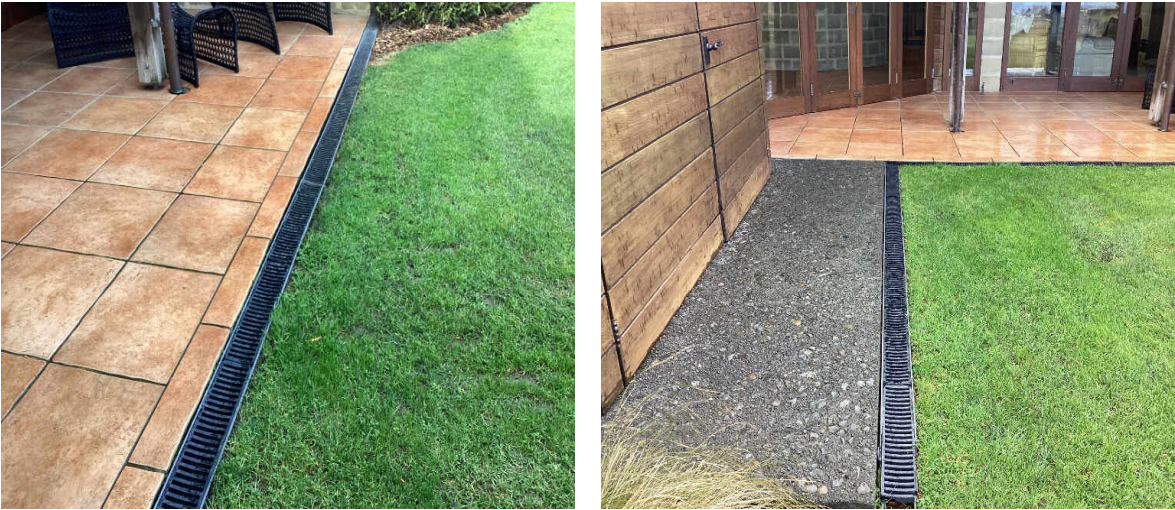
The slab height is low in areas. Strip drains have been installed to divert water away from the dwelling. We recommend these are maintained and kept clean.

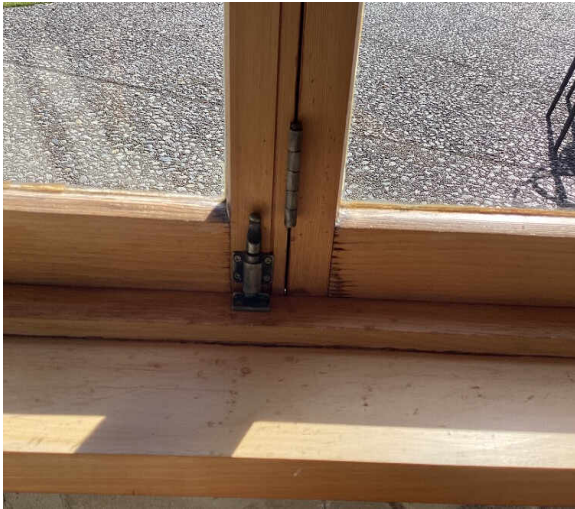
The kitchen window is binding and requires easing to improve functionality. There is moisture staining on some frames. We recommend these are monitored. If staining continues to spread we recommend they are further in by a suitably qualified professional.
