## Pre-Sale Inspection

**14 Kauika Road, Whangarei**

**Inspection Date: 17 August 2026**

**Award Building Services**

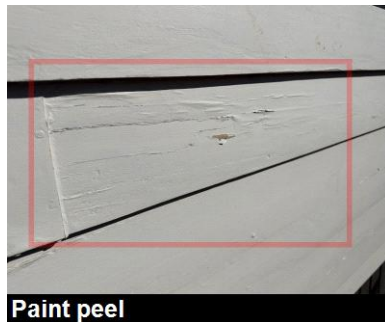
Painted. Paint is peeling or blistering, these areas require surface preparation and repainting to protect the cladding from moisture.

Paint peel

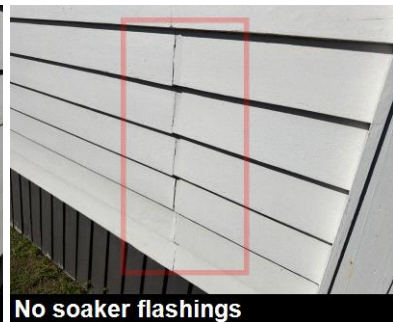
Some soaker flashings are missing and require repair or replacement. The internal framing was not visible therefore the condition is not known.

No soaker flashings

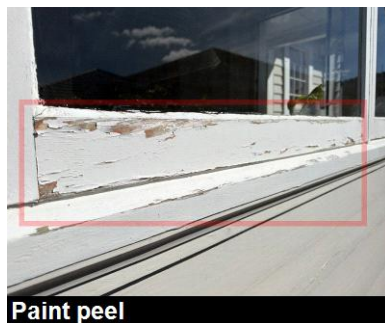
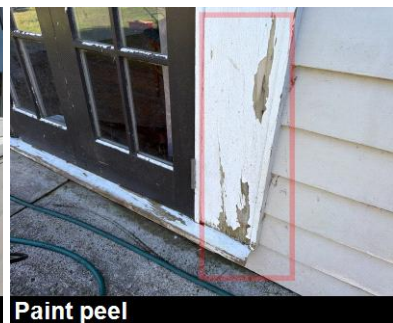
Timber. Paint is peeling, the joinery is due to be cleaned back and re-painted, should this highlight any defects these should be repaired before repainting.

Paint peel

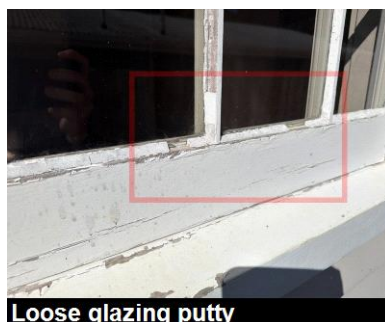
Glass type is single glazed. Some glazing putty is loose or missing, glazing putty requires repair in conjunction with exterior maintenance.

Loose glazing putty

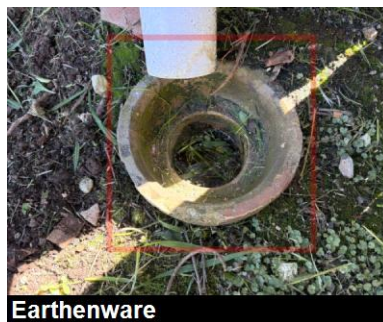
Earthenware gully. Earthenware gully pipes and wastes are prone to damage over time and this damage is often not apparent. You may wish to engage a registered Plumber to survey the underground pipes using a camera to check for any concealed damage or indications underground pipes require repair or upgrading as one storm drain appears blocked.

Earthenware

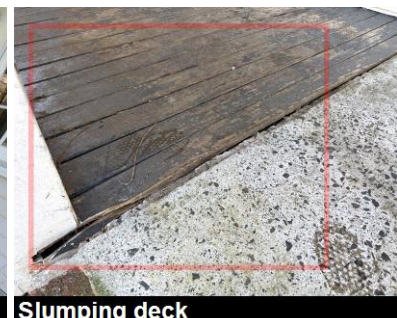
We note undulation and slumping of the timber patio decking. This may be due to foundation movement or material shrinkage. You may wish to have this assessed and repaired to avoid trip hazards.

Slumping deck

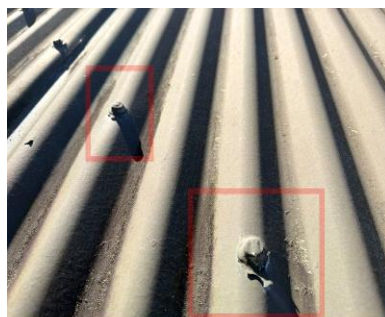
| Roof Material: | <p>Corrugated profile metal sheet. Lead head fixings are in use on this roof. These nails are no longer in use as they cause rust damage to the roof cladding and weathertight issues. You may wish to have the lead head nails replaced with screw-type fixings. Defects may become evident during this process.</p> <p>Severe rot damage was noted to the timber shingle awning roof section near the entranceway. You may wish to have the awning roof replaced, a roofing contractor can assist you with this.</p> |

Lead head fixings

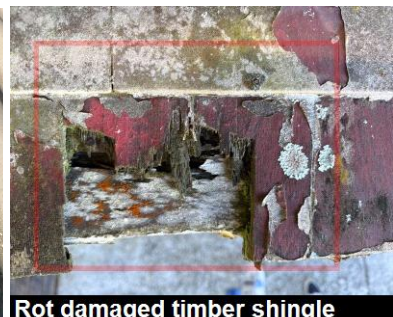
Rot damaged timber shingle roof

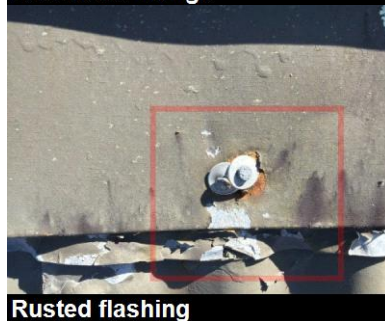
Rusted flashing

| Material: | Metal. Surface rust to some roof flashings which may be able to be cleaned back, primed and painted alternatively, you may wish to have the rusted flashings replaced. |

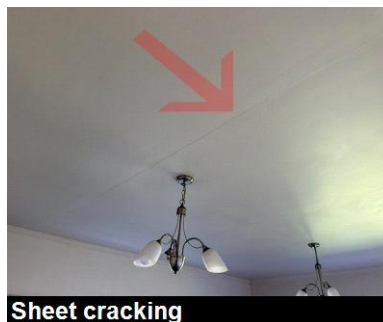
Plaster board. Sheet joint cracking is visible in some areas, this could be addressed when next redecorating.

Sheet cracking

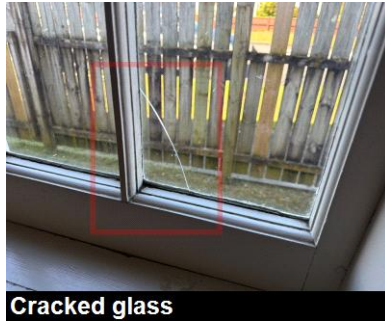
Timber. Cracked glass, damaged glass could at some stage be replaced.

**Cracked glass**

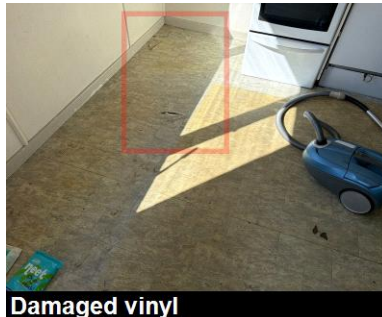
Vinyl. Vinyl floor coverings are damaged and may be the type that contain asbestos, however confirming the presence of asbestos would require a sample to be laboratory tested. Should you have concerns we recommend a sample is taken and tested for the presence of asbestos.

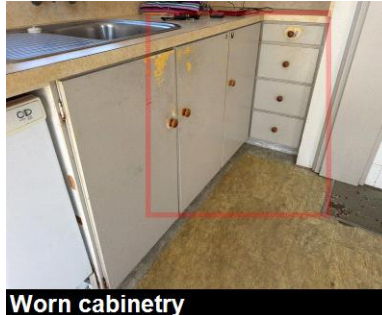
Cabinetry: Timber. General wear and tear consistent with cabinetry age and use.

**Worn cabinetry**

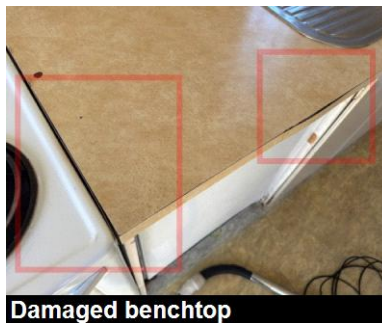
Bench Top: Formica laminate. Bench top is delaminating, this may be able to be repaired or the bench top could be replaced.

**Damaged benchtop**

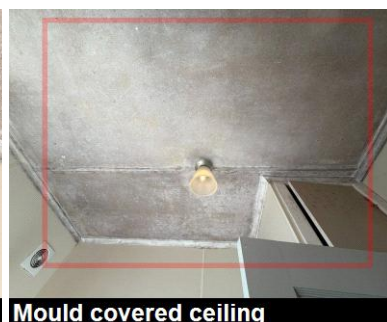
Mould staining visible. The moisture meter indicated what is regarded as "within normal tolerances" at the time of inspection. As mould is a potential health concern you may also wish to consider removal and correction.

**Mould covered ceiling**

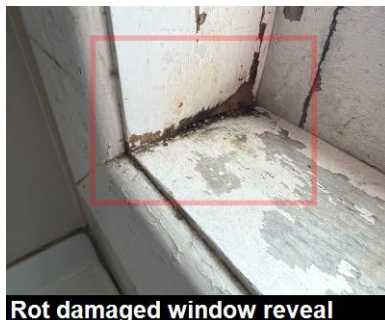
Timber. Rot damage and decay was found to some of the window frames, the rot damaged areas will require repair/replacement. The internal framing was not visible therefore the condition is unknown.

**Rot damaged window reveal**

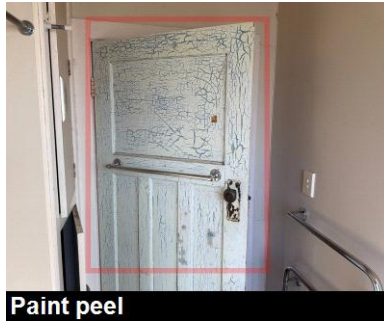
Timber panel. Paint/sealer deteriorating, door could be prepared for re-coating in conjunction with redecorating.

**Paint peel**

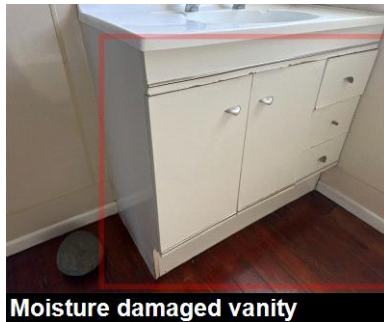
Laminated/prefinished. Prefinished laminate is delaminating, this may be able to be repaired or the cabinetry could be replaced.

**Moisture damaged vanity**

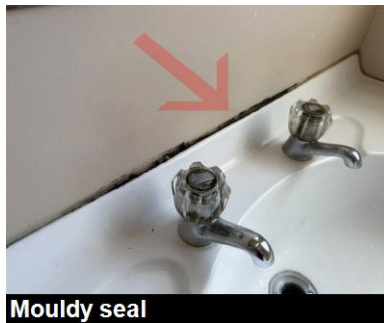
Sealant adjacent to the wall is mouldy and could be replaced.

**Mouldy seal**

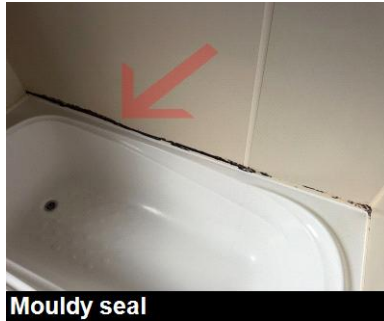
Sealant adjacent to the wall is mouldy and could be replaced.

**Mouldy seal**

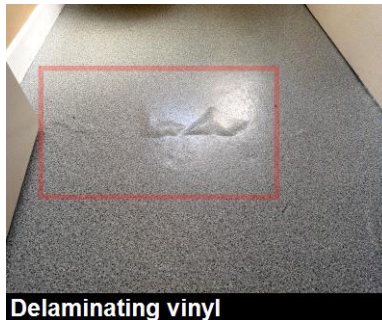
Floor: Vinyl. Some flooring vinyl is delaminating. You may wish to consider further assessment and repairs by a qualified vinyl specialist.

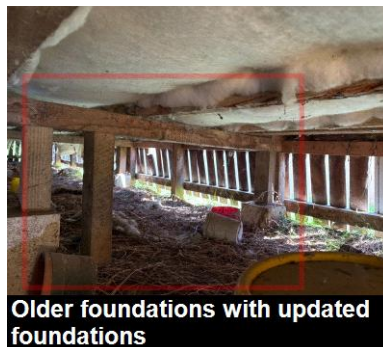
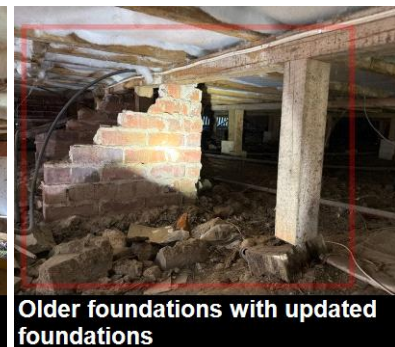
There is obvious settlement and undulation noted in the foundations, however, new foundations have been installed which appear in sound condition. The undulation is likely due to the house not being levelled while installing the new foundations.

Foundation: Concrete piles with timber jack studs. Timber piles. The foundation has been upgraded at some point. New concrete foundations with timber jack studs have been installed along side the original foundations. In some areas the bearers are founded on the old brick entrances and fire place supports which appears to be causing some undulation noted inside the building. It doesn't appear the house was levelled when installing the new foundations. You may wish to have this process completed. A foundation specialist can assist you with this.

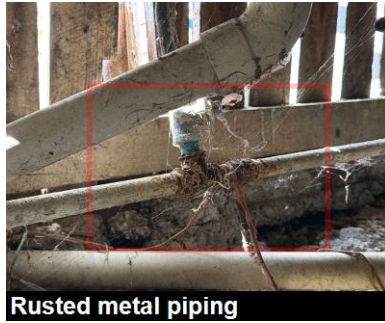
Plumbing/Drainage: Plastic pipe. Copper pipe. Galvanised pipe. We note some rust forming to areas of metal plumbing. You may wish to have these repaired or replaced. A plumber can assist you with this.
