Released under the Official Information Act 1982  
**EQC Full Assessment Report**

**Claim Number:** CLM/2011/179146  
**Claimant:** DM DEVINE  
**Property Address:** 904 WATERHOLES ROAD  
ROLLESTON 7678

**Assessment Date:** 31/10/2011 10:04  
**Assessor:** Jones, Rodger  
**Estimator:** Lawler, Tony

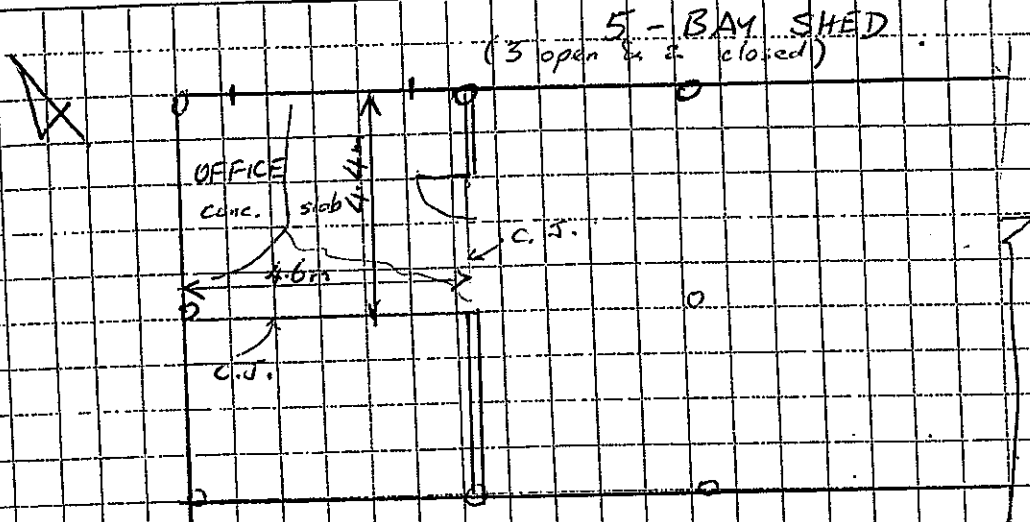
Cracks 1-3 mm wide due to the EQ in the cova-crete surfaced concrete floor of the office room.

Telcon Rick, Advanced; tel. estimate  
7.5 m of crack repair, 1-3mm wide @ 750  
7.5m @ \$100/m

Grind out and epoxy crack repair. Remove and reapply covacrete in the office (20.25 m2)

Concrete 20.25 m<sup>2</sup> @ \$130/m<sup>2</sup> = \$2633
