## Pre-purchase Building Inspection

34 Shoesmith Road Westbrook Qld 4350

## **Pre-Purchase Inspection - Residential Building Report (Except ACT)**

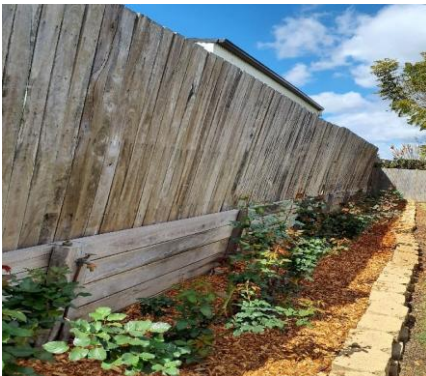
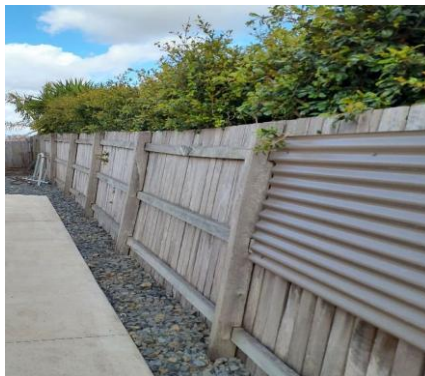
Retaining wall and fence is leaning

Fence and retaining wall are leaning

- *Retaining walls leaning on both side boundaries and wood decay to retaining wall timbers in areas. Future maintenance will eventually be required.*

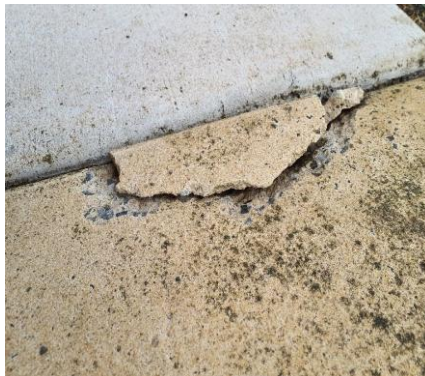
Section of path has broken away

- *Cracking to the concrete paths in various locations. Future maintenance may be required.*
- *Section of path has broken away at the rear of the dwelling. Engage a concreter for repair.*

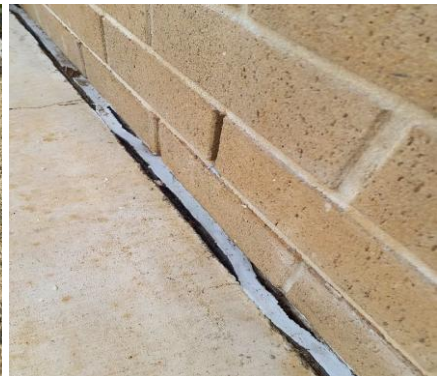
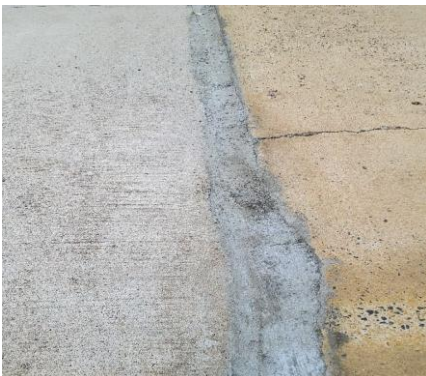
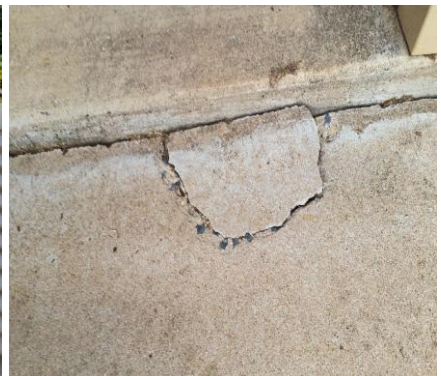
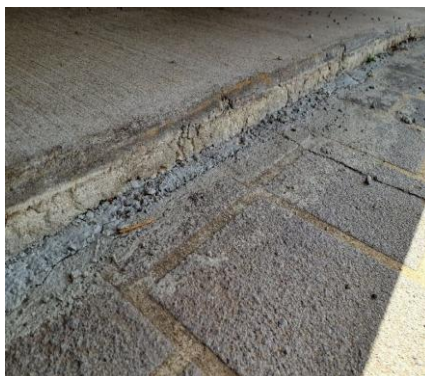
Driveway has separated from the wall of the dwelling

Patching to the driveway to the shed

Section of the driveway has broken away

Water will pool in section of the front driveway as section of driveway is uneven

- *Cracking to the driveway in various locations, patching to the driveway to the shed and section of driveway has separated from the wall of the dwelling. Future maintenance may be required.*
- *Water will pool in section of the front driveway as section of driveway is uneven. Section of the driveway has broken away by the shed. Engage a concreter to quote for repair.*

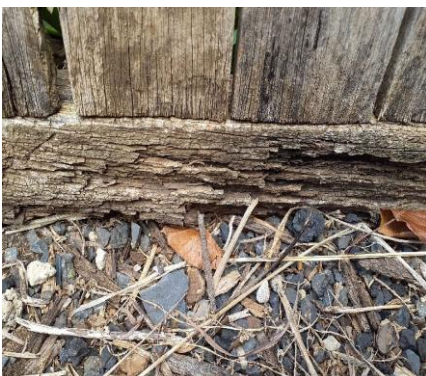
Wood decay to retaining wall timbers

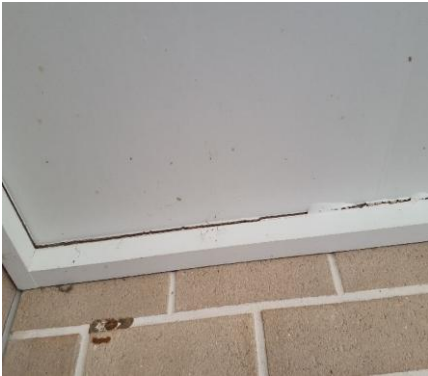
Timber moulding has separated slightly from the patio ceiling

- Timber moulding has separated slightly from the patio ceiling in areas. Engage a carpenter for repair.*

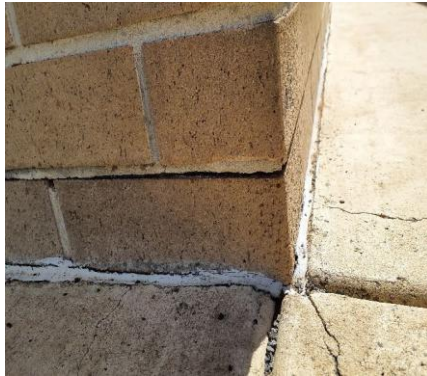
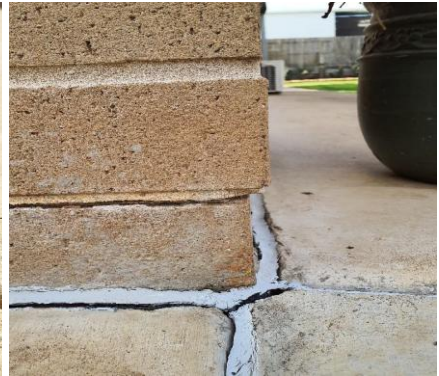
Signs of movement to the brickwork

- There is cracking and movement to masonry walls at damp course level. This is due to the expansion and contraction of different materials and not deemed a structural defect.*

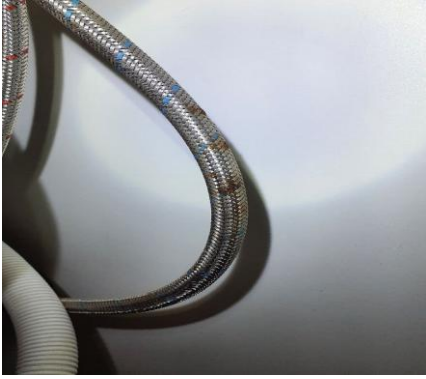
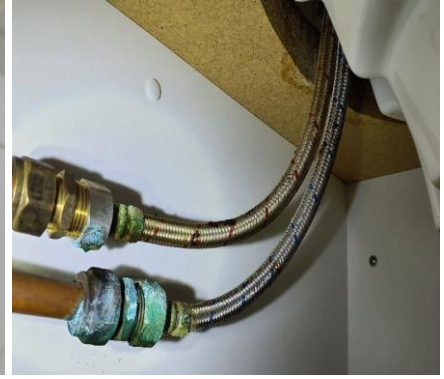
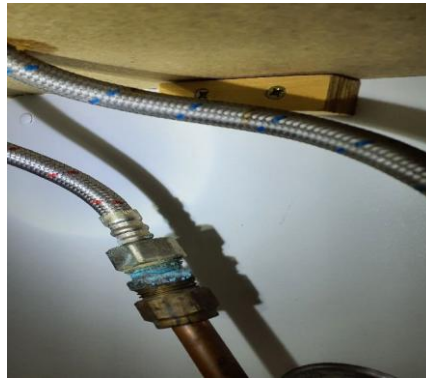
Rust to flexible hose under the laundry cabinet

Rust to the flexible hoses under the wash basin

Rust to the flexible hose under the ensuite wash basin

- *There are signs of corrosion to the flexible hoses in the property. Rust spots on the exterior of the stainless steel braided flexible hoses are a good indication that the hose should be replaced. Engage a plumber to advise.*
- *Regular inspections are a key component in minimising the risk of a flooded house from a burst flexible hose and regardless our recommendation is to replace them every 3-5 years as part of a proactive preventative maintenance plan.*

- *Regular inspections are a key component in minimising the risk of a flooded house from a burst flexible hose and regardless our recommendation is to replace them every 3-5 years as part of a proactive preventative maintenance plan.*

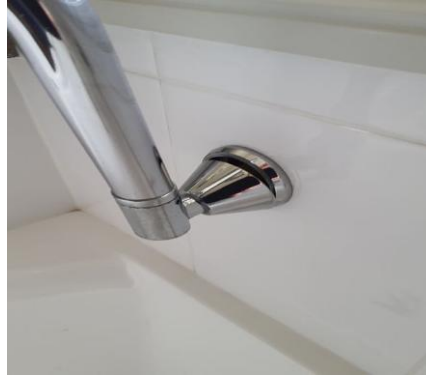
Bath spout is loose

- *Bath spout is loose. Plumber to advise.*
- *Evidence of water leakage was noted coming from the shower recess. There was no obvious structural damage; however remedial action should be taken at the earliest opportunity.*
- *There are signs of corrosion to the flexible hoses in the property. Rust spots on the exterior of the stainless steel braided flexible hoses are a good indication that the hose should be replaced. Engage a plumber to advise.*

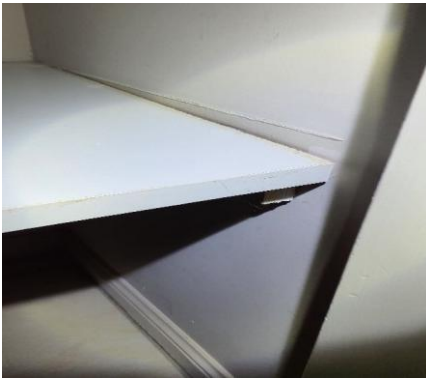
Support for linen cupboard shelf has separated

- *Support for linen cupboard shelf has separated. Engage a carpenter for repair.*

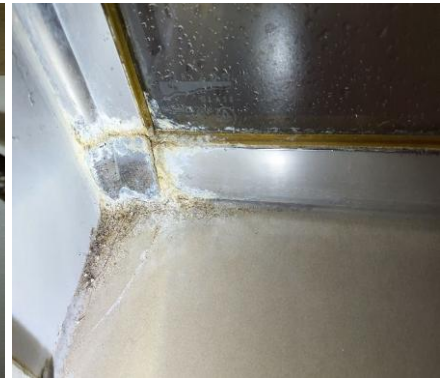
Sign of leakage from the ensuite shower frame

- *Evidence of water leakage was noted coming from the shower recess. There was no obvious structural damage; however remedial action should be taken at the earliest opportunity.*
- *There are signs of corrosion to the flexible hoses in the property. Rust spots on the exterior of the stainless steel braided flexible hoses are a good indication that the hose should be replaced. Engage a plumber to advise.*
- *Regular inspections are a key component in minimising the risk of a flooded house from a burst flexible hose and regardless our recommendation is to replace them every 3-5 years as part of a proactive preventative maintenance plan.*

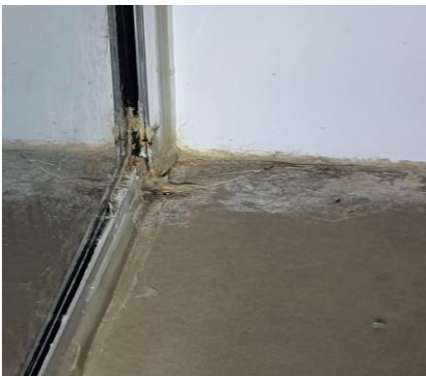
Leakage from the bathroom shower recess

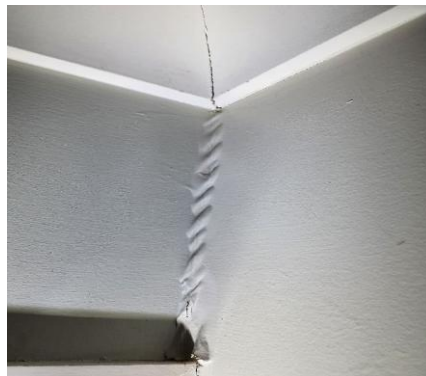
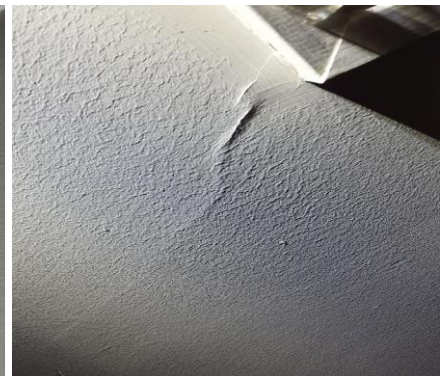
Plaster defects

- *There are some plaster & paint defects to the internal linings consistent with a house of this age. Patching and painting by tradesman would improve the overall appearance.*

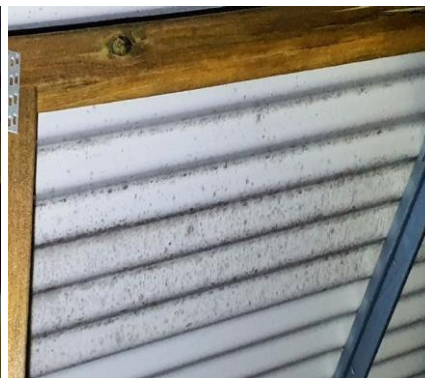
Mould to underside section of the roofing iron

- *Roof condensation occurs when moisture becomes trapped between the roof and the ceiling insulation, this problem can be caused by insufficient ventilation or no ventilation to the roof cavity.*
- *Moisture in the roof cavity can contribute to growth of bacteria, mildew, mould. Recommend to properly ventilate the roof cavity.*

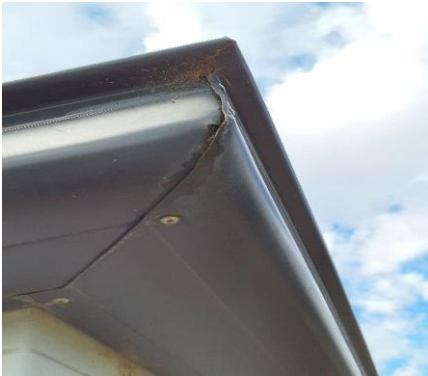
Gutter is leaking on join

- *Gutter sealant shows signs of deterioration and there is evidence of leaks to joins. Maintaining a leak-proof gutter requires periodic checks to assure sealants such as caulk have not chipped, cracked, or pulled away from places they seal. These areas include guttering. They require occasional reapplication of caulk where the guttering joins together.*
- *Gutter sealant has been applied prior to the inspection; such application is a temporary waterproofing measure and may last for some months before breaking down. Engage a roofing contractor to quote for repairs to rectify where required.*

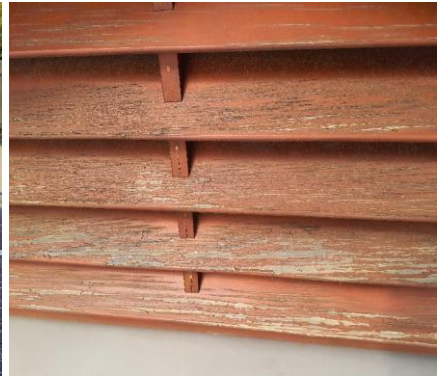
Weathering to timber work in the gable

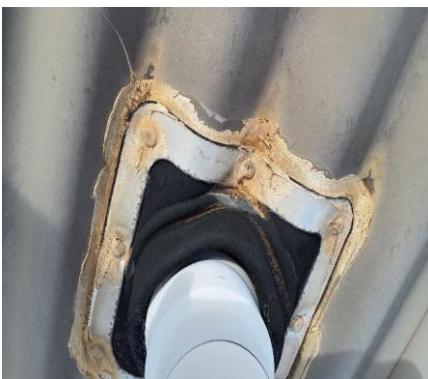
Sealant shows signs of deterioration around vent pipe boot

- *Rooftop vent pipe sealant shows signs of deterioration. Maintaining a leak-proof roof requires periodic checks to assure sealants such as caulk have not chipped, cracked, or pulled away from places they seal. These areas include roof vents. They require occasional reapplication of caulk around the base where the vent contacts the surrounding roof.*
- *Rooftop sealant has been applied prior to the inspection; such application is a temporary waterproofing measure and may last for some months before breaking down . Engage a roofing contractor to quote for repairs to rectify where required.*

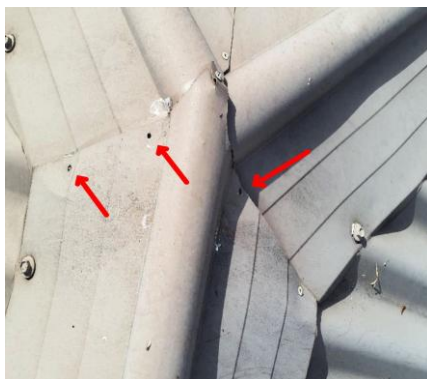
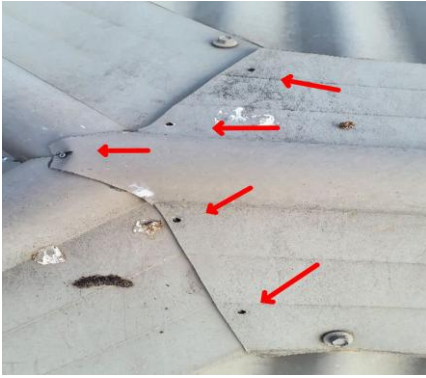
Pop rivets missing from joins of ridge capping

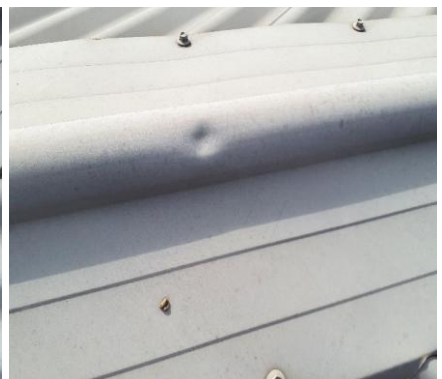
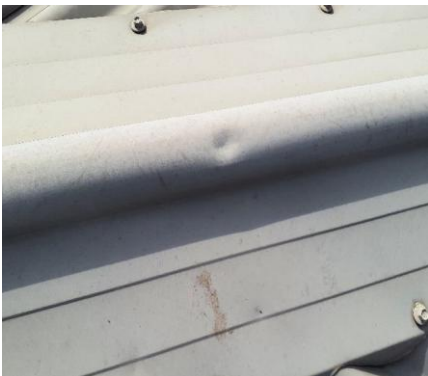
Hail indentations to the roof exterior

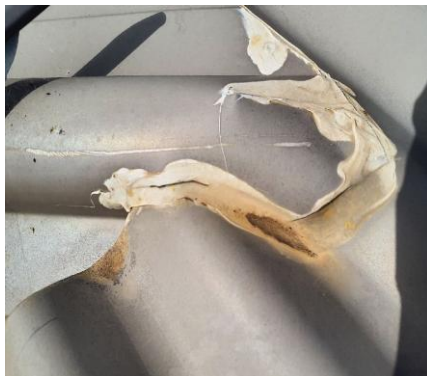
Sealant has split on join of ridge capping

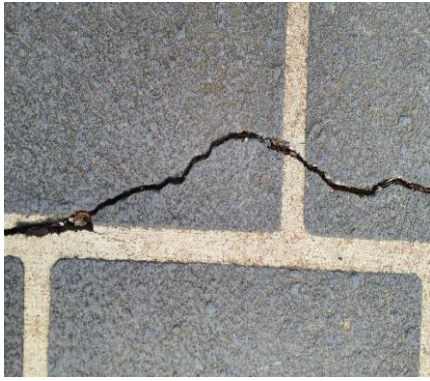
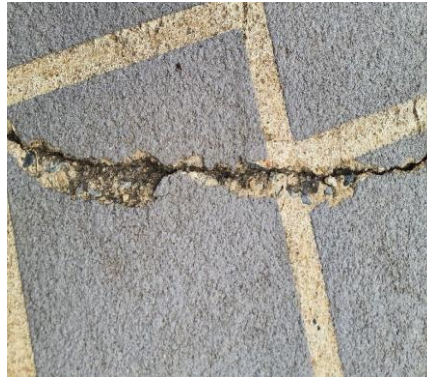
Cracking to the driveway

Cracking to the path

| <b>Areas Inspected</b> | <b>Location and Description of the Cracking Defect at the time of the Inspection.</b> |
|---|---|
| <b>Concrete Slabs</b> | <i>Cracking to the concrete areas, driveway, paths etc. Future maintenance may be required.</i> |

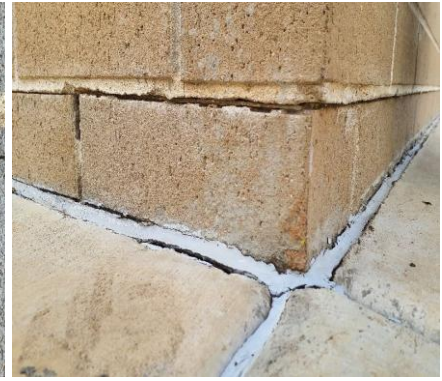
Cracking to mortar at damp  
course level

| <b>Areas Inspected</b> | <b>Location and Description of the Cracking Defect at the time of the Inspection.</b> |
|---|---|
| <b>Masonry Walls</b> | <i>There is cracking and movement to masonry walls at damp course level. This is due to the expansion and contraction of different materials and not deemed a structural defect.</i> |
