# EARTHQUAKE RECOVERY (EQR) DOCUMENTATION

# EQR Property Overview Report

| EQC Property ID | Property Address | Vulnerable? | Property F Status | Property Finalisation Indicator | | |
|---|---|---|---|---|---|---|
| 2010126991 | 7A GORDON STREET, SOUTHBRIDGE | | F3 - Complete & Finalised | Some Finalisation has taken place | | |

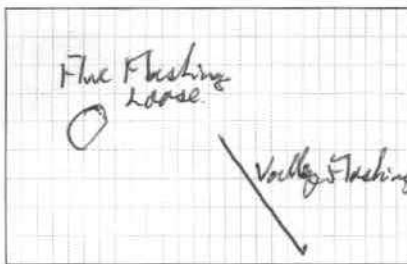
| Item | | Event<br>Damage<br>Y / N | Repair Strategy |
|---|---|---|---|
| Roof | | Y | Flashing in Valley Moved, Checked. Remove roofing, Replace Valley flashing - Reinstall roof.<br>Metal flue surround moved. Refix & Repaint.<br>Loose Bricks, Mortar Cracks. Patch, Refit, Re-mortar |

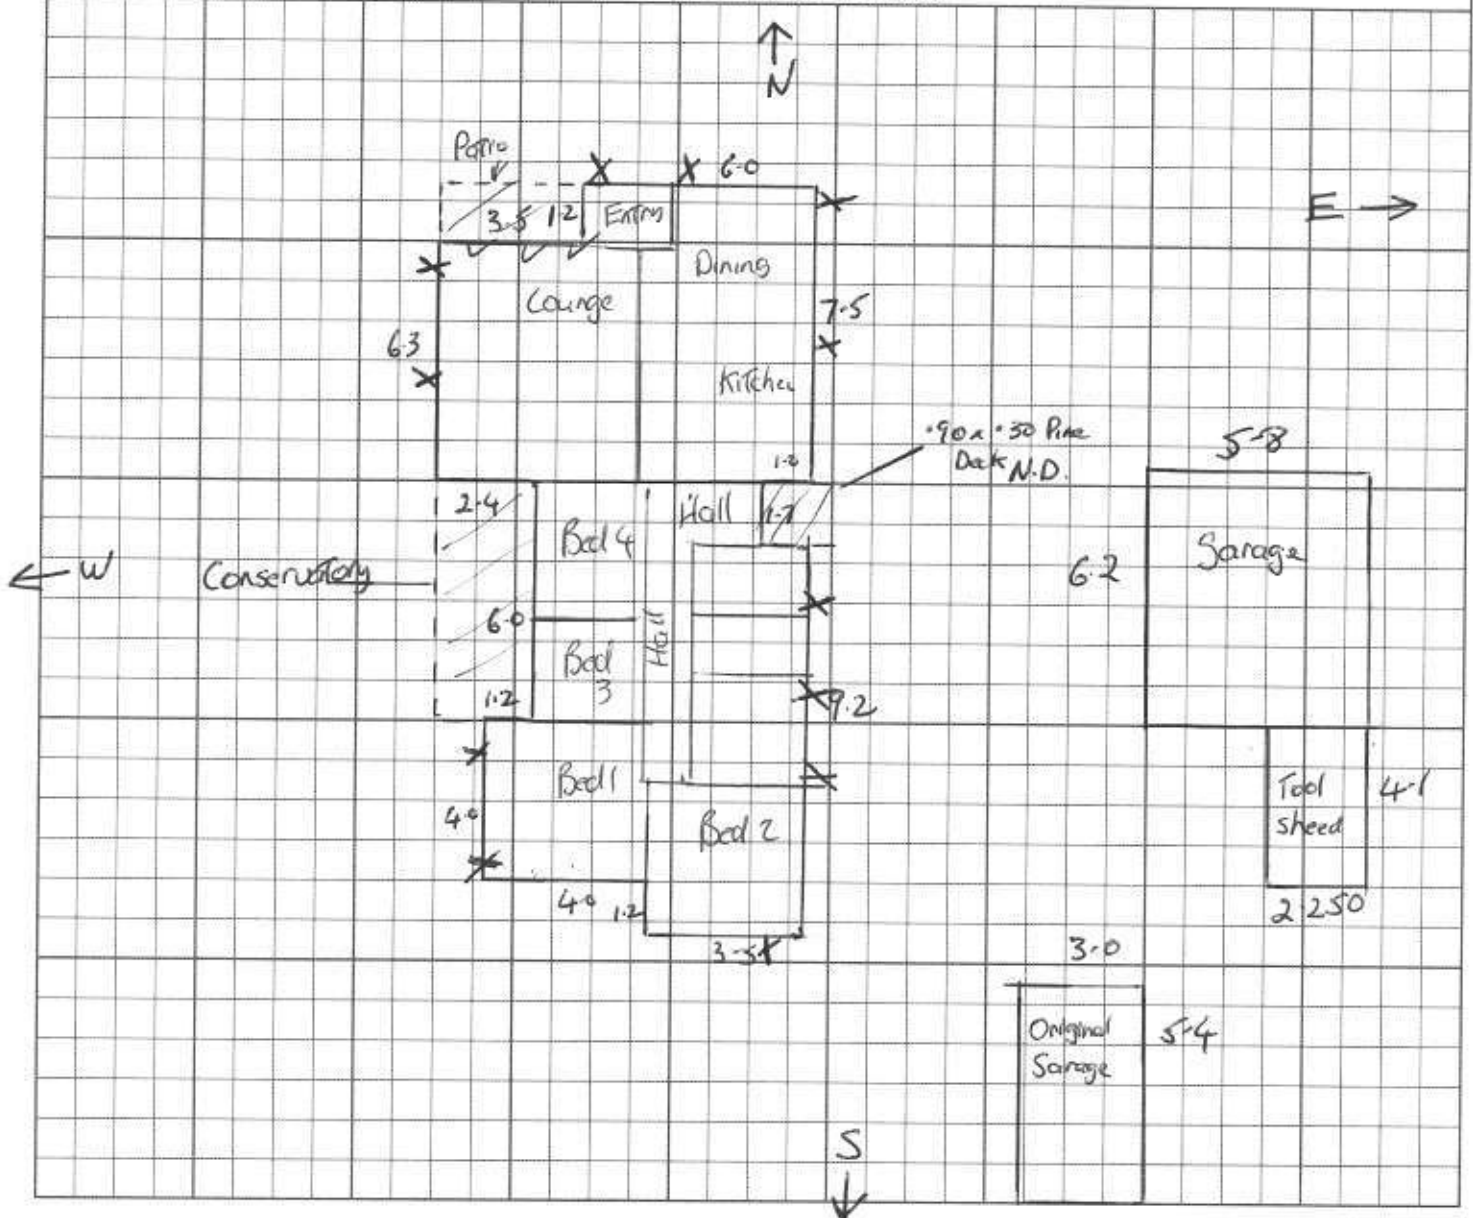
PLAN SKETCH OF PROPERTY (identify each room, indicate damage). Attach photo if available

| <p>1-5m Stair Cracking.<br/>North</p> | <p>1.500 Stair Cracking<br/>South</p> | <p>Where the 2 Ridge Cappings meet by the valley there is leaking due to gaps. where the Ridge Capping meets the Barge Roll there is a gap causing a leak. East chimney Flashing is loose causing leaking.<br/>Roof</p> |
| <p>1-5 Stair Cracking.<br/>East</p> | <p>3m Stair Cracking<br/>West</p> | <p>N<br/>S<br/>E<br/>W. N.D.<br/>Foundations</p> |

| Item | | Event Damage | Repair Strategy |
|---|---|---|---|
| Roof | | Y | LEAK IN ROOF X 3, INSURED HAS ARRANGED FOR A PLUMBER/ROOFER TO ATTEND NEXT WEEK AND CARRY OUT REPAIRS UNDER (EMERGENCY REPAIRS) DMT PRICE |
| EXTERNAL WALLS | North | Y | GRIND OUT & RE MORTAR CRACKS IN BRICK WORK. |
| | South | Y | GRIND OUT & RE MORTAR CRACKS IN BRICK WORK. |
| | East | Y | GRIND OUT & RE MORTAR CRACKS IN BRICK WORK. |
| | West | Y | GRIND OUT & REMORTAR CRACKS IN BRICK WORK |
