# CASH SETTLED CLAIM(S)

## Statement of Claim Checklist / Repair Strategy

CLM/2010/158807

C SC Carvell  
 C 44 PENNINGTON STREET  
 S LEESTON  
 H: [REDACTED]  
 W: [REDACTED]  
 M: [REDACTED]

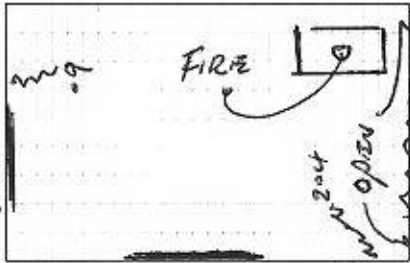
| Room | Earthquake Damage | Walls | Ceiling | Floor | Repair Strategy |
|---|---|---|---|---|---|
| 4.72x3.80<br>Lounge<br>CARPET | Y | ✓ | - | - | Cracks in walls. Rake out stop & paint<br>3 walls only. |

| DESCRIPTION: | Units | Length | Breadth | Depth | Qty | Rate | Cost |
|---|---|---|---|---|---|---|---|
| Lounge: Cracks in walls Rake out, stop, paint. | | | | | | | |

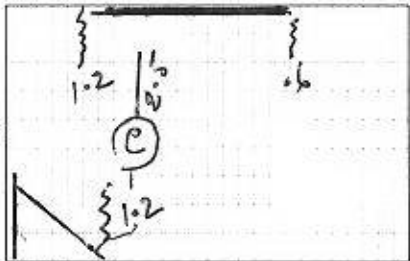
| Room | Earthquake Damage | Walls | Ceiling | Floor | Repair Strategy |
|---|---|---|---|---|---|
| 2.91x3.93<br>Bedroom 2<br>CARPET | Y | ✓ | ✓ | - | Cracks in walls & ceiling. Rake out stop<br>& paint. |

| DESCRIPTION: | Units | Length | Breadth | Depth | Qty | Rate | Cost |
|---|---|---|---|---|---|---|---|
| Bed 2: Cracks to walls + Ceiling<br>Rake out, stop + Paint. | | | | | | | |

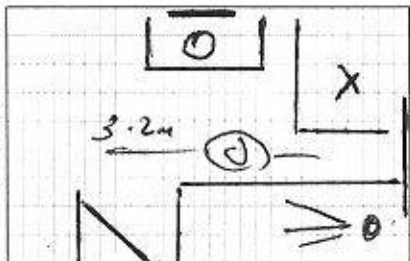
| Room | Earthquake<br>Damage | Walls | Ceiling | Floor | |
|---|---|---|---|---|---|
| 3.53x2.88<br>Bathroom<br>T96 | Y | - | ✓ | - | Crack in ceiling. Rake out, stop, paint |

| DESCRIPTION: | Units | Length | Breadth | Depth | Qty | Rate | Cost |
|---|---|---|---|---|---|---|---|
| Bathroom: Crack to ceiling, Rake out, stop, paint. | | | | | | | |

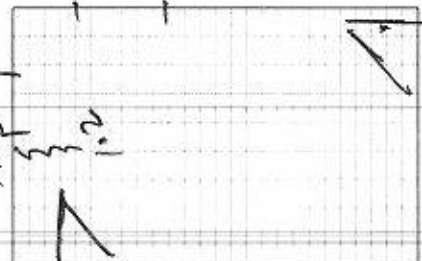
| Room | Earthquake<br>Damage | Walls | Ceiling | Floor | |
|---|---|---|---|---|---|
| 1.06x1.61<br>Entry /<br>Hall(s)<br>CARPET | Y | ✓ | - | - | Crack in walls. Rake out, stop & paint |

| DESCRIPTION: | Units | Length | Breadth | Depth | Qty | Rate | Cost |
|---|---|---|---|---|---|---|---|
| Hall: Crack to walls, Rake out, stop, paint. | | | | | | | |

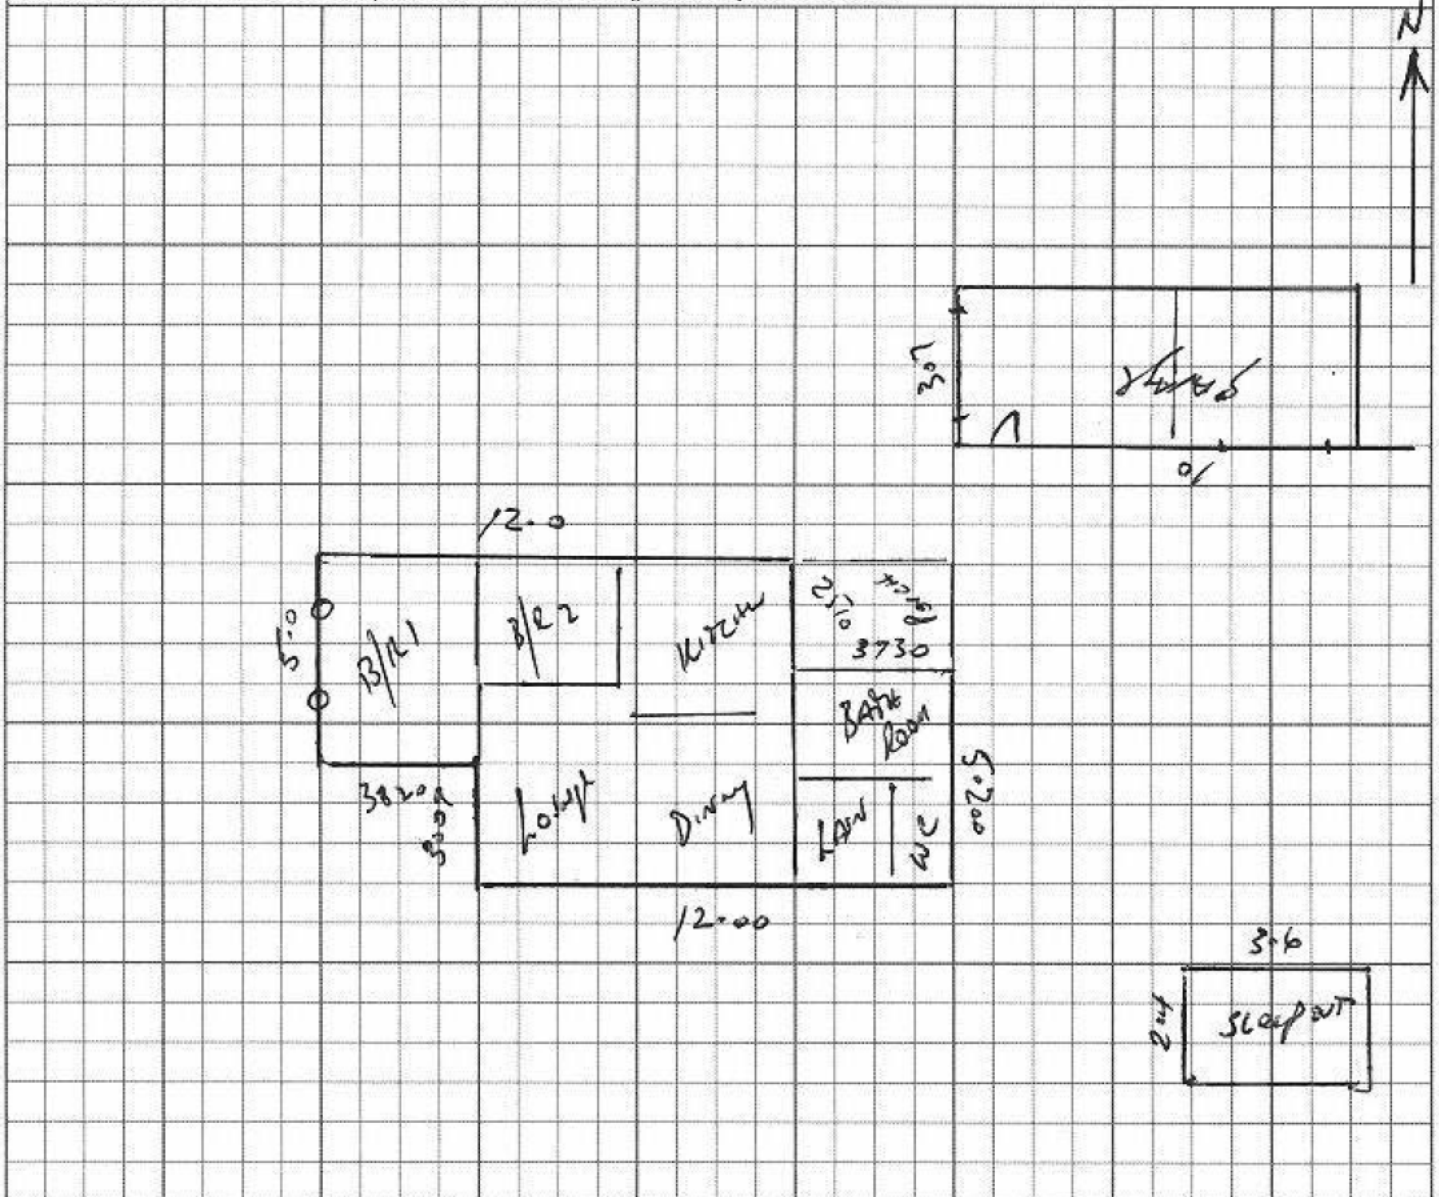
PLAN SKETCH OF PROPERTY (identify each room, indicate damage). Attach photo if available

φ = EXISTING CRACKS TO Ring FOUNDATION.
