# Pataha Creek – PALS and BDAs

# Tucannon River – Project Area 10

# Little Tucannon River – Post Assisted Log Structures

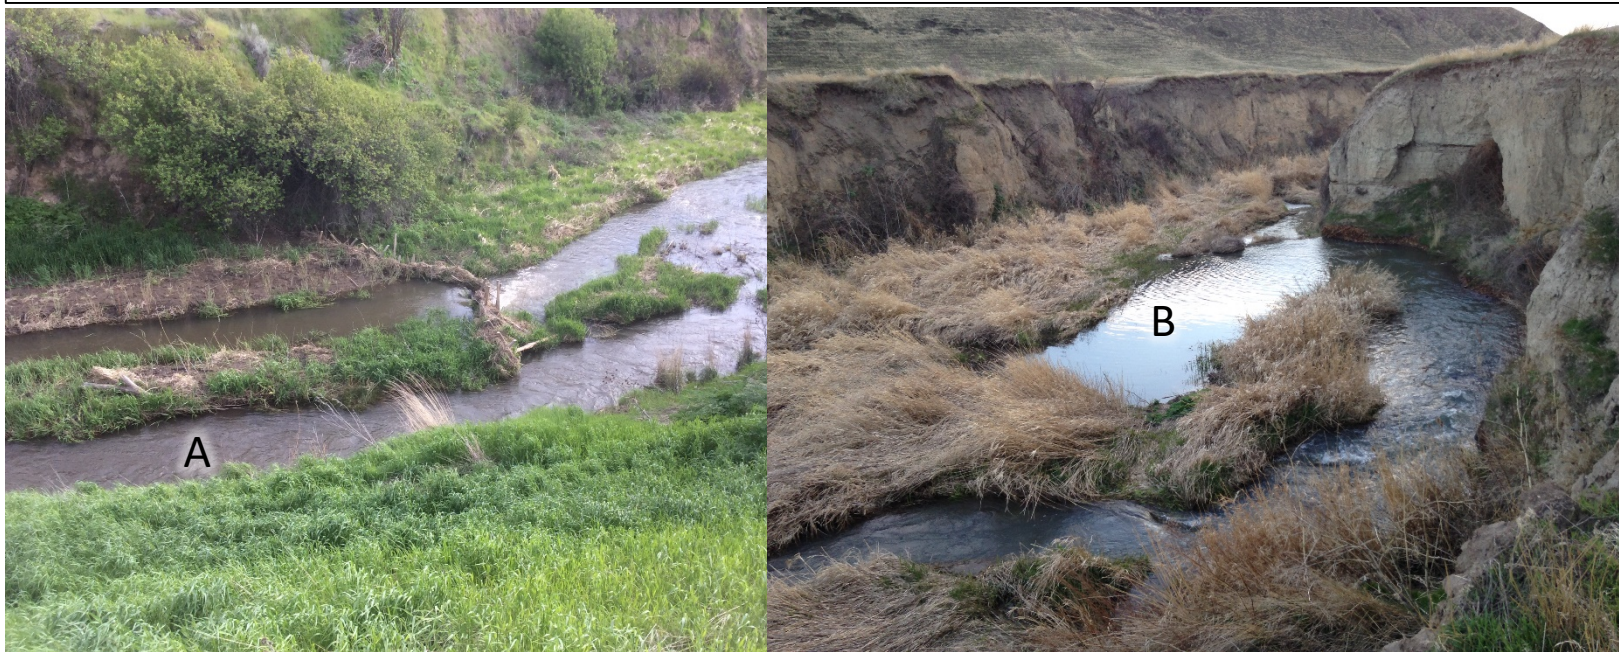
**Figure 1.** Two BDA structures on Pataha Creek during receding high flows. Note A) activated side channel and B) ponding upstream of BDA. Areas such as these were heavily planted with willow and cottonwood whips and poles to take advantage of increased water retention and fresh fine sediment deposits.

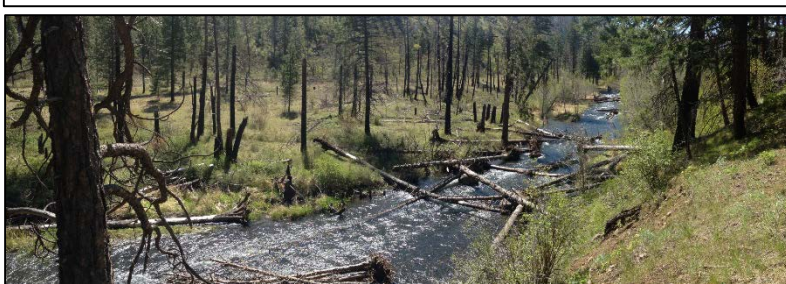
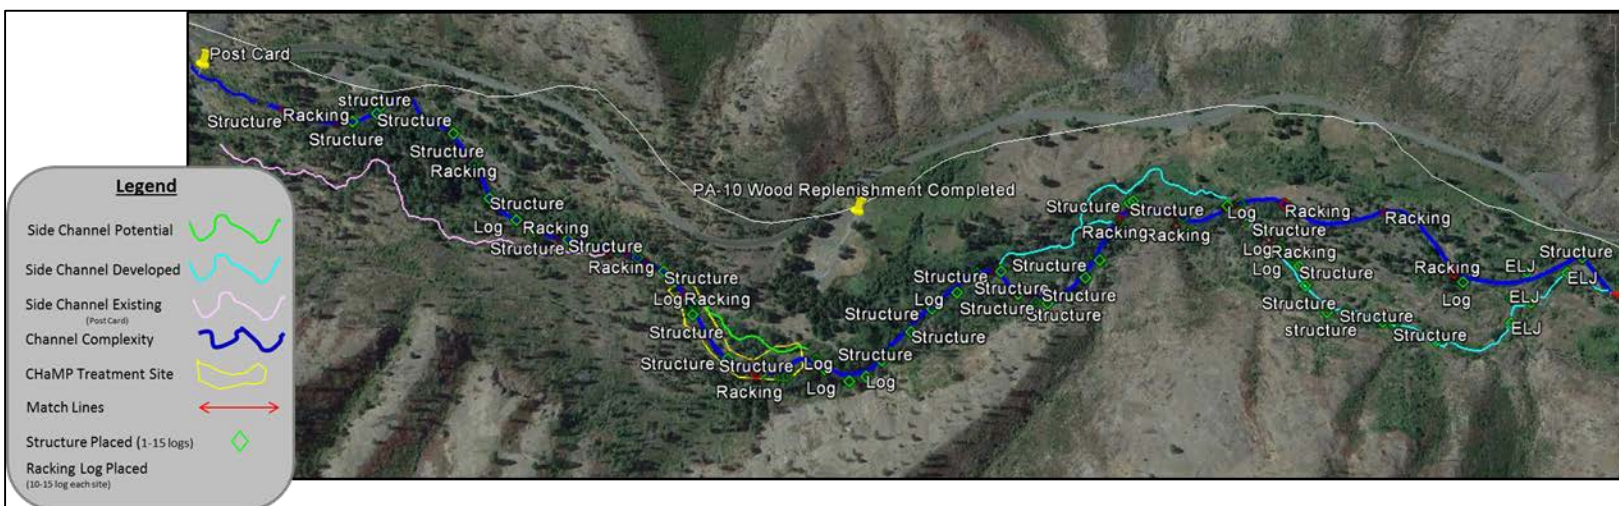
**Results:** Monitoring results at the CHaMP site show an increase in key (>.3m D, >6m L) LWD pieces as well as pool frequency and percent pools compared to pre-treatment results. After high flows in winter 2017, one new side channel formed and another became reconnected. Pre and post treatment comparisons are shown in the table to the right.

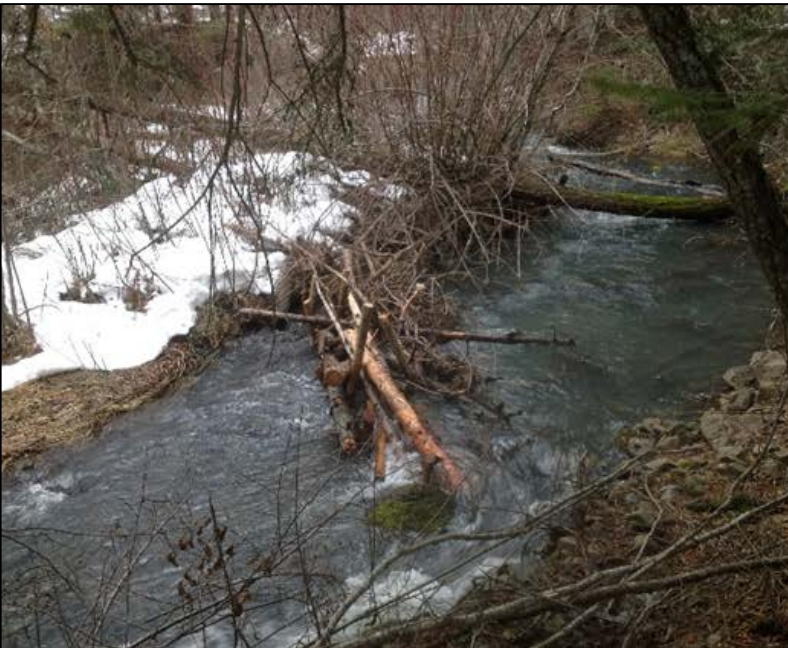
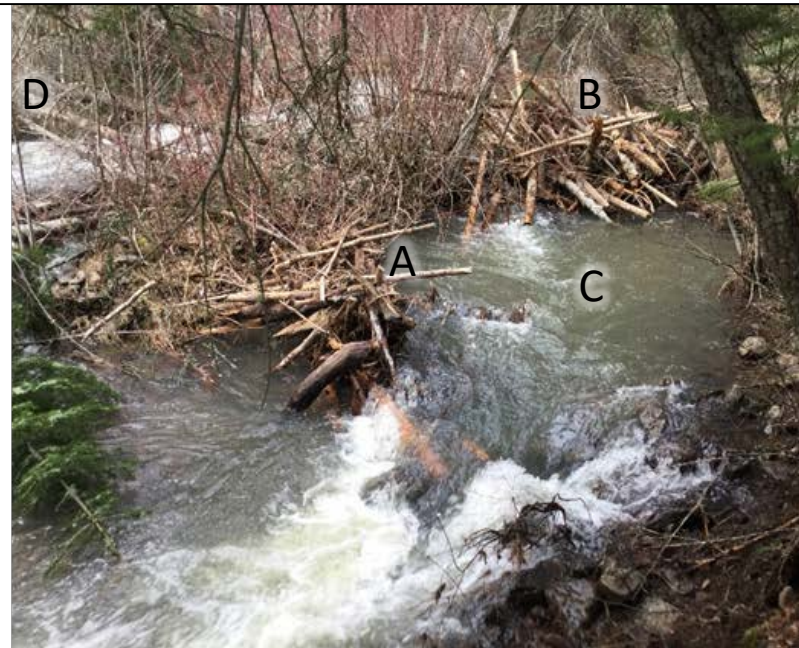
**Results:** During the high flows of winter 2017, several structures were lost, primarily in the lower treatment section. The majority of LWD from these structures accumulated on downstream structures or on LWD spanners creating complex debris jams. Structures that resisted the high flows show evidence of bed aggradation upstream of structures, LWD accumulation on structures, and pool forming scour downstream of structures creating more of a step-pool character compared to the plane-bed character the channel exhibited prior to PALS installation.

**Figure 1.** Pre (Feb. 2017; left photo) and post (March 2017; right photo) high flow images of PALS 48. In the post high flow photo, note A) debris accumulation on the original PALS, B) debris from failed upstream PALS on the upstream large wood spanner, C) pool formed upstream of structure/downstream of debris jam, and D) activated side channel in the far background.
