## PHOTOMONITORING

### Photopoint 1, facing north

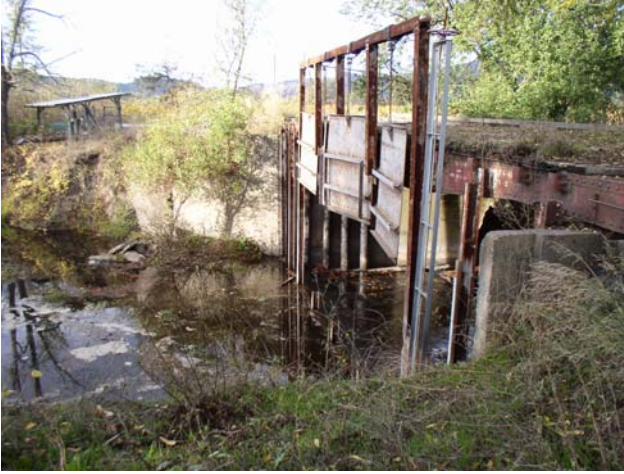
Pre-construction: This old seasonal water retention structure including bridge, wing walls, and sill were removed because it acted as a low-flow barrier to steelhead and Chinook. (July 2007)

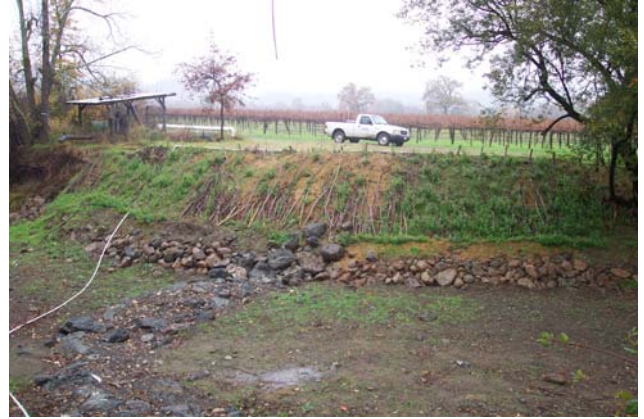
Post-construction: Banks were laid back and stabilized with willow brush mattress and toe rock along the north bank. This boulder weir was installed in place of the sill at a height that is passable for fish passage. (Dec. 2007)

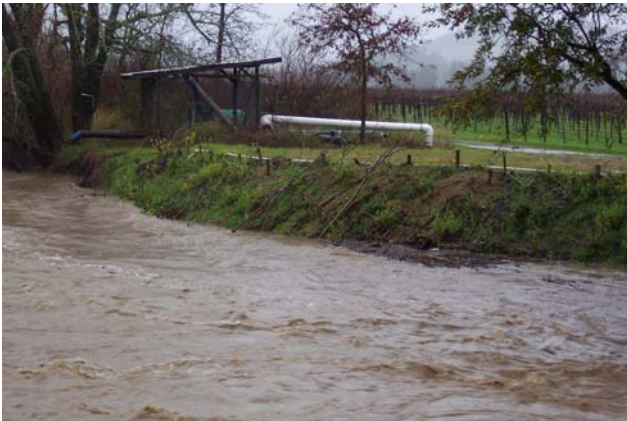
Site observed during first high flows of the season where the water level was just several feet from the top of bank. (January 4, 2008)

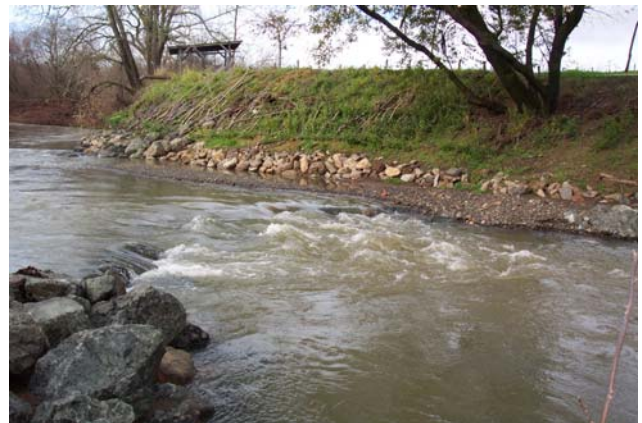
Site observed after flows subsided. No major erosion noted and flows were being directed toward the center of the channel and a pool created. (January 8, 2008)

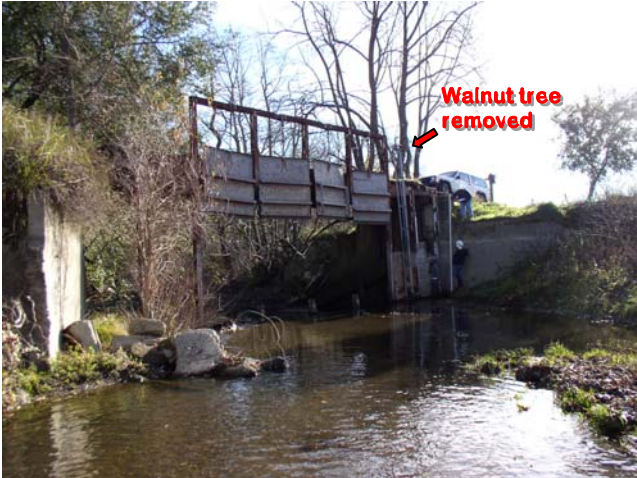
### Photopoint 4, facing south

Pre-construction: Looking at the other side of the old seasonal water retention structure. To accommodate the design, a California black walnut was taken down. (July 2007)

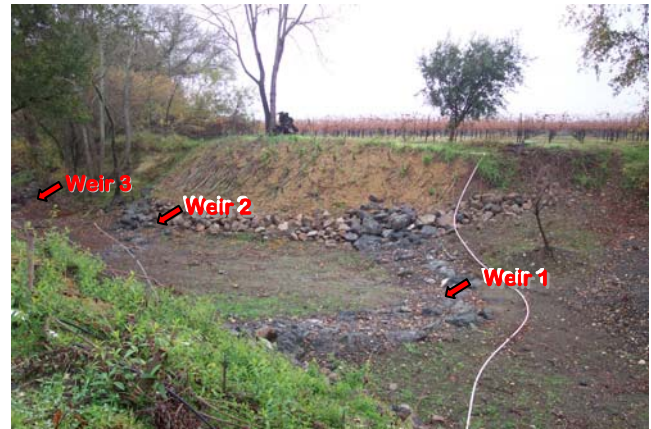
Post-construction: Banks were laid back and stabilized with willow brush mattress and toe rock. Three boulder weirs were installed to allow for easier fish passage and to stabilize the grade of the channel. (Dec. 2007)

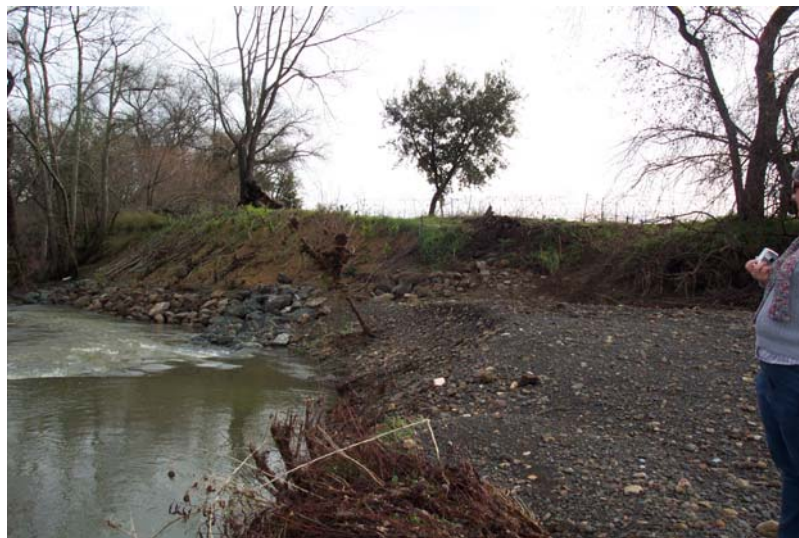
Site observed after flows subsided. Minor erosion of the willow mattress was noted along with variable sediment movement on the gravel bar. (January 8, 2008)

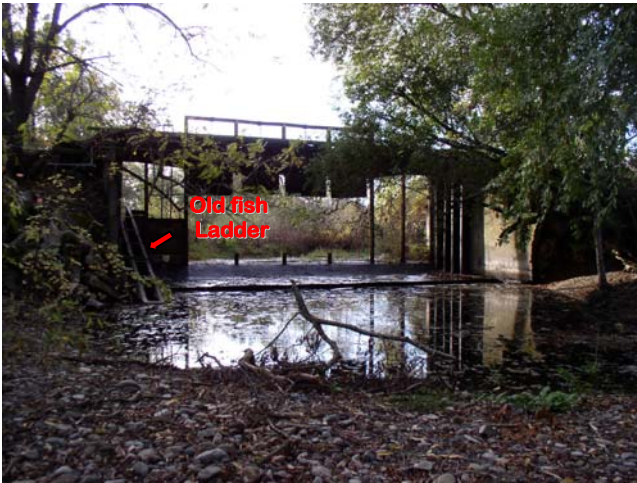
### Photopoint 6, facing west

Pre-construction: Facing upstream at barrier, towards concrete sill and apron of the structure which were all removed in addition to the fish ladder on left. (July 2007)

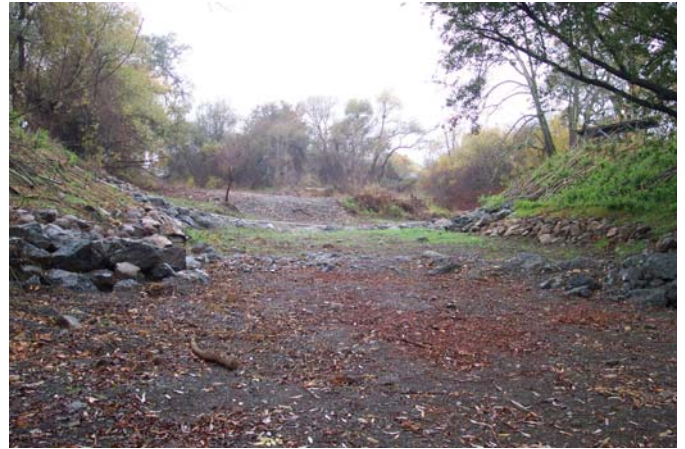
Post-construction: View facing upstream towards remaining gravel bar from 3<sup>rd</sup> most downstream weir. (Dec. 2007)

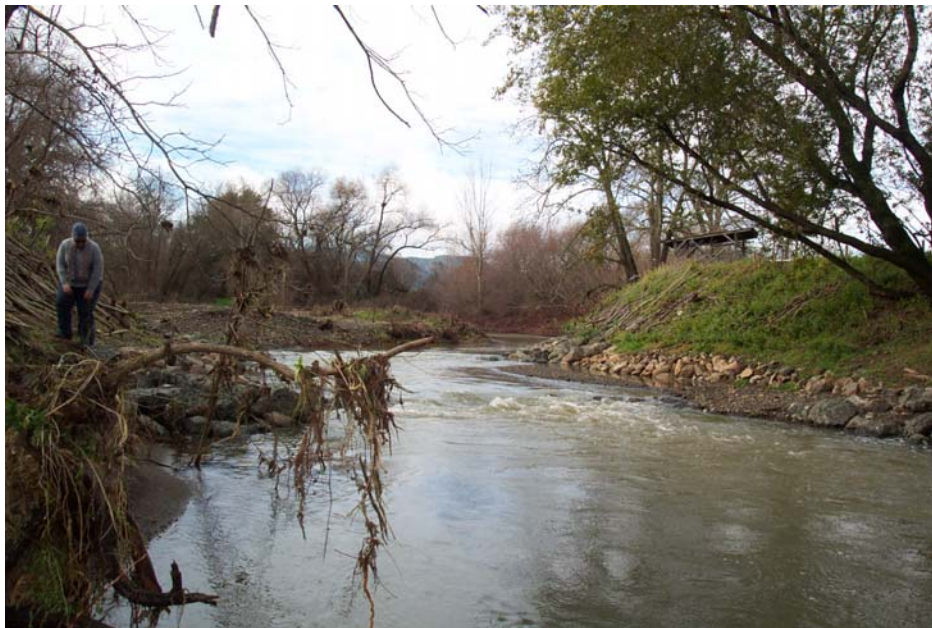
Assessing the site after the rains... January 8, 2008

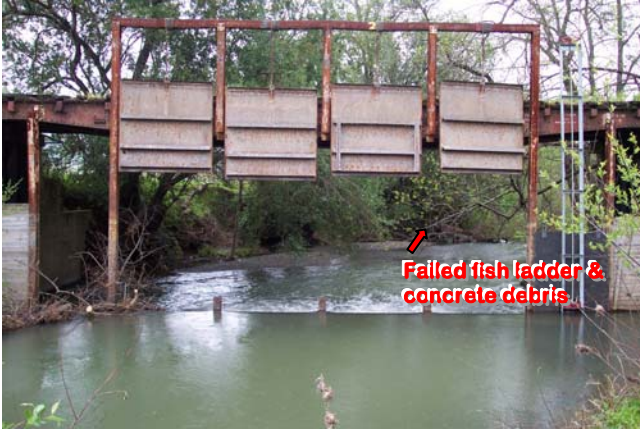
### Photopoint 7, facing east

Pre-construction: Facing downstream, towards metal gates. A 2<sup>nd</sup> washed out fish ladder and concrete debris downstream of the structure were also removed. (July 2007)

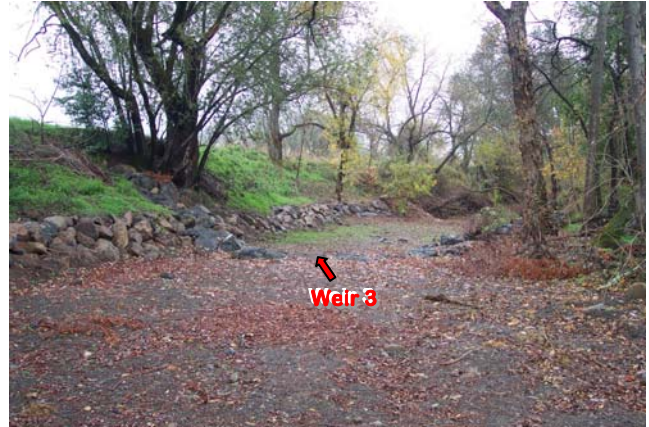
Post-construction: View facing downstream from 2<sup>nd</sup> vortex weir towards 3<sup>rd</sup> weir. Note construction of willow brush mattress and toe rock along left bank. (Dec. 2007)

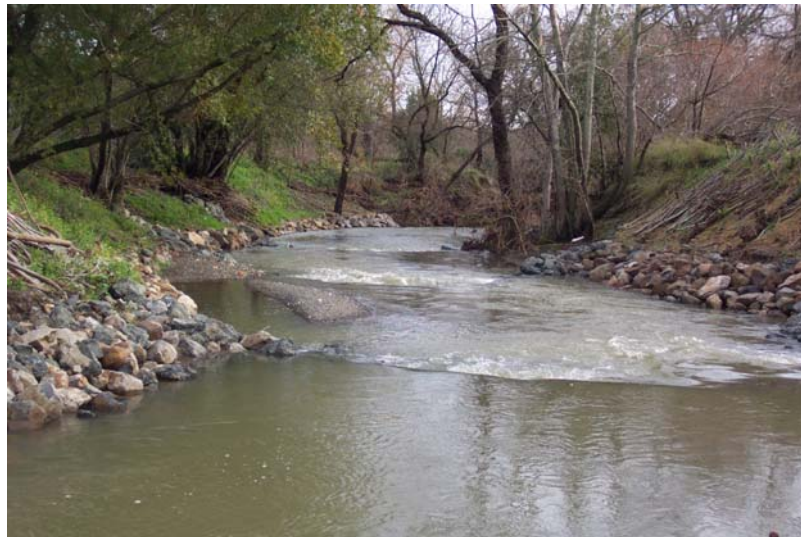
After first rains looking downstream, with all 3 weirs being visible. Note channel thalweg is meandering nicely in the center of channel and fish-passable pools are being scoured in front of the weirs. (January 2008)
