# **Trout, Uninterrupted:**

## **Assessment and Monitoring of the Mills Creek Dam Removal**

LAEP 227 Univ Calif Berkeley  
Dec 2000

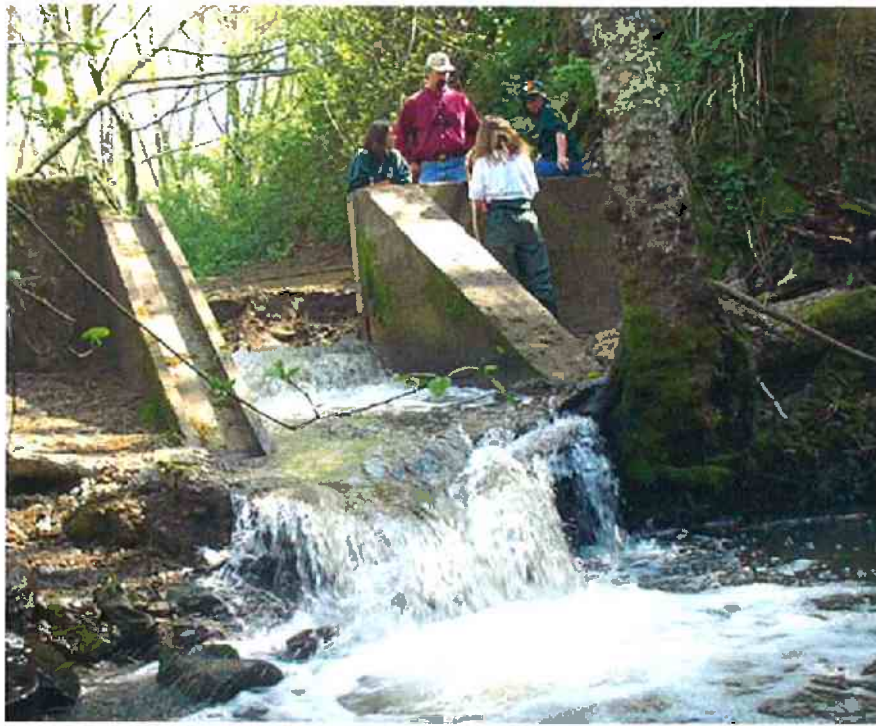
**Photo 1:** The dam as it appeared on March 17, 2000. After the 1997 construction was halted, all but one flashboard were removed from the dam.

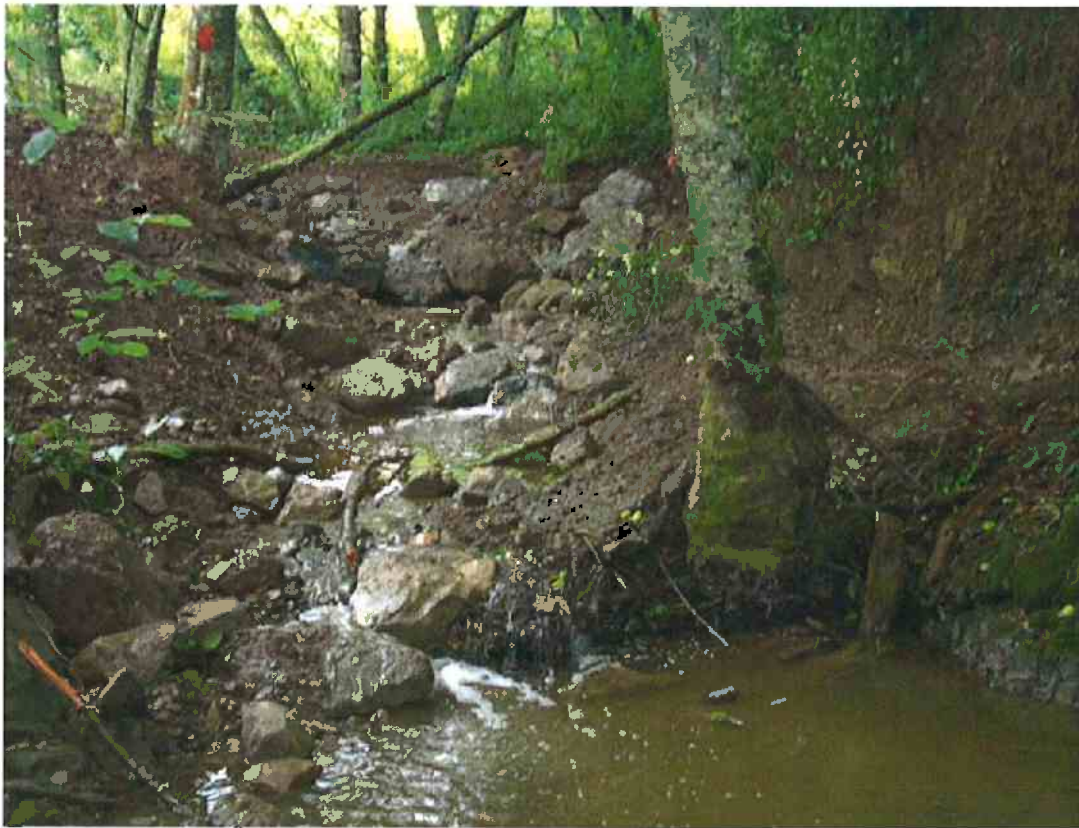
**Photo 2:** Post-removal view of the dam reach.

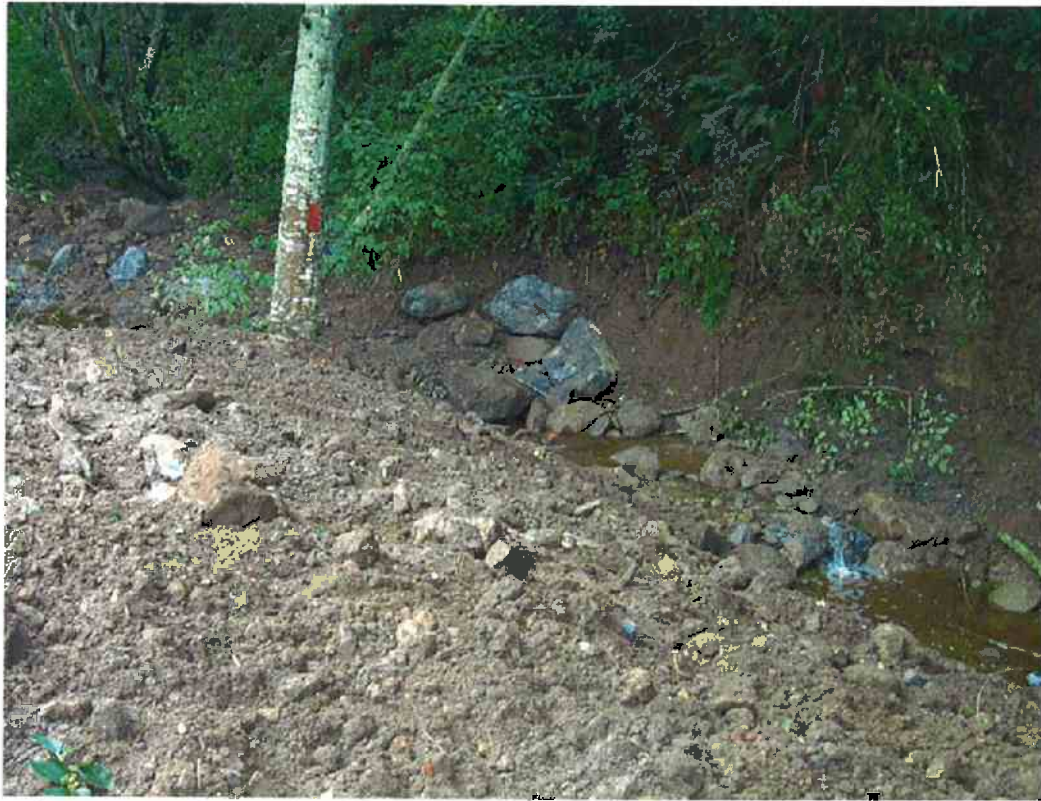
The initial site visit was conducted during the end of the construction phase. Construction equipment was still on the site, and site work had not yet been completed. Channel slopes were bare where construction equipment had disturbed them. There were no erosion control features in place, and no method of stabilization was in place for disturbed banks. Two alders were damaged from the construction, having noticeable gouges in their trunks (labeled A and B on the plan view sketch). Tree A appeared to be unstable with much of the root structure exposed as a result of having been disturbed by the excavator. Overall, the site was very muddy. The netting to prevent fish passage into the project reach was still in place. The area disturbed in 1997 was fully vegetated with native species. The location of the former dam was not obvious. The step-pool morphology looked appropriate for fish migration since the vertical drop never exceeded three feet.

**Photo 3:** Taken on September 22, 2000, this photo shows the disturbed condition of the site immediately following the dam removal.

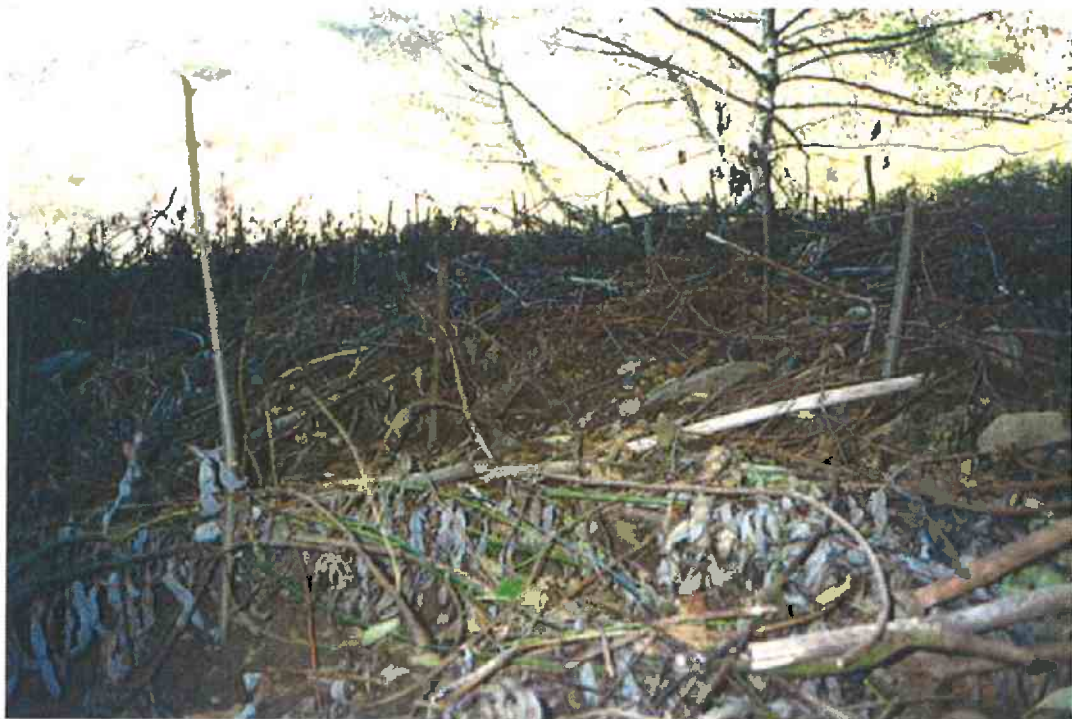
The revegetation and bank stabilization we observed at the site also merits discussion. Immediately following the destruction of the dam, the site was very muddy and erosion seemed highly probable. By the second site visit, clippings from nearby trees had been strewn on the banks as an attempt at stabilization and revegetation. This approach seemed inadequate to protect the banks from erosion; also the resulting possibility of long-term revegetation was questionable. Fortunately, by the fourth visit alder poles had been planted and the ground was covered in hay. The alder poles and hay seemed more likely to contribute to bank stabilization and revegetation as evidenced by the improved gravel conditions observed in the pools on this date as compared to prior site visits.

**Photo 4:** Efforts towards bank stabilization and revegetation had improved by the November 20, 2000 site visit. Cuttings from local vegetation had been strewn on the banks and willow poles had been planted.

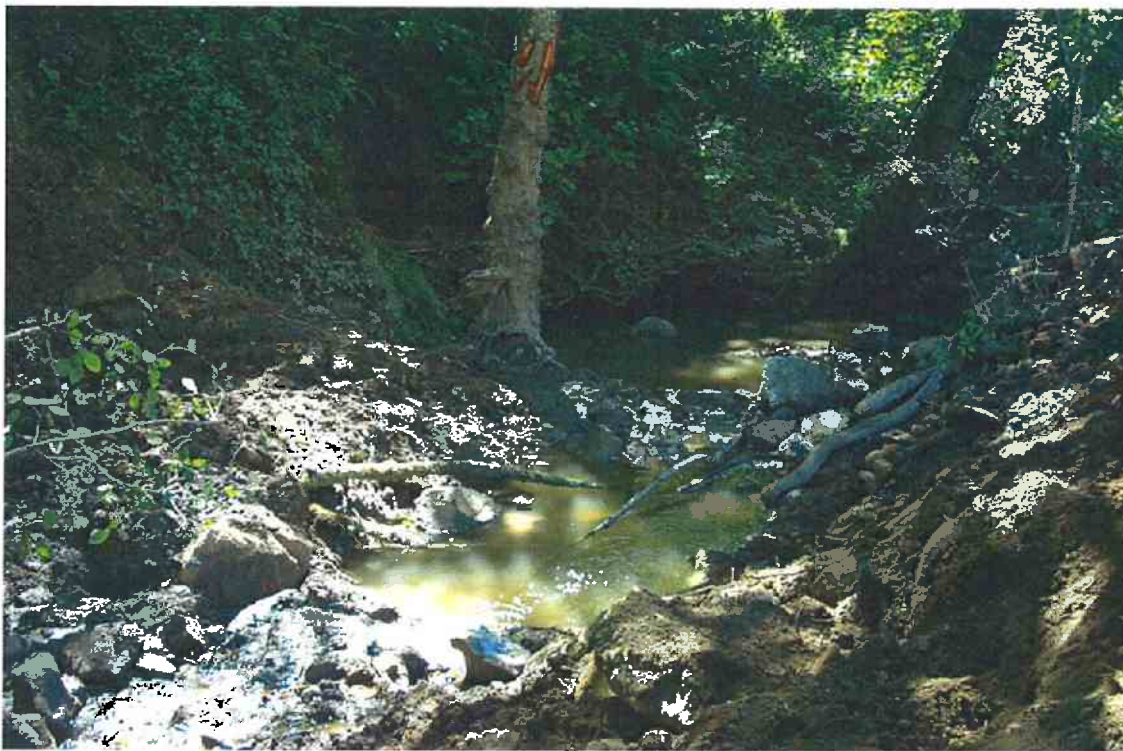
**Photo 5:** This post-dam removal shot shows an alder tree on the left bank that was scarred during construction.

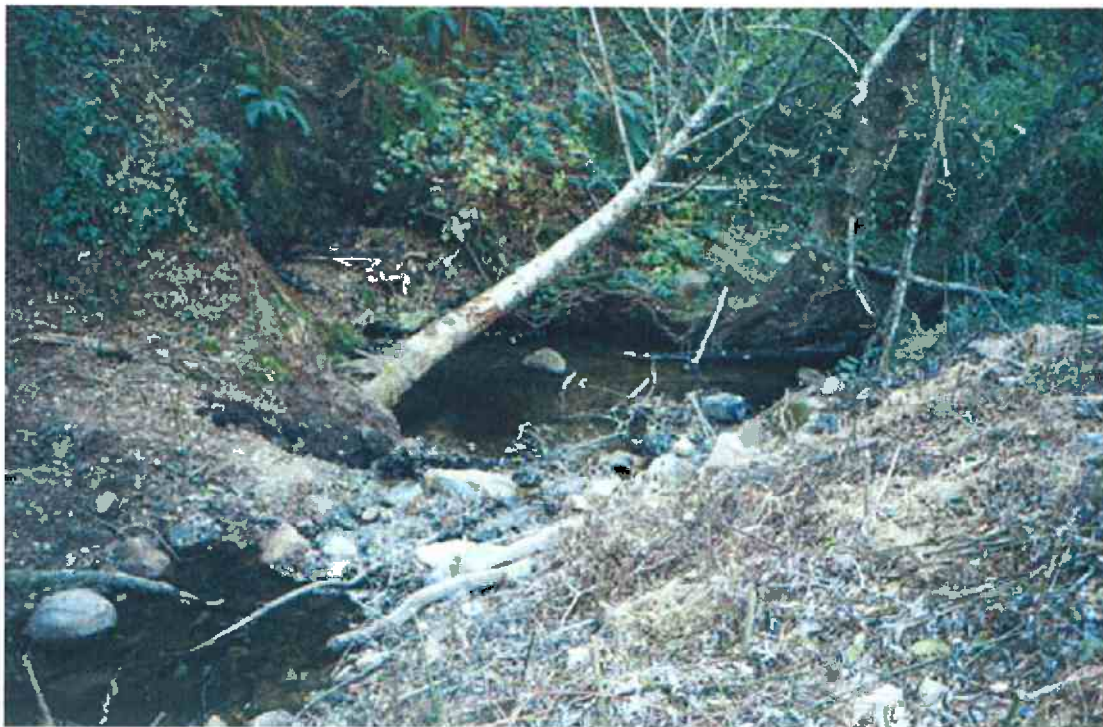
Several days of heavy rains occurred between October 9 and November 11. The fine sediment appeared to have been flushed out of the pools leaving a more varied grain size distribution of mostly courser grained gravel. The disturbed banks had been revegetated with alder poles, and slopes were further stabilized with hay. Tree A had fallen and was resting on the left bank.

**Photo 6:** By the November 20, 2000 site visit, the tree had fallen over, most likely due to changes in the bank that occurred following the dam removal.

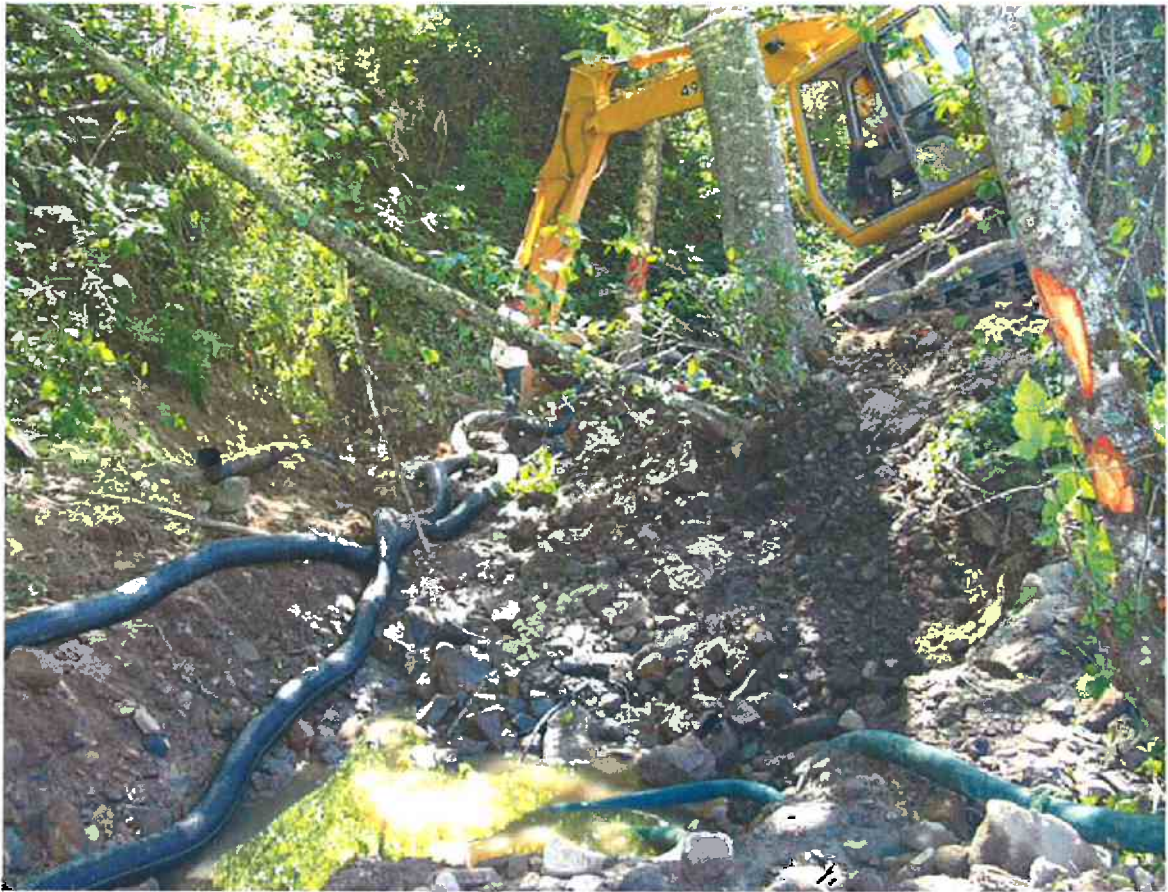
**Photo 7:** During the 2000 construction phase, the river was diverted through pipes. Excavation was used to establish a pool-riffle sequence.
