Implementing a long-term monitoring system on the restored Conococheague Creek  
following removal of Birch Run Dam

A Thesis submitted to the  
Geography-Earth Science Department  
and the Graduate Council  
in partial fulfillment of the requirements for the degree of  
Master of Science

Shippensburg University  
Shippensburg, Pennsylvania  
December 2009

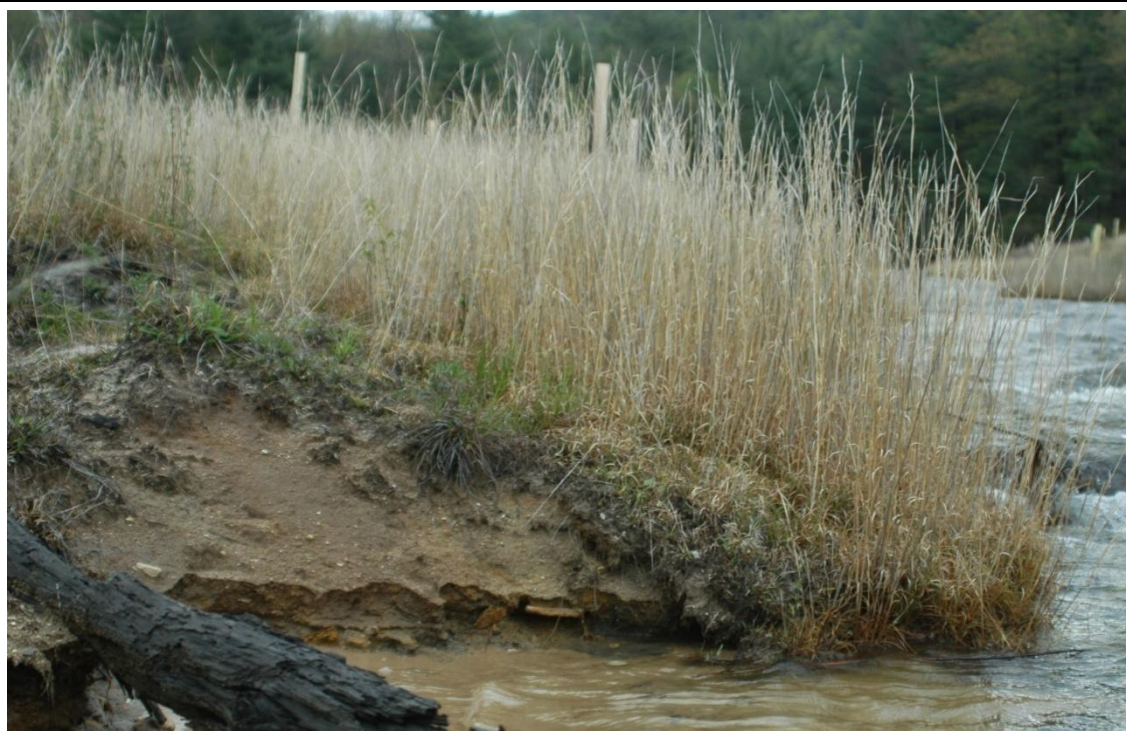
Figure 3. An example of the material deposited near the upstream extent of the former Chambersburg Reservoir behind Birch Run Dam. The image is looking upstream along the right bank of the Conococheague Creek (author's image dated, 07.May.2009).

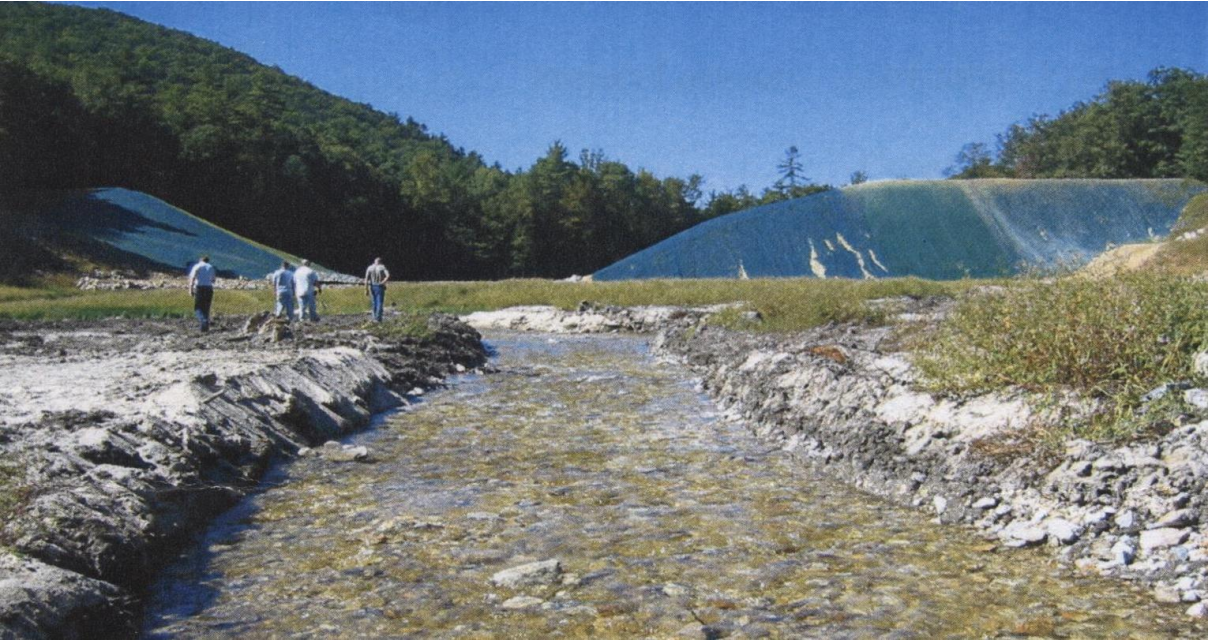
Figure 4. Image of the re-constructed Conococheague Creek channel after activation (DEP file photo dated, 1.February.2006). This image was used as photographic evidence of as-built conditions in order to submit a “Dam Breach Completion Certification” to DEP.

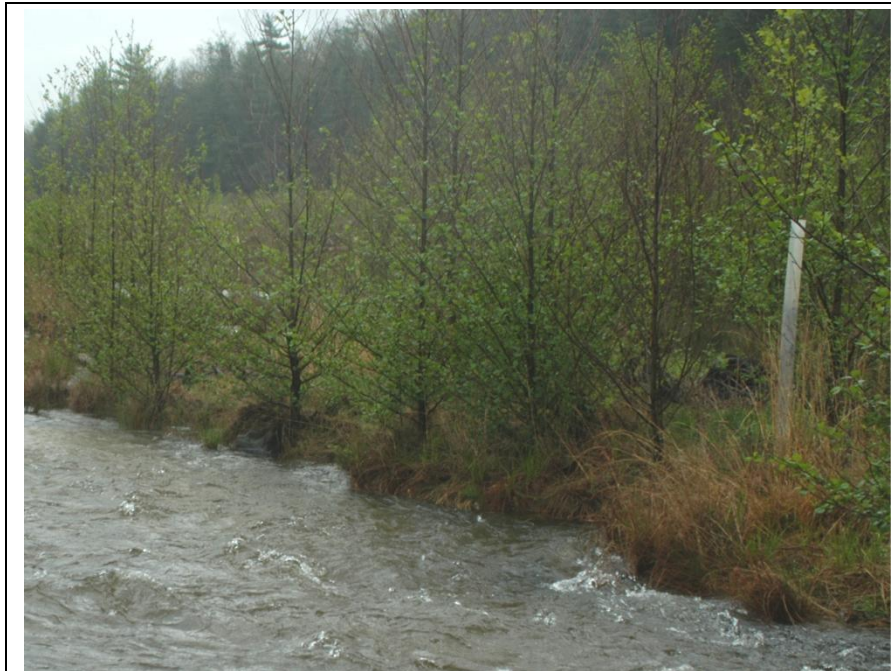
Figure 10. Image of the vegetation on the left bank of the *Alpha* reach. The left side of the channel has a far denser distribution of trees as compared to the right side (author's image dated, 7.May.2009).

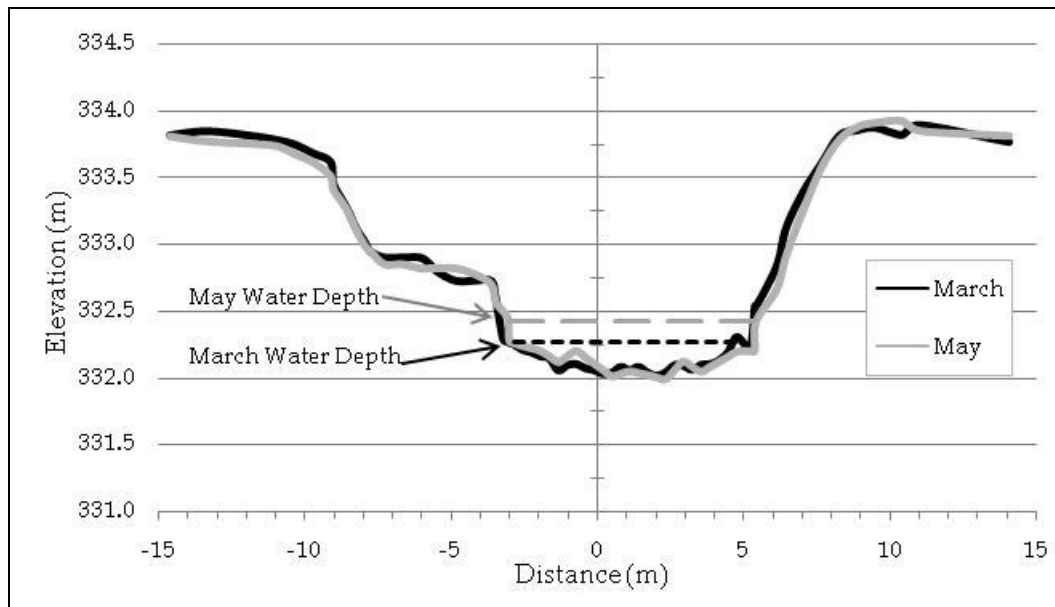
The channel cross-section was measured with an automatic level as described in the Methods Chapter. During both field visits the automatic level was located on the flood plain above the right bank, downstream of the cross-section. The channel cross-section in the *Bravo* reach was approximately 9.4 m wide at the lower bank height (elevation 332.6 m) and 20.2 m wide at the top bank (elevation 333.8 m; Figure 12). The lower and upper banks were 0.5 m and 1.7 m above the channel bottom respectively. Water depth increased during the May field visit by 80% as compared to the March measurements, while the water width remained 8.4 m during both field visits (Table 9).

Figure 12. Comparison of the Bravo channel cross-sections observed during two field visits (March and May 2009) to the Conococheague Creek.

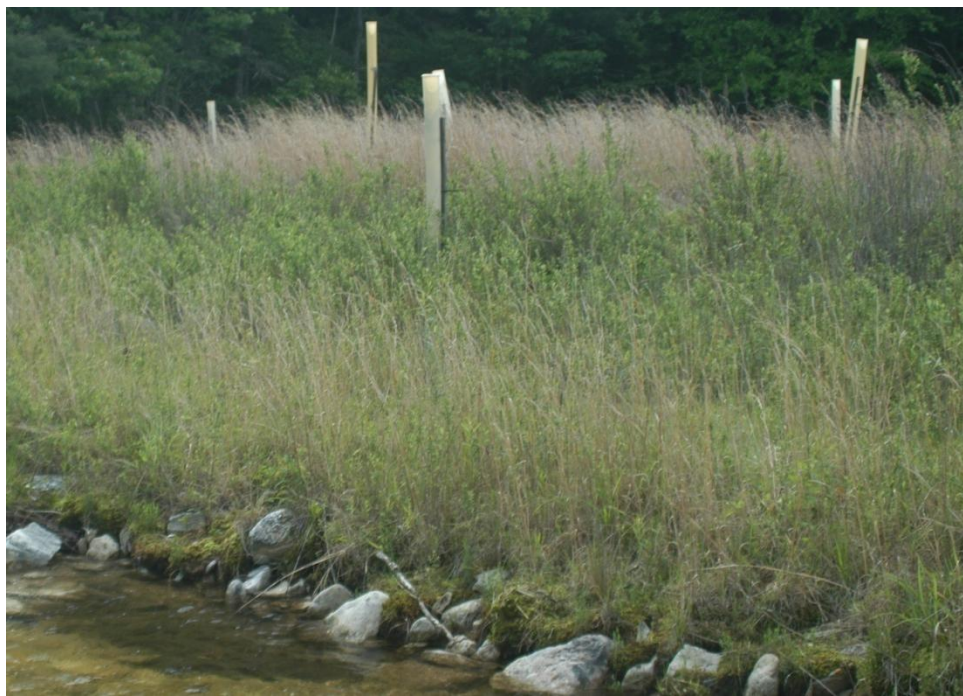
Figure 13. Image of the vegetation along the left bank of the *Bravo* reach. Note the slight change to shrubs at the toe of the upper bank and then returning to grass on the flood plain (author's image dated, 29.May.2009).

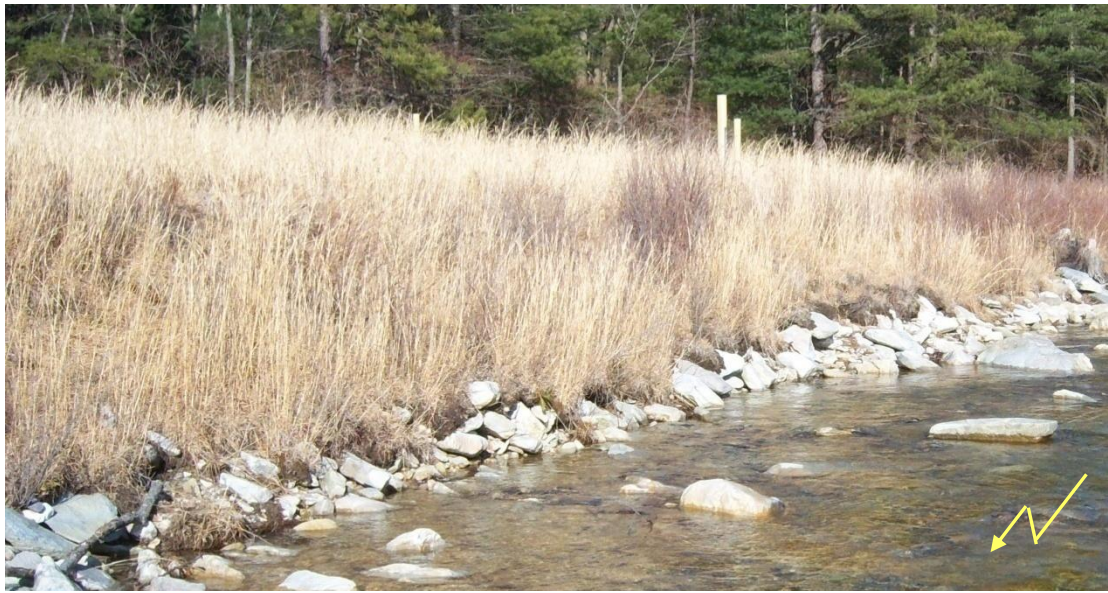
Figure 14. Image of the cobble-sized armoring along the right bank of the *Bravo* channel. Grasses are dominant cover along the majority of the bank (author's image dated, 05.March.2009).

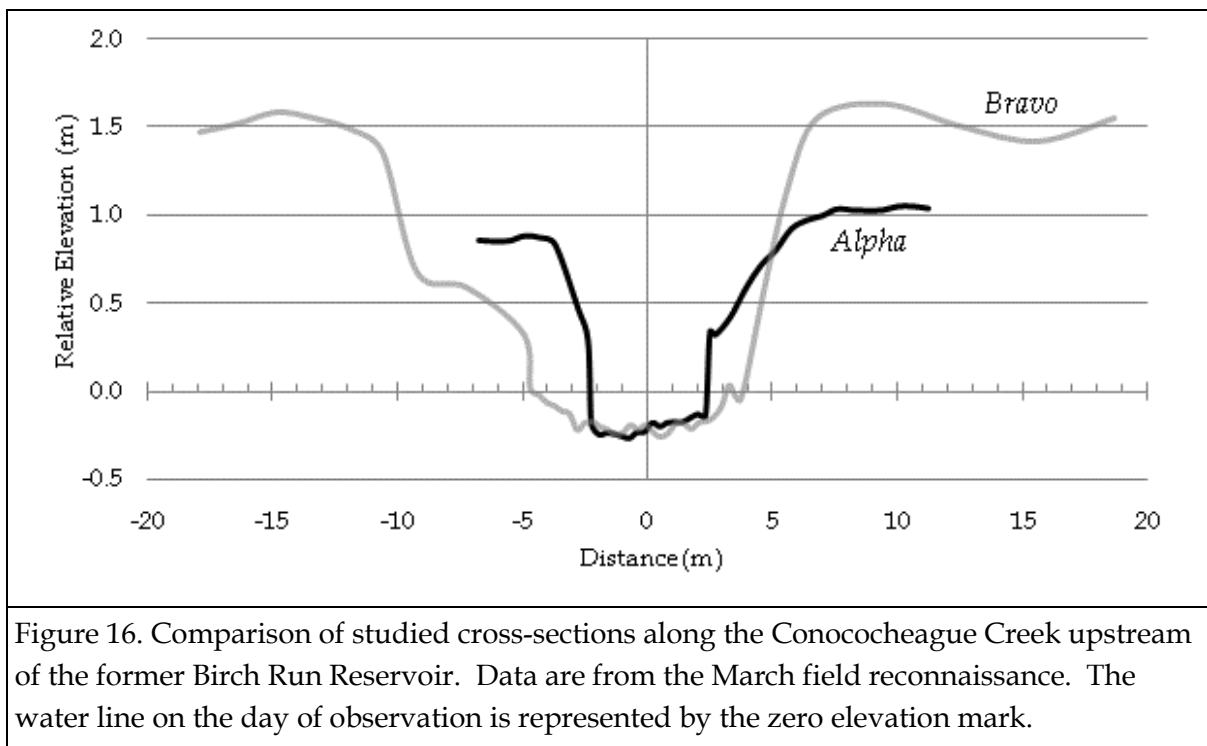
Evidence of undercutting and slope failure at the *Alpha* and *Bravo* reaches, respectively, indicate differing bank responses to high flow events. The banks of the *Alpha* reach are comprised of cohesive material, thus the entire bank does not fail in response to erosive action (parallel or impinging flow). The *Alpha* bank is undercut which displays exposed tree sapling roots in the riparian zone and previously buried stumps. If the entire undercut area of the *Alpha* left bank fails, the channel width could increase by 0.5 m (10%). The increased cross-sectional area could have dramatic impacts on the connectivity of the channel with the flood plain. The cohesive clays that comprise the banks, in addition to the sapling roots, are currently preventing collapse.

The non-cohesive materials along the *Bravo* reach are more vulnerable to erosional and geotechnical failures than the silty clays found at the *Alpha* reach. Scallop along the length of the channel provide evidence of past bank failures. These failures occur when shear stress is greater than shear strength (Ritter et al. 2002). Two potential mechanisms for high shear stress values in the *Bravo* reach are steep bank angles and the removal of underlying support. The 75 degree angle of the right bank (Appendix III) combined with the coarse sands comprising the bank raise the likelihood that the summed shear stresses

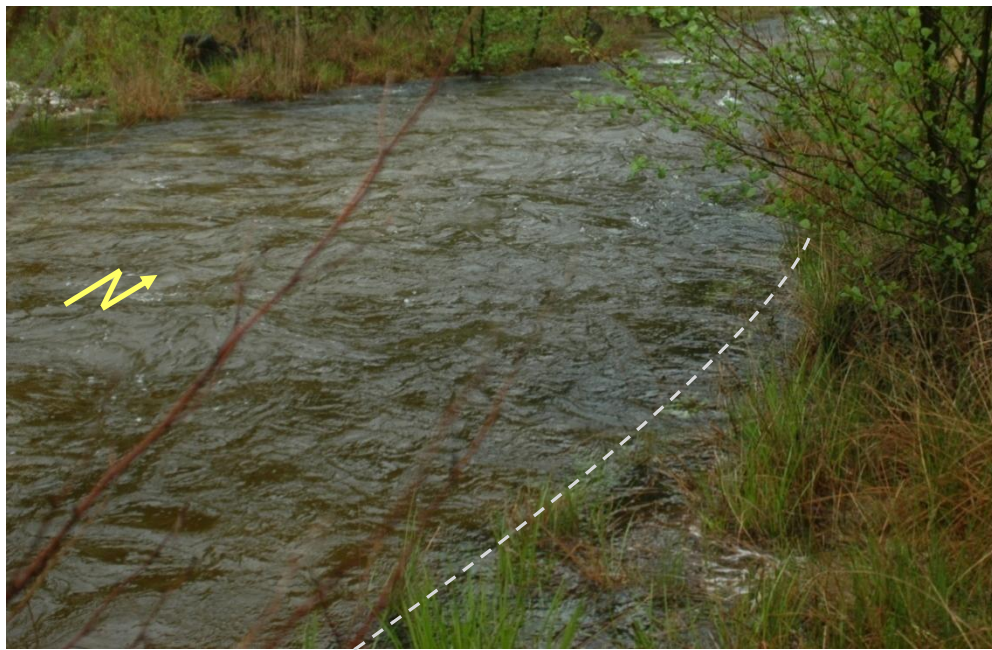
Figure 17. Image of the *Alpha* reach flowing slightly above the lower bank following 7.9 cm of rain over five days. The location of the lower bank edge is approximated by the dashed line (author's image dated, 07.May.2009).

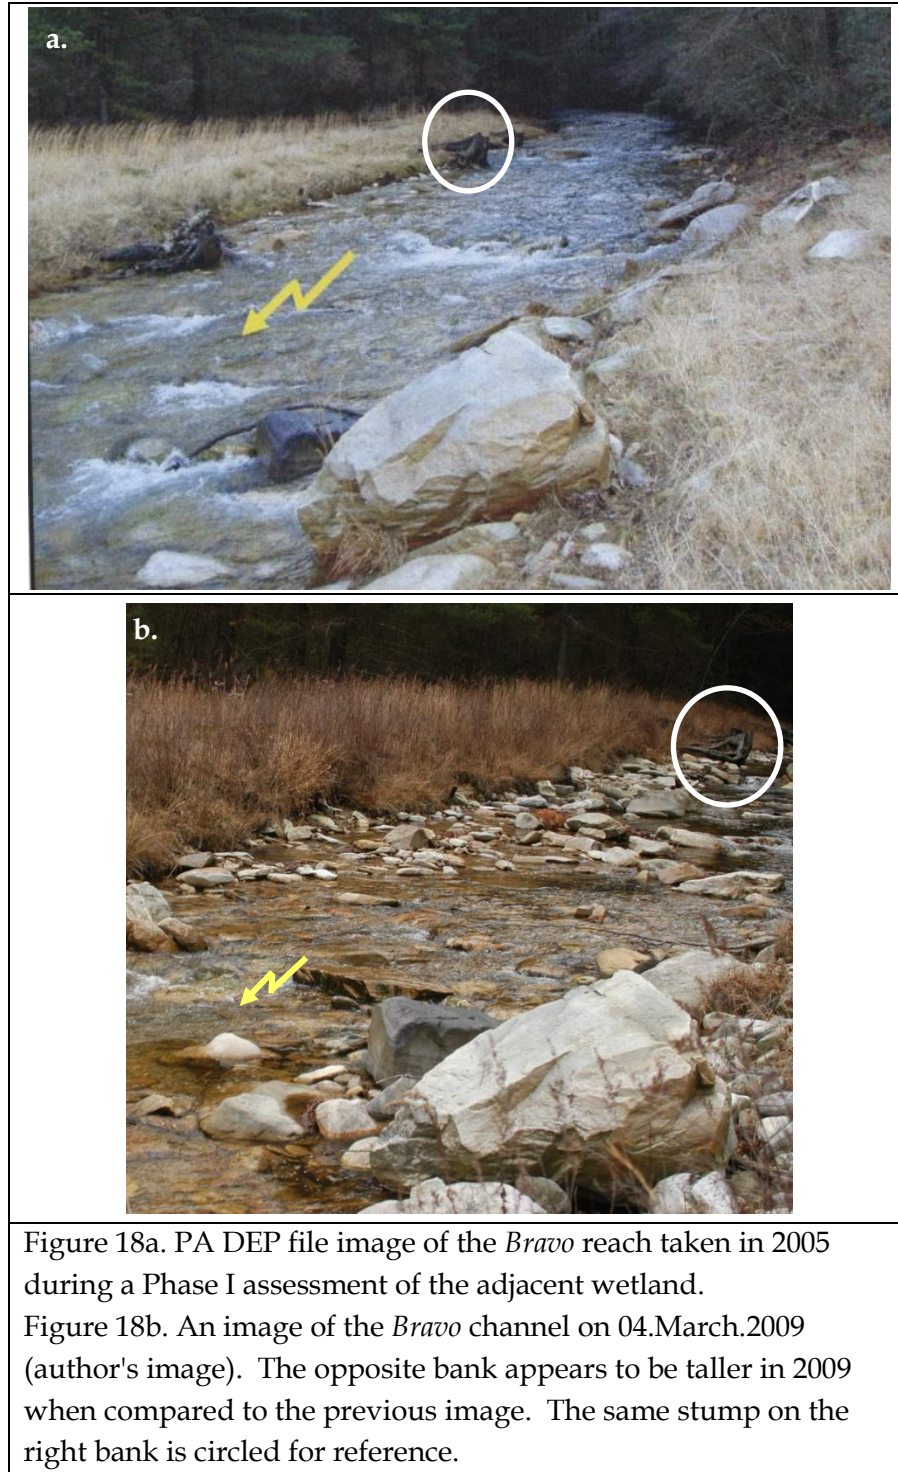
The *Bravo* reach appears to be shifting from the 'Degradation Stage' (Stage III) to the 'Threshold' Stage (Stage IV) of the Simon and Hupp (1986) CEM. Stage III is characterized by taller/steeper banks; pop-out failures, and a lack of alternate bars. Stage IV is dominated by mass wasting, while bed erosion may still continue. All of these conditions appear to be

present along the *Bravo* reach. A photograph of the *Bravo* reach (Figure 18a; PA DEP file photo dated, 13.January.2005) taken during a Phase I assessment of an adjacent wetland provides insight into the evolution of the stream channel over the last four years. The right bank observed in 2009 appears to be heightened and steeper compared to the right bank in

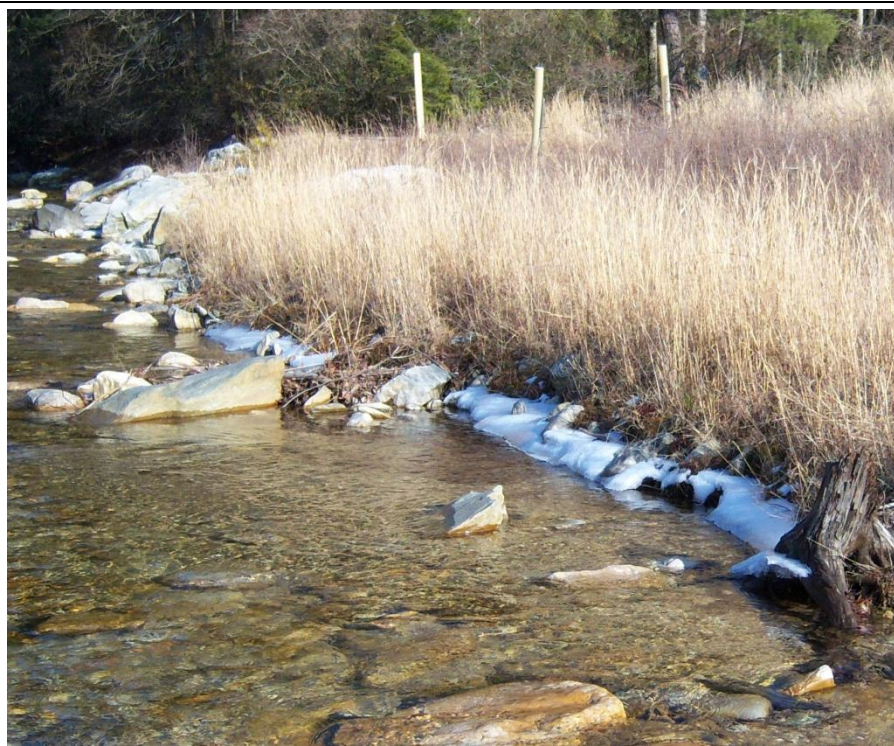
Figure 19. Image of sand and gravel deposited along the left bank of the *Bravo* reach. Future growth and established permanence of this deposit may indicate an increasingly stable channel form (author's image dated, 5.March.2009).

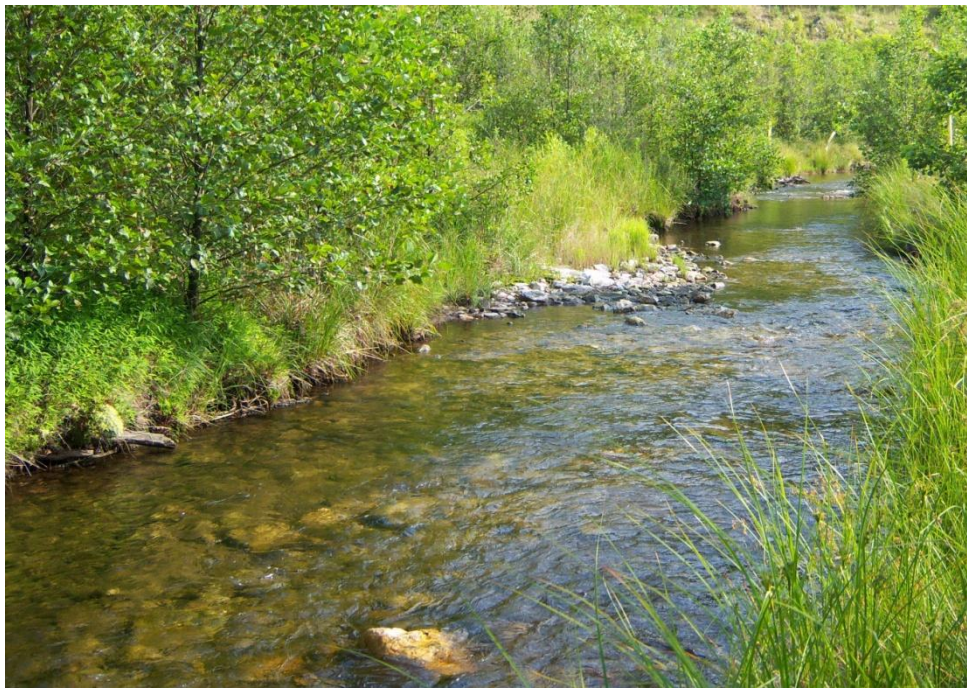
Figure 21. Image of point-bar development downstream of the *Alpha* reach of the Conococheague Creek. Note the colonization of vegetation on the point bar (author's image dated, 9.July.2009).
