Attachment E

Dive Report

Iron Gate Dam, Copco 1 Dam, and JC Boyle Dam are three facilities owned and operated by Pacific Corp, a subsidiary of MidAmerican Energy Holdings Company, that were examined by the Bureau of Reclamation Pacific Northwest Underwater Inspection Team members from April 12 through 16, 2010.

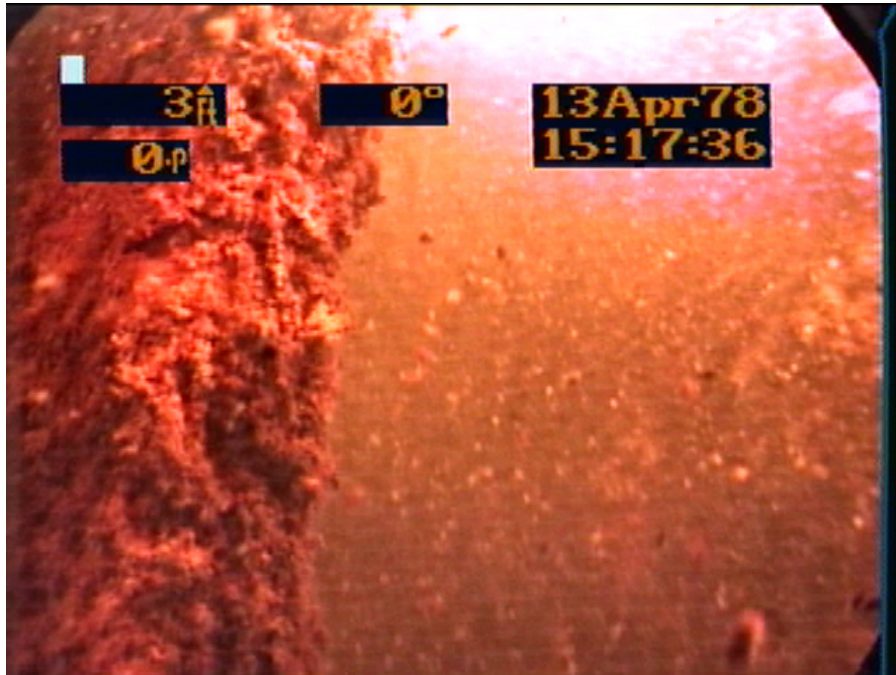
The intake structure at Iron Gate Dam should be periodically inspected by ROV to determine if the rust nodules and algae growth are increasing with time, possibly reducing the structure’s capacity to release flows. At this time it did not appear that the capacity of the intake structure is reduced. The intake concrete appeared to be in satisfactory condition.

**Photograph No. 9** ROV captured video image showing example of organic debris coating the trashrack bars on the outlet intake structure at Iron Gate Dam (Note: Date, time, and depth readings are not accurate). **Bureau of Reclamation - Pacific Northwest Underwater Inspection Team. Iron Gate Dam, Klamath Hydroelectric Project, Oregon-California – April 12-16, 2010.**

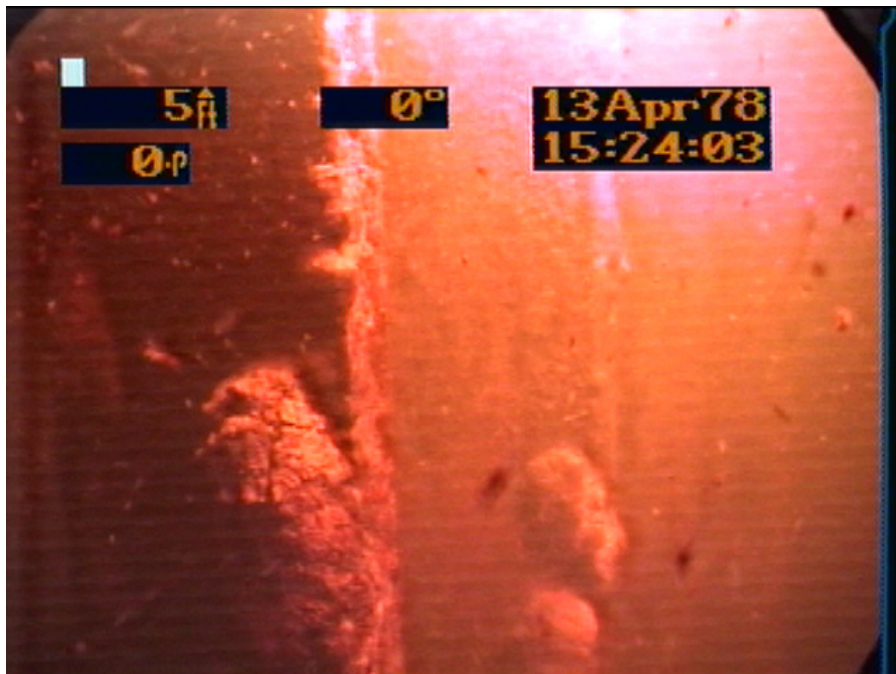
**Photograph No. 10** ROV captured video image showing example of rust nodules found on trashrack surface (Note: Date, time, and depth readings are not accurate). **Bureau of Reclamation - Pacific Northwest Underwater Inspection Team. Iron Gate Dam, Klamath Hydroelectric Project, Oregon-California – April 12-16, 2010.**

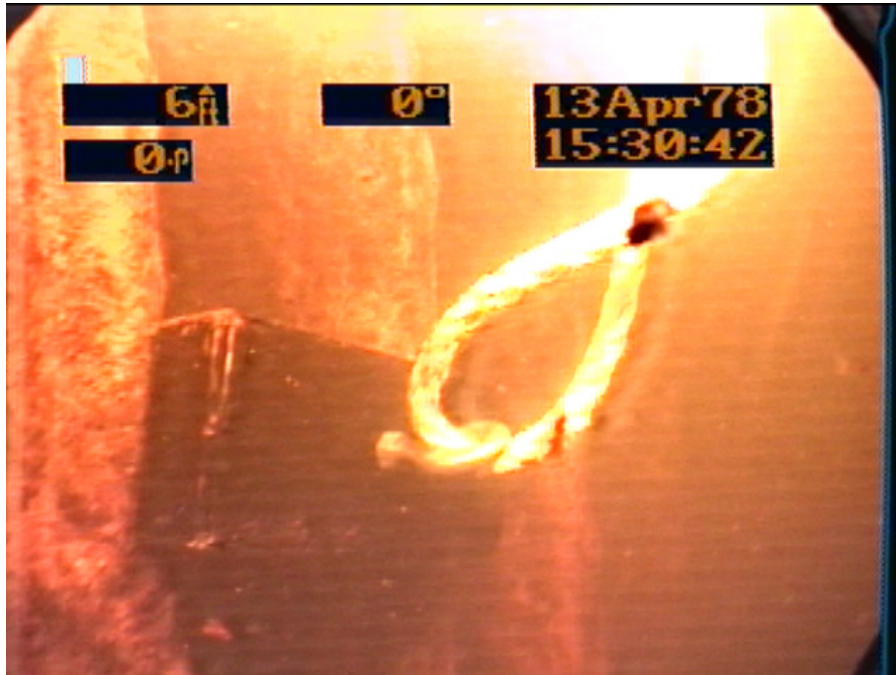
**Photograph No. 11** ROV captured video image of fishing magnet attached to steel trashrack bars of outlet intake at Iron Gate Dam (Note: Date, time, and depth readings are not accurate). **Bureau of Reclamation - Pacific Northwest Underwater Inspection Team. Iron Gate Dam, Klamath Hydroelectric Project, Oregon-California – April 12-16, 2010.**

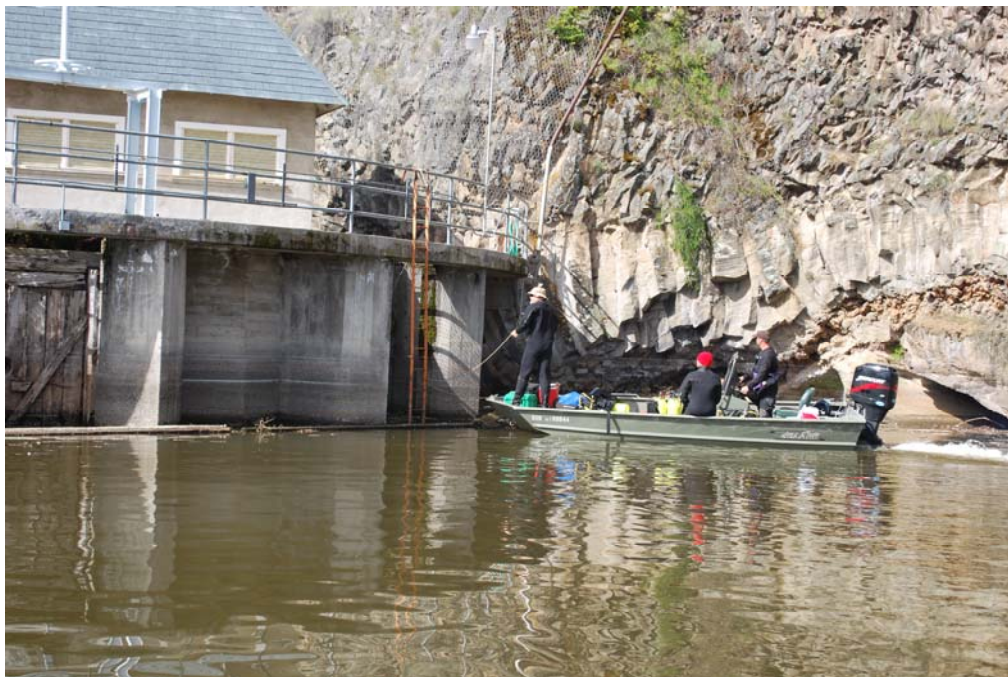
Divers moved downstream to the face of the dam and performed an inspection of the powerplant intake structure to the right of the radial gates (Photo 12 and 13); see Figure 5 for reference drawing. Divers reached a maximum depth of 21 feet on the power intake structure. The limited visibility did not allow for divers to take photos of the structure. Woody debris up to 3-inches in diameter and approximately 12-foot deep was encountered by divers. The second bay looking downstream had a slightly higher amount of woody debris collected. The concrete had minor spalling on leading edges that was felt by hand. A ¼-inch deep covering of algae was noted on all concrete surfaces. The trashracks were 100% covered with rust and rust nodules up to ½ - inch in diameter and ¼-inch high were noted. A steel L-Bracket was found across bay 2 from pier to pier with no apparent purpose.

The power intake structure at Copco 1 Dam is severely clogged with woody debris. The woody debris should be removed so that this material is not ingested by the turbines. In addition, if the

**Photograph No. 12** Dive team securing boat for dive inspection of powerplant intake structure at Copco 1 Dam. **Bureau of Reclamation - Pacific Northwest Underwater Inspection Team. Copco 1 Dam, Klamath Hydroelectric Project, Oregon-California – April 12-16, 2010.**

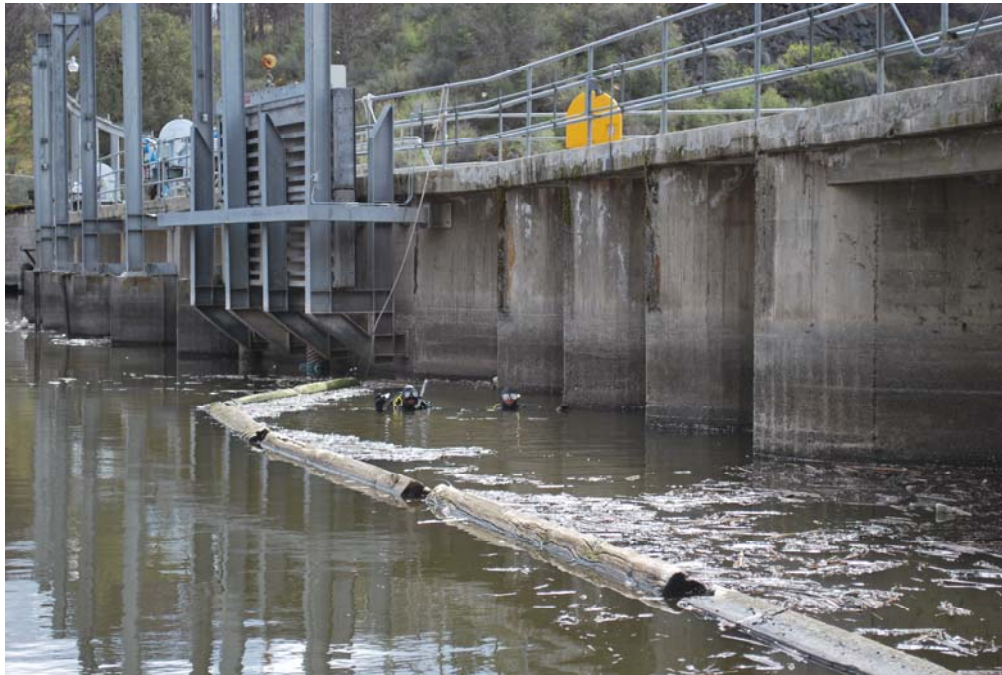
**Photograph No. 13** Divers on surface relaying findings of dive inspection of the powerplant intake at Copco 1 Dam. Bureau of Reclamation - Pacific Northwest Underwater Inspection Team. Copco 1 Dam, Klamath Hydroelectric Project, Oregon-California – April 12-16, 2010.

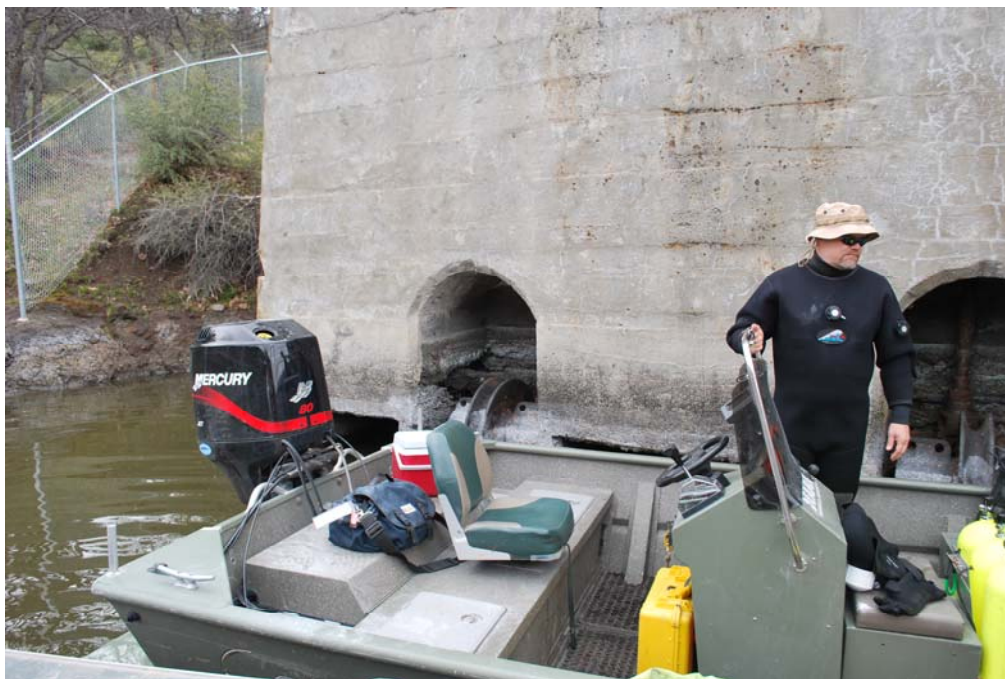
The diversion intake was surveyed by divers to a maximum depth of 42-feet (Photos 14 through 16); see Figure 6 for reference drawing. Divers encountered very limited visibility and were only able to survey the structure by touch. Divers found what appeared to be the cables used to open and close the abandoned intake structure valves. The cables are 100% covered in rust and buried in silt. As divers proceeded deeper they encountered increasing amounts of gravel up to 4-inches in diameter and boulders that ranged from 12 -to-18-inches in diameter. A large amount of woody debris was also discovered up to 6-inches in diameter. Due to the deep depths the ROV was dispatched in an attempt to survey the intake structure on the bottom. Due to the limited visibility adequate references for driving the ROV were not possible. Therefore, the intake structure was not found and no further information could be collected.

**Photograph No. 14** Dive boat secured at right abutment near abandoned low level intake control structure at Copco 1 Dam. Bureau of Reclamation - Pacific Northwest Underwater Inspection Team. Copco 1 Dam, Klamath Hydroelectric Project, Oregon-California – April 12-16, 2010.

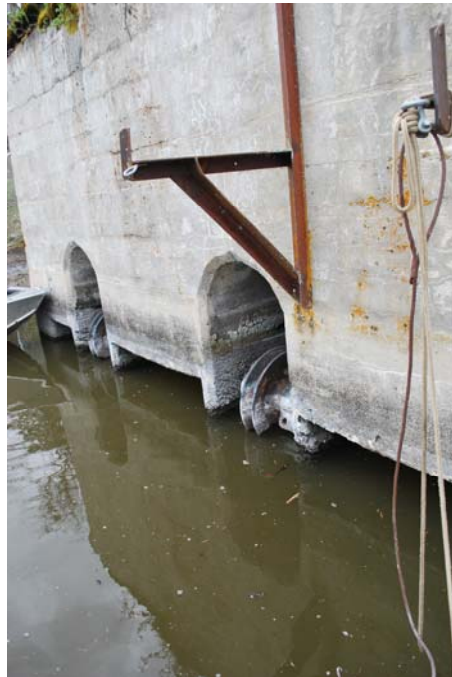
**Photograph No. 15** Cable roller device for abandoned low level intake structure at Copco 1 Dam. Bureau of Reclamation - Pacific Northwest Underwater Inspection Team. Copco 1 Dam, Klamath Hydroelectric Project, Oregon-California – April 12-16, 2010.

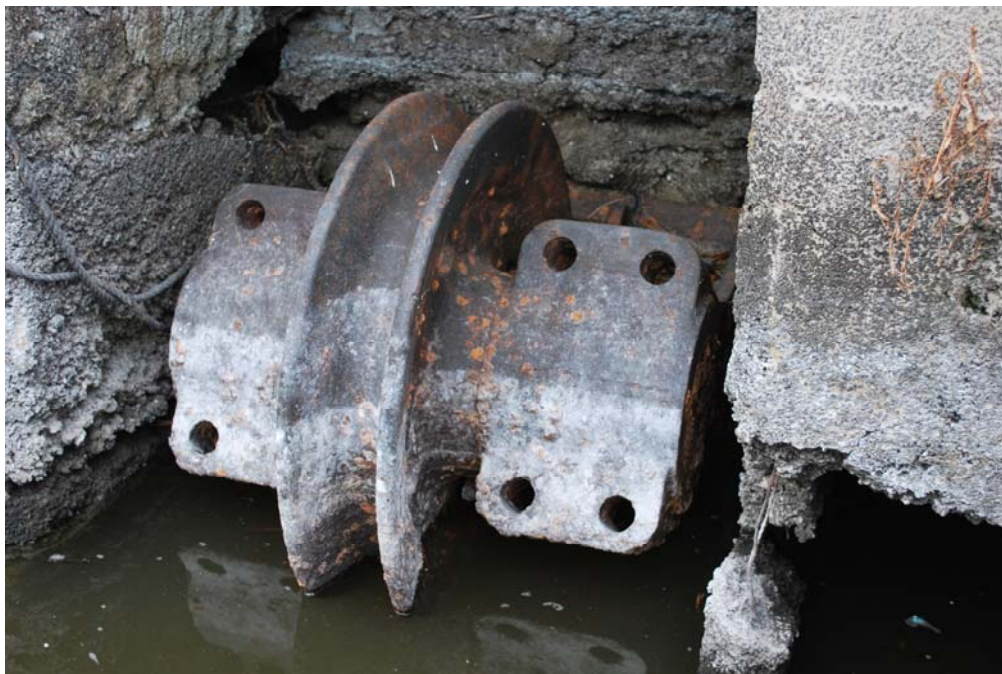
**Photograph No. 16** Close up of roller for abandoned low level intake structure at Copco 1 Dam. Copco 1 Dam, Klamath Hydroelectric Project, Oregon-California – April 12-16, 2010.

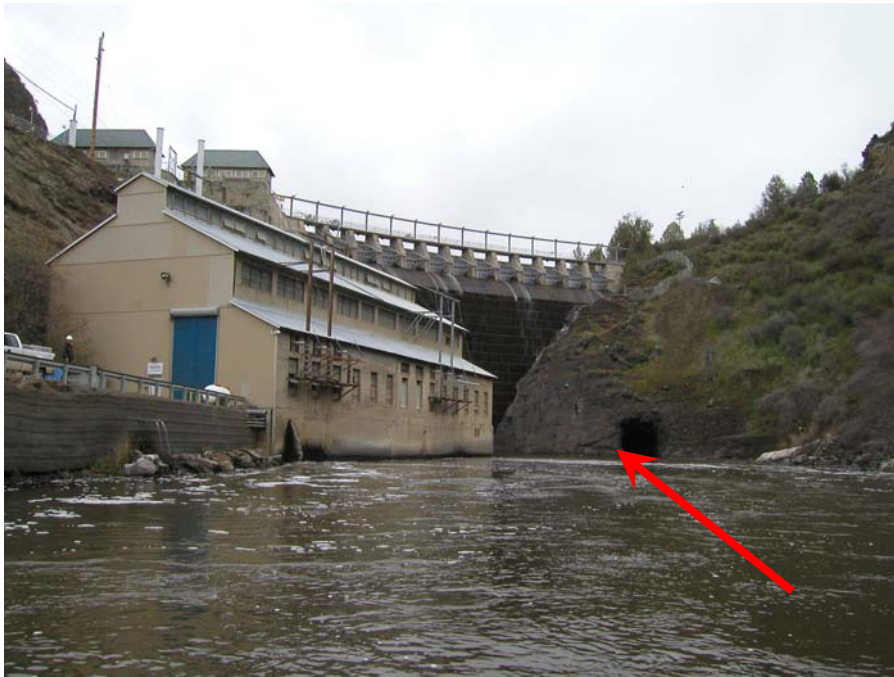
The dive team proceeded downstream to Copco 2 reservoir. The team launched a boat to survey the diversion tunnel and concrete plug in Copco 1 Dam (Photo 17 through 19), see Figure 7 for reference drawing. The boat was able to float approximately 95-feet up the tunnel before requiring an on-foot approach to the concrete plug (Photo 20). The total length of the tunnel is approximately 189-feet. The concrete plug is approximately 14.5-feet wide and 20-feet tall. The concrete plug is concave in the middle approximately 18-inches upstream and the center square is approximately 7-by-7 feet (Photo 19). On the centerline at the bottom is a 3-foot-by 3-foot opening in the concrete. Inside the opening is a rusted steel valve (Photo 21). On top of the concrete plug is what appears to be a grout pipe that is now flowing water. Flows from the grout pipe are estimated to be approximately 15-20 gallons per minute (Photo 22). There is some minor visible leakage at the concrete-rock interface along the outer sides of the concrete plug (Photo 23).

**Photograph No. 17** Upstream view of Copco 1 Dam. On left side is powerplant generator structure. On right side (red arrow) shows abandoned low level outlet tunnel. Divers made a boat assisted surface inspection of concrete plug. Bureau of Reclamation - Pacific Northwest Underwater Inspection Team. Copco 1 Dam, Klamath Hydroelectric Project, Oregon-California – April 12-16, 2010.

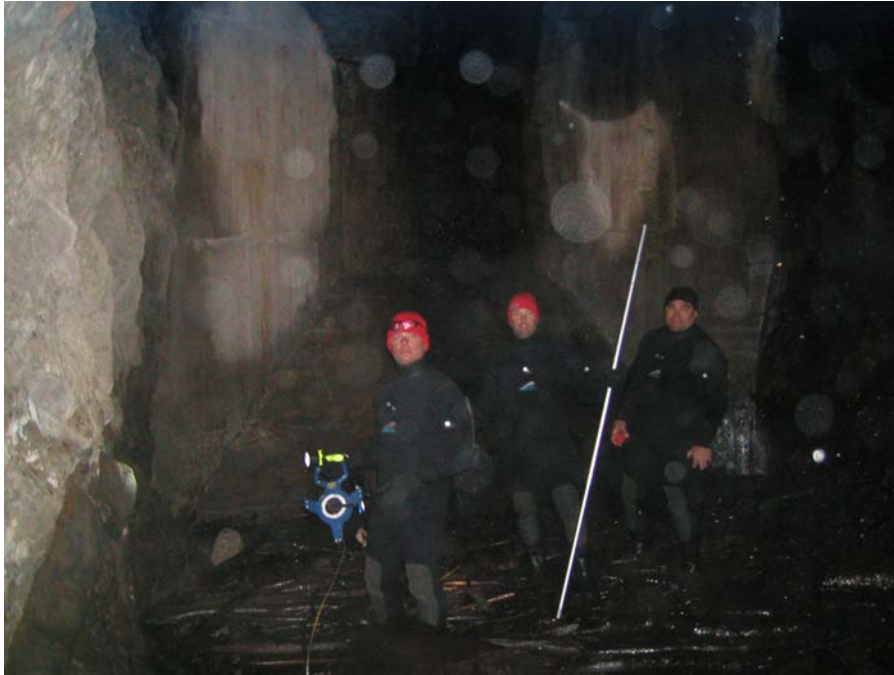
**Photograph No. 18** Divers standing at furthest most point accessible next to concrete plug, making field measurements. Bureau of Reclamation - Pacific Northwest Underwater Inspection Team. JC Boyle, Copco 1 and Iron Gate Dam, Klamath Hydroelectric Project, Oregon-California – April 12-16, 2010.

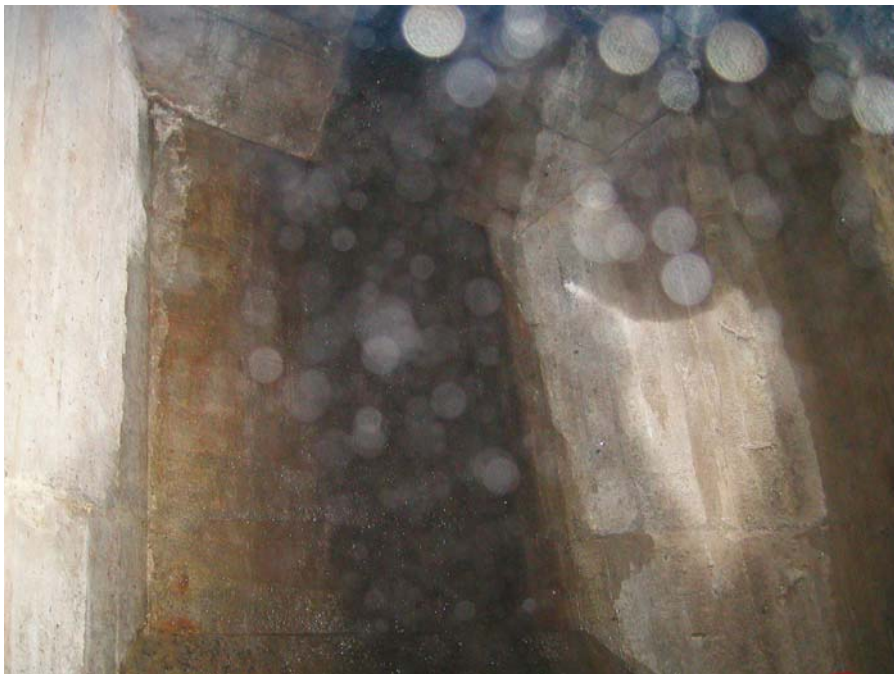
**Photograph No. 19** Close-up view of concrete plug in the abandoned low-level outlet tunnel at Copco 1 Dam. Bureau of Reclamation - Pacific Northwest Underwater Inspection Team. Copco 1 Dam, Klamath Hydroelectric Project, Oregon-California – April 12-16, 2010.

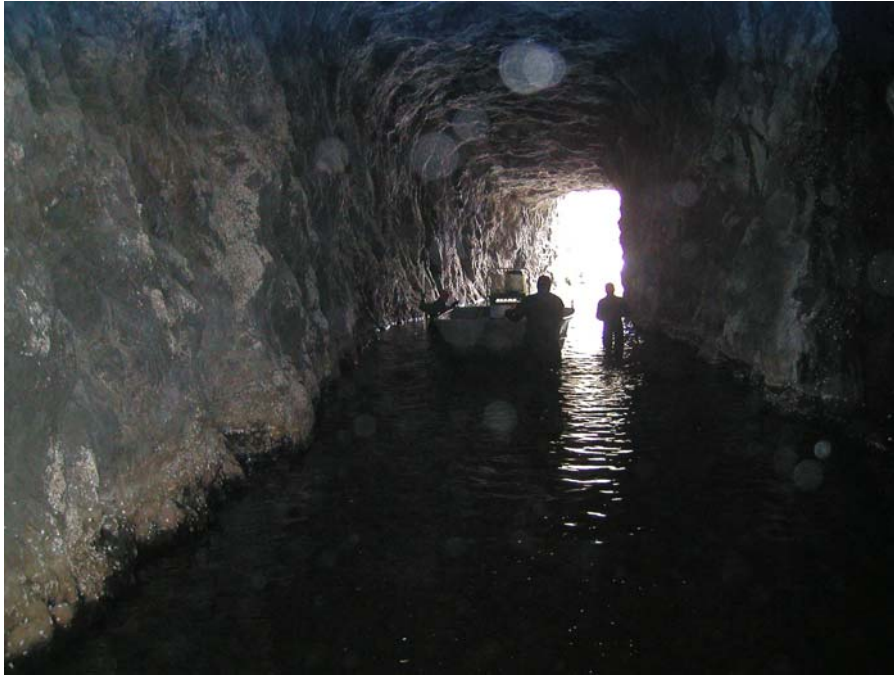
**Photograph No. 20** View of low-level outlet tunnel looking downstream to portal. Bureau of Reclamation - Pacific Northwest Underwater Inspection Team. Copco 1 Dam, Klamath Hydroelectric Project, Oregon-California – April 12-16, 2010.

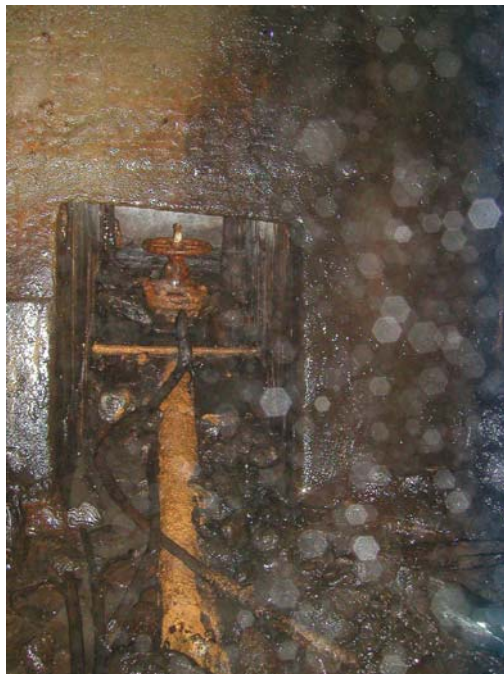
**Photograph No. 21** Rusted gate valve located at bottom of concrete plug in the abandoned low-level outlet tunnel at Copco 1 Dam. Bureau of Reclamation - Pacific Northwest Underwater Inspection Team. Copco 1 Dam, Klamath Hydroelectric Project, Oregon-California – April 12-16, 2010.

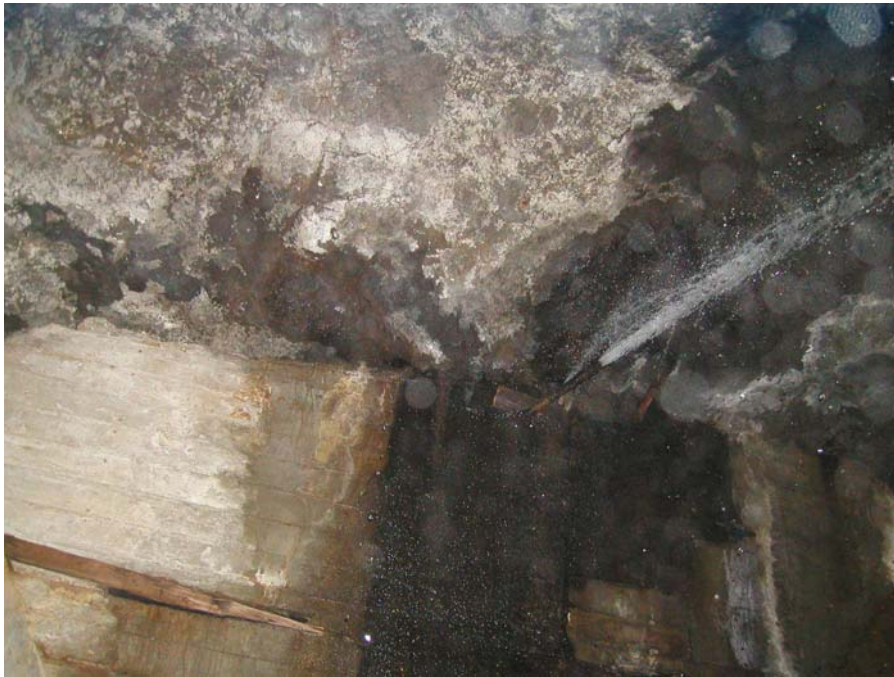
**Photograph No. 22** View at top of concrete plug. Pipe at top of plug releasing water at approximately 10 to 15 gals/min. Bureau of Reclamation - Pacific Northwest Underwater Inspection Team. JC Boyle, Copco 1 and Iron Gate Dam, Klamath Hydroelectric Project, Oregon-California – April 12-16, 2010.

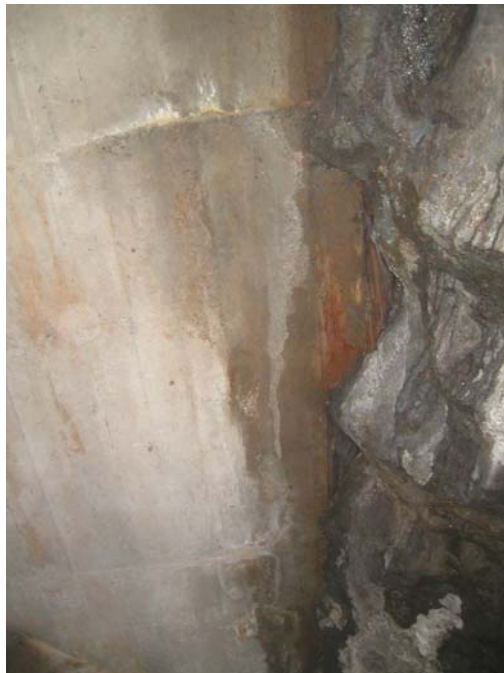
**Photograph No. 23** Concrete plug interface with rock tunnel in the abandoned low-level outlet tunnel at Copco 1 Dam. Bureau of Reclamation - Pacific Northwest Underwater Inspection Team. Copco 1 Dam, Klamath Hydroelectric Project, Oregon-California – April 12-16, 2010.

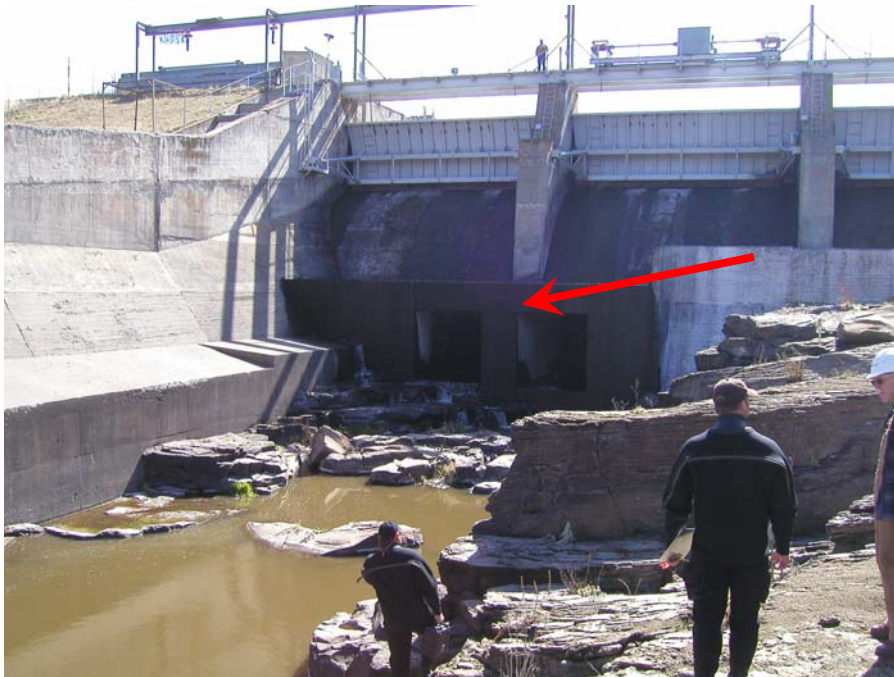
The dive team proceeded downstream to perform a topside inspection of the downstream portion of the double barrel diversion conduit (Photo 24). The conduits measurements are approximately 9-1/2 feet wide, 10-feet high, and 40-feet to the stoplogs face. Looking downstream the left side conduit shows signs of very little leakage (Photo 25 through 27). The right side conduit has significant leakage as also discovered by divers underwater due to the stoplogs being racked in the guide channel (Photo 28 through 31). Flows through the right side are approximately 20 gallons per minute. Measurements of the racked stoplog show there is a 1¾ inch offset from the top of the second stoplog. A probe of the gap allowed a plumbers rule to enter the gap by as much as 21-inches before significant resistance was noted.

**Photograph No. 24** View looking upstream at double barrel diversion conduit (red arrow) used during construction of JC Boyle Dam. Bureau of Reclamation - Pacific Northwest Underwater Inspection Team. JC Boyle Dam, Klamath Hydroelectric Project, Oregon-California – April 12-16, 2010.

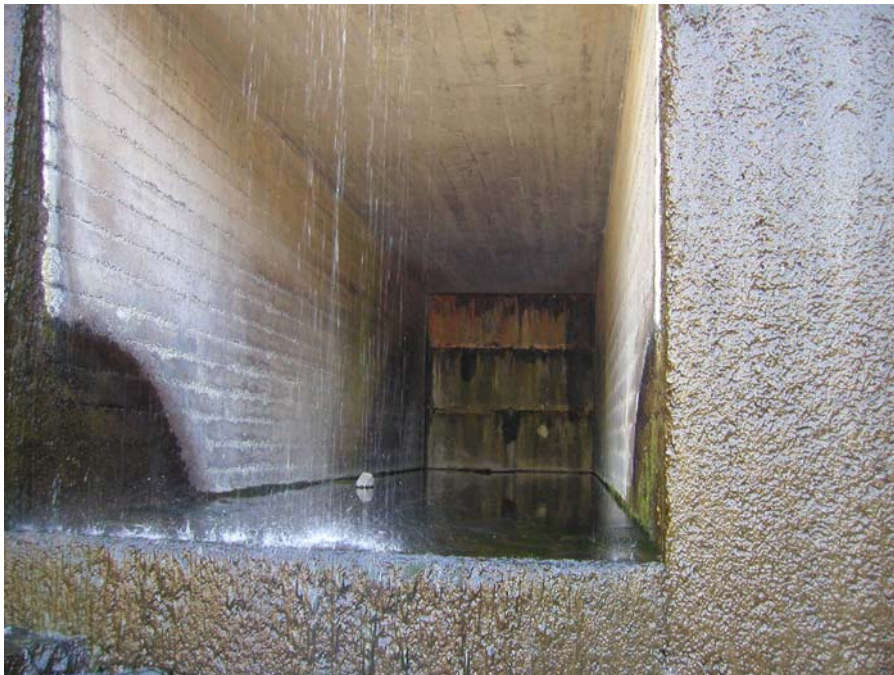
**Photograph No. 25** View looking upstream at left double barrel diversion conduit. Bureau of Reclamation - Pacific Northwest Underwater Inspection Team. JC Boyle Dam, Klamath Hydroelectric Project, Oregon-California – April 12-16, 2010.

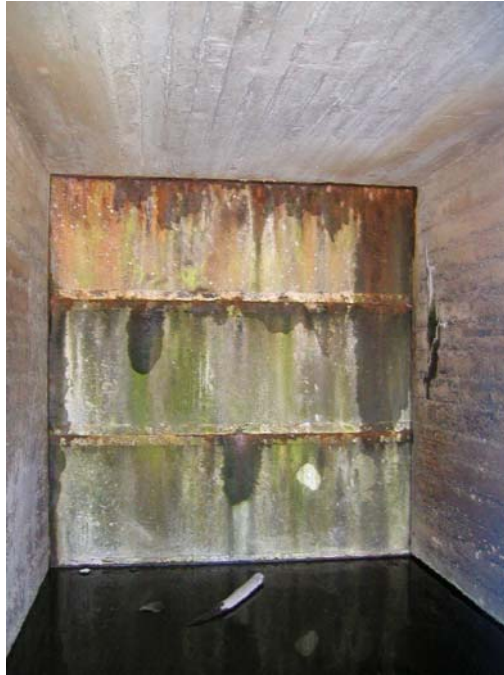
**Photograph No. 26** Upstream view of stop logs in the left side of the double barrel diversion conduit. Bureau of Reclamation - Pacific Northwest Underwater Inspection Team. JC Boyle Dam, Klamath Hydroelectric Project, Oregon-California – April 12-16, 2010.

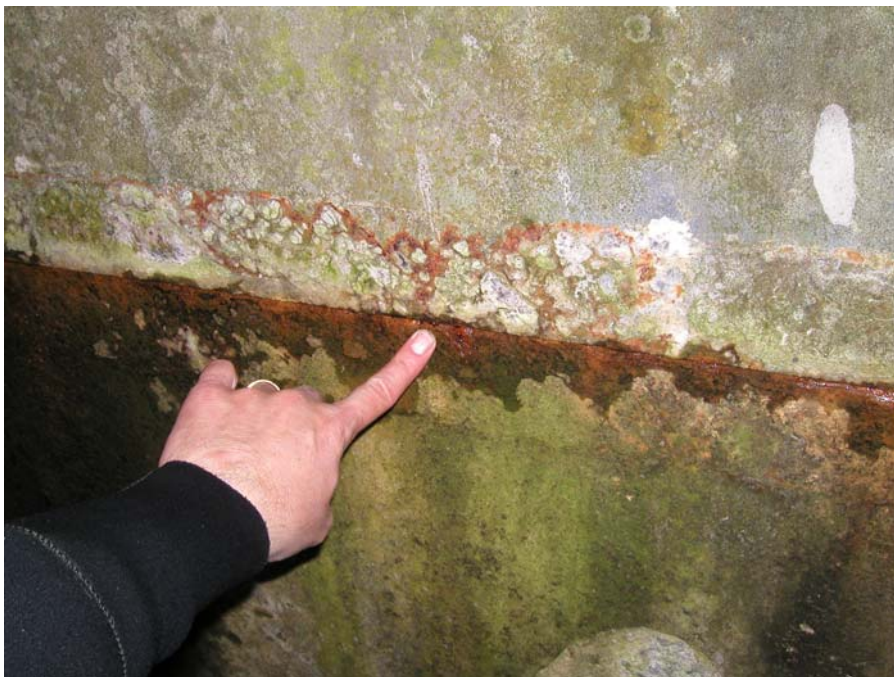
**Photograph No. 27** Finger pointing to seepage through horizontal lift line of the stop logs in the left side of the double barrel diversion conduit. Bureau of Reclamation - Pacific Northwest Underwater Inspection Team. JC Boyle Dam, Klamath Hydroelectric Project, Oregon-California – April 12-16, 2010.

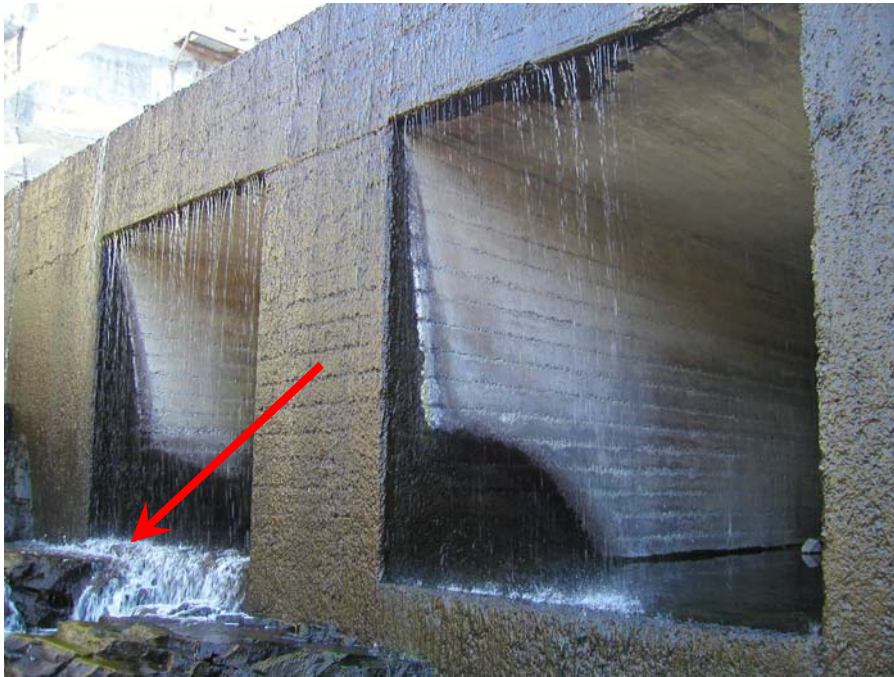
**Photograph No. 28** Close-up view of double barrel diversion conduit exit. Note surface flow exiting right side conduit (red arrow). Stop logs on right side are racked in the guide slot causing leakage. Significant P-Delta effects were noted by divers at this location. Extreme caution and distance should be maintained by any future dive team to this area. Bureau of Reclamation - Pacific Northwest Underwater Inspection Team. JC Boyle Dam, Klamath Hydroelectric Project, Oregon-California – April 12-16, 2010.

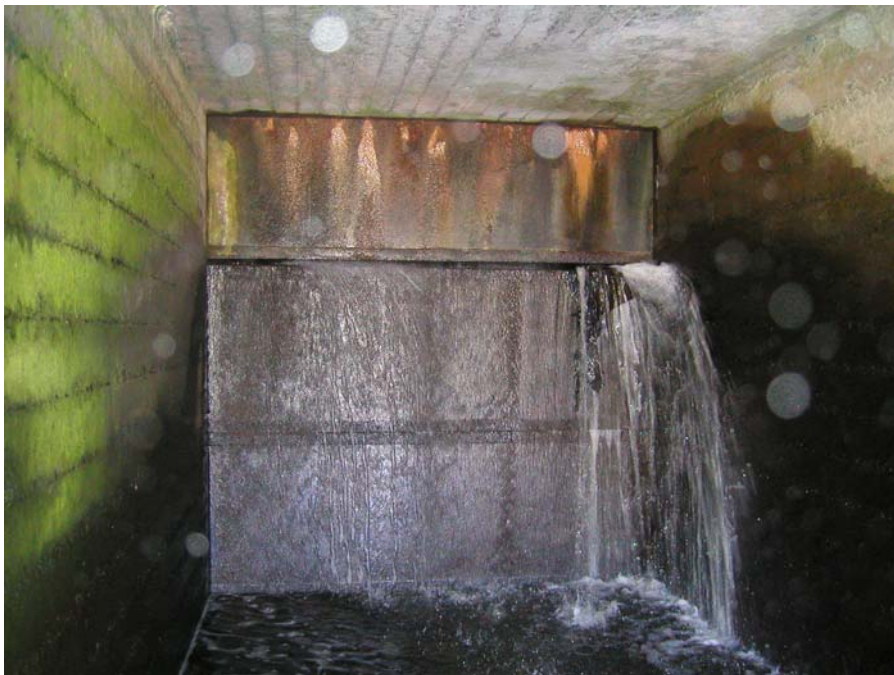
At JC Boyle Dam the grassy weed material in front of the power intake structure is apparently a constant problem. PacifiCorp has in place and should maintain their current procedure for removal of this material on a regular basis. The concrete was found to be in good condition with no spalling or exposed rebar noted. Divers in future diving operations, in and around the right side of the double barrel diversion conduit, should be briefed on the leakage and possible P-Delta effects of working in this area.

**Photograph No. 29** Upstream view on right side of double barrel diversion conduit showing flow through the concrete stop log. P-Delta effects were noted by divers on the upstream side of this structure. Bureau of Reclamation - Pacific Northwest Underwater Inspection Team. JC Boyle Dam, Klamath Hydroelectric Project, Oregon-California – April 12-16, 2010.

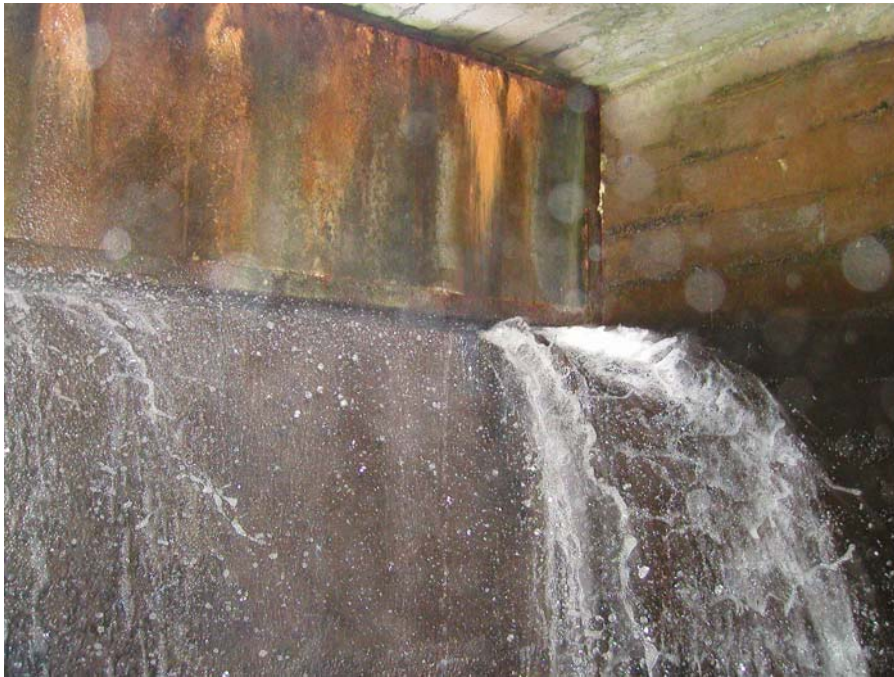
**Photograph No. 30** Flow through the stop logs on the right side of the double barrel diversion conduit. Bureau of Reclamation - Pacific Northwest Underwater Inspection Team. JC Boyle Dam, Klamath Hydroelectric Project, Oregon-California – April 12-16, 2010.

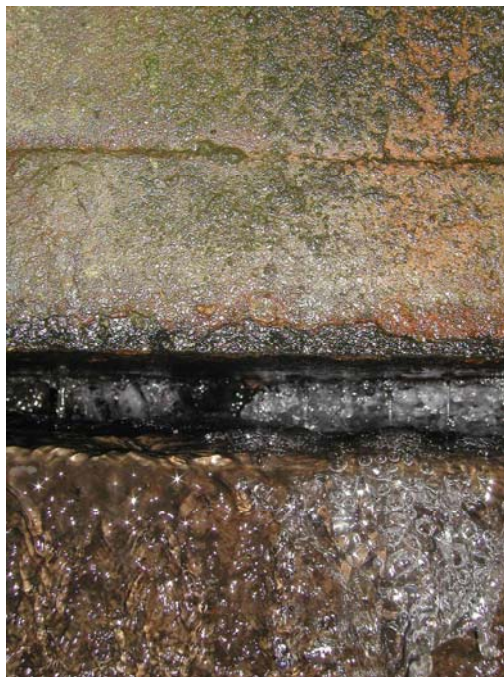
**Photograph No. 31** Close up of flow through the stop logs on the right side of the double barrel diversion conduit. Bureau of Reclamation - Pacific Northwest Underwater Inspection Team. JC Boyle Dam, Klamath Hydroelectric Project, Oregon-California – April 12-16, 2010.
