# **Solstice Creek Field Review: Results and Recommendations**

## **Santa Monica Mountains National Recreation Area**

March 6, 2002

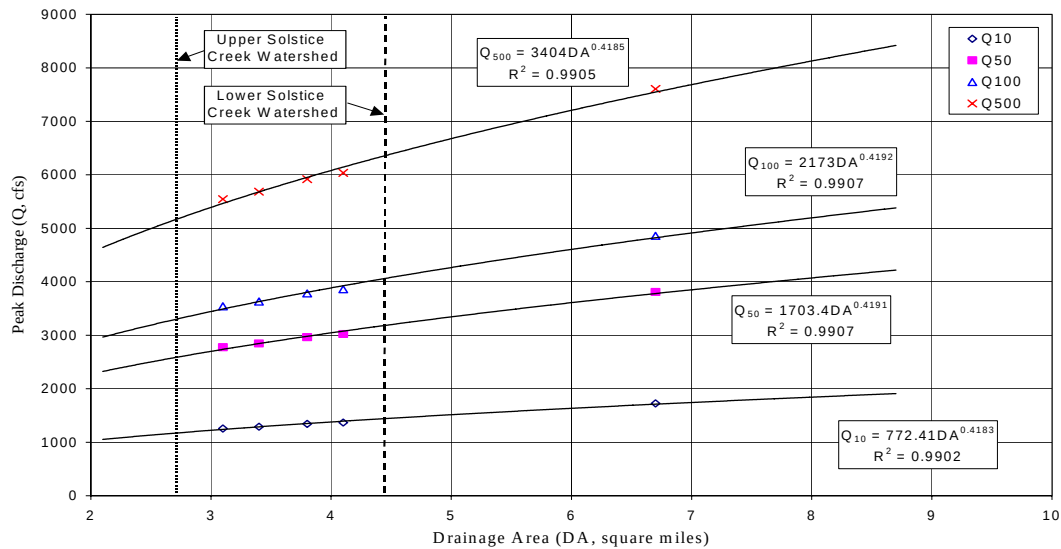
Figure 1. Flood frequency relationships for Lindero Canyon (from FEMA, 1980)

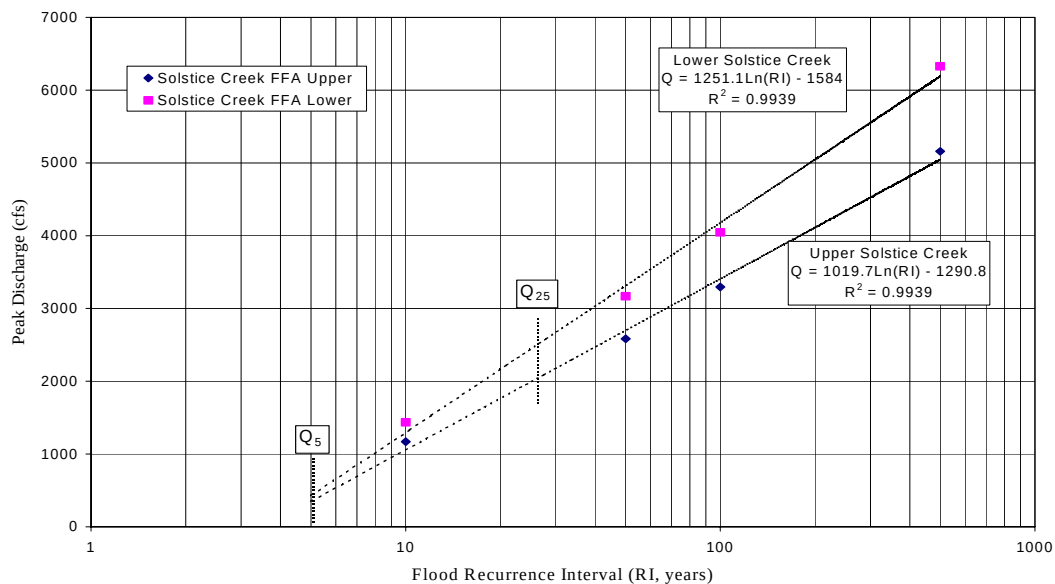
Figure 2. Solstice Creek flood frequency relations (adapted from FEMA (1980)).
