Project No 2602.  
Name of Project Dillsboro  
Name of Development(s) Dillsboro

**SPECIAL OPERATION REPORT**  
**FEDERAL ENERGY REGULATORY COMMISSION**  
**Atlanta Regional Office**  
**Electronically Transmitted**

**For the period** February 27, 2001 to February 24, 2003

**Inspected by** John C. Lyon, Jr. **Date** February 24, 2003

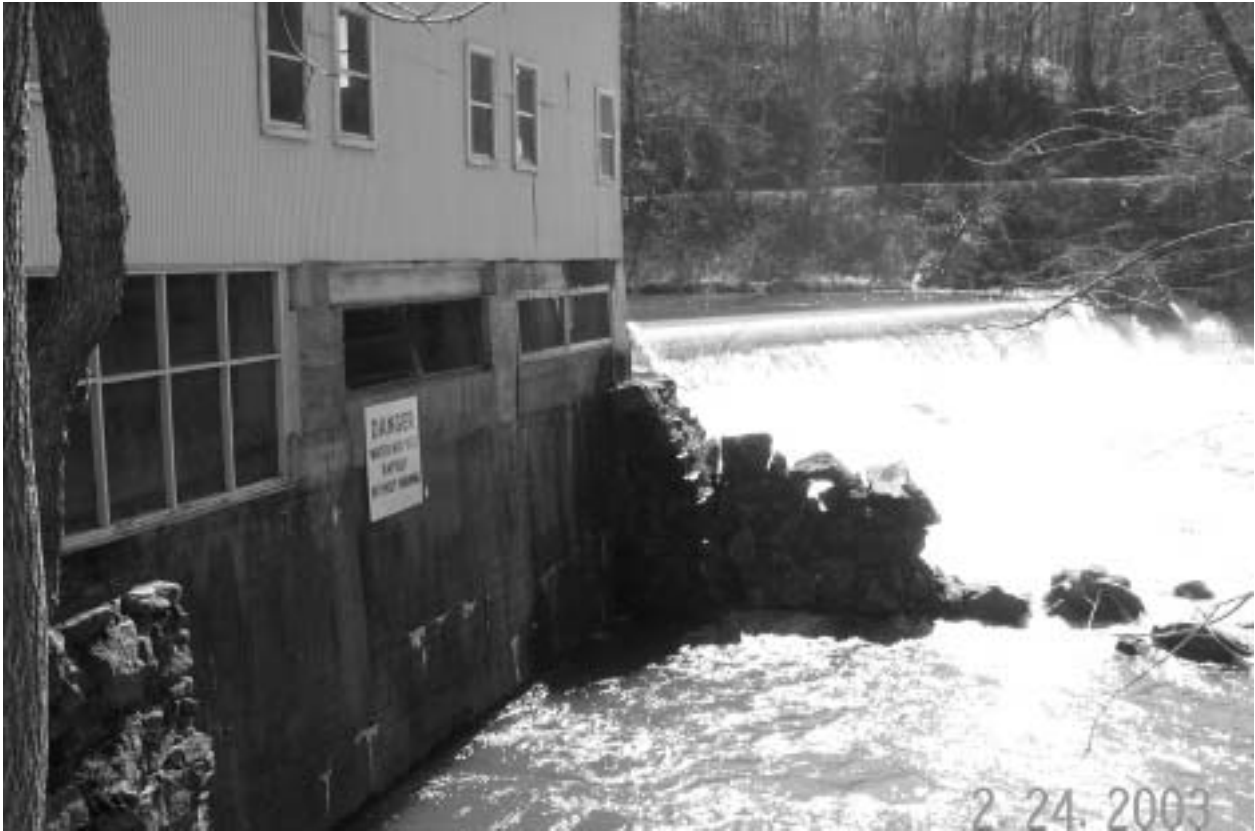
**Photograph 1** Dillsboro dam and powerhouse tailrace, note high flows from recent rainfall.

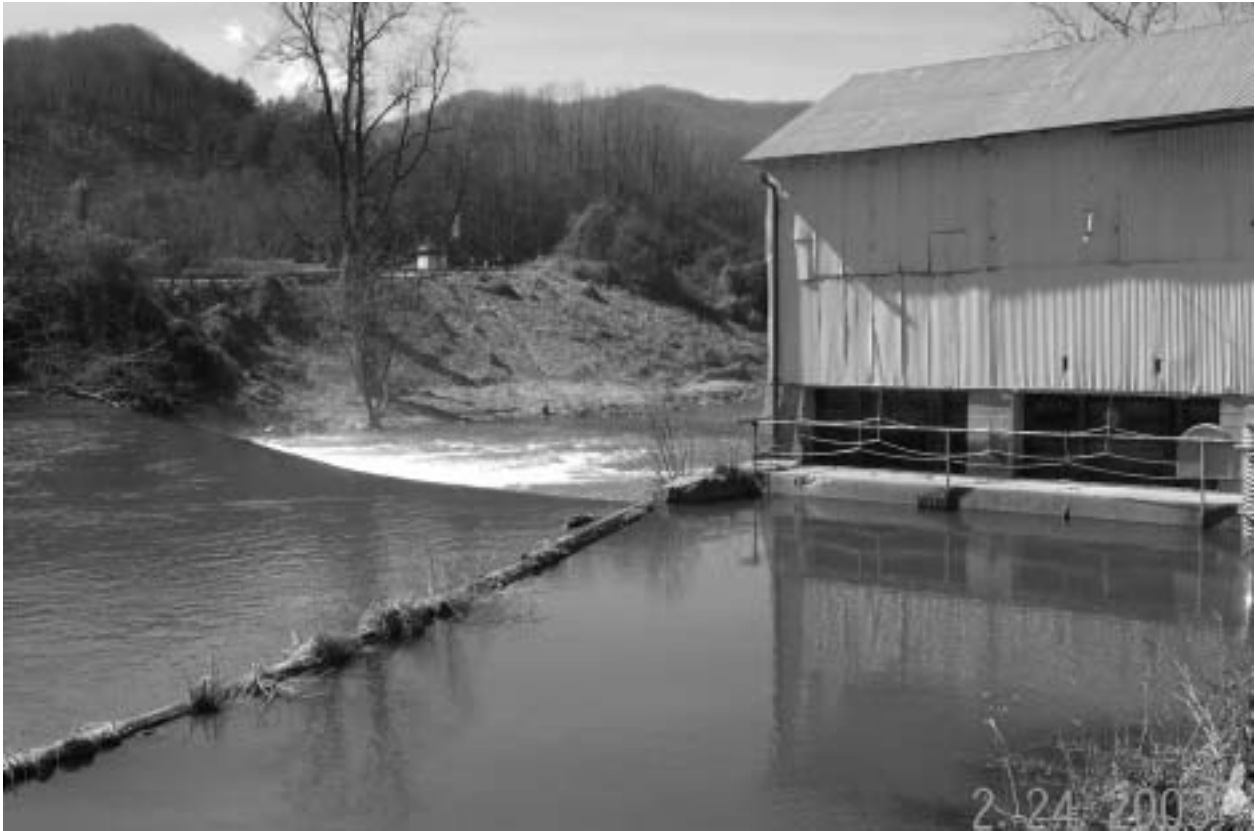
**Photograph 2** Upstream side of Dillsboro dam and powerhouse as seen from the right bank.

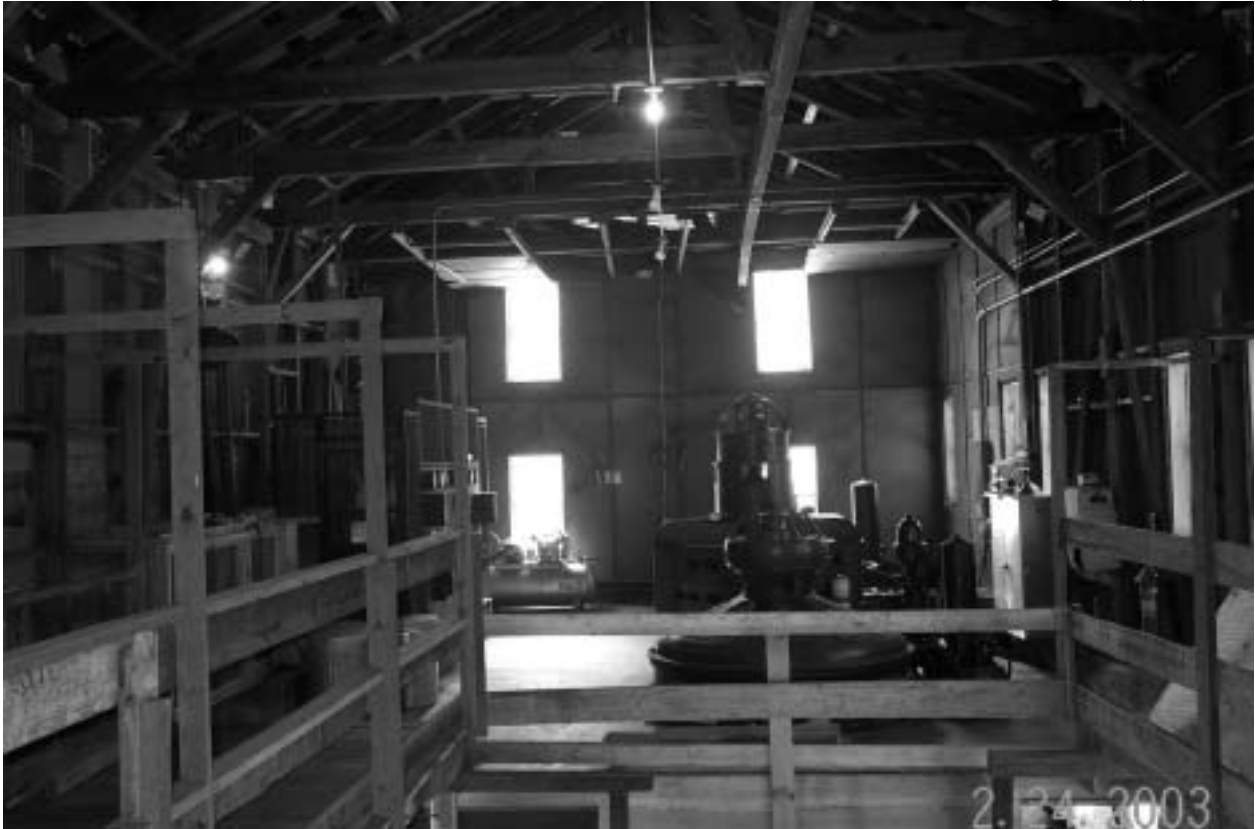
**Photograph 3** Dillsboro powerhouse interior, both units visible.
