## INDIGENOUS MONITOR OVERVIEW REPORT

**Month: August 2022**

**Project Region: Edmonton and  
Yellowhead**

### **Indigenous Monitors on the Trans Mountain Expansion Project – Overview**

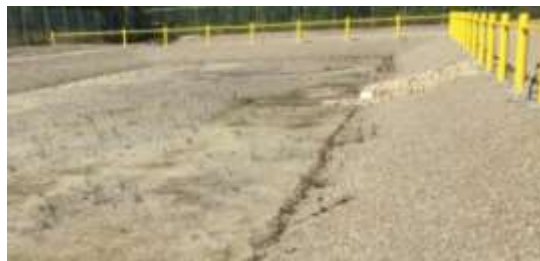
Hydrocarbon retention pond complete at Gainford Pump Station KP 116.

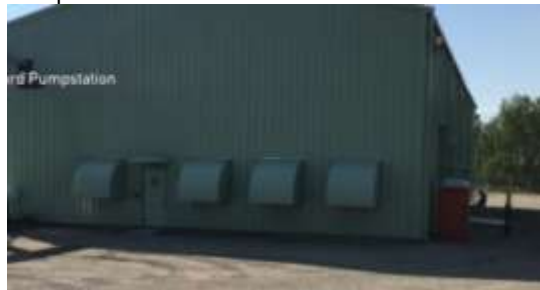
Good housekeeping at Gainford Pump Station KP 116.

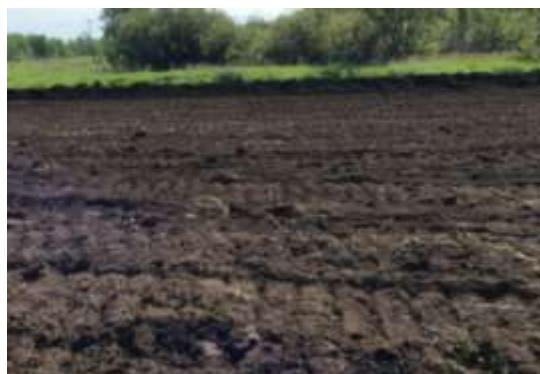
Topsoil replacement at KP 133.

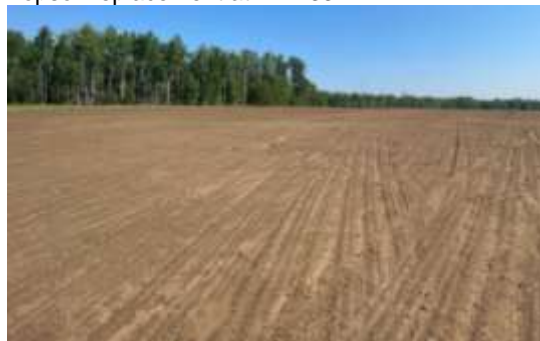
Seeded area KP 255.

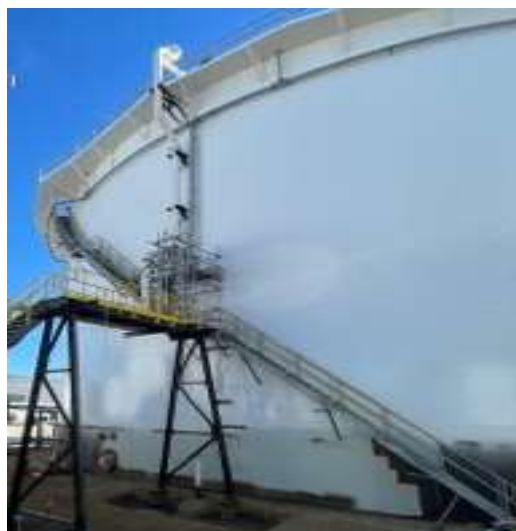
Vapour recovery unit installed on Tank 1 at Edmonton Terminal.

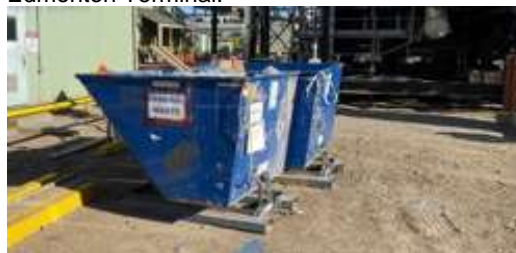
Waste segregation labelled and executed properly at Edmonton Terminal.

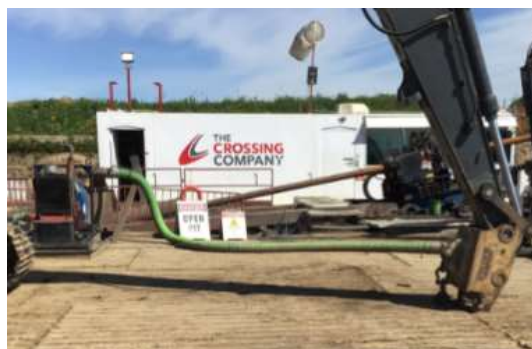
Organized site, clear walking paths at KP 49.

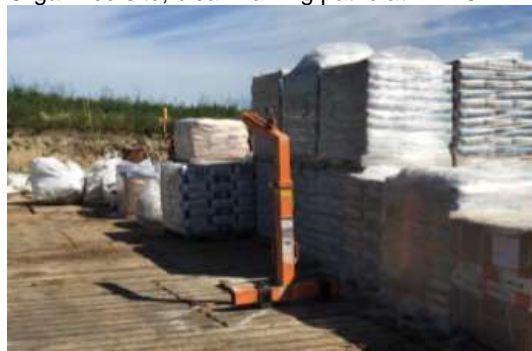
Good housekeeping at KP 49.

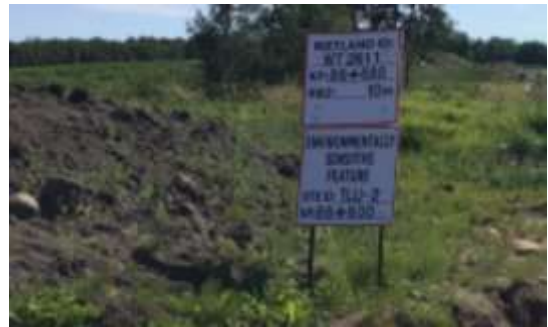
Signage in place at TLU-2

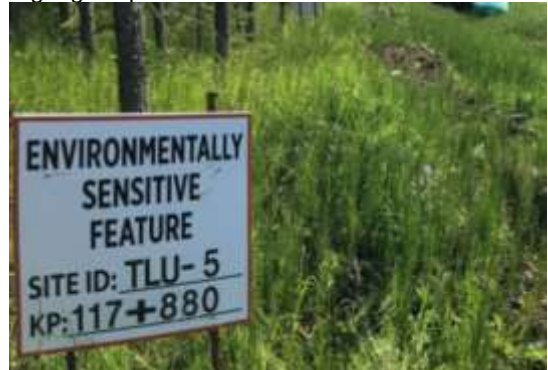
Signage in place at TLU-5 .

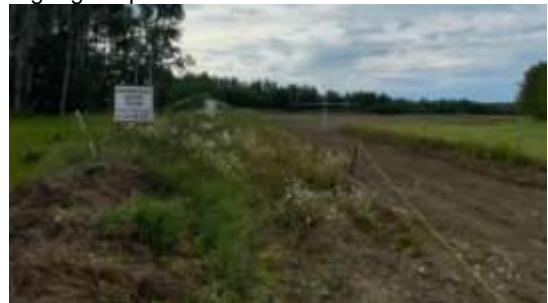
Signage in place at TLU-25.

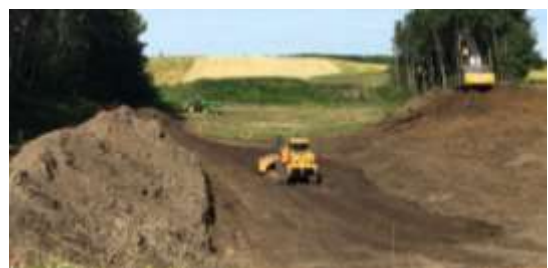
Topsoil strip and grading crew working at KP 77

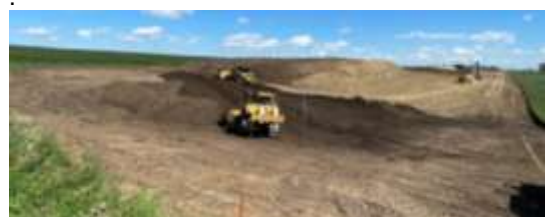
Strip and grade at KP 68

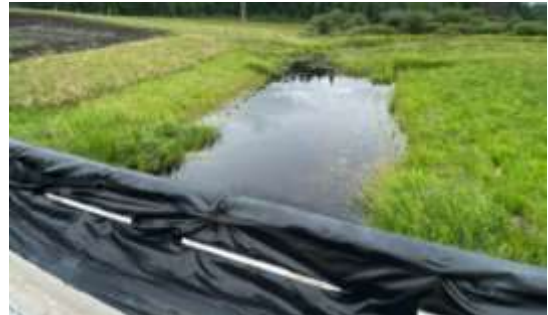
Stream bank restoration at AB-60 KP 125.

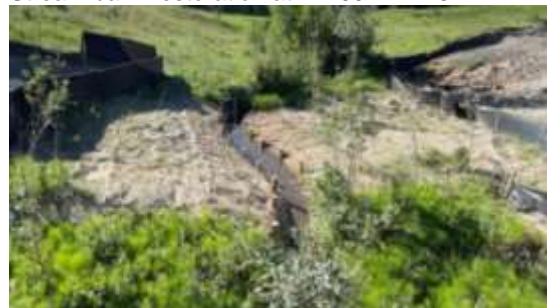
Stream bank restoration at AB-202 KP 337.

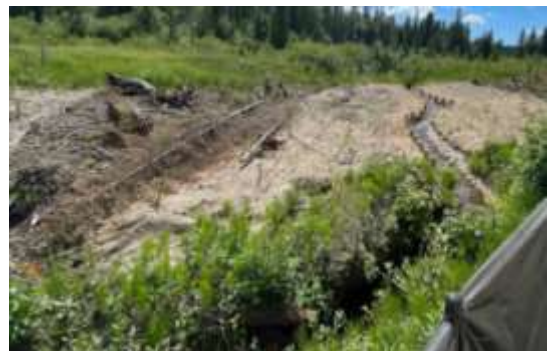
Stream bank restoration at AB-153 KP 290.

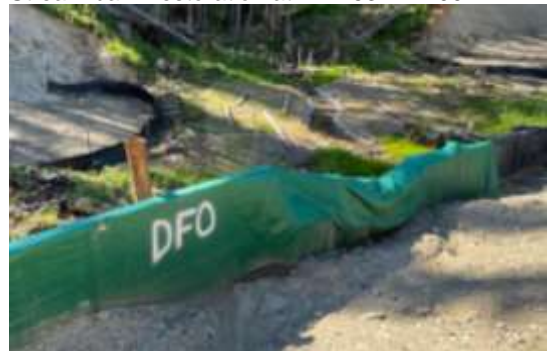
Stream bank restoration at AB-178 KP 317.
