# INDIGENOUS MONITOR OVERVIEW REPORT

**Month: August 2022**

**Project Region: Fraser Valley**

**Kilometre Posts (KPs) monitored:  
KP 1075–1165**

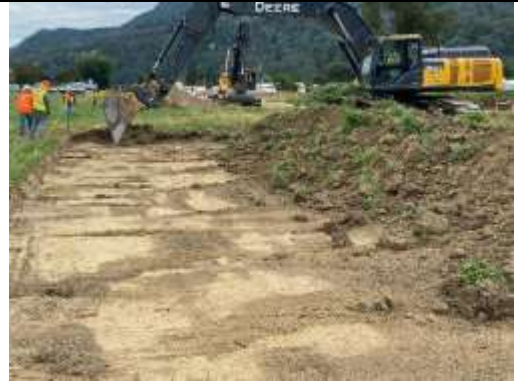
At locations near KP 1104, KP 1106 and KP 1136, Indigenous Monitors were involved in monitoring and inspecting such soil salvage mitigations. They confirmed topsoil was separated and labelled and piles remained inside the construction footprint.

Topsoil being stripped near KP 1104.

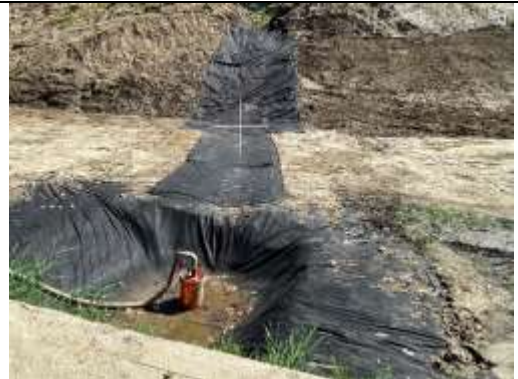
Indigenous Monitors, alongside Environmental Inspectors, observed and inspected numerous ESC measures at TMEP construction sites throughout Spreads 6 and 7A. Inspections were completed in areas including but not limited to KP 1116, KP 1118, KP 1119 and KP 1164. Near KP 1116, geotextile fabric placed around an area requiring a sump pump was inspected. The fabric was installed as a mitigation to prevent erosion sediment from entering the water accumulating in the area. Near KP 1119, the Indigenous Monitor inspected geotextile fabric placed on an access road prior to gravel being placed. The fabric is used to contain sediment from the gravel. No concerns were observed.

ESC measures using geotextile fabric near KP 1116 observed to be functioning as intended.

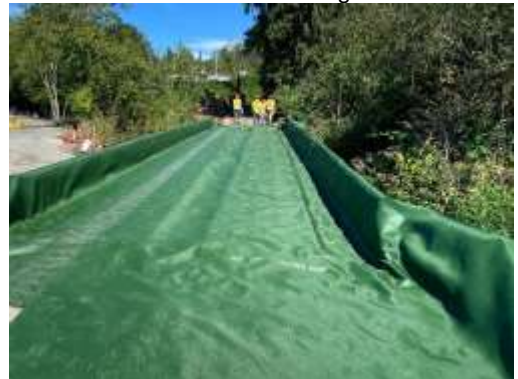
Geotextile fabric installed on top of an access bridge as an ESC measure near KP 1119 prior to gravel placement.

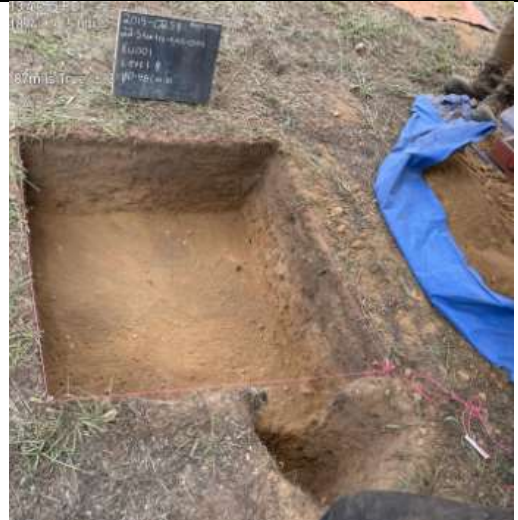
The Indigenous Monitors observed Archaeological Impact Assessments (AIA) conducted along the right-of-way near KP 1134 and KP 1144. The assessments, completed by a qualified archaeologist and Indigenous participants, included visual inspections to identify features with archaeological potential, surface inspection of areas with exposed sediments for cultural or terrain features exhibiting archaeological potential and subsurface testing (shovel testing) of terrain features exhibiting archaeological potential. If an archaeological site is found, Trans Mountain completes the applicable reporting and applies for the required permits in alignment with the *Heritage Conservation Act*. Ongoing AIA activities continue in the area.

Excavation unit near KP 1144.

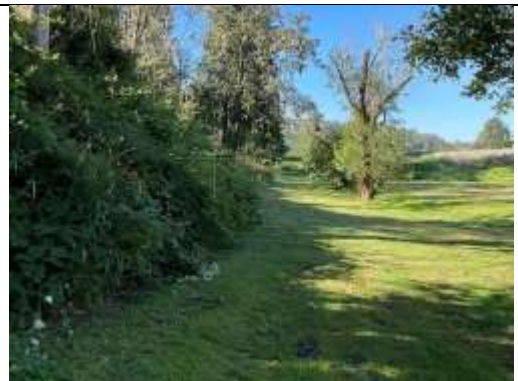
The Indigenous Monitor observed the Resource Specialist conduct amphibian sweeps at various construction work areas between KP 1100 and KP 1104. At KP 1102, the Indigenous Monitor participated in a wildlife sweep with the Resource Specialist for Coastal Giant Salamanders, which are protected under the Species at Risk Act. No salamanders were discovered during the inspection.

Area swept for Coastal Giant Salamanders near KP 1102. No salamanders were found.

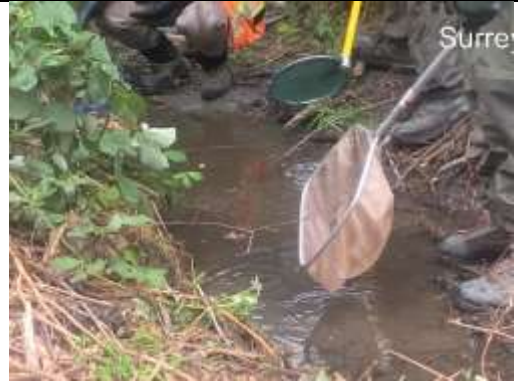
Indigenous Monitors observed the contractor prepare for in-stream work at watercourse BC770F near KP 1159 and monitored the Resource Specialist conduct fish salvages. During the inspections, 245 fish of various species were salvaged and relocated downstream.

Resource Specialist conducting the fish salvage at watercourse BC770F near KP 1159.

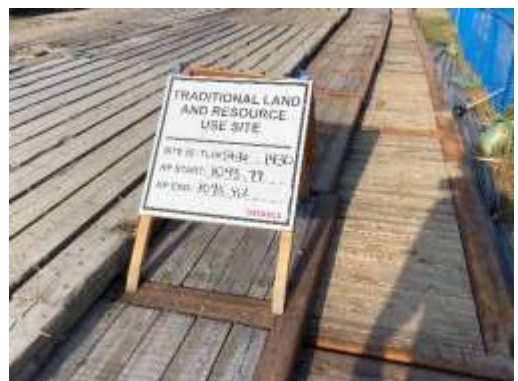
Environmental feature signage inspected near KP 1095.

Existing environmental feature signage was also inspected to ensure visibility and sturdiness at KP 1075, KP 1095, KP 1101, KP 1131, KP 1132, KP 1143 and KP 1147.

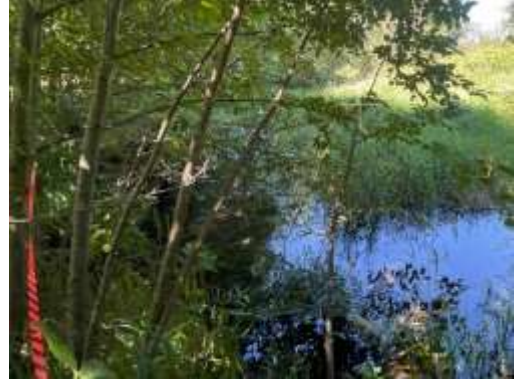
flagging and signage and discussing upcoming construction activities and associated environmental mitigations like fish and amphibian salvages. In addition, the Indigenous Monitor looked for culturally modified trees (CMTs). No CMTs were discovered, and no environmental concerns were identified during the walk-throughs.

Pre-construction walk-through near KP 1101.
