INDIGENOUS MONITOR OVERVIEW REPORT

Month: August 2022

**Project Region: Jasper to Mount
Robson Reactivation**

**Kilometre Posts (KPs) monitored:
KP 322–461**

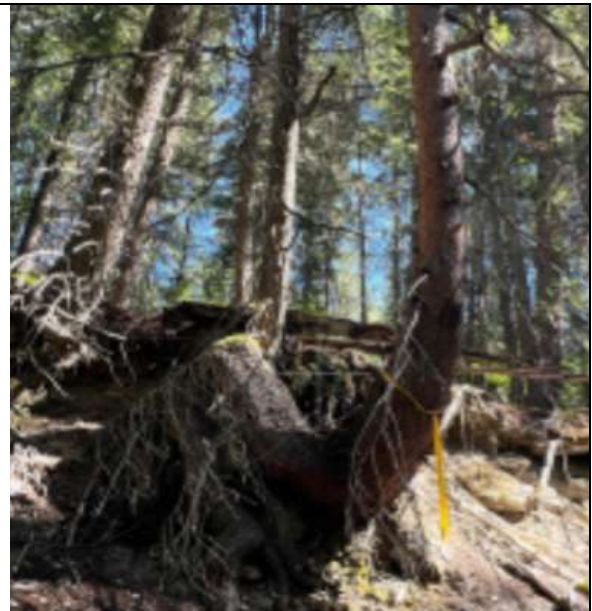
Danger tree assessments were conducted near KP 458 and the Indigenous Monitors participated to ensure no potential Culturally Modified Trees (CMTs) or TLU sites were present. No potential CMT or TLU chance finds were identified.

Danger tree assessment KP 458.

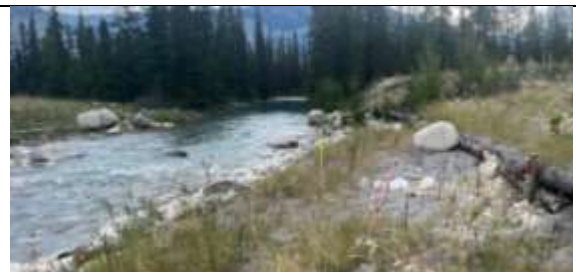
An Indigenous Monitor performed an inspection on the ESC measures in place near KP 360. Rock and CWD were placed across a slope to reduce runoff velocity and retain sediment. Vegetation is becoming re-established and will act as another ESC measure. No issues or environmental concerns were identified during the inspection.

Restoration maturing Snaring Side Chanel West at KP 360.

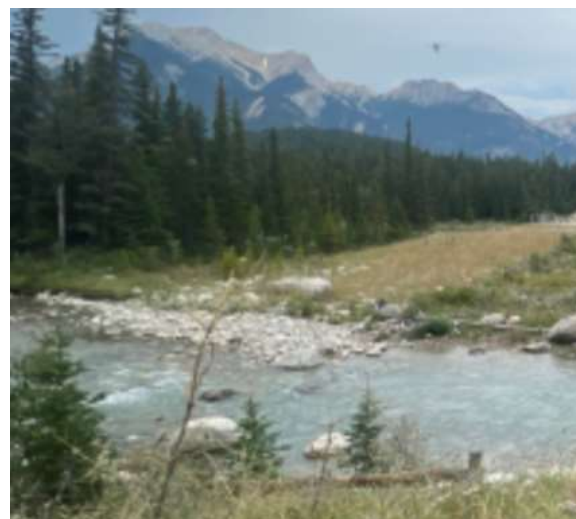
Restoration maturing Snaring Side Chanel West at KP 360.

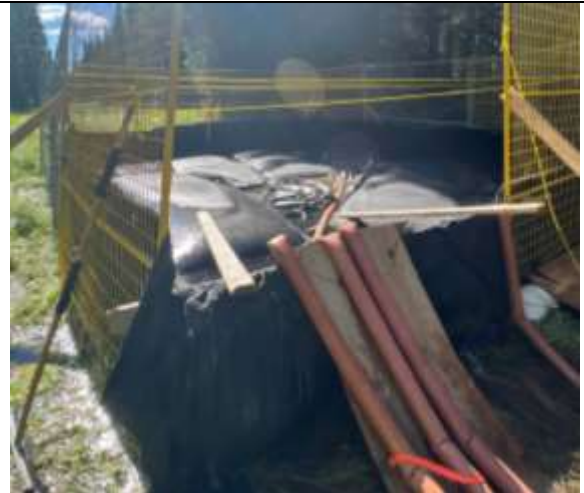
The Indigenous Monitors confirmed that pump-off water was released a minimum of 50 m from the nearest watercourse, replacement materials were readily available, including sediment control devices, pumps, spills kits and secondary containment, and housekeeping of off-construction footprint locations. No deficiencies were identified during the inspection.

Pump-off location near KP 339.

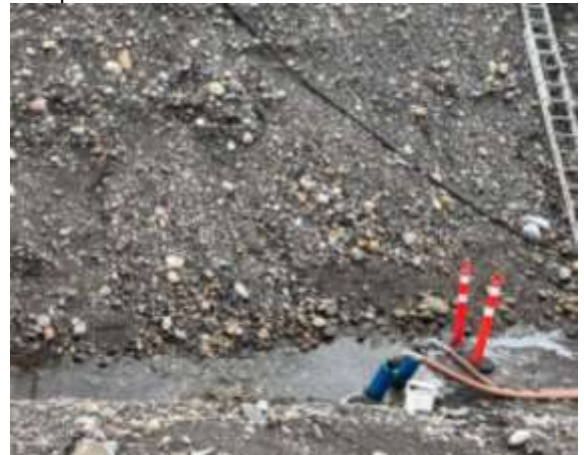
Trench dewatering location at KP 339.

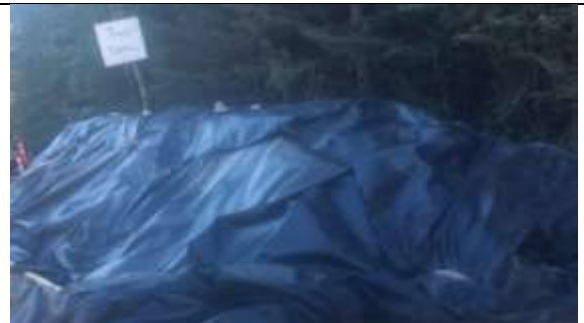
Miette Valve KP 390.

The Indigenous Monitors were involved in monitoring and inspecting such topsoil salvage mitigations near KP 390 and KP 343. The Indigenous Monitors also inspected the construction areas before and after topsoil stripping to identify any potential archaeological chance finds. No potential archaeological chance finds were identified

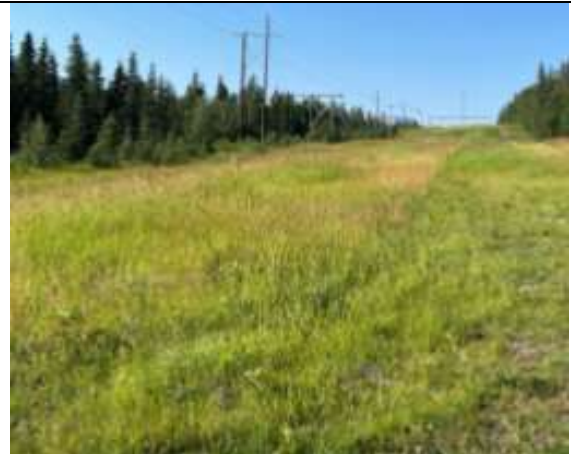
Indigenous Monitors observed and continue to monitor regrowth of planted sites in reclaimed areas. No concerns were identified during inspection activities.

Regrowth at KP 325.

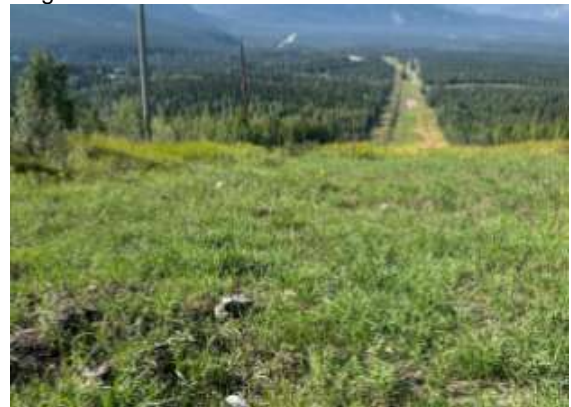
Regrowth at KP 369.

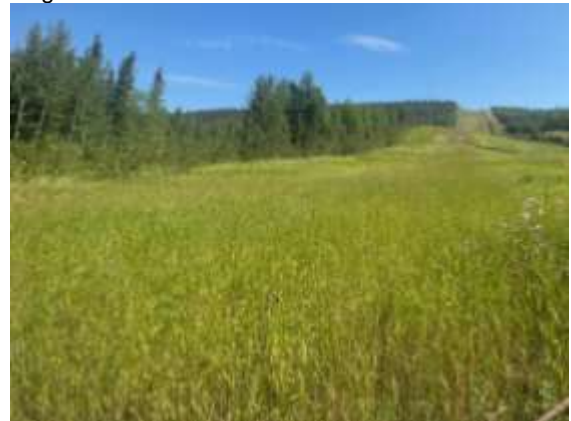
Regrowth at KP 369.

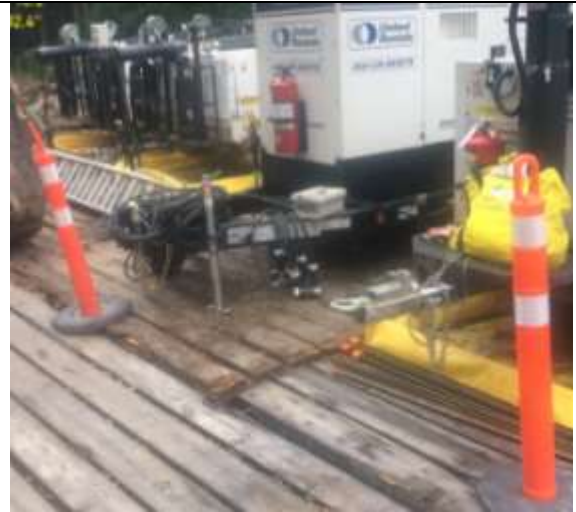
At the Grant Brook Valve, Indigenous Monitors confirmed signage is up to date, required flagging and staking is present, housekeeping is compliant, secondary containment is in use, washrooms are clean and appropriately maintained, spill kits inspected for volume and types of spill response material and to ensure the appropriate placement in relation to work fronts. No deficiencies were identified during inspection.

Housekeeping observed at Grant Brook Valve KP 428.

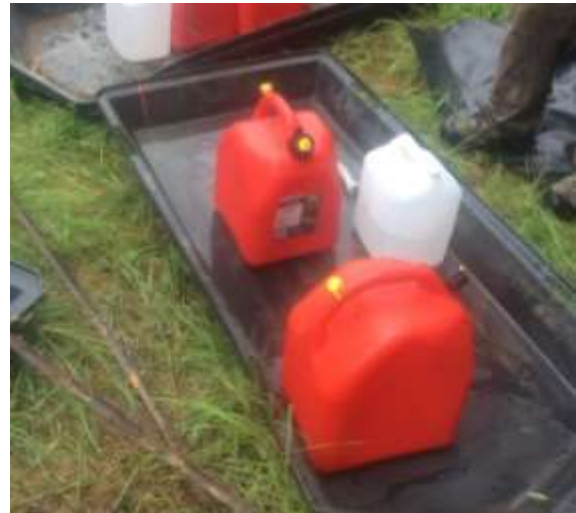
Secondary containment in use Grant brook Valve at KP 428.

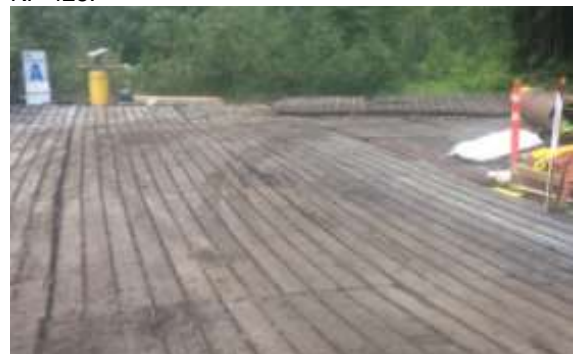
Good housekeeping Grant Brook Valve at KP 428.
