The Nebraska State Capitol Exterior Masonry Project Copper Roof Restoration

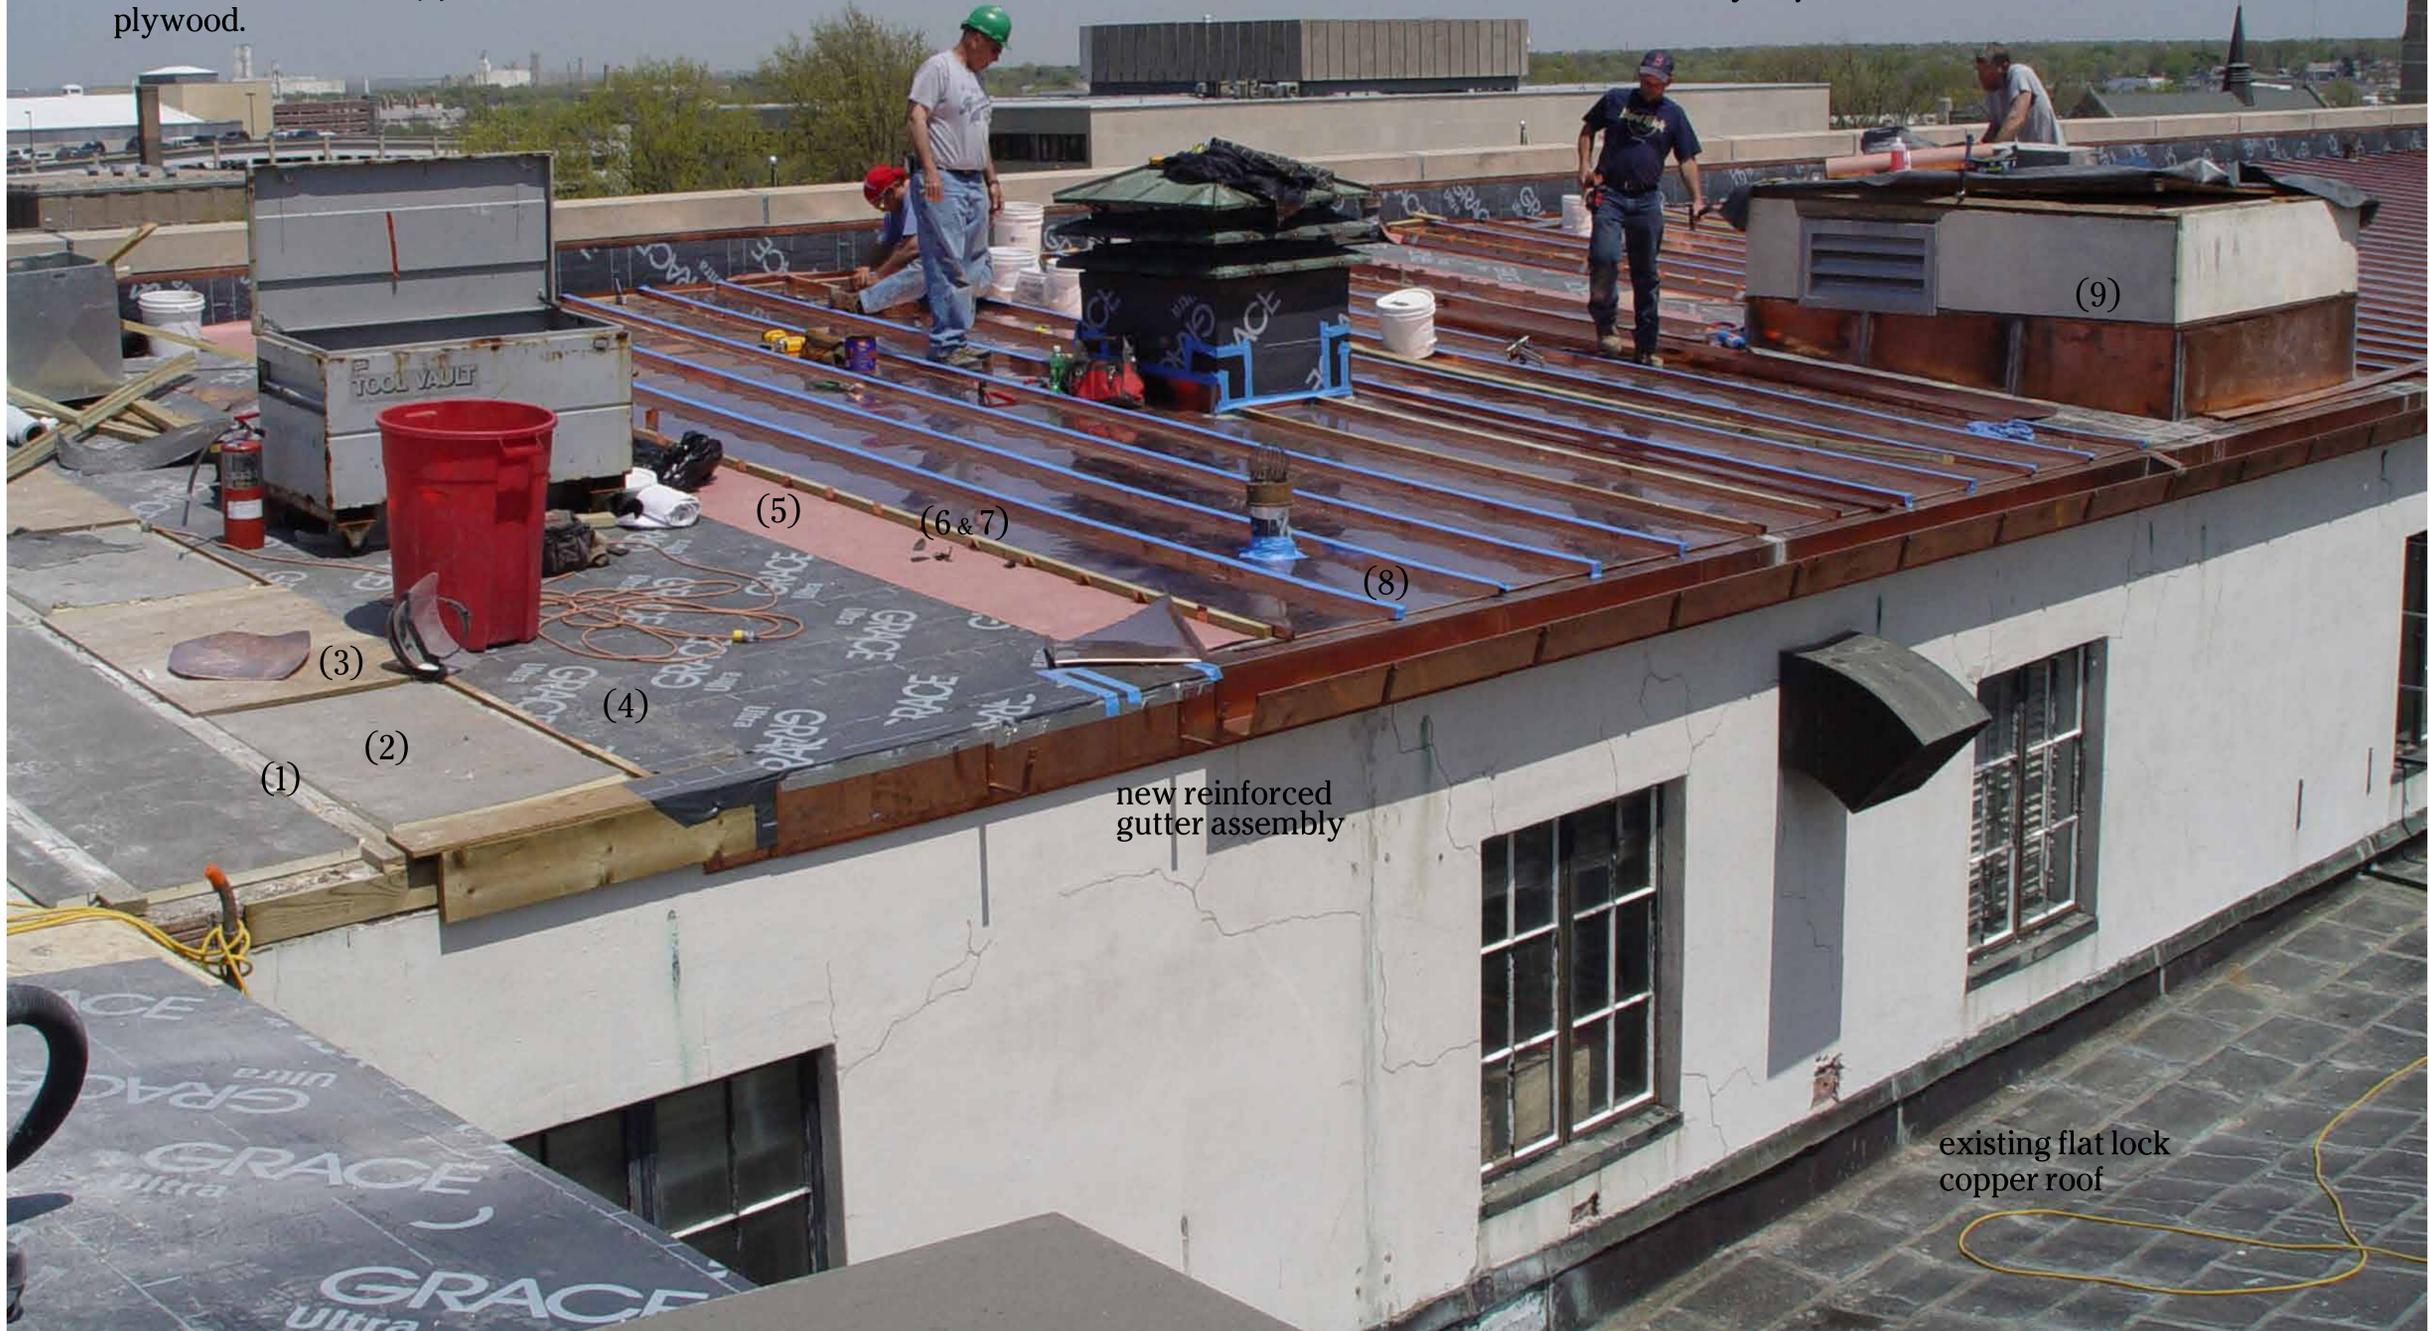
The old copper roof was stripped down to the original structural deck and the copper salvaged. Then new 2" X 4" sleepers (1) were screwed to the deck and insulation (2) placed between them. Next a plywood deck (3) which supports and holds the copper roofing as it is nailed down was applied. An ice and water shield, Gracie Fabric (4), was rolled out to cover the plywood.

Rosin paper (5) is placed on top of the waterproofing and the new copper roof is nailed on. The copper batten roof is a series of wooden battens (6) with copper pans (7) nailed in between using special cleats. (8) The wooden battens are capped with copper which is crimped into special slots for stability. Vertical areas (9) on the roof are flashed. Finally all joints are sealed with solder.
