Juffermans Surveyors Ltd

ENGINEERS REPORT

PROPOSED TWO LOT SUBDIVISION FOR N KATENE 65 EGMONT STREET HAWERA

22 October 2021

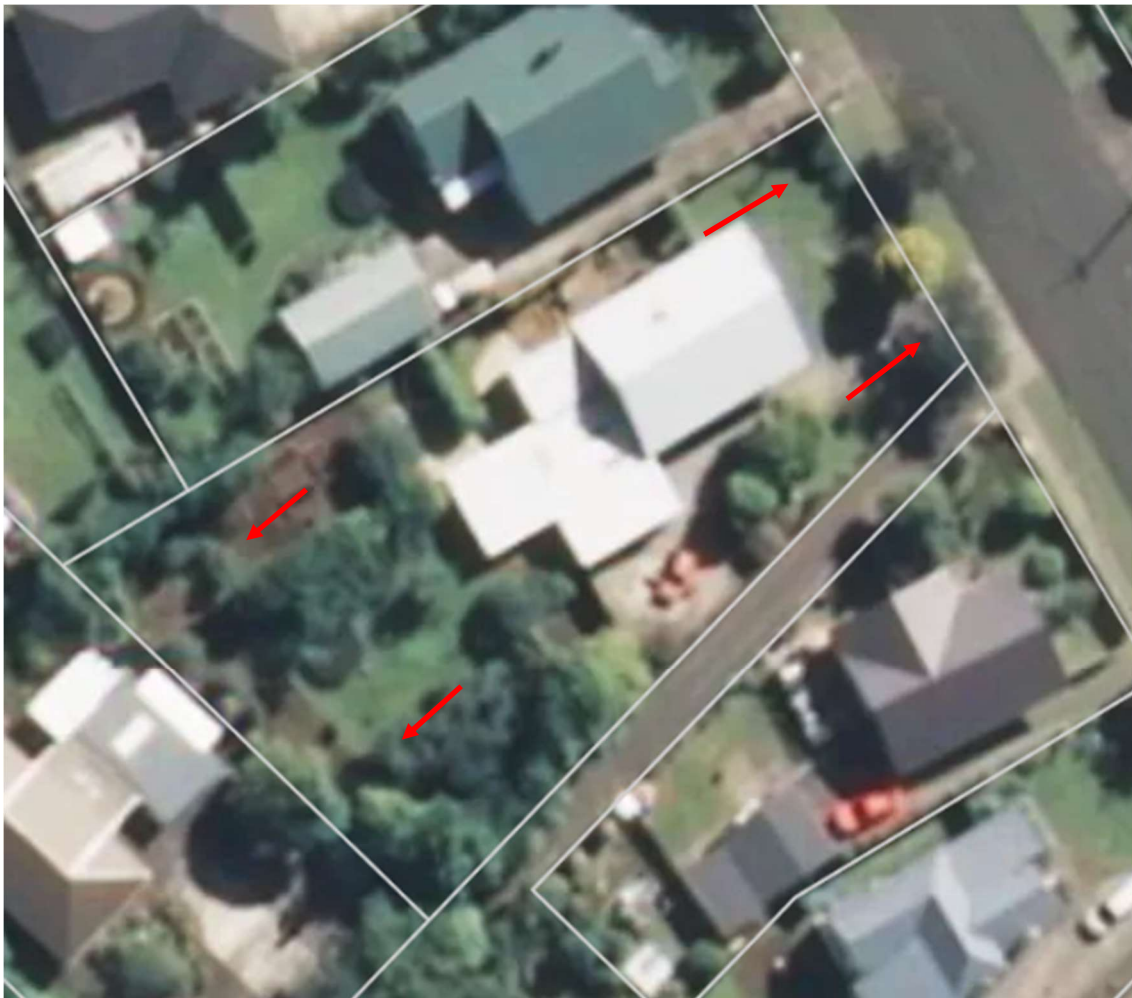
Figure: 1.1 Juffermans Surveyors Site Plan

The site has slight fall to the south within Lot 2 as indicated in Figure 1.1 below.

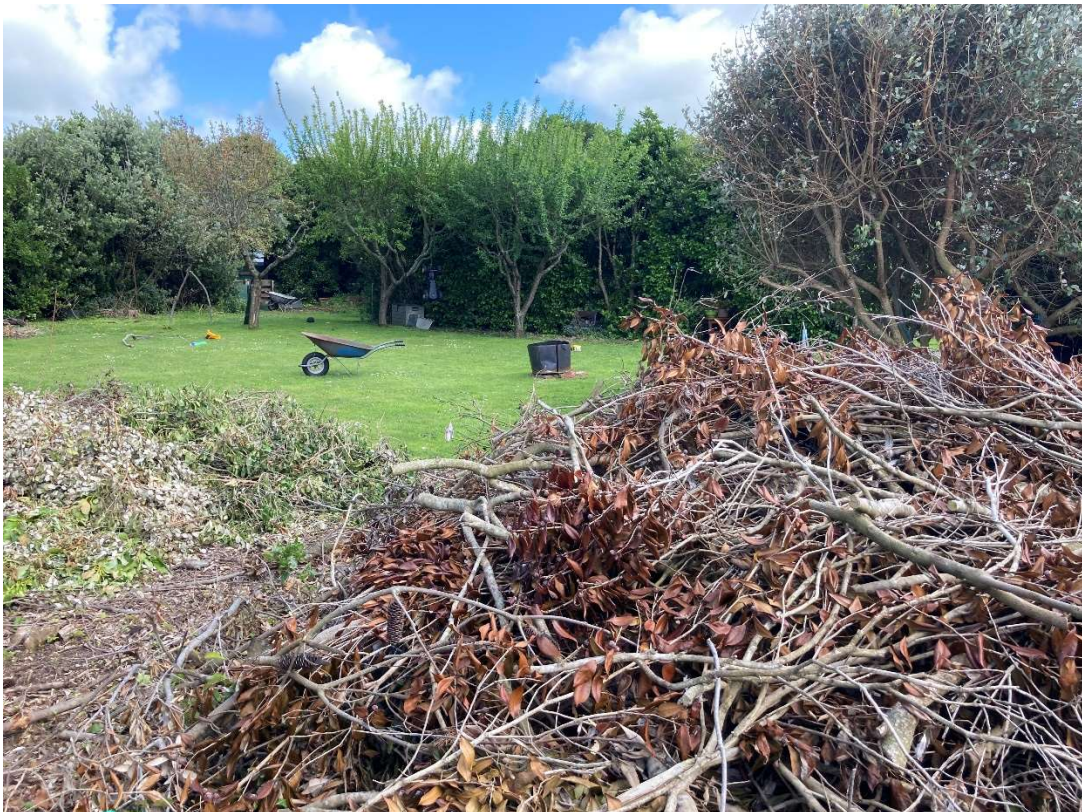
PHOTO 4: Lot 2 looking south west from north east corner, note hedges and trees.

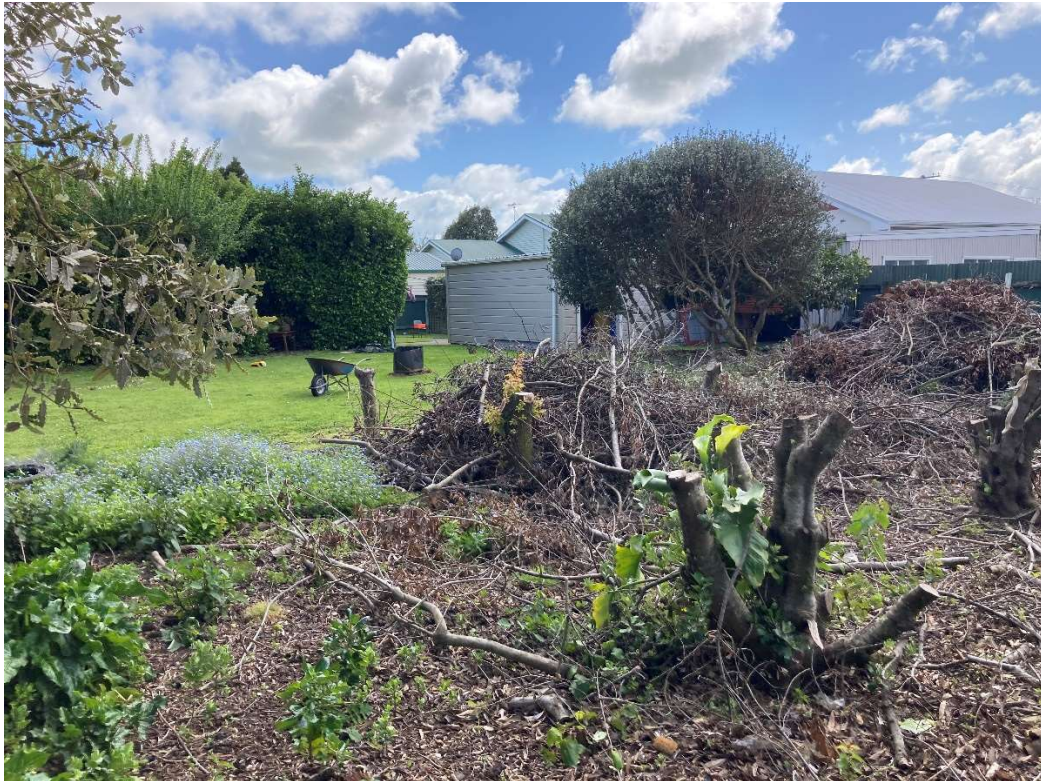
PHOTO 5: Lot 2 looking north west from south east corner, many tree stumps requiring removal.

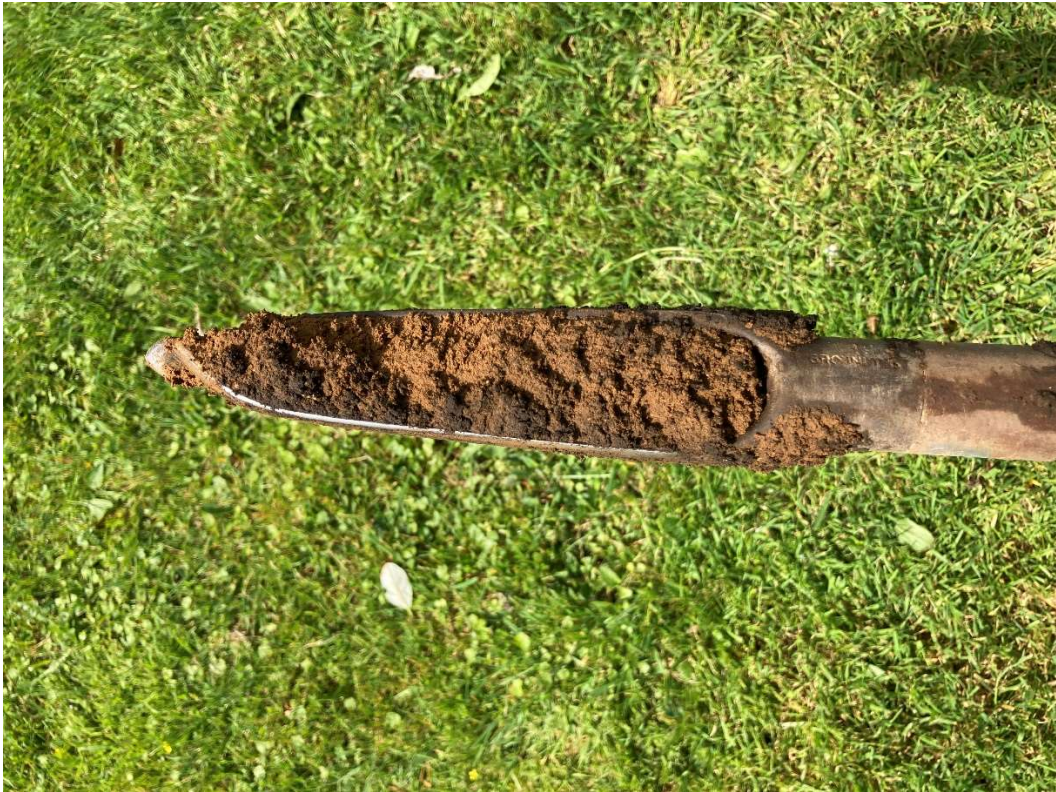
Hand augering encountered the ground water table at a depth of 3.0 metres below surface level. The fine brown silty ash encountered at a depth of 1.0 is moist and expansive. Moisture progressively increased with depth and the silty ash became grey brown with the increased moisture content. Lined soak holes to the water table will be appropriate for this site.

PHOTO 7: Fine brown silty Taranaki ash.

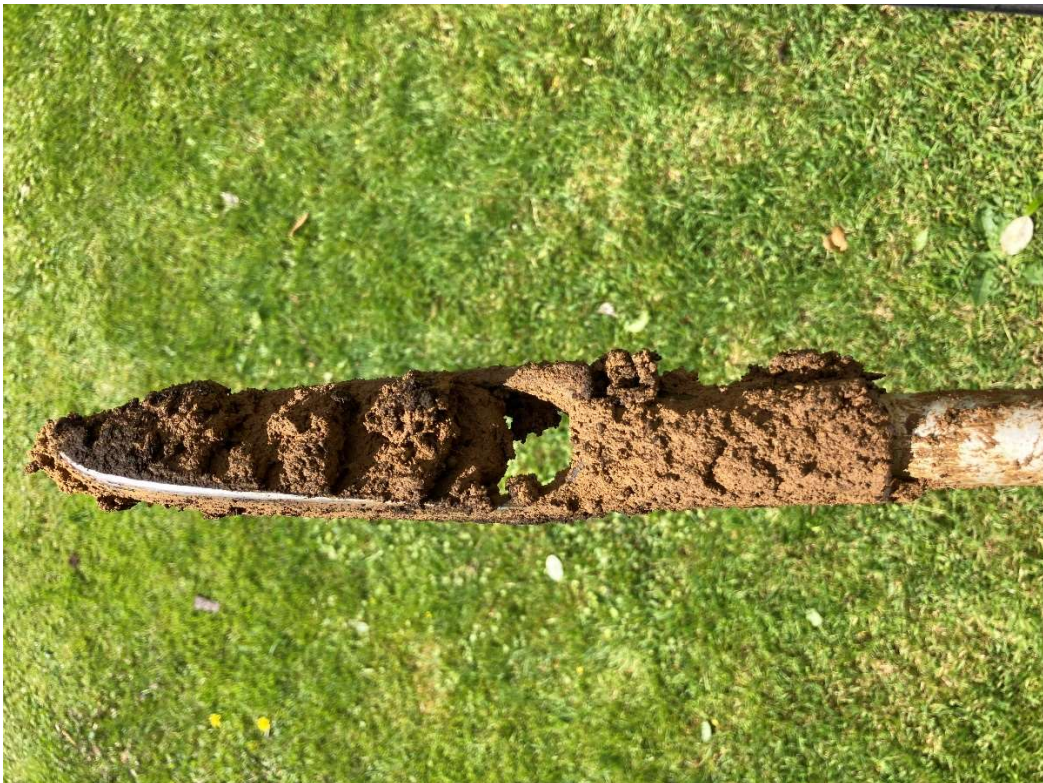
PHOTO 8: Moisture increase in silty Taranaki ash.

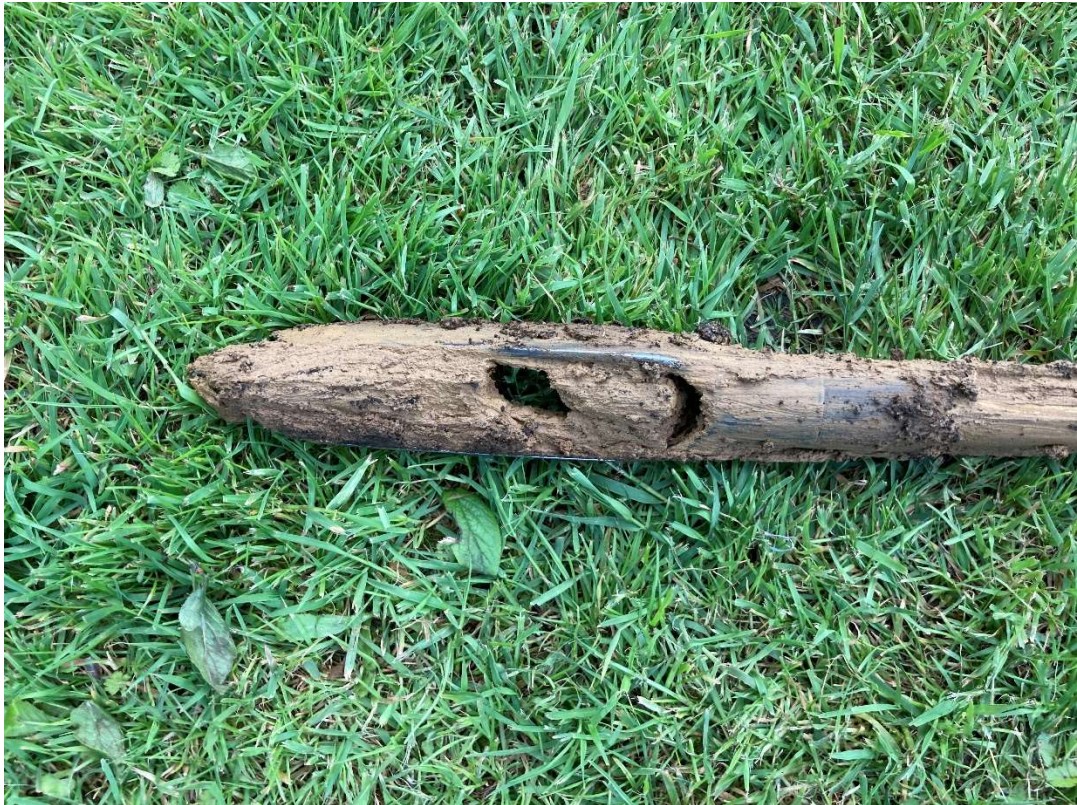
PHOTO 9: Light grey brown silty ash at 2.7 metres depth.

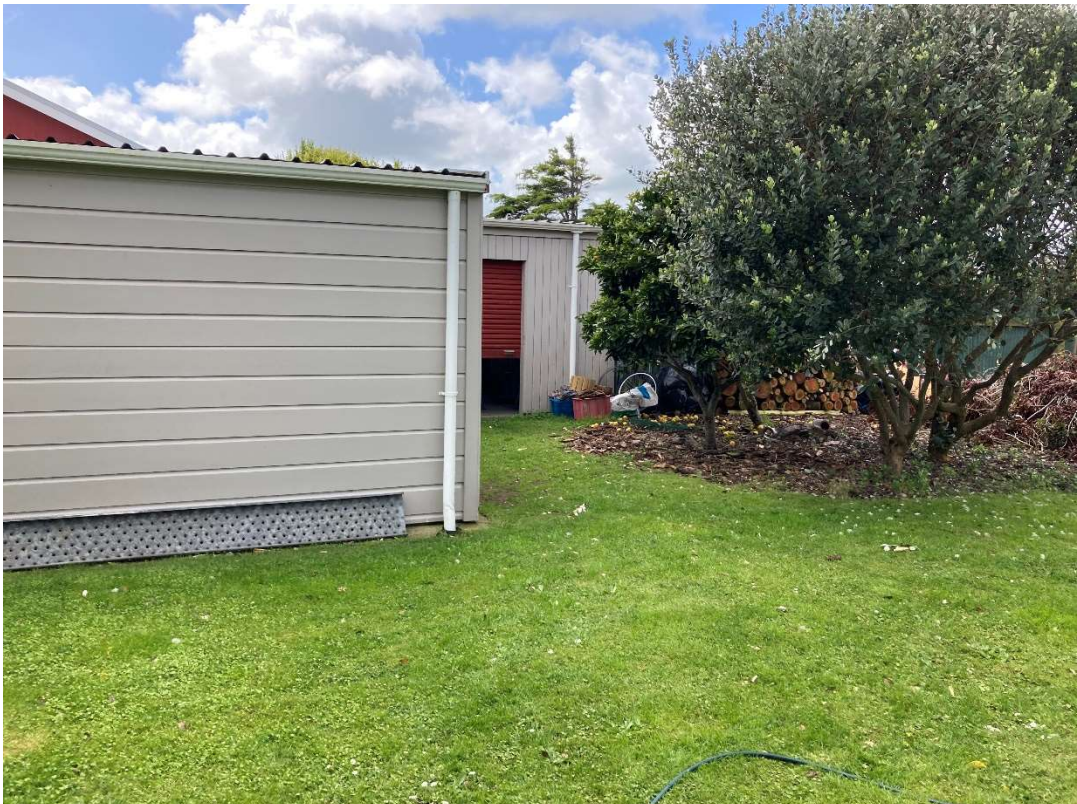
There are two downpipes along the southern walls of the existing building on Lot 1. Any soak holes which serve these downpipes must be located within Lot 1 in accordance with NZBC E1.

PHOTO 10: Downpipes from Lot 1 building, need to ensure soak holes are not in Lot 2.

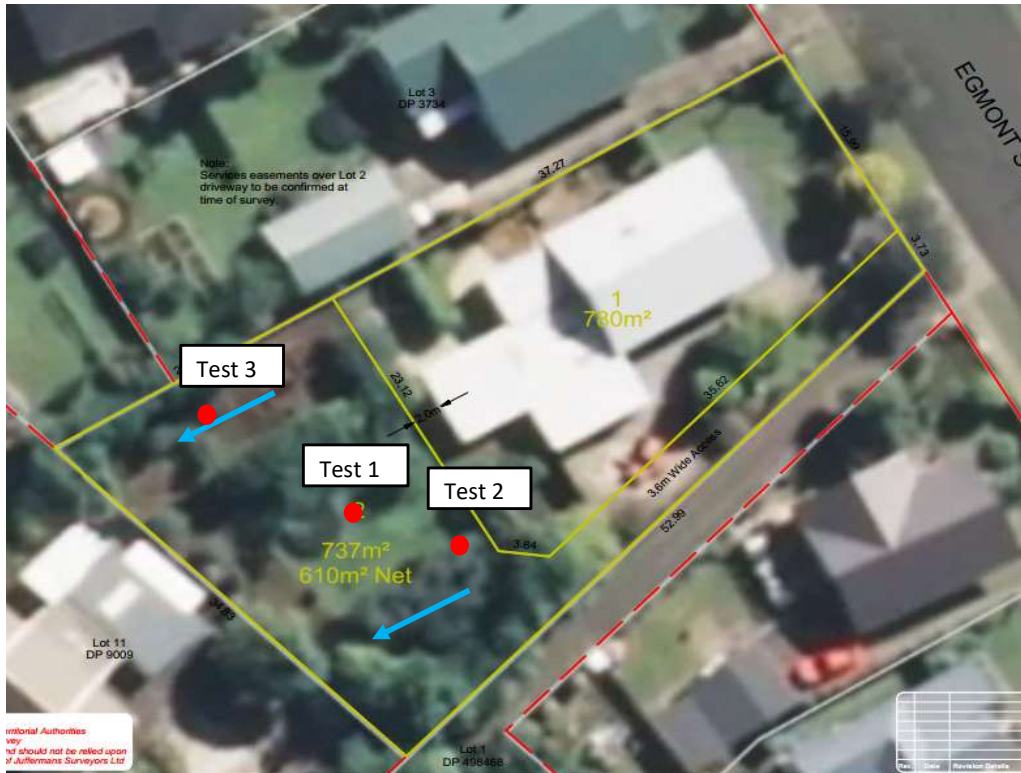
Test Locations

The subsoil conditions were consistent at the three test locations with scala penetrometer results indicating poor bearing capacity. The subsoil conditions on Lot 2 did not meet the strength requirements as set out in NZS 3604:2011 “Good Ground” - any rock or soil capable of permanently withstanding an ultimate bearing capacity of 300 kPa, (i.e. an allowable bearing pressure of 100 kPa using a factor of safety of 3)

The subsoil conditions on Lot 2 are not suitable for standard NZS 3604:2011 building foundations such as concrete slab on grade or timber pile.

It is recommended that further subsoil investigations are undertaken at time of building platform location being confirmed to ensure that ground conditions are consistent and to ensure a site-specific Engineering Design for foundations is carried out if required.
