## CASE STUDY 1 Caudle ORCHARD Improving Irrigation Efficiency

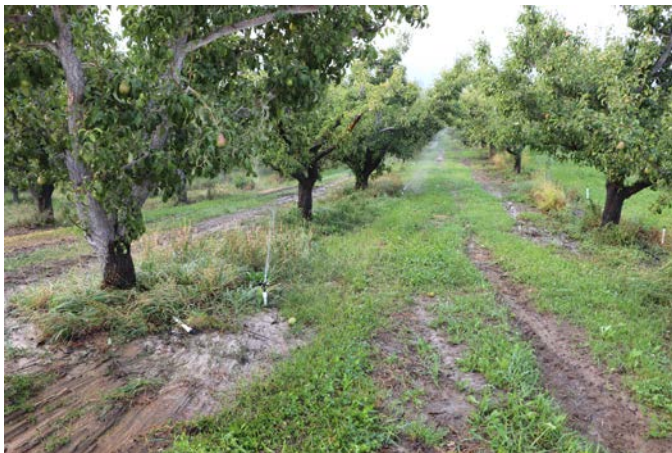
Figure 1 Standard system created run-off in order to maintain sufficient moisture at the top of the slope.

**STANDARD SYSTEM** Impact sprinklers (Rainbird) on 36 foot by 36 foot spacing. Growers generally run 1 row at a time skipping a row as they go across the field and return taking 9 days to irrigate the five-acre field.

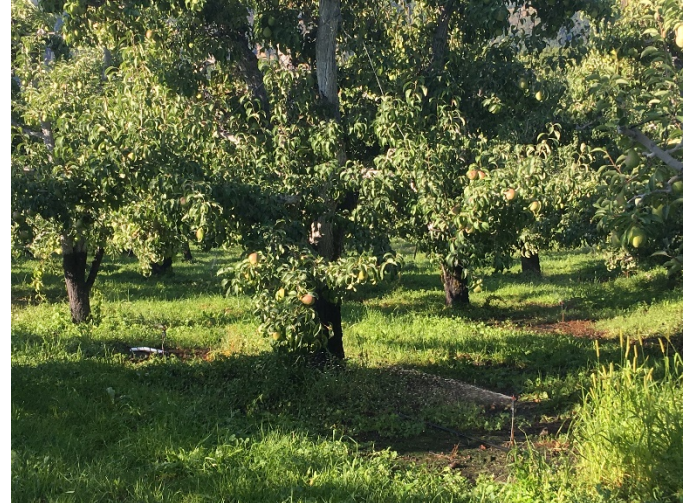
Figure 2 R10 micro-sprinkler system upgrade.

**NEW SYSTEM** R10 micro sprinklers were installed every row on a 20 by 20 foot spacing in a five-acre field encompassing one half of the sloped field in spring 2018.

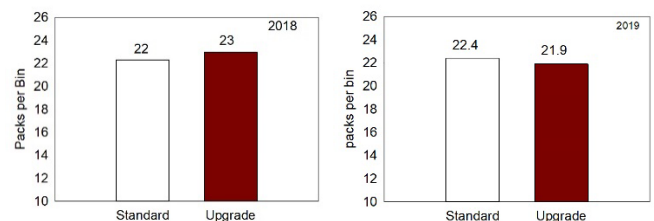
Figure 3. Fruit quality

In 2018 the packout for the upgraded block was 95.6% compared to 92.7% for the standard system resulting in 23 vs 22 packs per bin. In 2019 the packout for the upgraded block was 92.1% compared to 93.7% in the standard block.

20% of the culls in the standard block were due to small fruit, and 8% to cork in the standard block compared to 10% to small fruit and 14% cork in the upgraded block.

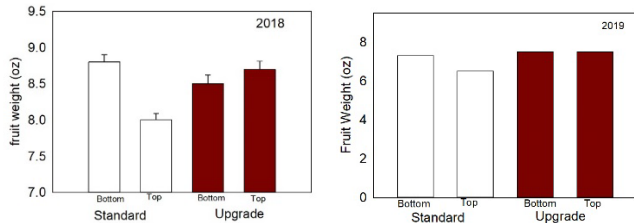
**IMPACT ON FRUIT SIZE** In 2018 and 2019 fruit size was more uniform in the upgraded block compared to the block irrigated using the standard system.

Figure 4. Fruit size in 2018 (left) and 2019 (right).

The upgraded block had more large fruit which impacted returns. Returns were estimated using average by fruit size from the Washington State Tree Fruit Association for Sept 2019 and January 2018 (months fruit was packed). Using the average

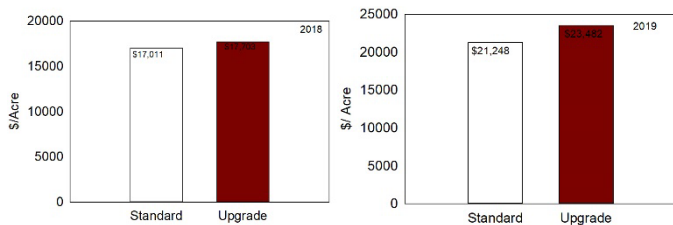
Figure 5. Returns per acre based on block packs and fruit sizes from a 56 bin run. Assumes 40 bins per acre.

price per box per size class (90s:\$22.48; 100:\$19.37; 110:\$18.21; 120-:\$21.88) revenue per acre in the upgraded block was \$17,703 compared to \$17,011 for the standard system in 2018. In 2019 assuming prices per box of 90s+:\$29.7; 100: \$27.2; 110:\$25.5; 120+:\$23 revenue per acre was \$23,482 in the upgraded block compared to \$21,248 in the standard.

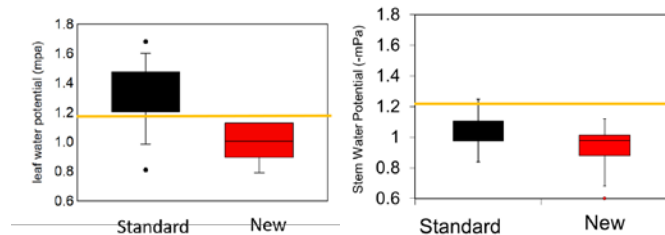
Water limitation measured by leaf water potential was lower in the upgraded block (0.79 to 1.13 mpa on July 17, 2018) compared to the standard block (0.81 to 1.7 mpa).

Figure 6 Tree water stress for 2018 (left) and 2019 (right).

Tree water limitation is measured by using a pressure chamber to measure leaf water potential. Water within the plants moves through a network of cells (xylem) that act like pipes carrying water from the roots. When the soil dries and the roots cannot keep pace with evaporation from the leaves the water in the plant becomes under tension. Tension over 1.2 mpa is considered too high.

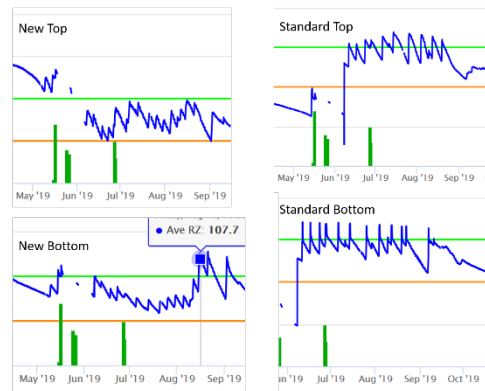
Figure 7 Soil moisture record from 2019. The soil in the standard system tended to stay too wet.
