- 1. Key Points
- 2. Project Overview
- 3. Access Route Requirements
 - a. Construction Equipment Requirements
 - b. Equipment Mobilization
- 4. Alternative Routes
- 5. Road Improvement Summary
 - a. Cachagua Road
 - b. Jeep Trail
- 6. Estimated Construction Traffic
 - a. Northern Cachagua Road
 - b. Tassajara to Southern Cachagua Road
- 7. Mitigation Measures

Project Overview

Access Route Requirements

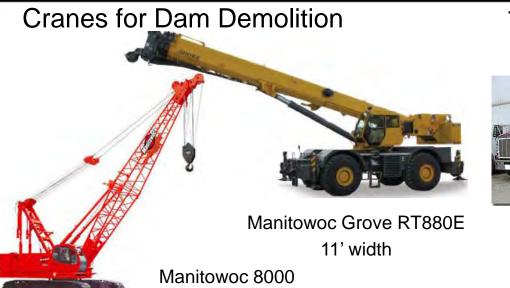
16.25' width

Tractor-Trailer with Lowboy for Equipment Mobilization

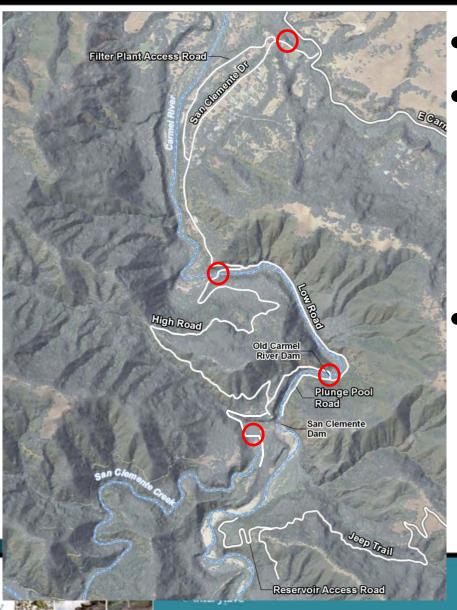
Three Bridges Required

- Tularcitos Creek
- Carmel River
 - High Road at Sleepy
 Hollow Ford or
 - Low Road at Old
 Carmel River Dam
- San Clemente Creek
 - To reach reservoir area

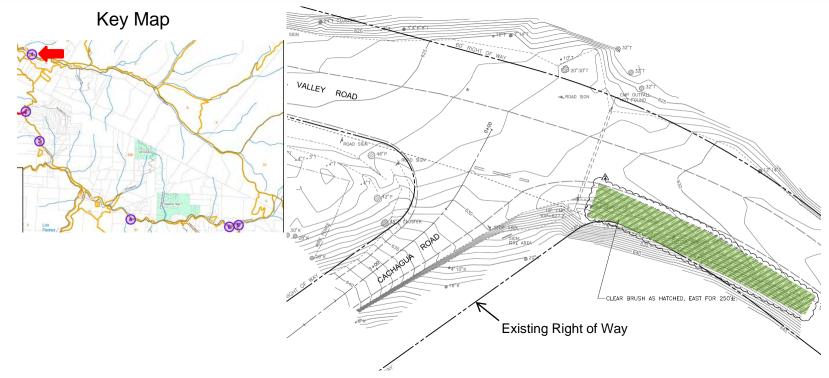
Public Road Improvements 1. Carmel Valley Road & Cachagua Road

Improve sight distance at intersection by clearing vegetation (green highlight) south of Carmel Valley Road and east of Cachagua Road

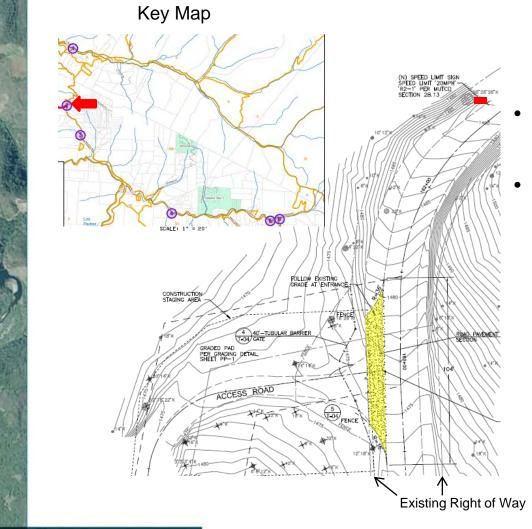
Public Road Improvements 2. Cachagua Road & Jeep Trail

- Harden western shoulder of Cachagua Road at entrance to Jeep Trail (yellow highlight)
- Erect reduced speed limit sign (red highlight) for southbound traffic on Cachagua Road to mitigate limited sight distance due to hillslope east of Cachagua Road

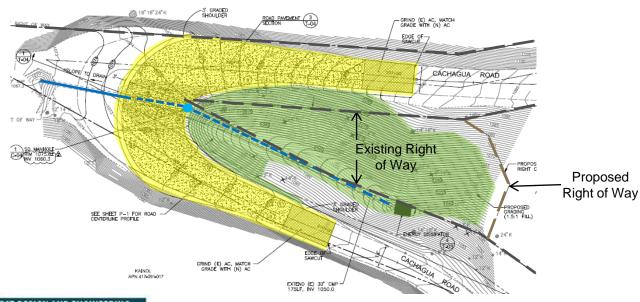
Public Road Improvements 3. Cachagua Road Switchback No. 1

- Extend existing culvert (solid blue line) with proposed culvert (dashed blue line), construct new manhole (blue dot) and discharge into rock energy dissipator.
- Place, grade and compact rockfill (green highlight) inside of existing switchback
- Replace existing asphalt concrete pavement with new pavement (yellow highlight) in proposed alignment
