Parks and Grounds Building

Town of Sudbury ADA Transition Plan

October 2020

**Town of Sudbury
Parks and Grounds Building**

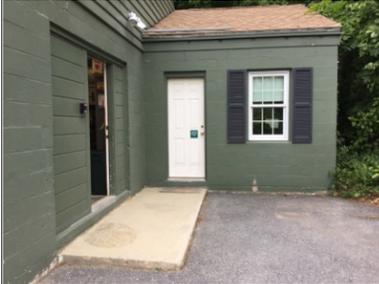
ID	Location	Floor	Room	Element	Type	Photo	Issues	Current Measure	Recommendations	Quantity	Price	Cost Estimation
Approach and Entrance												
Entrance												
1	Entrance to Office on East	Ext.		Entrance	Secondary Entrance

Entrance not on an accessible route Clear width at door is < 32" Mat not securely attached Threshold > 1/2" high Hardware not operable with a closed fist	- 29" - 1.25" -	Provide a directional sign indicating the location of the nearest accessible entrance. Secure the mat. Provide hardware that can be operable with one hand and not require tight grasping, pinching, or twisting of the wrist.	1	830 Labor	\$830
2	East Garage - Building Exit	Ext.		Entrance	Main Entrance

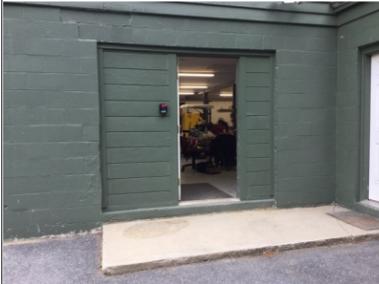
International Symbol of Accessibility not provided Threshold > 1/2" high	- 7"	Install a metal ramp to provide an accessible entry route to the building. After the entrance is made accessible, provide a sign with the International Symbol of Accessibility (ISA). (Cost is for a 7' perforated metal ramp with a 5' x 5' platform courtesy of Amramp and an exterior sign.)	1	3146	\$3146

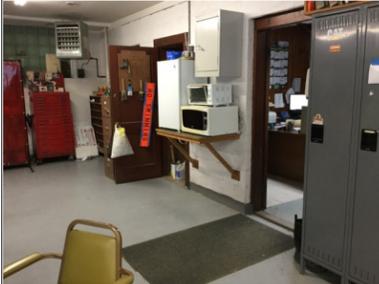
Emergency Exit												
3	Office Entrance From East Garage	1		Emergency Exit	N/A

Tactile sign not provided at exit Directional sign to accessible emergency exit not provided	- - -	Provide tactile exit signs with raised characters and braille at exit doors. Mount signs between 48"- 60" above the finished floor located on the latch side of the door. Provide a directional sign indicating the location of the nearest accessible emergency exit.	1	464	\$464
4	East Garage - Building Exit	1		Emergency Exit	N/A

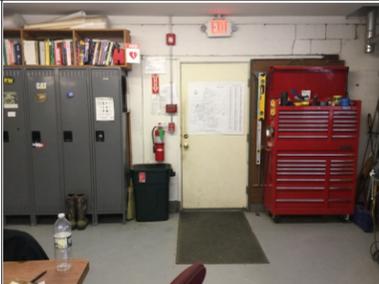
Tactile sign not provided at exit Illuminated Int. Symbol of Acc. not provided (MAAB)	- -	Provide tactile exit signs with raised characters and braille at exit doors. Mount signs between 48"- 60" above the finished floor located on the latch side of the door. After the entrance/exit door is brought into compliance, provide an illuminated sign with the International Symbol of Accessibility.	1	432	\$432

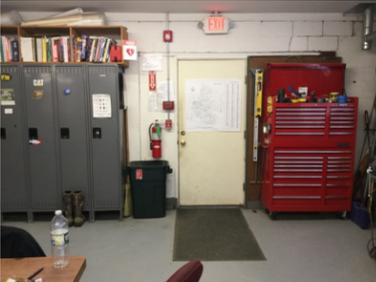
ID	Location	Floor	Room	Element	Type	Photo	Issues	Current Measure	Recommendations	Quantity	Price	Cost Estimation
Doors, Doorways, & Gates												
5	East Garage - Building Exit	1		Doors, Doorways, & Gates	Circulation

Maneuvering clearance(s) not provided Mat not securely attached Hardware not operable with a closed fist	- - -	Relocate the trash bin. Secure the mat. Provide hardware that can be operable with one hand and not require tight grasping, pinching, or twisting of the wrist.	1	Labor 484	\$484
6	Route to Center Garage From East Garage	1		Doors, Doorways, & Gates	Circulation

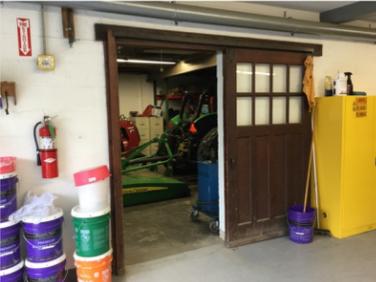
Hardware not operable with a closed fist	-	Provide hardware that can be operable with one hand and not require tight grasping, pinching, or twisting of the wrist.	1	484	\$484
Toilet & Bathing Rooms												
Lavatory												
7	Center Garage Toilet Room	1		Lavatory	N/A

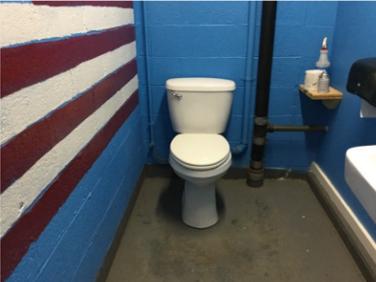
Not on an accessible route Flush control not on open side Toe or knee clearances not provided Turning space not provided Faucet is not operable with a closed fist Grab bar not provided Plumbing underneath is exposed Mirror above lavatory w/reflective surface > 40" Dispensers not within reach range	7.75" - 26.5" 51" - - - 50.5" 58"	Add an accessible single-user toilet room located on an accessible route.	1	24604	\$24604

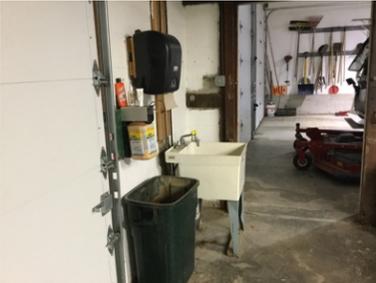
Additional Access												
Sink												
8	Center Garage	1		Sink	Other

Toe and knee clearances not provided Non-compliant faucets Dispenser not within reach range	- - 55"	Ensure there is a 27" knee clearance positioned for a forward approach. Install faucets that do not require tight grasping, pinching, or twisting of the wrist. Relocate dispenser 48" max. above the finished floor or ground.	1	2928	\$2928
