Inspection Summary

CLM / 2011 / 058677

VICTORIA GROSE
46A PACIFIC ROAD
NORTH NEW BRIGHTON
CHRISTCHURCH
H: & W:
M:

Land Assessment – L

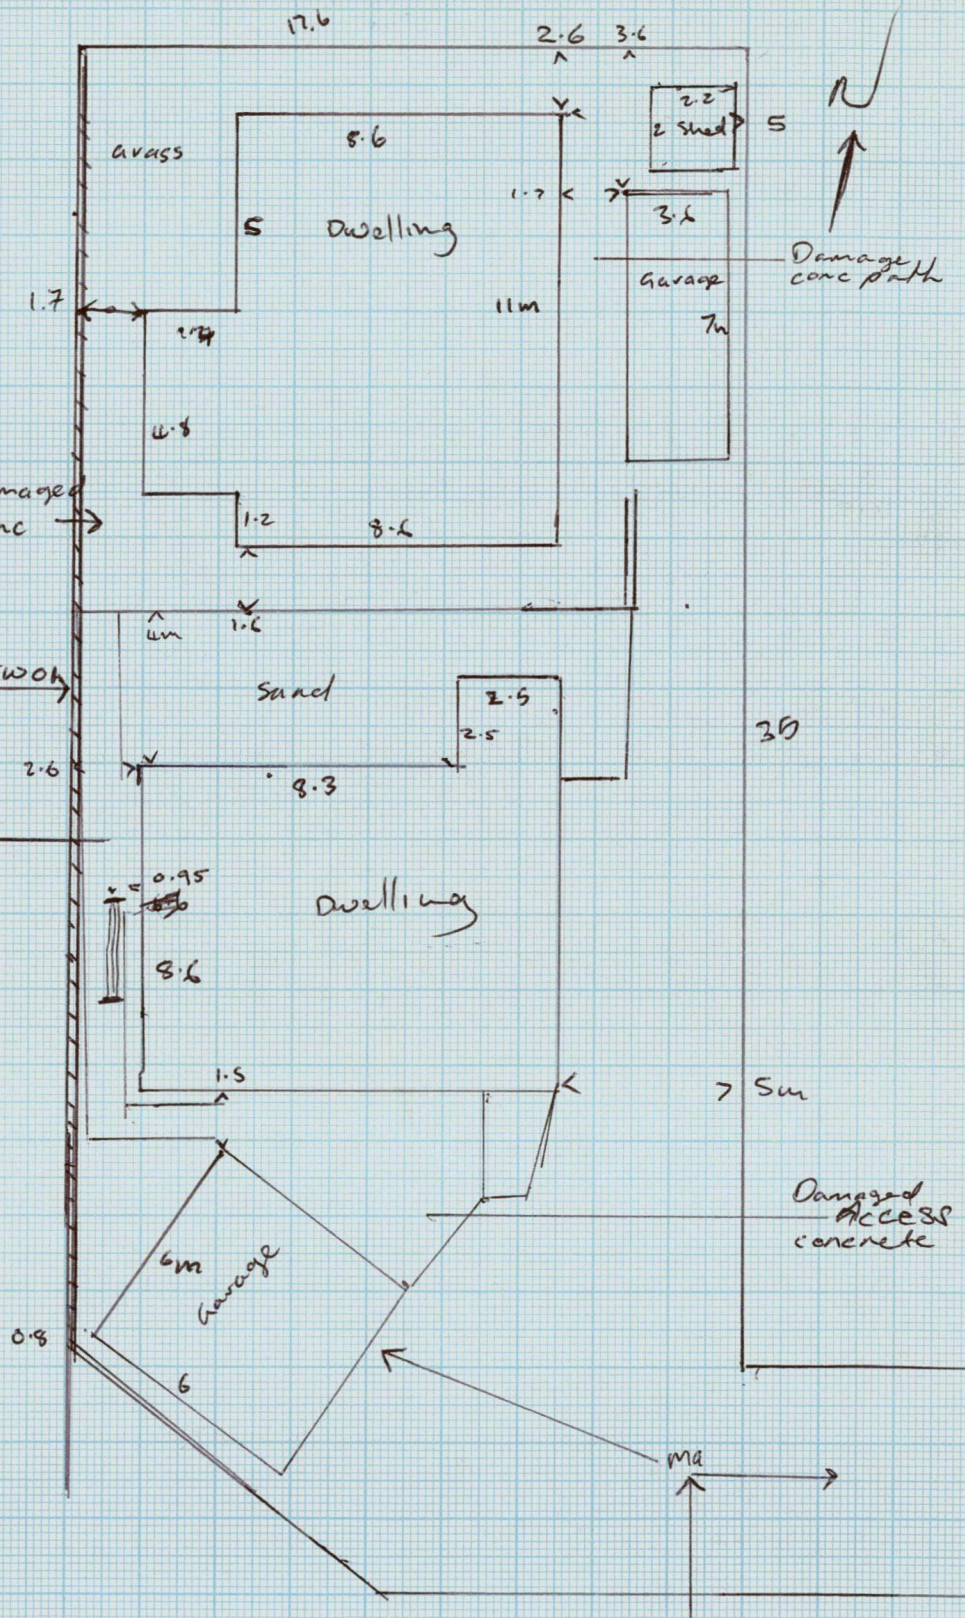
Post & Rail
 timber RTW
 supporting assessed
 dwellings

Damaged
 conc path

RTW

Damaged
 Conc

MA 25.6 x 4.5
 Damaged concrete

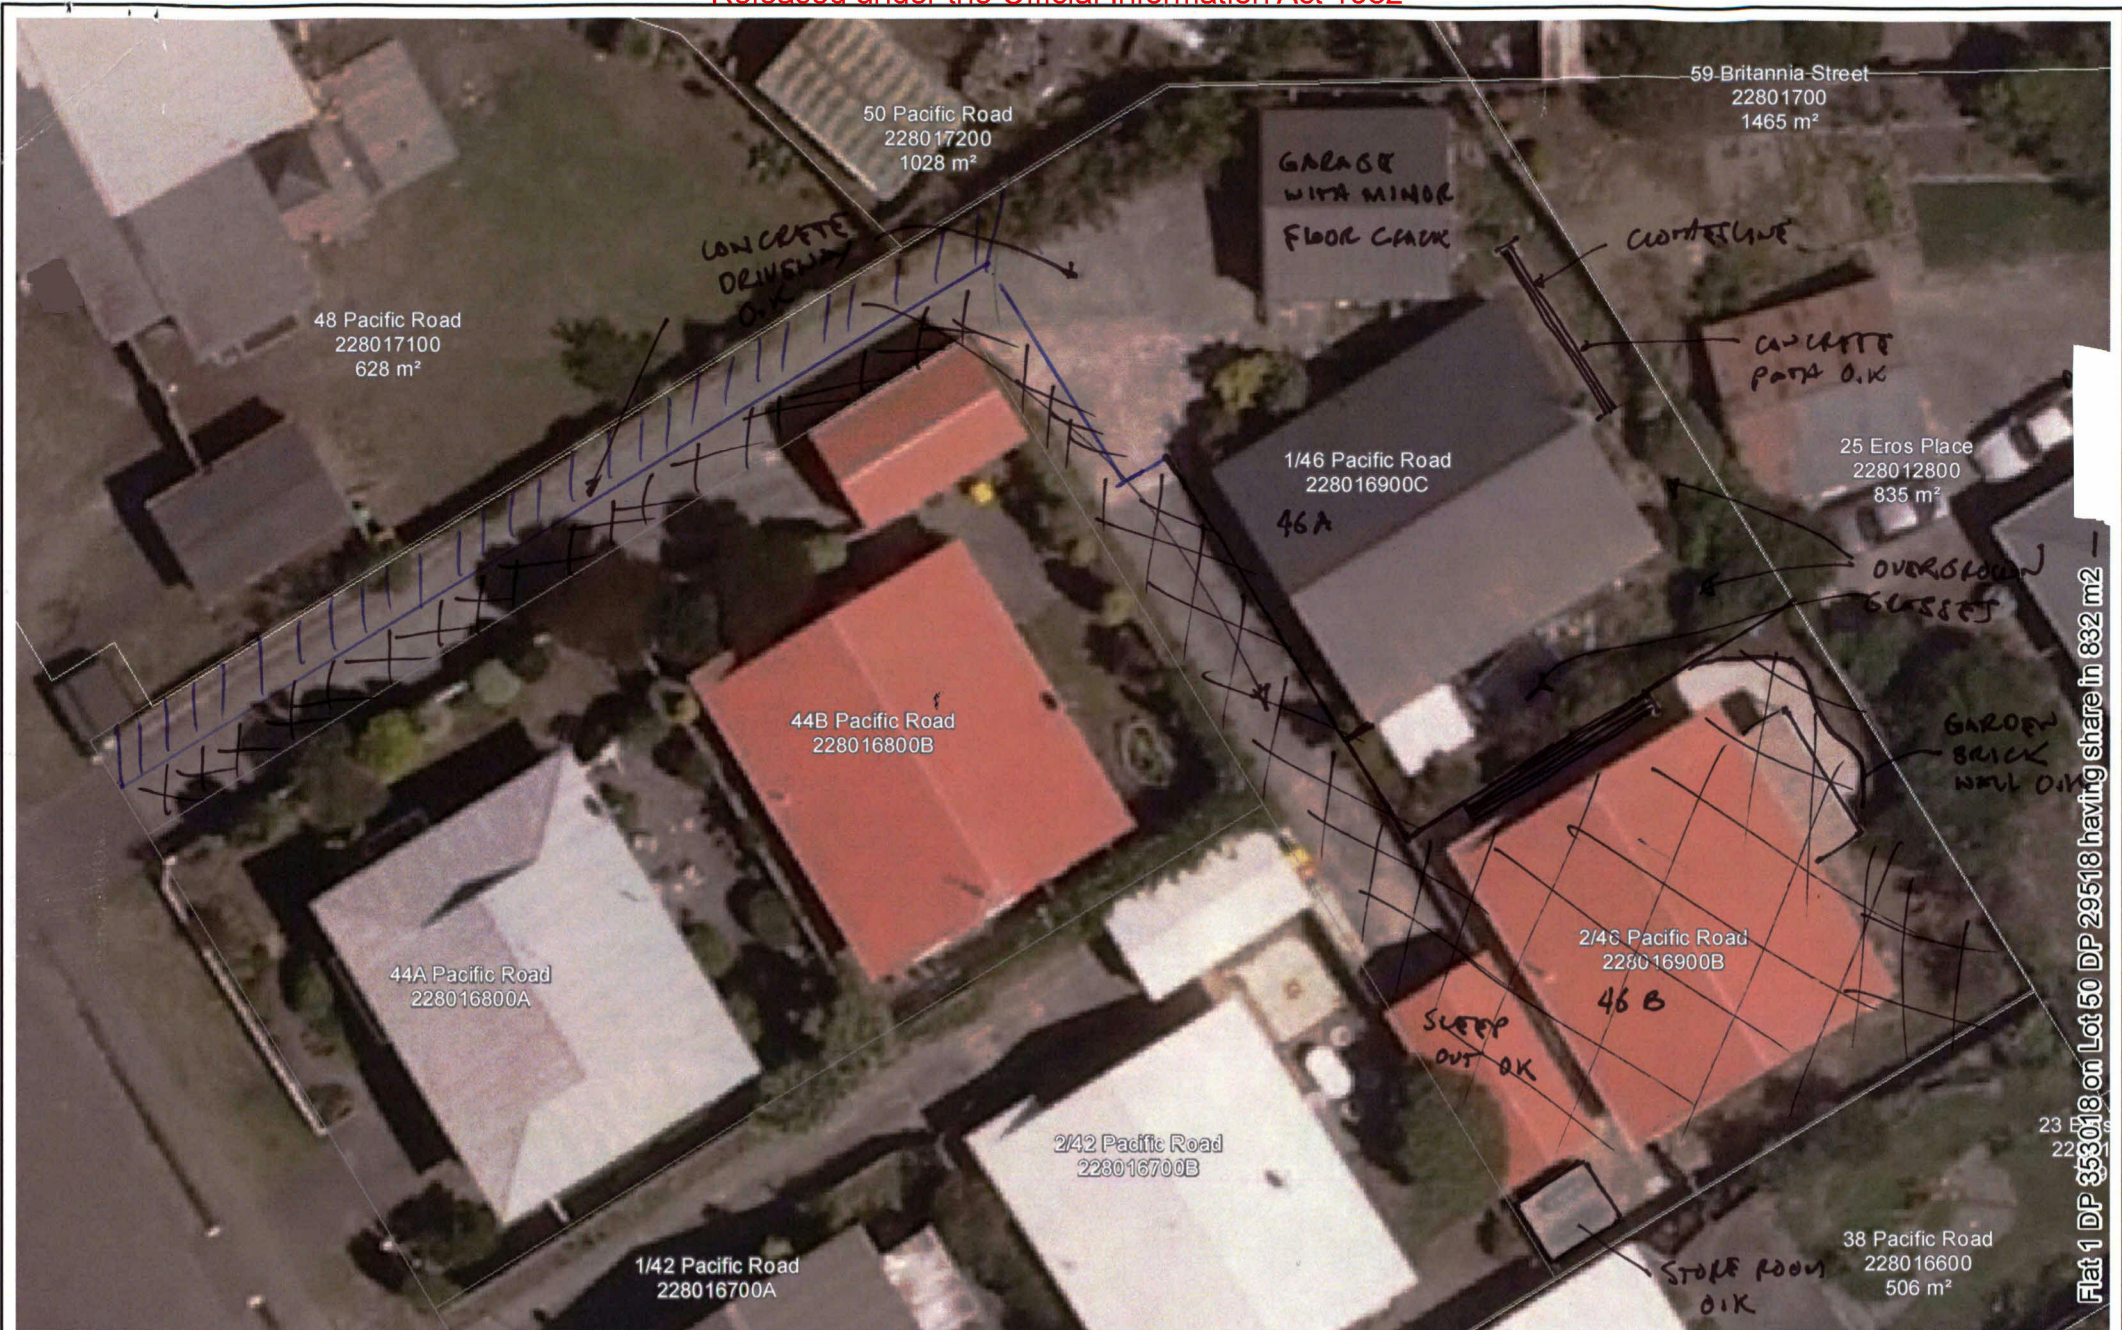
Notes: NO LAND DAMAGE

1/1: 2/46 Property

1/1: Accessway - 51m²
