# Land Information Memorandum

Property address:  
1/46 Pacific Road

We understand the dwelling at the site sustained damage as a result of the 2010-2011 Canterbury earthquake sequence and that you require a geotechnical assessment of the ground conditions to determine a suitable solution for the proposed repair

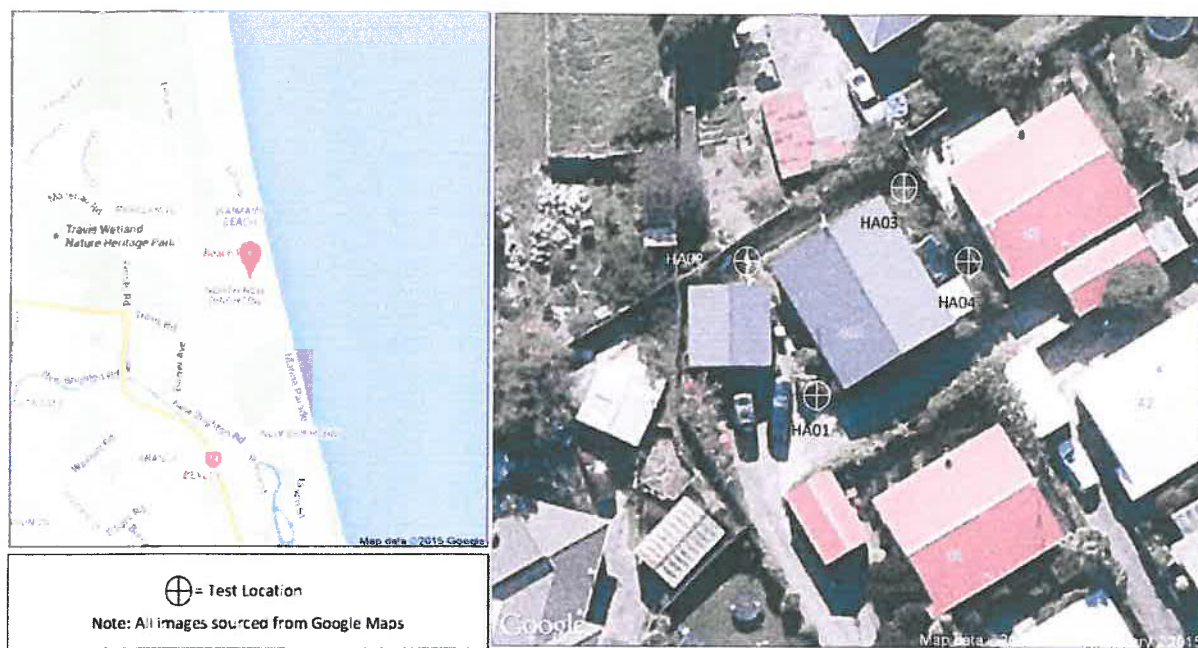
**Figure 1: Site Location Plan and Investigation Locations**

The site is located in North New Brighton, Christchurch, on a relatively flat section of around 425 m<sup>2</sup>, share in 832 m<sup>2</sup> (Figure 1). It is bound to the north/east/south/west by residential properties. The site is 340m west of the beach.

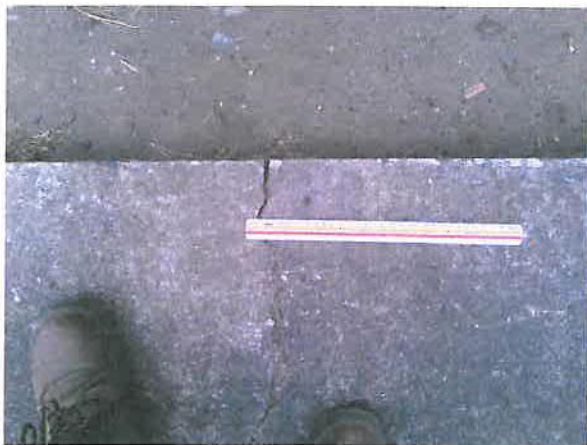
- The dwelling is a timber framed structure with light/medium weight cladding on a concrete floor (slab on grade) (Type C1, as defined by MBIE). The site has a separate double garage on the western side with light/medium weight cladding and concrete slab on grade foundation.
- The paved surfaces have 5mm wide cracks in the northern path and up to 30mm wide cracks in the northwest corner path.

Photo 1: 5mm crack in northern path

We recommend a structural assessment to evaluate the foundation distress and practicality of relevening and repair. Provided the structure complies with the appropriate indicator criteria for floor/foundation releve provided in Table 2.3 of the guidance document, we recommend repairing foundations in line with Section 4 of the MBIE guidance.

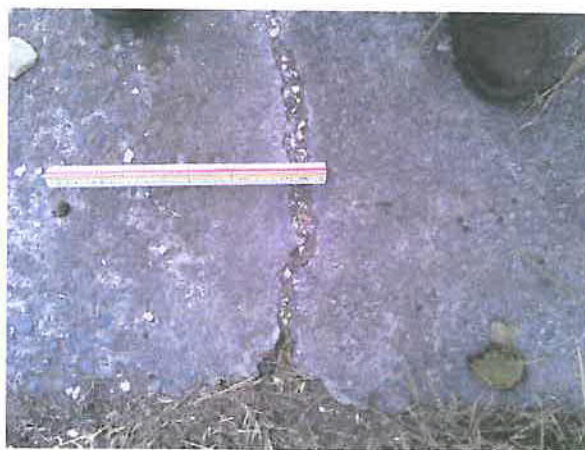
Photo 2: 30 mm crack in northwest corner path

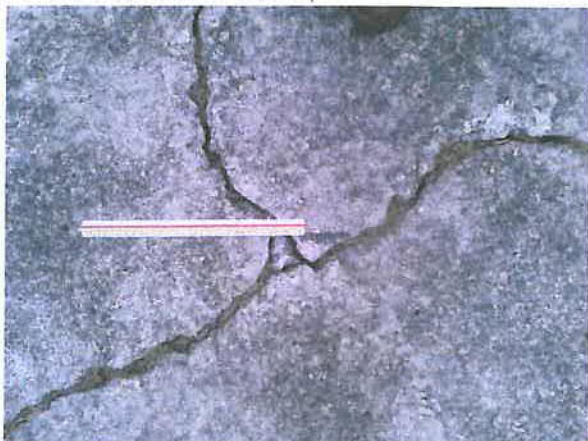
Photo 3: Driveway crack

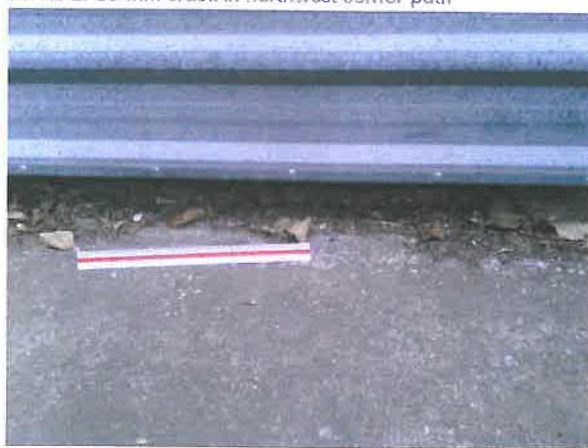
Photo 4: Garage slab 50 mm higher than driveway

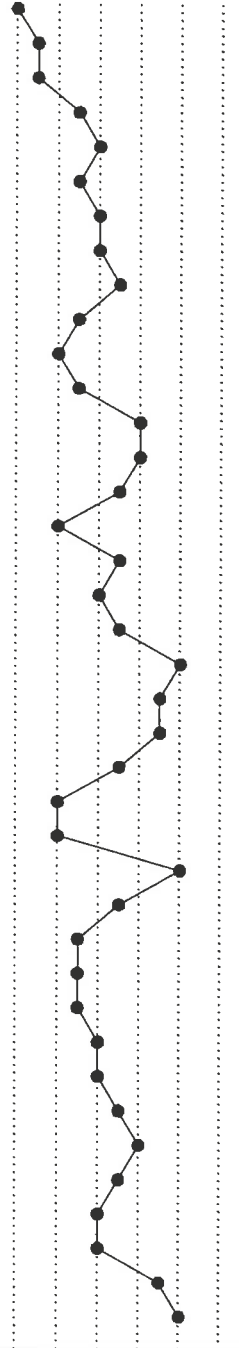
Depth (m)	Material	USCS Symbol	DESCRIPTION	Graphic Symbol	Water Level	Moisture Cond.	Consistency/ Density Index	Shear Vane Undrained Shear Strength (kPa) Peak/Remolded	Scala Penetrometer					
									Blows per 100mm					
									2	4	6	8	10	12
0.5	DUNE SANDS	SP	Fine to medium SAND; grey. Poorly graded, subrounded to subangular.

L-MD

Becomes moist at 0.6 m depth.											
1.0														
1.5														
2.0						M	MD							
2.5														
3.0														
3.5														
4.0						W								
End of Hole Depth: 3.4 m Termination Condition: Practical refusal														
Hand auger met practical refusal at 3.4 m depth due to hole collapse. Scala Penetrometer met target depth at 3.9 m. Dip test showed no standing water
