# Rockfall Risk Assessment

70 Landsdowne Terrace, Cashmere

Report reference: 250274-A

Date: 22 August 2025

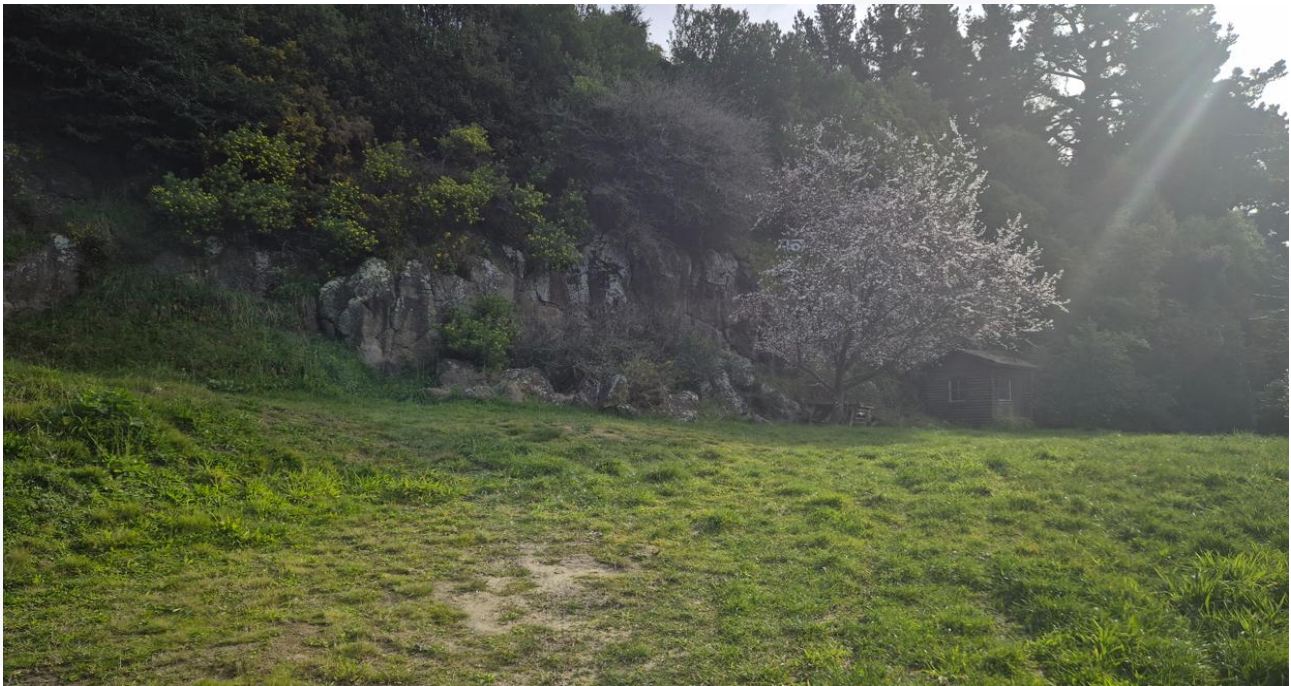
Three rockfall source areas were identified during the site inspection on 17 August 2025. The first consists of near vertical rock outcropping located around 35m upslope (west) of the property at 50mRL elevation. The outcrop is located on the upslope of a near horizontal benched area (<10 degree slope), the benched area is wider than the outcrop is high, and it is assessed any rock that mobilises will come to rest immediately beneath the outcrop. We consider this outcrop does not pose any risk to the dwelling. Refer to Figure 1.

**Figure 1: Rock outcropping on upslope side of flatter, benched area**

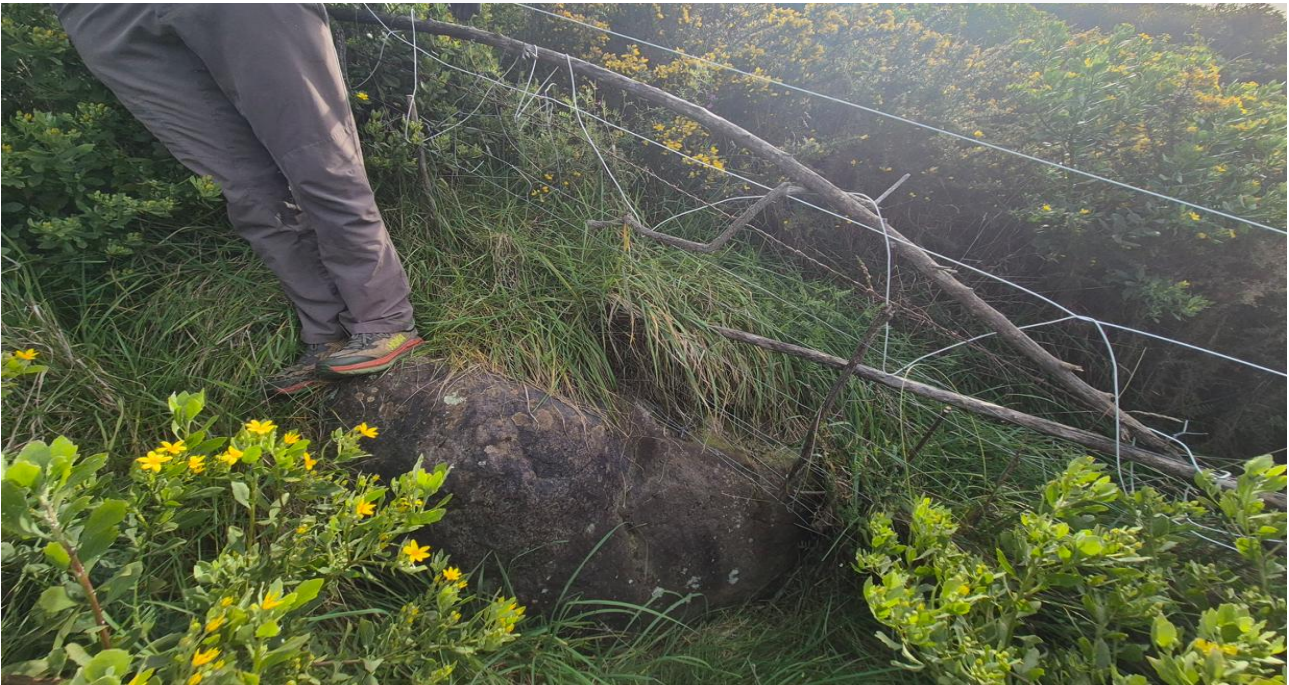
A small outcrop (or buried boulder) was observed around 90m south-west of the dwelling at elevation 70mRL. The outcrop appeared significantly buried and is considered very unlikely to mobilise. The rock did not show any obvious signs of weathering or jointing and is not considered to pose a significant risk to the dwelling. Refer to Figure 2.

**Figure 2: Buried rock outcrop or boulder at 70mRL**

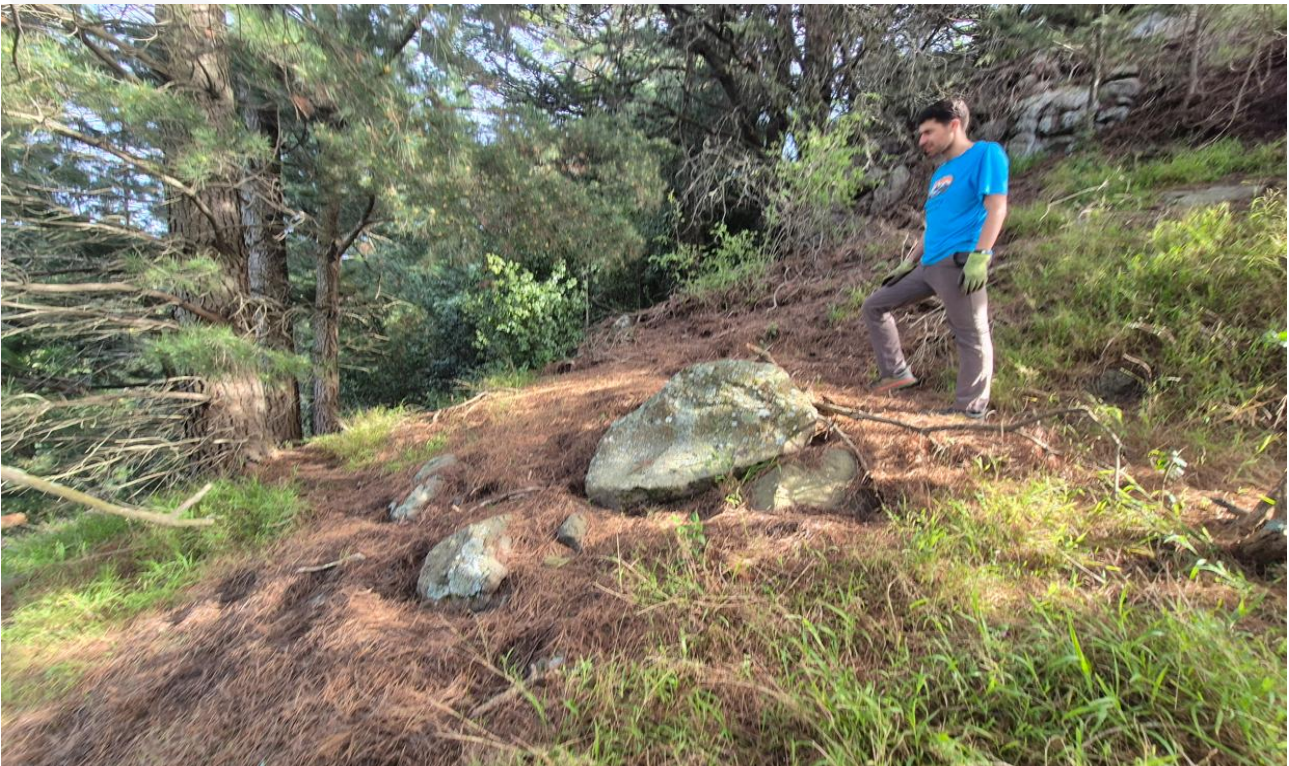
The third rockfall source was observed around 135m south-west and upslope of the dwelling at an elevation of 95-100mRL. The outcrop consisted of in-situ rock and boulders located 3-5m downslope of the source. The average boulder size appeared to be around  $0.8\text{m}^3$  and generally triangular or tabular in shape with the maximum size up to around  $1.5\text{m}^3$ . This source is considered to be the most likely to potentially pose a risk to the dwelling and has been used for the rockfall hazard assessment. Refer to Figures 3 and 4.

**Figure 3: Boulders located downslope of the rock outcrop in top-right corner**

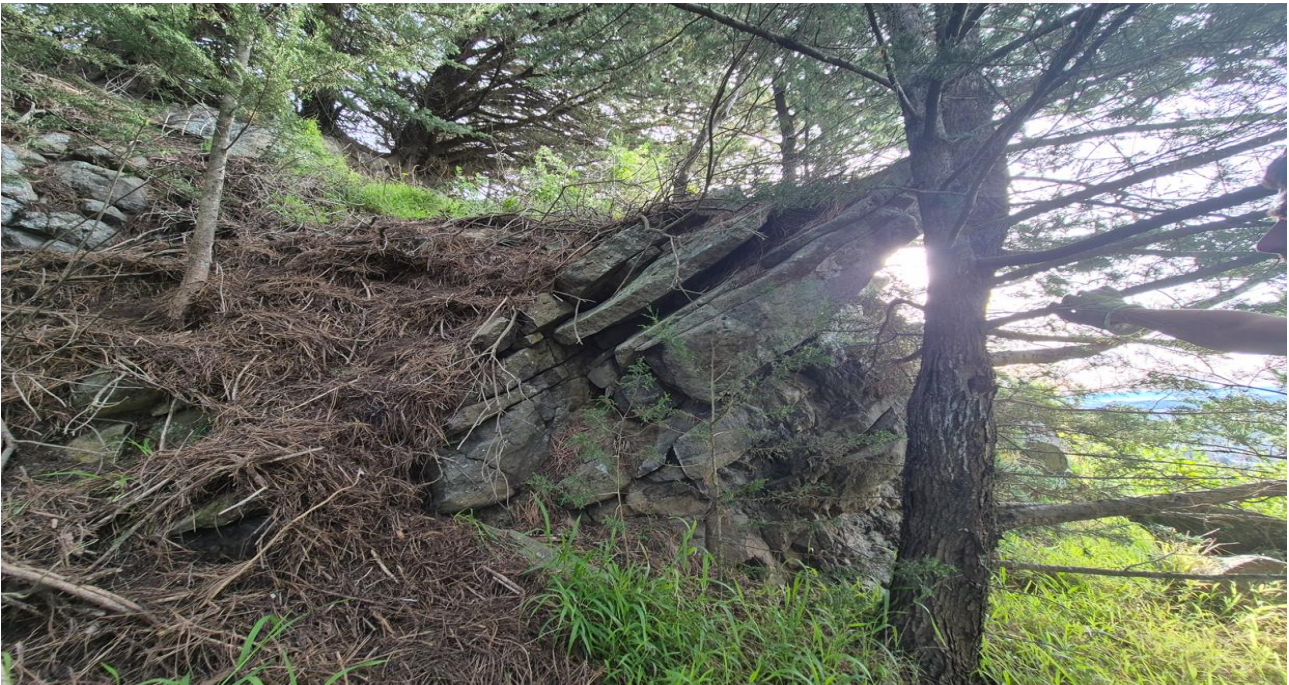
Figure 4: Example of rockfall source noting the jointing and tabular nature of potential rocks

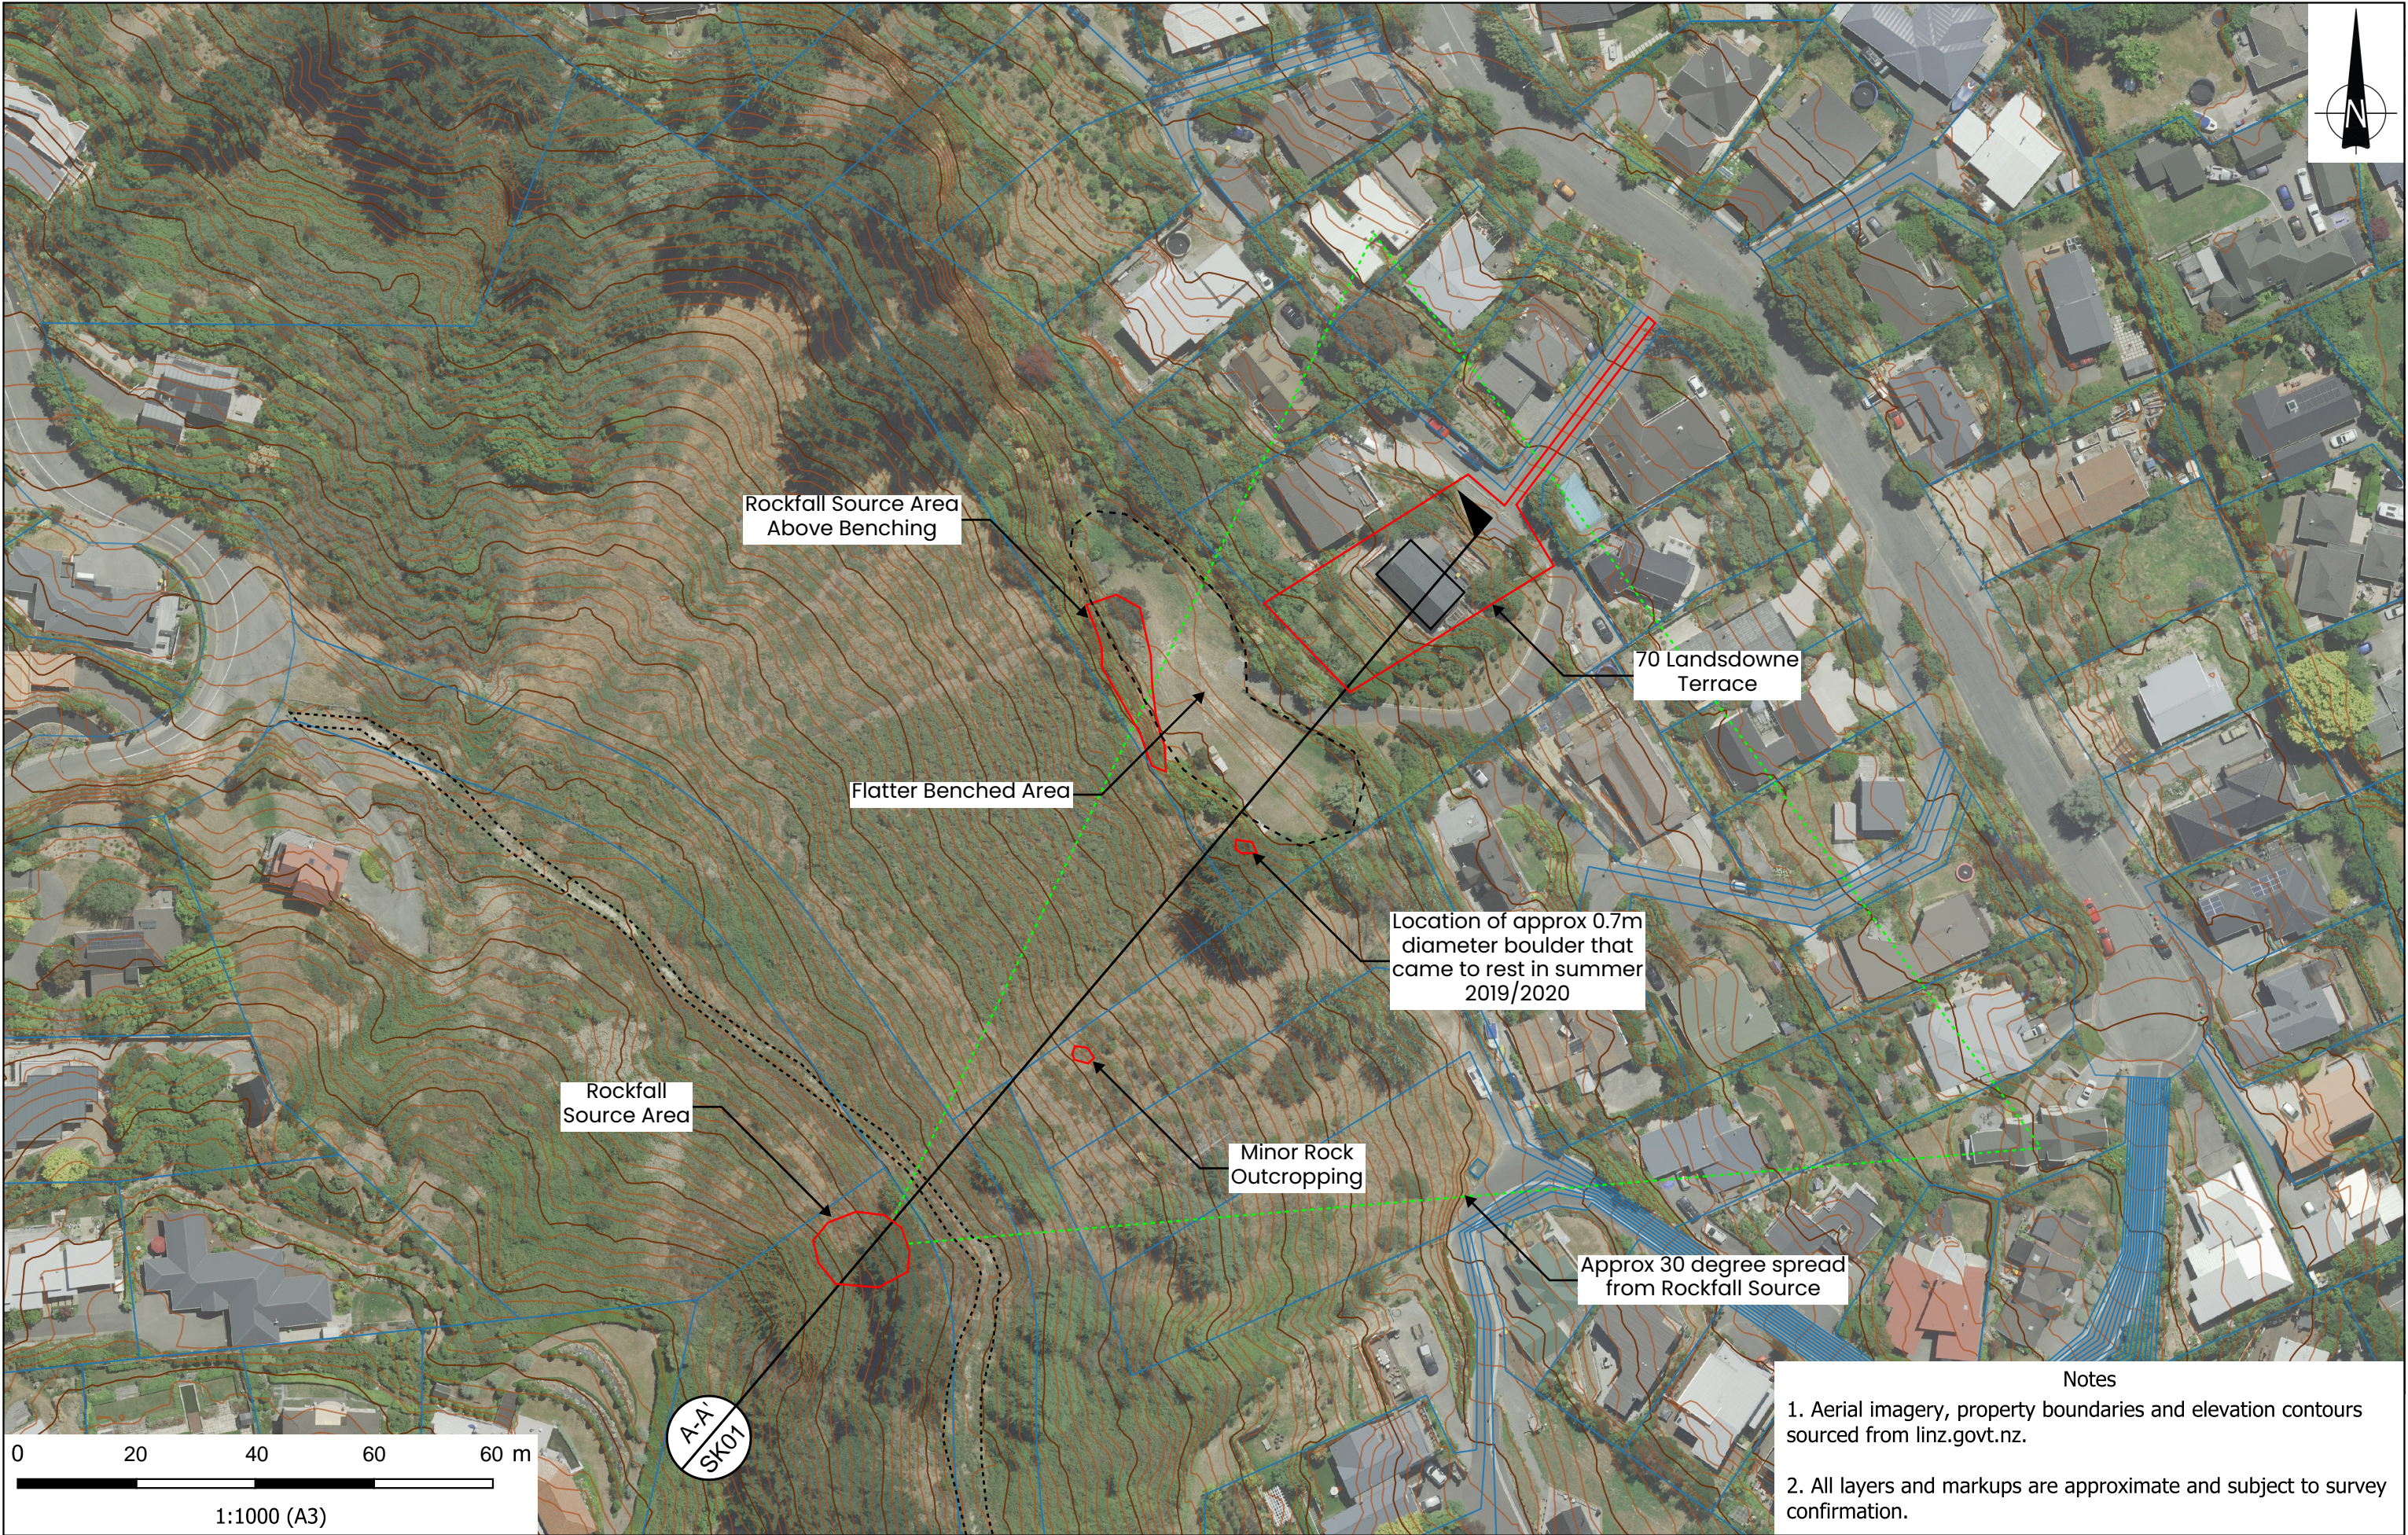
## Site Plan

Client	Timothy Farrant
Address	70 Landsdowne Terrace, Cashmere, Christchurch
Project	Riley Ref. 250274
Figure Title	Site Location Markup

A site assessment was undertaken by a Principal Engineering Geologist on 17 August 2025 that included a walkover of the property and the upslope area to the west of the site. The key observations are described in Table 1. An annotated site plan and cross section are included in Appendix B and Appendix C.
