## Liquefaction Assessment Report for 161, 167, & 169 Gladstone Road, Levin

**Prepared for:** John Poulton

**Issue Date:** 3/04/2025

**HWEL File:** 250201

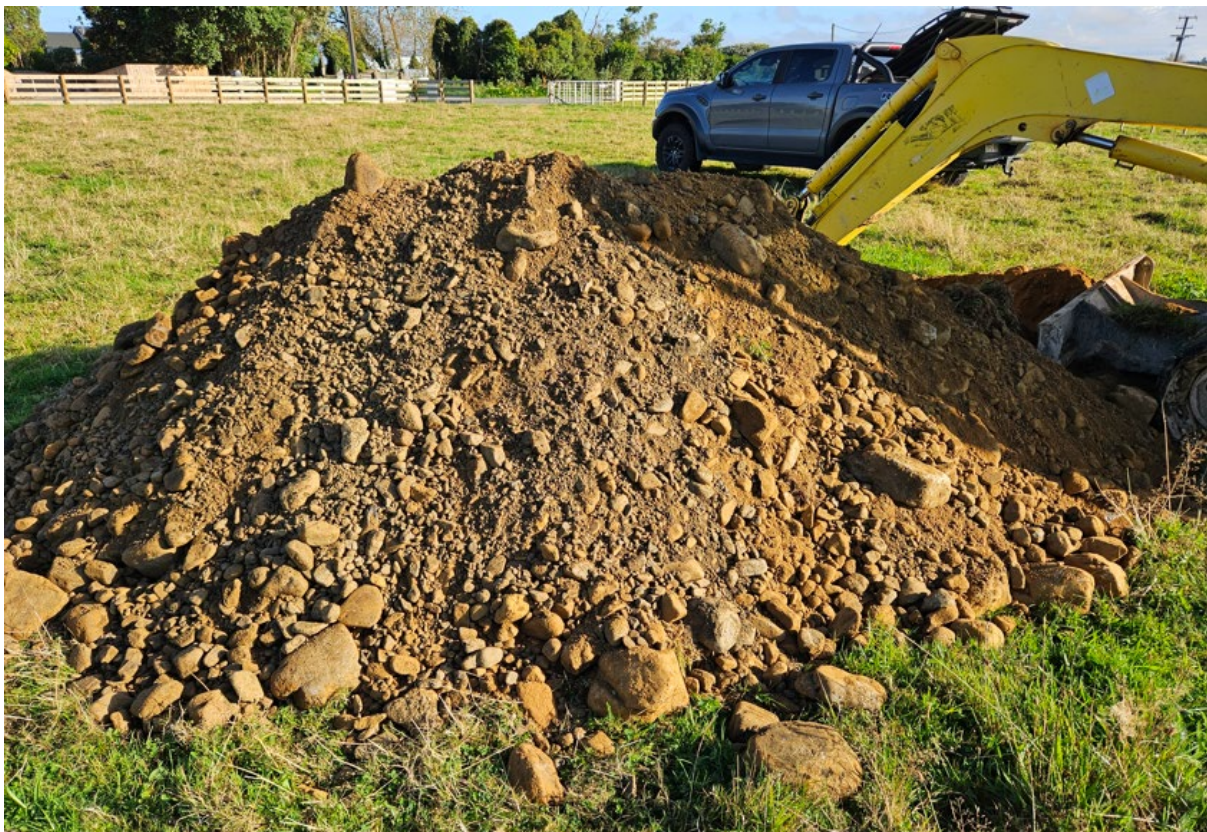
## Site Testing Locations

HWEL provided oversight to the testing process and generated a site soil investigation report following analysis of the field data. Testing involved 2 x machine excavated test pits and scale penetrometer testing by HWEL up to 2m bgl which were undertaken on 28/03/2025. Both test pits were very similar in nature with the only discrepancy being the depths of the overlying loess soils above dense alluvial deposits.

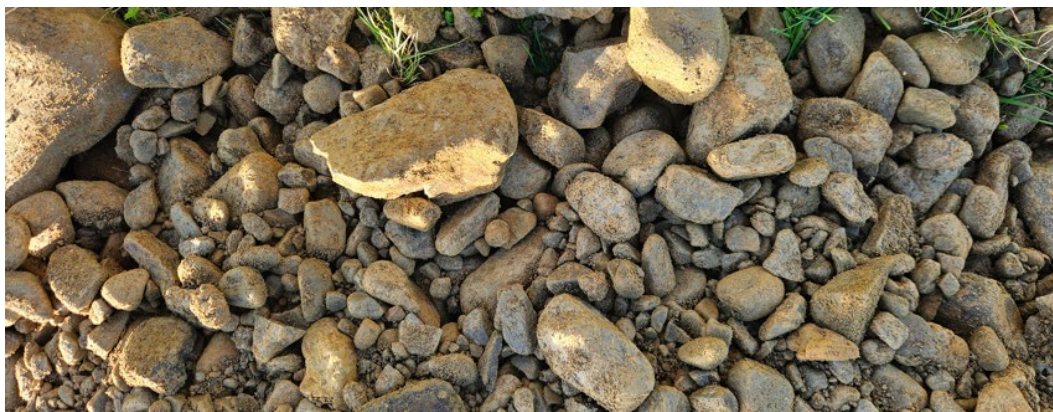
Table 1: Test Pit 1 & Scala A, Lot 3, 161 Gladstone Road. Soil classification as per the Field Description of Soil & Rock – NZ Geotechnical Society Inc, Dec 2005

Dense Alluvium deposits of gravels, COBBLES & boulders in a coarse sand matrix

Soil Type	Depths below existing ground level (egl).	Moisture Condition	Density Index (Relative Density) Terms
TOPSOIL with grass & rootlets, dark brown, friable	0 – 0.3m	Dry	Loose
Silty CLAY (loess), brown, firm, trace orangey mottles	0.3 – 1.2m	Dry	Medium dense to 1m bgl, dense from 1 – 1.2m
Grey silty CLAY, moderately plastic	1.2 – 1.3m	Dry	Very dense
Gravels & COBBLES, trace boulders, sub rounded to sub-angular, brown, iron staining & nodules, silty matrix	1.3 – 1.6m	Dry	Very dense
Gravels, COBBLES & Boulders in a coarse sand matrix, grey, clean, subrounded to sub-angular	1.6 - 3.6m EOH  Practical refusal of the digger at 3.6m bgl in densely packed boulders of greater than 300mm dia.	Damp	Very dense estimated, practical refusal of the scala penetrometer at 1.2m bgl

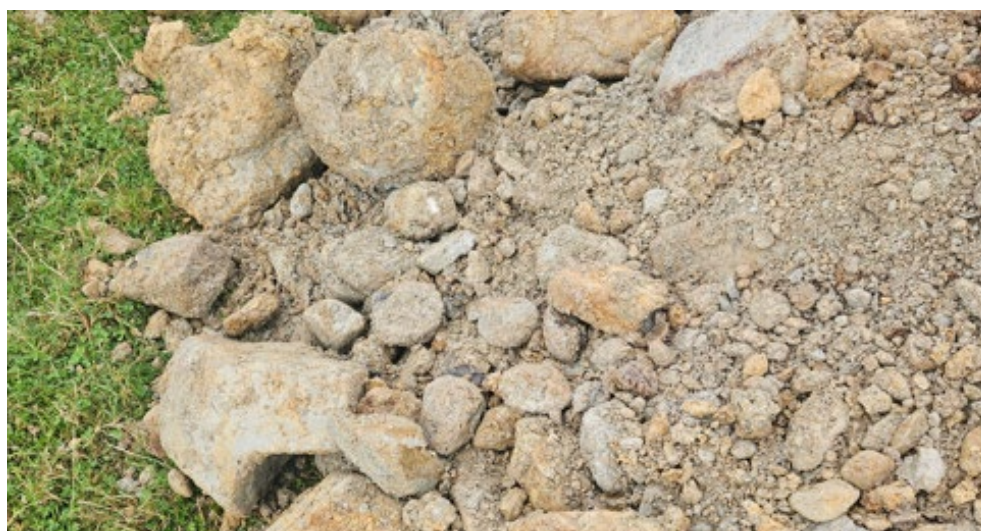
Table 2: Test Pit 2 & Scala I, Lot 1, 169 Gladstone Road. Soil classification as per the Field Description of Soil & Rock – NZ Geotechnical Society Inc, Dec 2005

Dense Alluvium deposits of gravels, COBBLES & boulders in a silty matrix

Soil Type	Depths below existing ground level (egl).	Moisture Condition	Density Index (Relative Density) Terms
TOPSOIL with grass & rootlets, dark brown, friable	0 – 0.3m	Dry	Loose
Silty CLAY (loess), brown, minor gravels, friable, brown	0.3 – 0.5m	Dry	Medium dense
Gravels, COBBLES & boulders in a silt matrix, brown, minor coarse river sand	0.5 – 1.3m	Dry	Very dense, practical refusal of the scala penetrometer at 0.5m bgl in dense river alluvium deposits
Gravels & COBBLES & boulders in a coarse sand & gravel matrix, sub rounded to sub-angular, clean, grey	1.5 – 3.4m EOH Practical refusal of the digger at 3.6m bgl in densely packed boulders of greater than 300mm dia.	Dry	Very dense

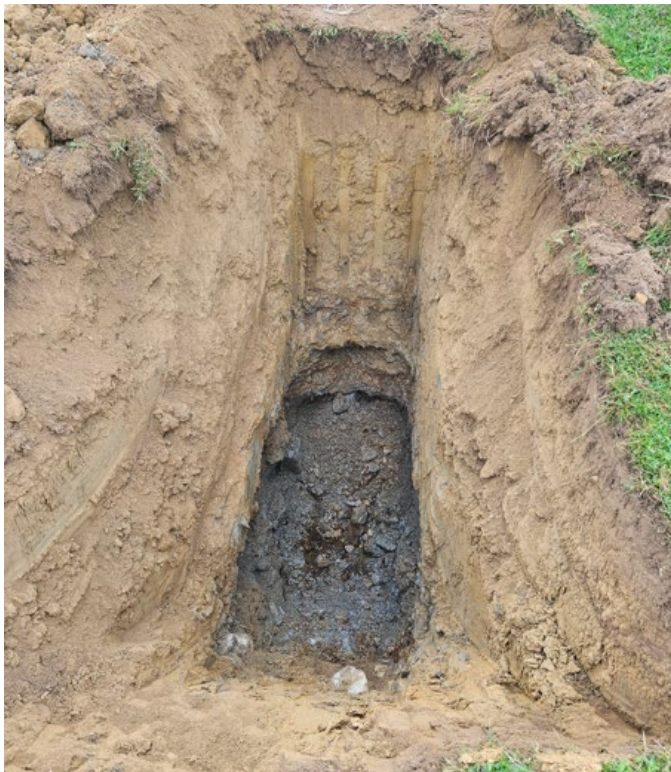
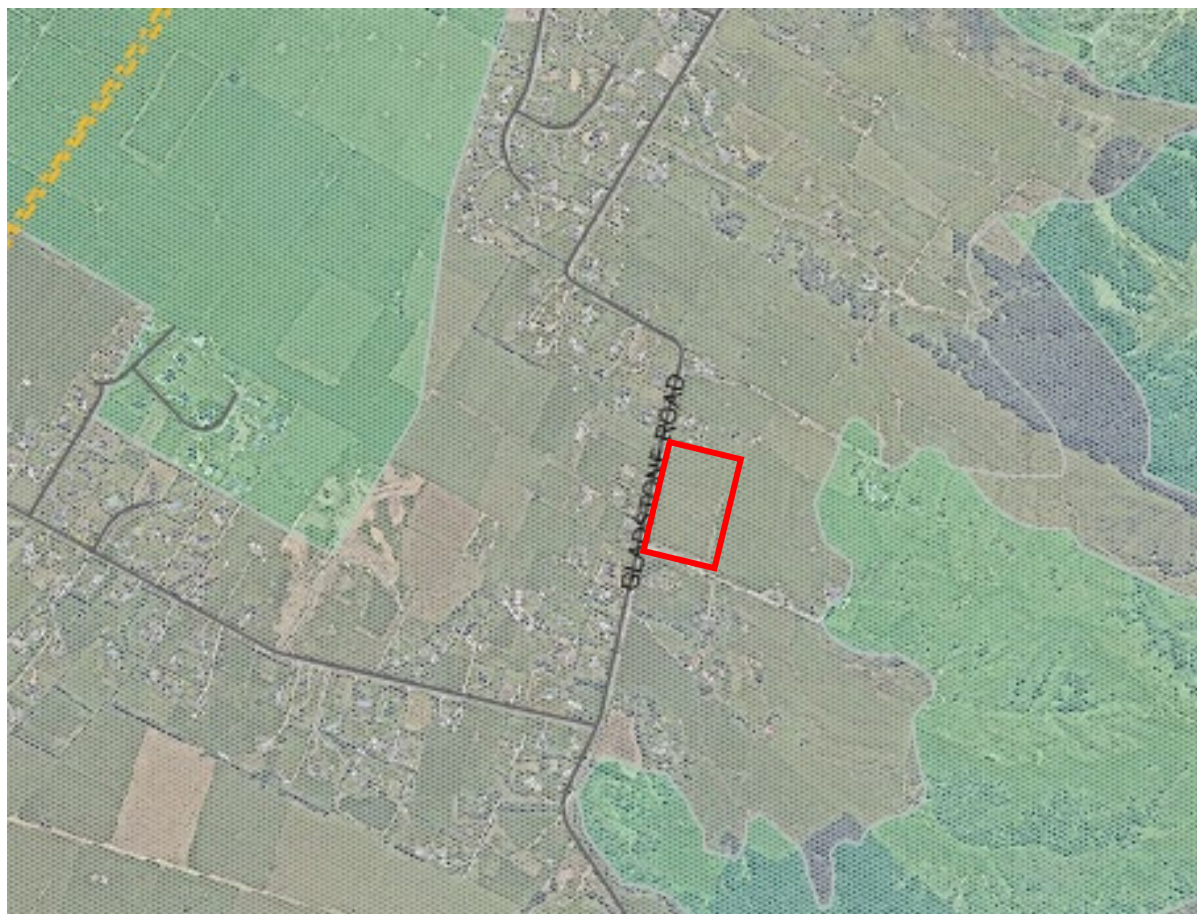
Above is an excerpt from the HDC liquefaction risk hazard mapping showing where the Q2a alluvial deposits between Tararua Road and Queen Street are identified as liquefaction risk unlikely and the location of the Poulton property immediately to the East. Below is the site specific Geology for 167 Gladstone Road as mapped by GNS NZ: [data.gns.cri.nz/geology](https://data.gns.cri.nz/geology) & 1:250,000 Geological Map 10, Wellington.

Damaging seismic induced vertical settlement and lateral spread is generally considered unlikely in older (Pleistocene) alluvial deposits (Q2a) with groundwater deeper than 4m. The Q2a geologic formation identified on this site is expected to be an extension of the Q2a alluvial deposits mapped between Tararua Road and Queen Street East that are identified as having a low liquefaction risk and have been mapped as liquefaction unlikely.
