Land Information Memorandum **L251916**

**Soil Contamination Risk
Preliminary and Detailed Site Investigation Report**

**45 Johnson Road,
West Melton, Canterbury**

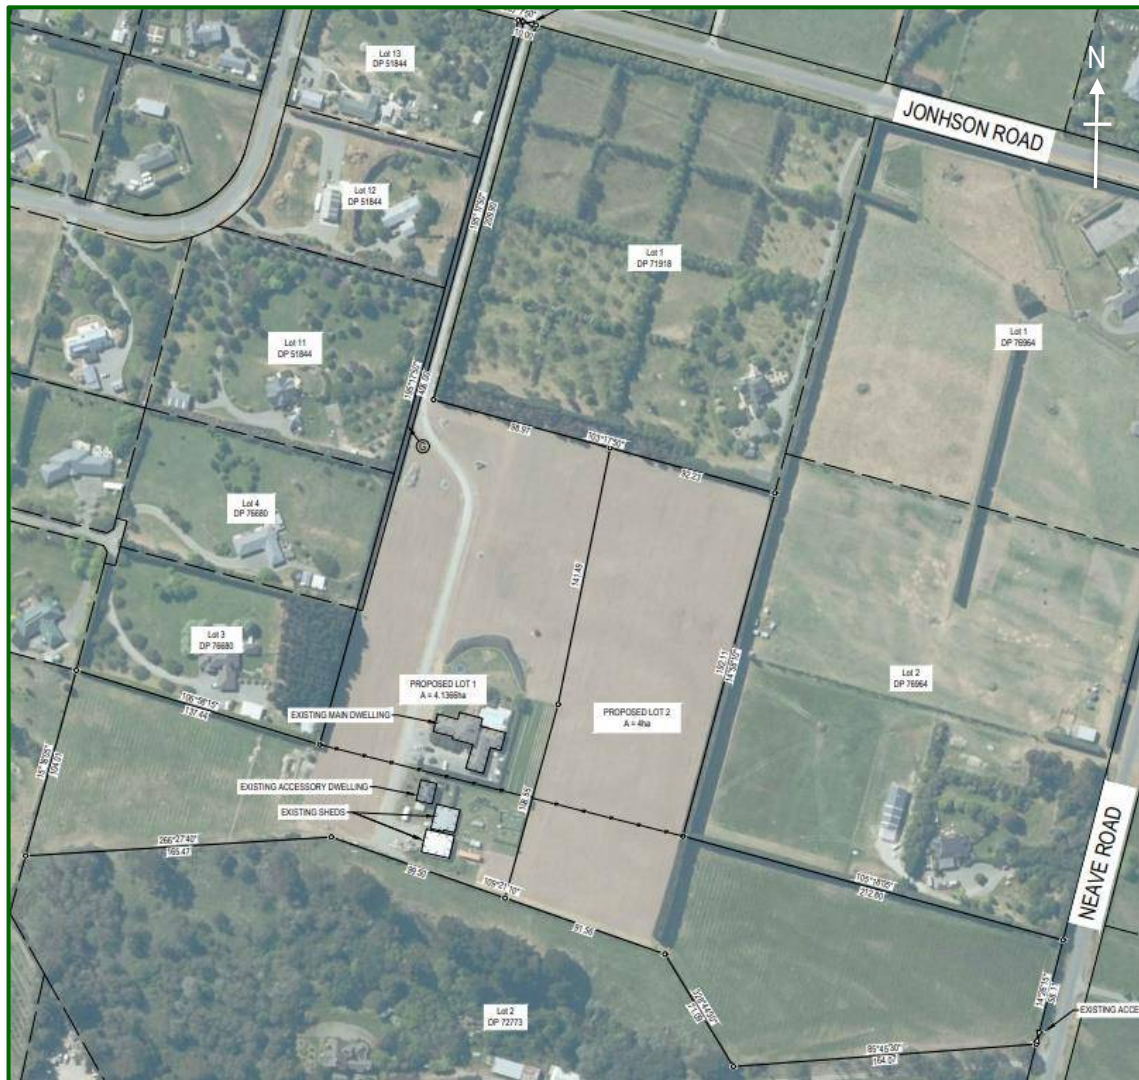
Figure 2 – Proposed Boundary Adjustment Layout

It is proposed to undertake a boundary adjustment, creating a 4ha rural residential lot to the east of the existing dwelling and farm buildings, as shown in **Figure 2** below.

The proposal will involve the subdivision and change of use of the land, future soil disturbance activities and possible disposal of soils off-site.

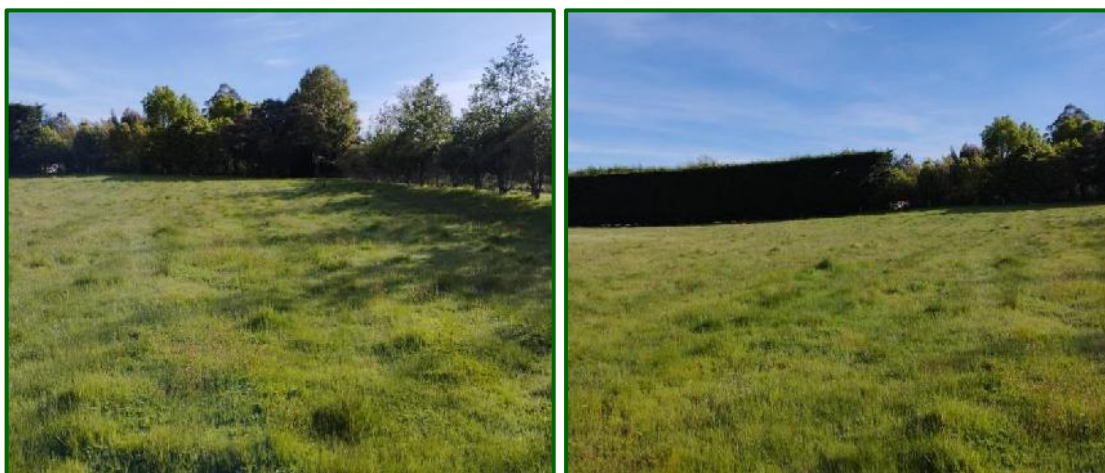
Photo 1 & 2 – Proposed Lot 2

Proposed Lot 2 consisted of two separate paddocks, both in pasture. There was no evidence of the previous vineyard, such as the CCA treated timber posts. There was no evidence of any other potential source of contamination within proposed Lot 2, such as burn areas or extensive storage. The clients were on site at the time of sampling and stated that they had purchased the property approximately seven years ago and removed the CCA treated timber posts approximately one year after purchasing. The clients stated that the posts themselves were in good condition upon removal and had likely only been in-situ for approximately 10 years.

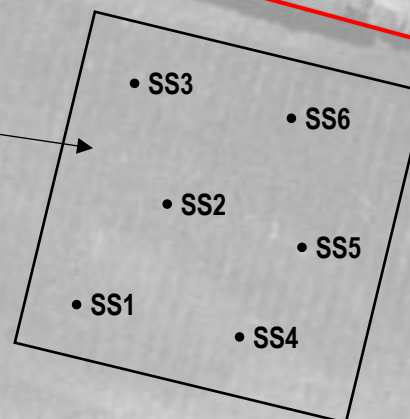
Appendix D – Sample Location Plan

A total of 13 samples, including a duplicate, were collected from six sample locations situated within the residential curtilage area of proposed Lot 2. Surface samples from every sample location were analysed for heavy metals.

Proposed building
platform and residential
curtilage area

A Sample Location Plan is included in **Appendix D**.
