# BUILDING INSPECTION REPORT

# 65 Coopers Road, Dallington.

Property Inspected by Graeme Potts 021 244 1047 graeme.potts@inspectedresidential.co.nz Qualified builder Licensed Building Practitioner National Certificate in Carpentry National Certificate in Construction This inspection was carried out in accordance with NZS4306:2005

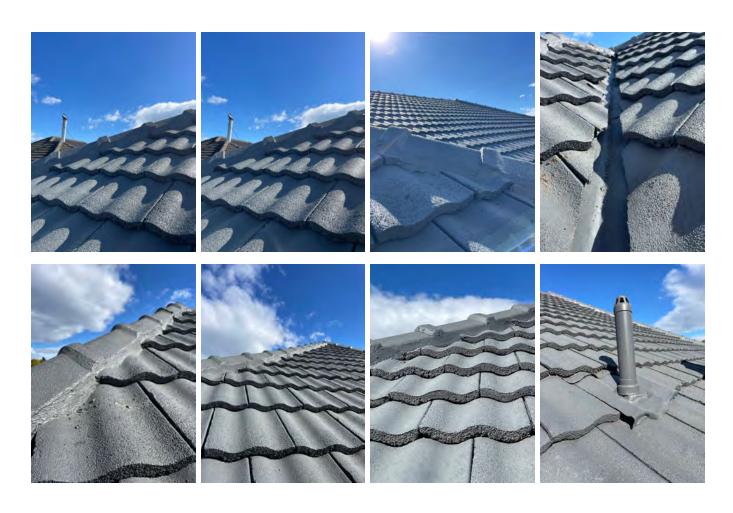
No signs of damage. Free from debris build up. Sufficient overlap. Looks to be sealing and functioning as intended. Penetration flashings are performing as intended.

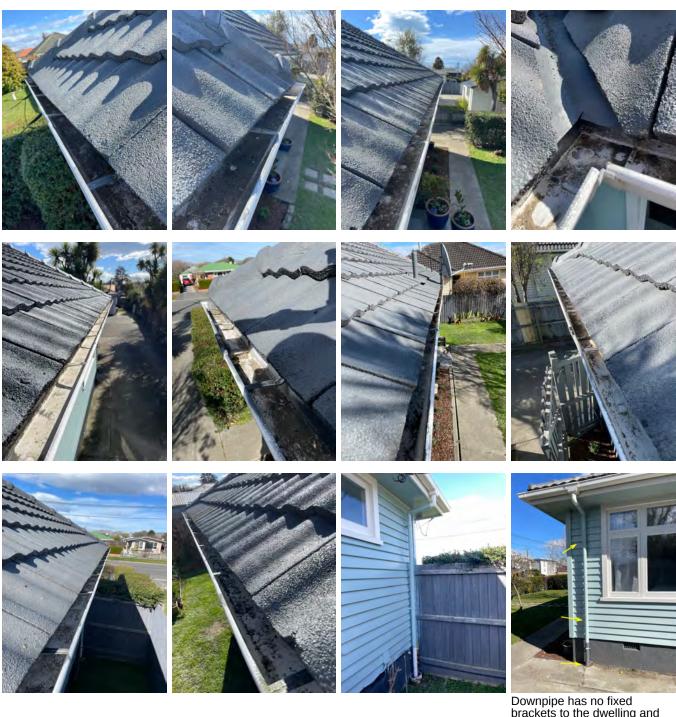
Downpipes on the main dwelling discharge into ground risers. Gutters and downpipes clear from debris build up. It is noted that the stormwater risers visible are earthenware/clay piping; earthenware pipes are more susceptible to damage from seismic activity than PVC. Seismic activity can cause some breakages or cracks to occur in the pipes under the ground.

Downpipe has no fixed brackets to the dwelling and the stormwater riser is not visible above the pathway, this could have a raised surround added to prevent debris entering the storm water system.

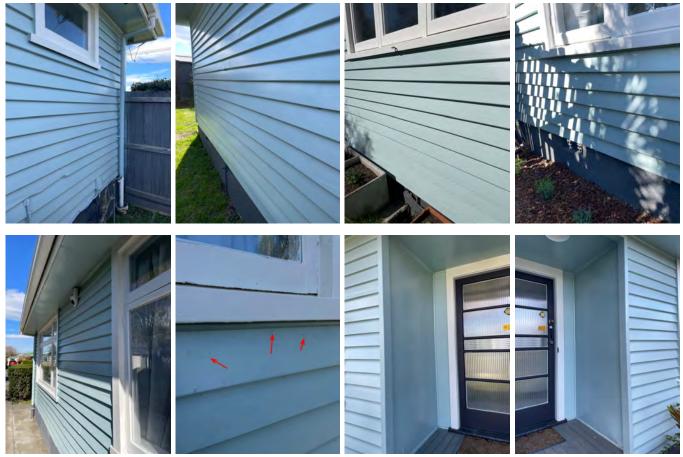
The exterior cladding is aging and has been well maintained with paint to help prolong the life of the material.

Example of signs of borer noted in the exterior cladding timber. Typical of dwelling from this age.

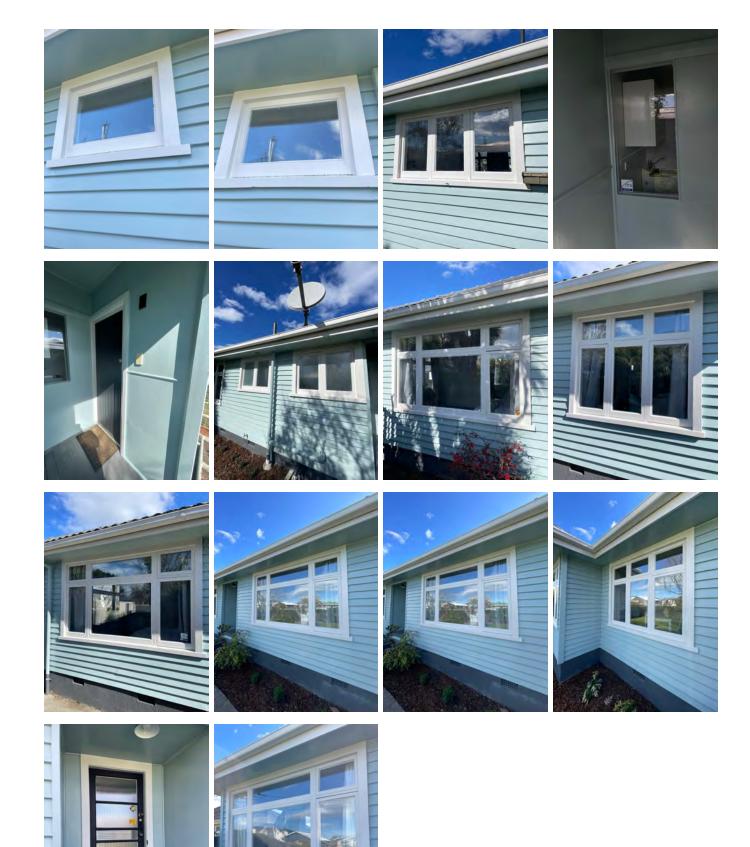
Exterior joinery comments are based on a visual assessment only; testing of the joinery function is found in the interior section of this report. Recently repainted. No general concerns

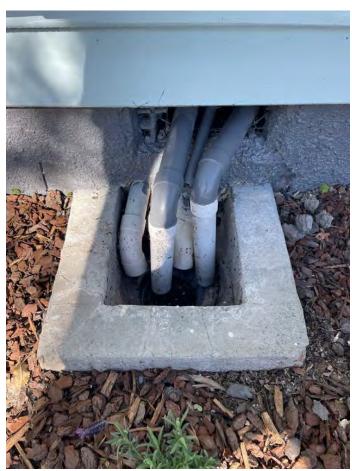
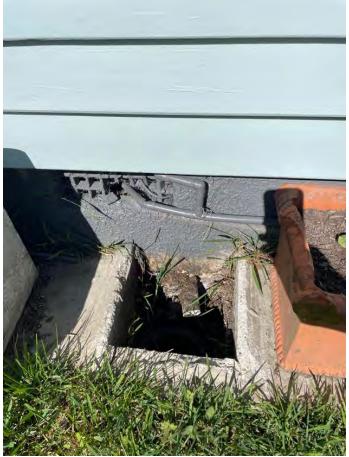
Gully traps are sufficient height off finished ground level. A grate should be installed onto the traps to prevent debris entering the grey water system. It is noted that the gully traps visible are earthenware/clay piping; earthenware pipes are more susceptible to damage from seismic activity than PVC. Seismic activity can cause some breakages or cracks to occur in the pipes under the ground.

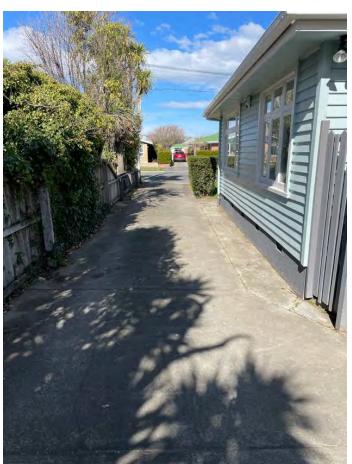
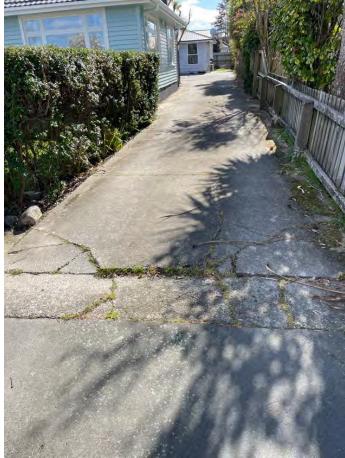
Cracking noted. General aging. Typical of its age.

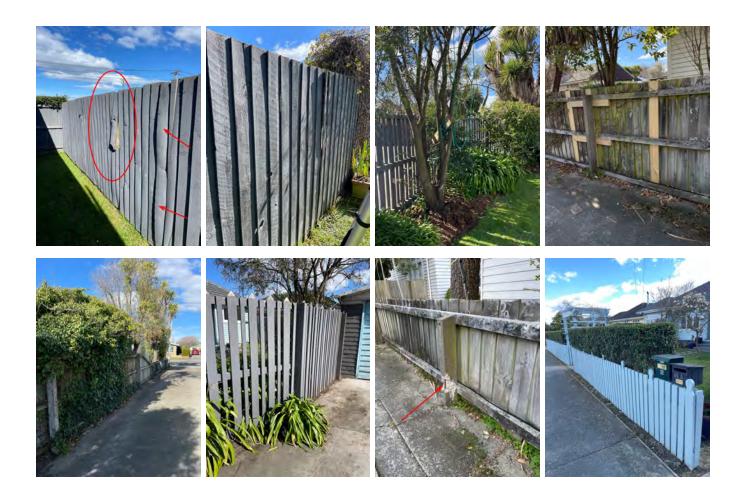
Some sections of fences are aged. Some general deterioration to the fencing, requiring some repairs and maintenance. See photo examples.

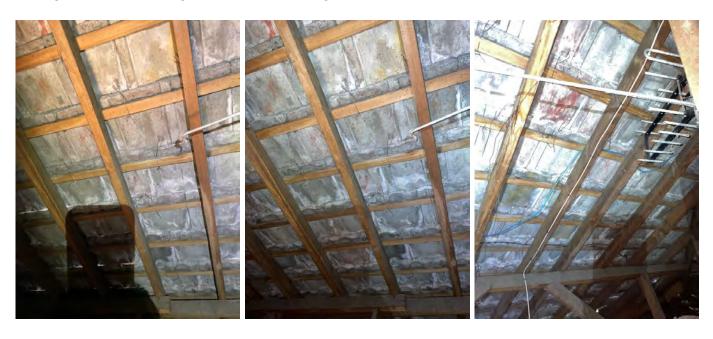
No signs of moisture ingress observed. No general concerns found.

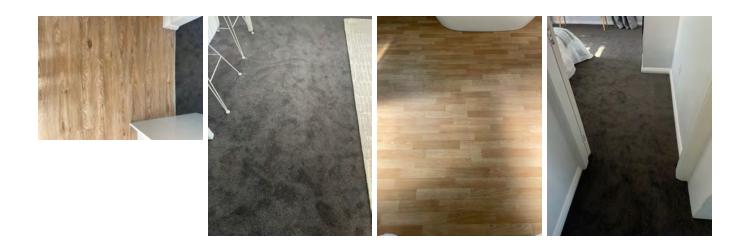
No obvious stains. Looks to be undamaged. Floor coverings look to be new with no concerns.

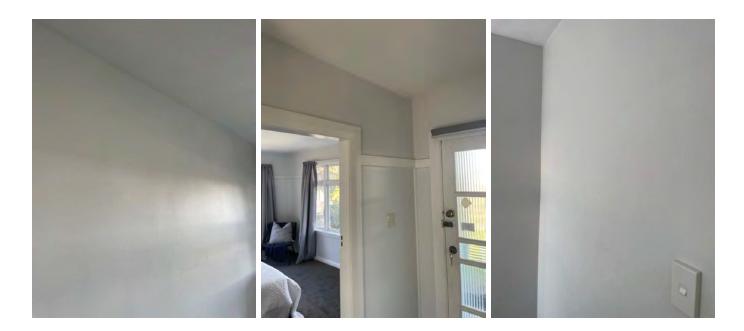
Looks to have been recently repainted. Typical of its age, no major concerns.

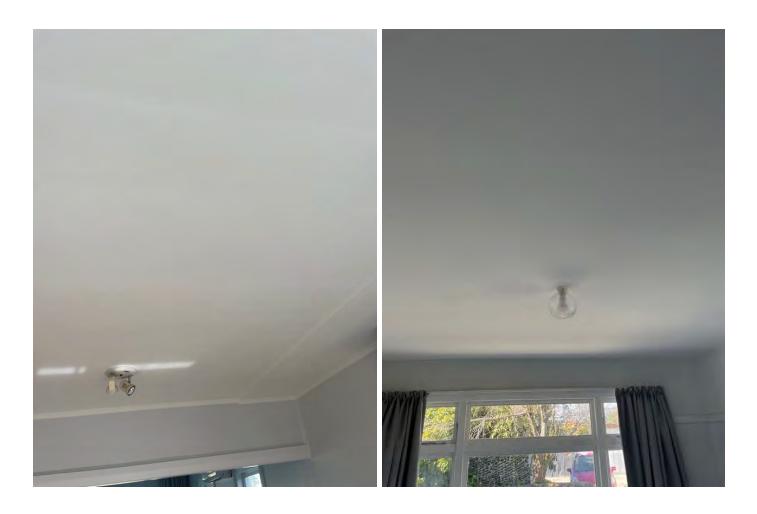
Looks to be recently painted. Typical of its age. No major concerns noted.

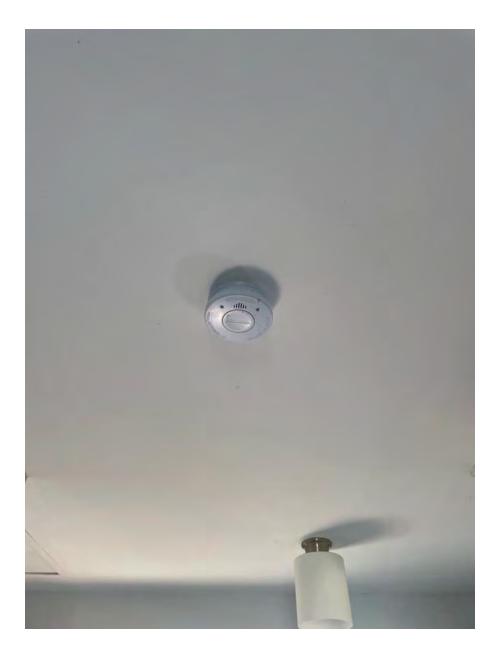
To comply with rental regulations and good practice, it is recommended that photoelectric smoke alarms be installed within 3 metres of every bedroom door or every room where someone sleeps. There should also be at least one on every level or storey of the home. Please use government agency online resources for further requirements to ensure you are complying with best practices. No testing was done during this inspection.

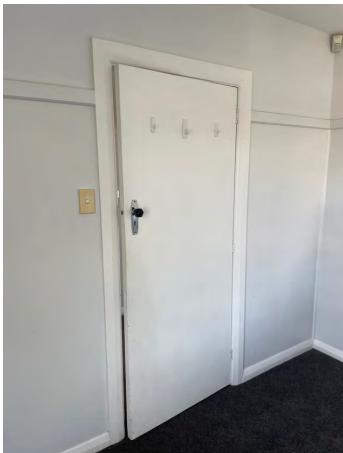
Doors are functioning fine, with no attention or adjustments needed.

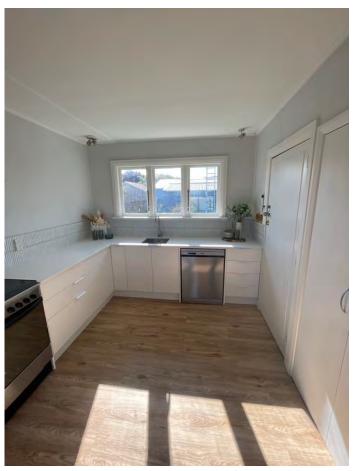
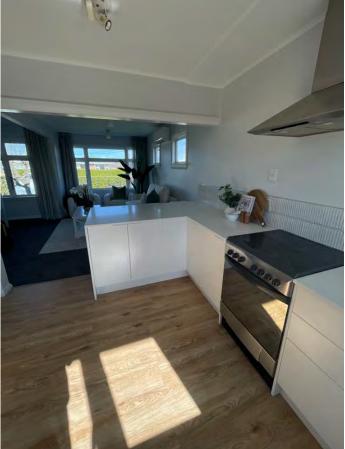
No adjustments needed to cabinetry.

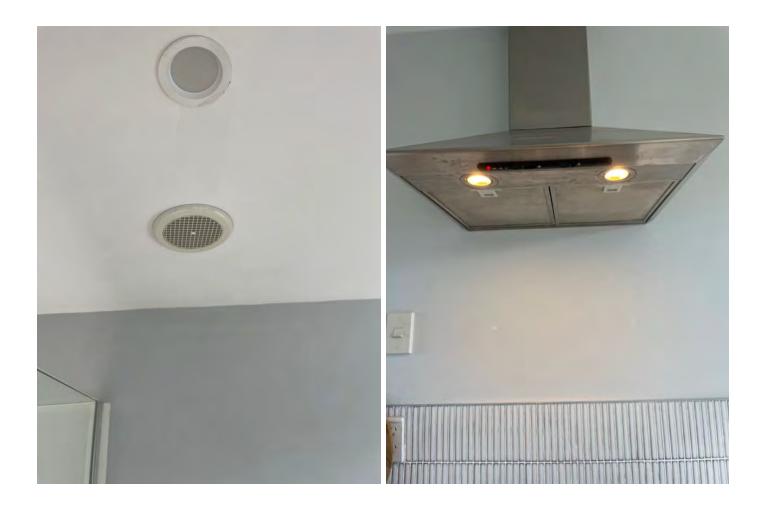
Powered on and appears to be operating fine. Extractors appear to be ducted externally.

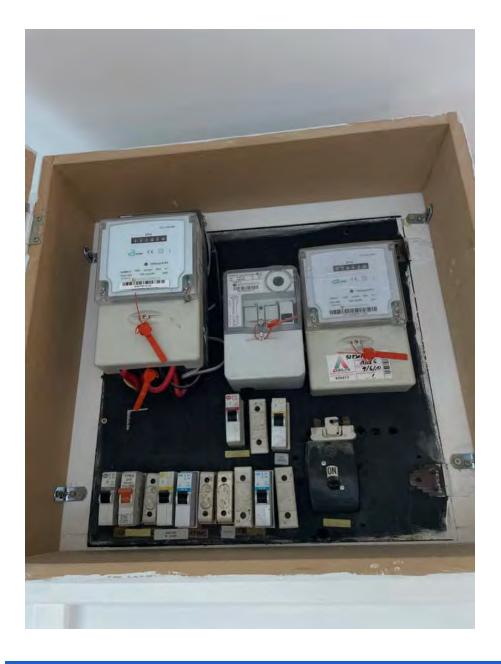
Modern meter box. Somewhat dated switchboard Looks to have been professionally installed. No signs of excess heat build up.

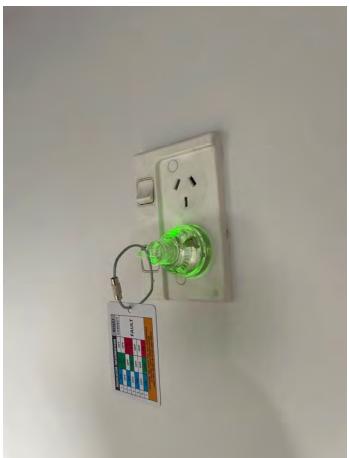
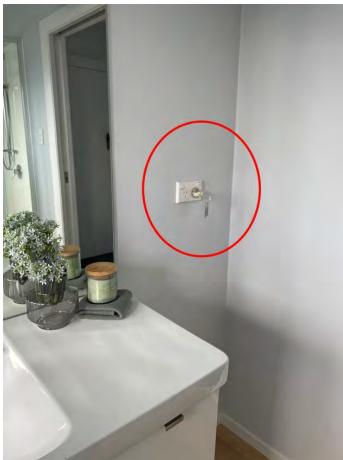
Please note that only sockets that were readily visible and accessible and had nothing plugged into them at the time of inspection were tested; any others are excluded from this report. Two power sockets in the bathroom were not working at the time of inspection.

Two power sockets in the bathroom were not working.

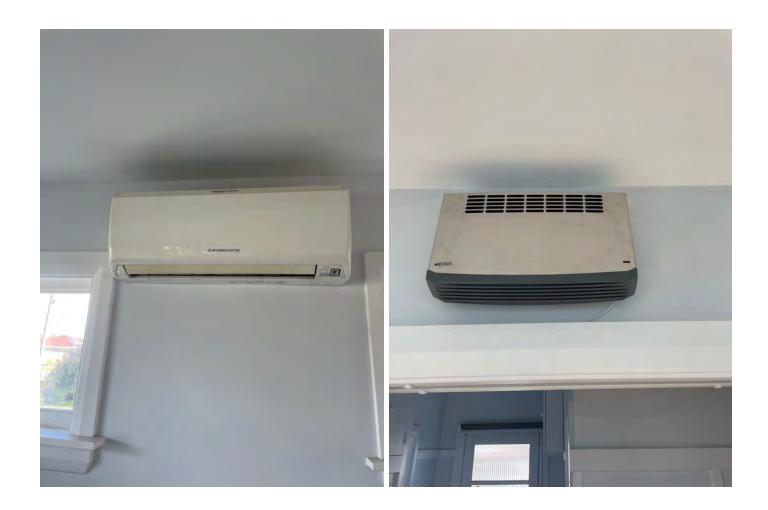
Looks to have been professionally installed. No testing of these elements was carried out during this inspection. Please consult a suitably qualified specialist for testing of these elements.
