# WOODSMAN

## Specifications, Installation and Operating Instructions for the: Coleridge & Coleridge Legs

**PROPOSED RELEVELLING PLAN  
32 NICHOLLS STREET  
RICHMOND, CHRISTCHURCH**

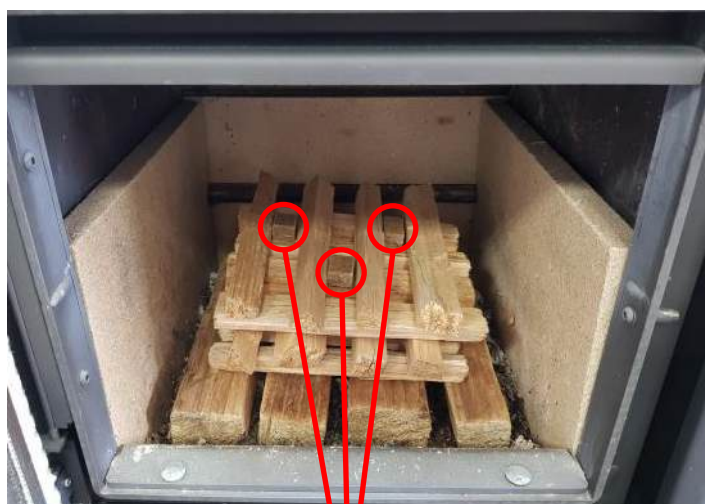
Then stack the 16 pieces of kindling wood in a 'cross stack' style on top of the intermediate load 1 with the 3 fire lighters placed on top of the kindling wood as shown.

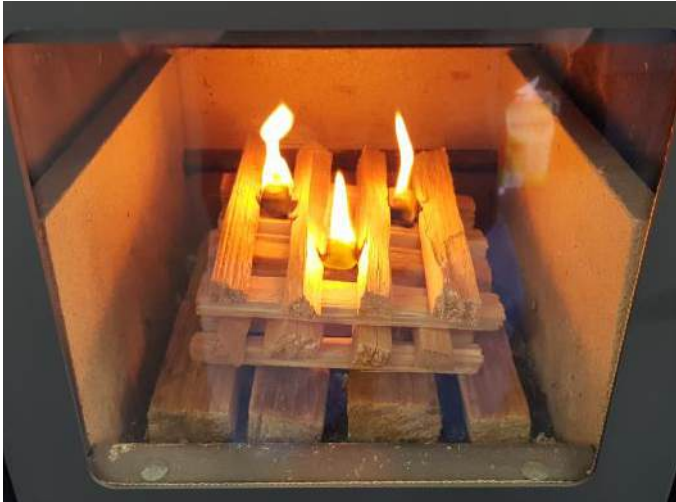
### Step 2. Light the fire lighter cubes

Light the 3 fire lighter cubes. Once the fire lighters have caught well alight, the main door can be fully shut.

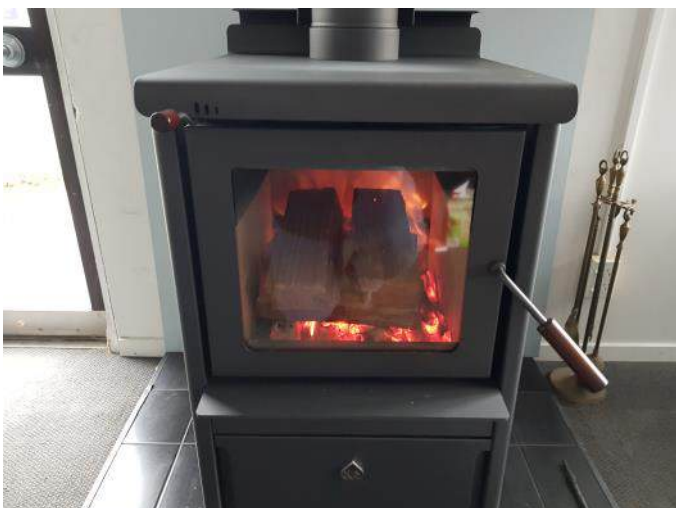
### Step 3. Load intermediate load 2 (4 pieces)

After approximately 30 minutes (or when the fire has burned down to red embers with minimal yellow flame), the fire is ready for the next load.

Load the '**intermediate load 2**' onto the embers and close the door.

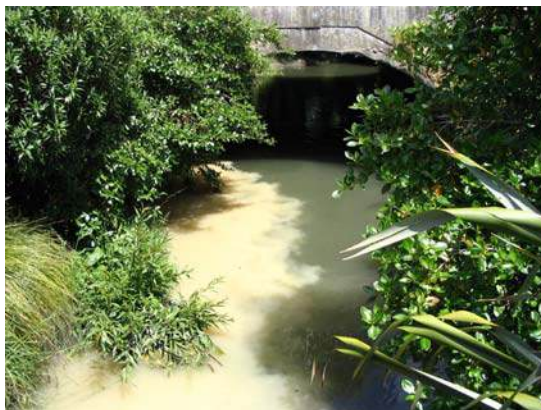
The lack of effective controls on a site caused this discharge of sediment into the Cashmere Stream.

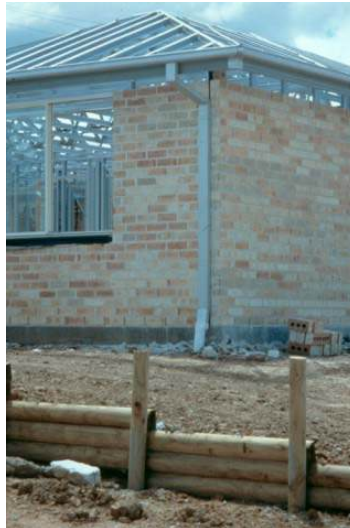
Permanent downpipes installed and connected into the stormwater system prior to the roof cover installation.

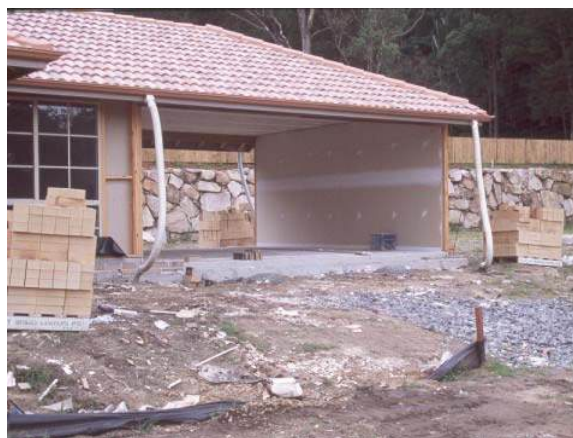
Temporary downpipes connected into the stormwater system with stabilised all-weather access. However the sediment fence needs urgent maintenance.

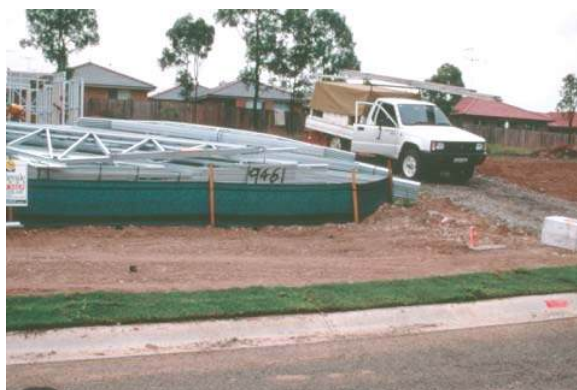
The site above shows sediment fencing along low side of site, with end returns to hold water and sediment. Building materials are stored within sediment control zone with a stabilised all-weather access and a turf filter strip behind kerb and channel.

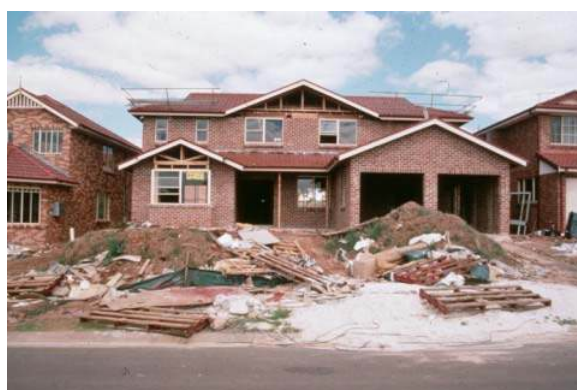
This site is an example of excessive surplus material stockpiled onsite with a sand stockpile outside the sediment control zone, in kerb and channel. The sediment fence also requires urgent maintenance.

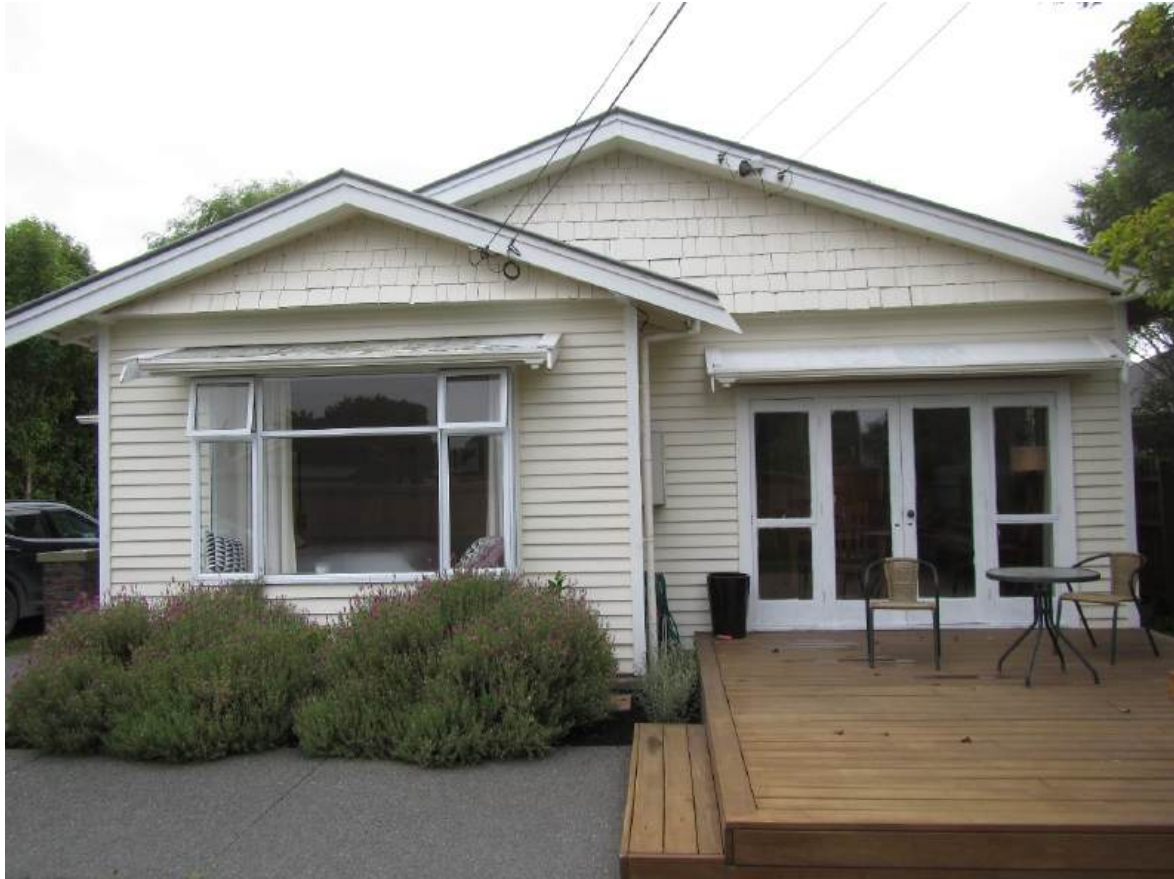
Figure 1: West elevation; deck added and paving constructed since the earthquakes.

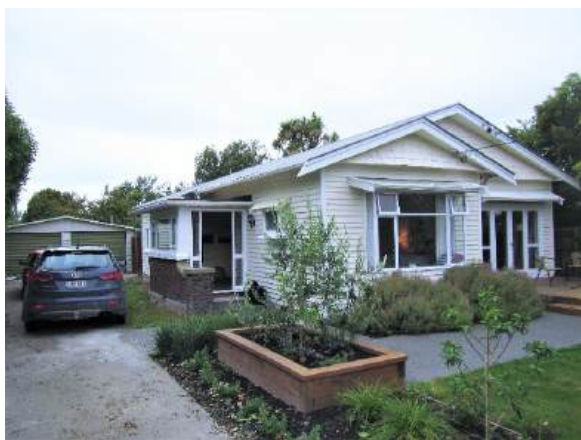
| No# | Photo | Comments |
|---|---|---|
| 1. | | Northwest View:<br>Exterior timber weatherboard cladding on timber framed walls, with corrugated roof and concrete ring foundation. |

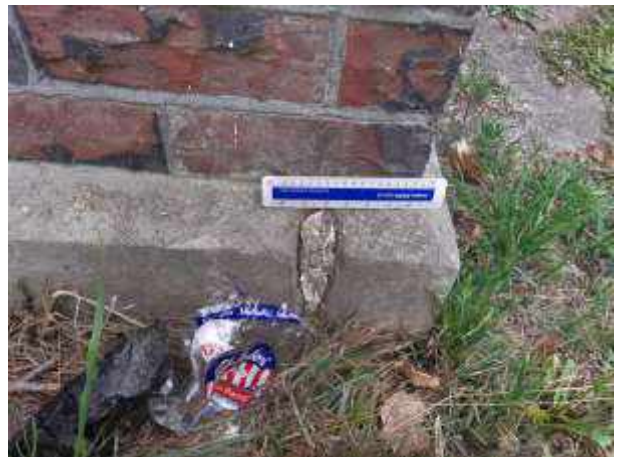
*Repaired crack on the porch*

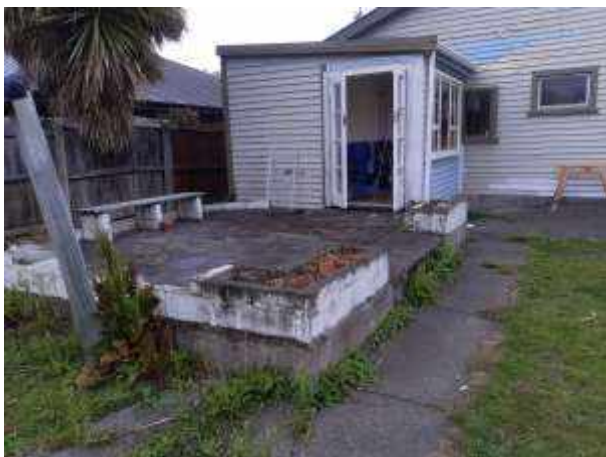
*The extension and concrete deck*
