Land Information Memorandum

4/75 Andover Street

LIM number: H09224028

Christchurch City Council

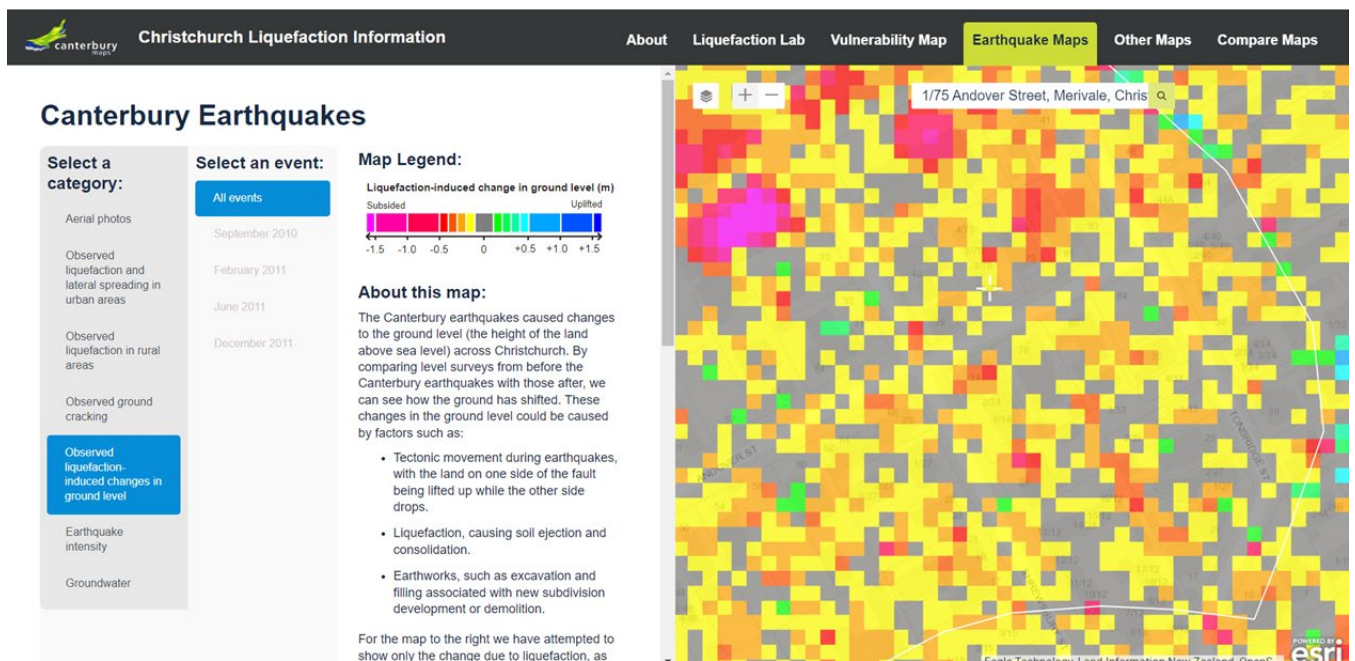
Figure 5: Observed Liquefaction Induced Settlement

Observed liquefaction induced changes in ground level: There are some subsidence in the ground level was registered due to past liquefaction as shown in the figure below. The change is less than 0.20m within this property.

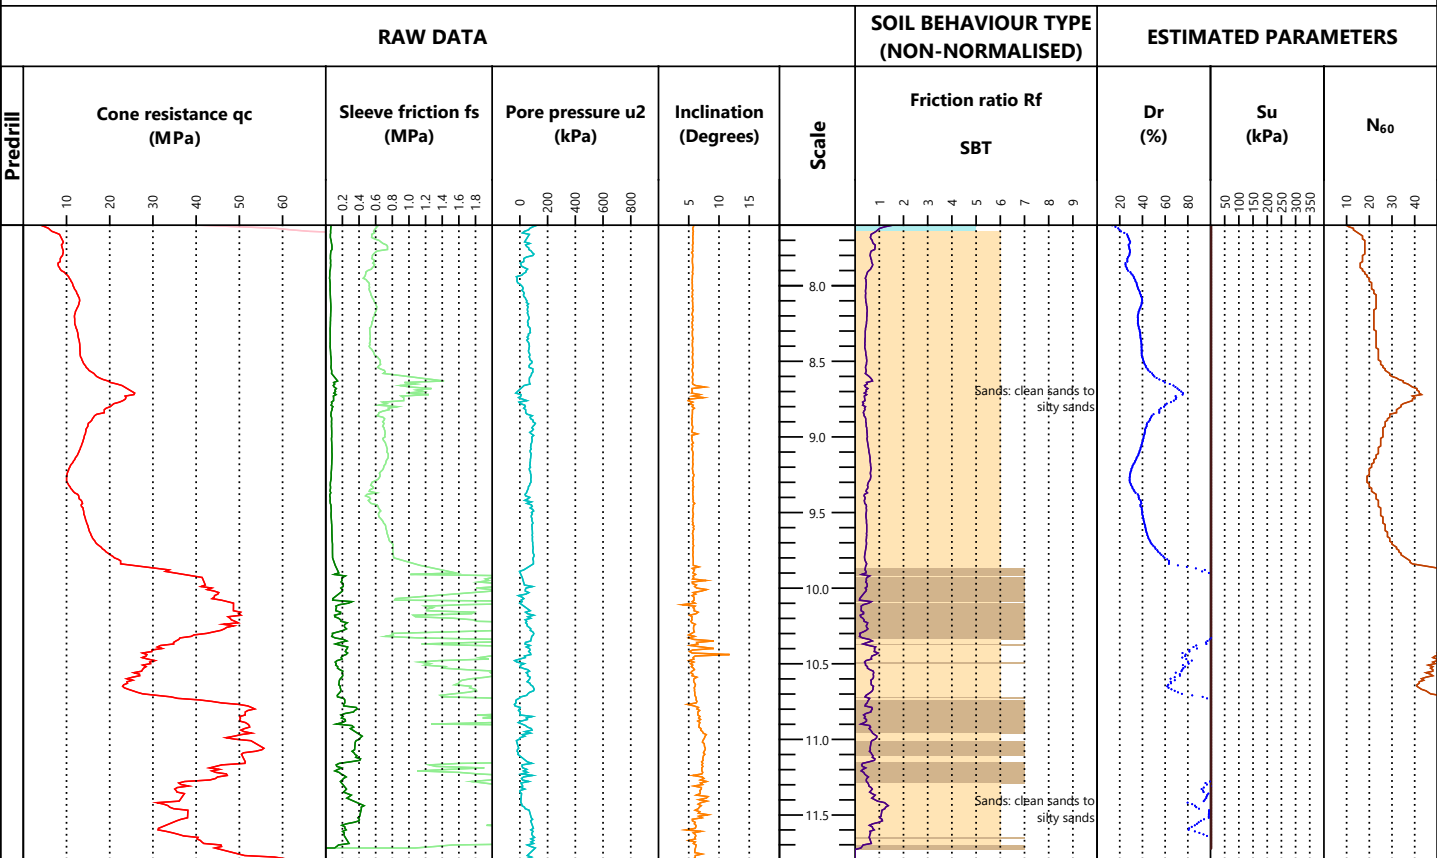
Site Location: 75 Andover Street, Christchurch	Date: 22/9/2022
Grid Reference: 1569614.36m E, 5181507.93m N (NZTM) - Map or aerial photograph	Rig Operator: C. Whitau
Elevation: 0.00m	Equipment: Pagani TG63-150
Datum: Ground

Cone Type: Pagani Piezocone - Compression Cone Reference: MKS365 Cone Area Ratio: 0.81 Standards: ISO 22476-1:2012	Predrill: - Water Level: 1.60m Collapse: 3.50m	Termination Target Depth <input type="checkbox"/> Effective Refusal Tip <input checked="" type="checkbox"/> Gauge <input type="checkbox"/> Inclinometer <input type="checkbox"/> Other <input type="checkbox"/>	Soil Behaviour Type (SBT) - Robertson et al. 1986 0 Undefined 1 Sensitive fine-grained 2 Clay - organic soil 3 Clays: clay to silty clay 4 Silt mixtures: clayey silt & silty clay 5 Sand mixtures: silty sand to sandy silt 6 Sands: clean sands to silty sands 7 Dense sand to gravelly sand 8 Stiff sand to clayey sand 9 Stiff fine-grained
---	---	--	--

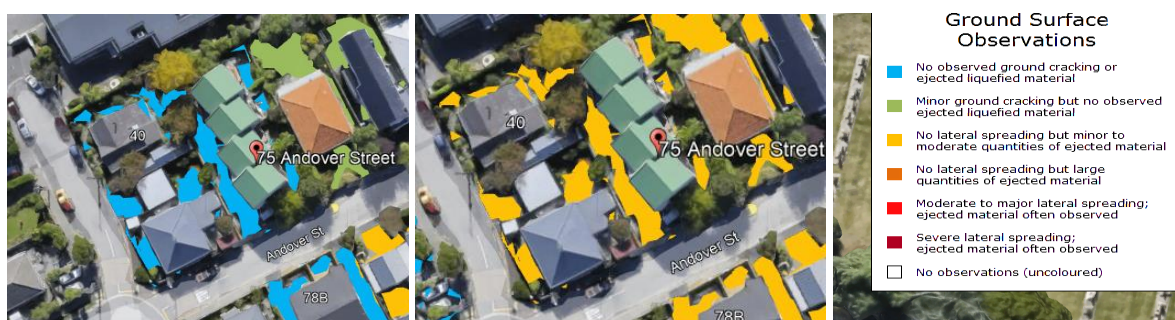
Figure 2. EQC liquefaction and lateral spreading observations obtained from the Canterbury Geotechnical Database.

EQC liquefaction and lateral spreading observations obtained from the Canterbury Geotechnical Database show “No observed ground cracking or ejected liquified material” following the September 2010 earthquake events and “No lateral spreading but minor to moderate quantities of ejected material” following the February 2011 earthquake events.

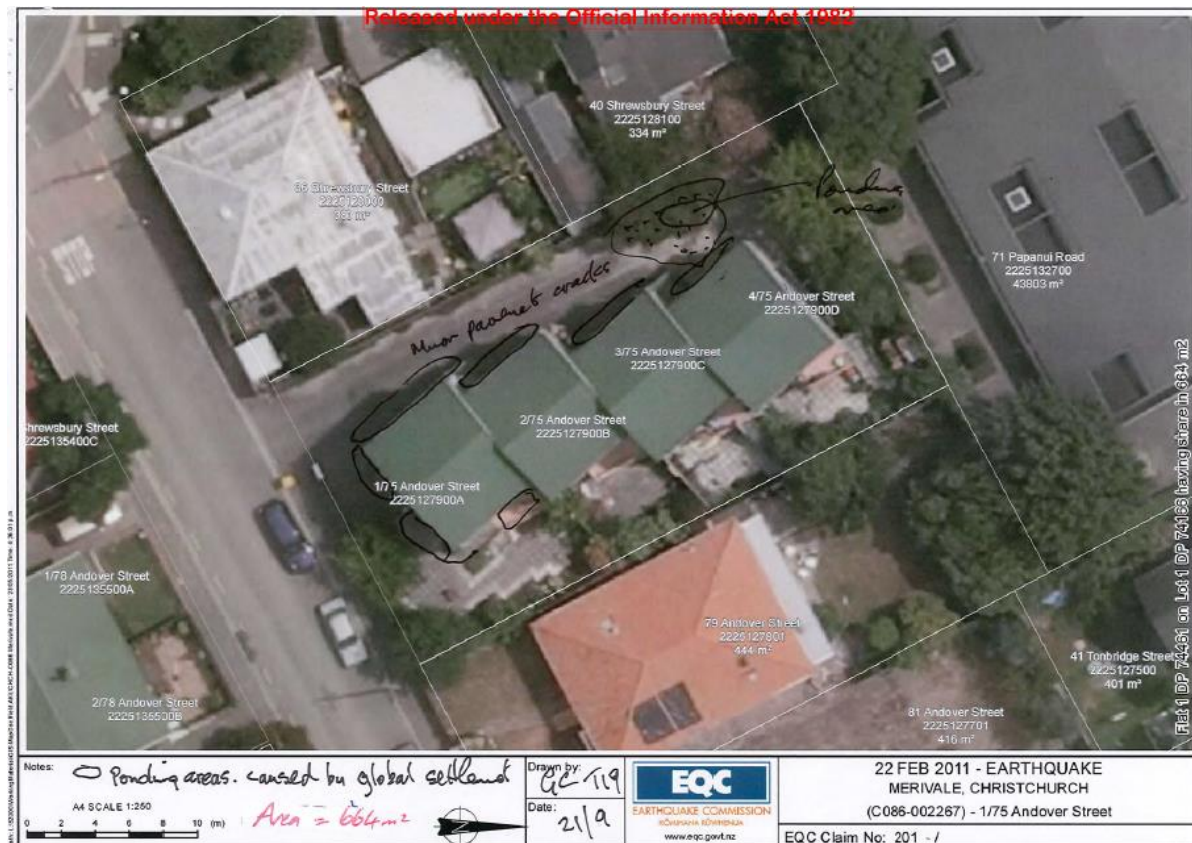
Figure 3. Aerial view of liquefaction observations obtained from Land Engineering Report by EQC.

As per the Land Engineering Report by EQC, dated 21 September 2011, the liquefaction was recorded at the northwest corner of the multi-unit complex.
